NextEra Energy Canada, ULC
Bluewater Wind Energy Centre

Final Water Assessment and Water Body Report

60155032

June, 2012

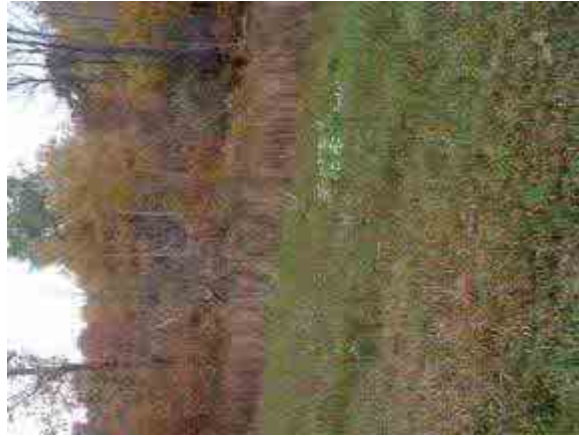
Photograph 1. Site overview ↗

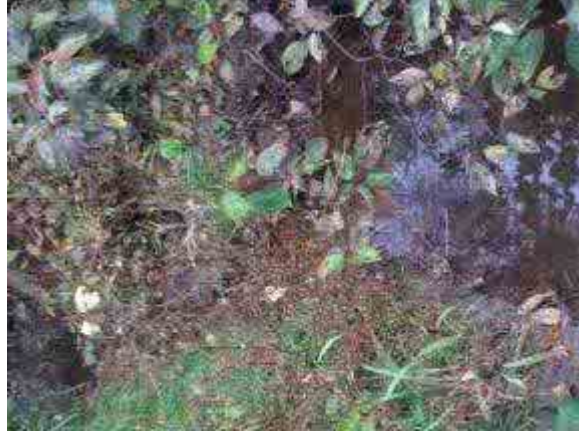
Photograph 2. Channel overview ↗

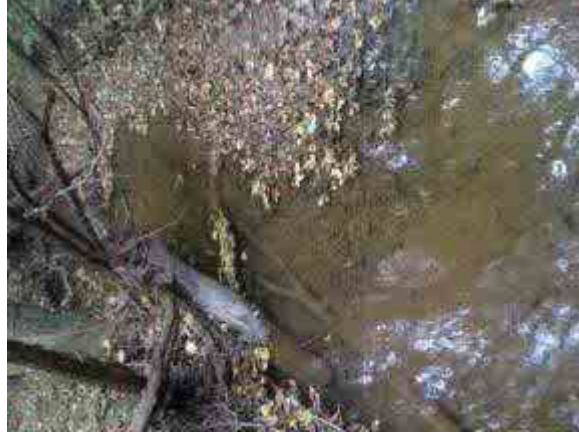
Photograph 3. Channel overview ↗

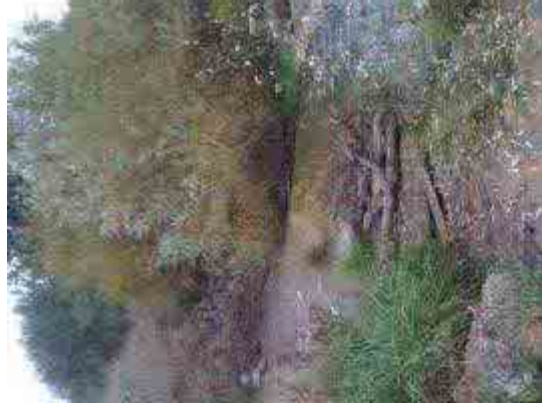
The watercourse is a defined natural feature. It is classified as intermittent by ABCA but during time of investigation water was flowing. It meanders and has a riffle, run, pool sequence. The banks were moderately unstable with evidence of erosion. The substrate is dominated by sand and silt followed by gravel then boulder and cobble. The canopy cover is high and mixed between trees and shrubs. The instream cover is moderate and dominated by woody debris, followed by undercut bank boulders, and aquatic vegetation. Groundwater indicators watercross, iron staining and bubbling were observed. Fish observed during site investigation. Also fish barrier observed – perched outlet.

Photograph 1. Site overview ↑

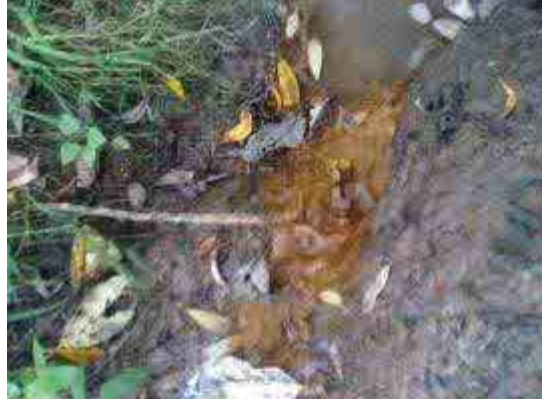
Photograph 4. Iron staining ↑

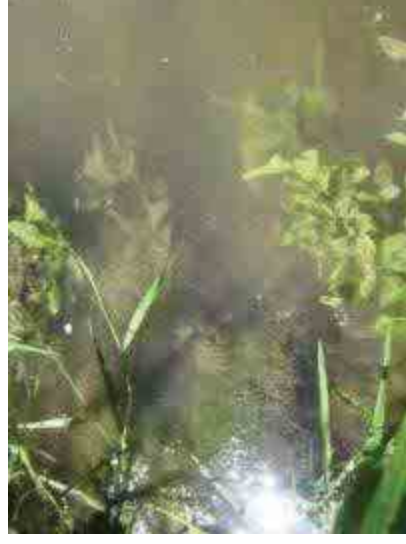
Photograph 3. Watercress ↑

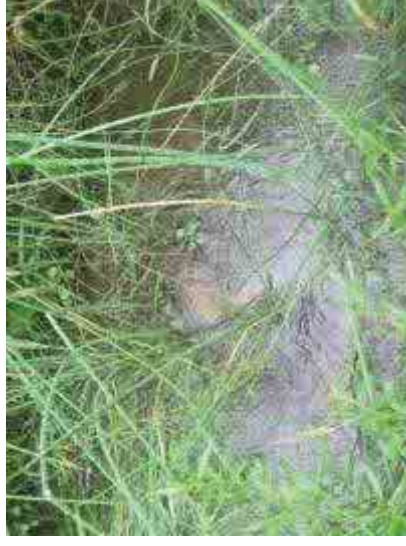
Photograph 3. Watercress on North side ↑

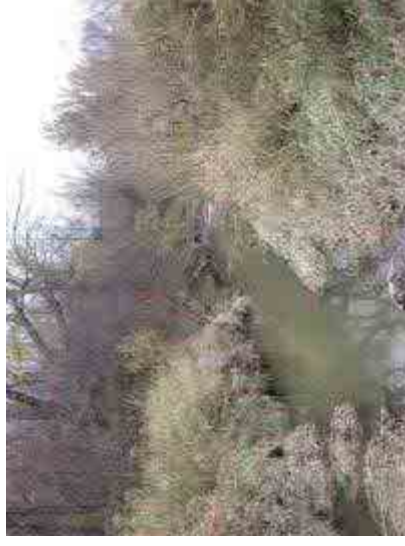
Photograph 3. Beaver dam ↗

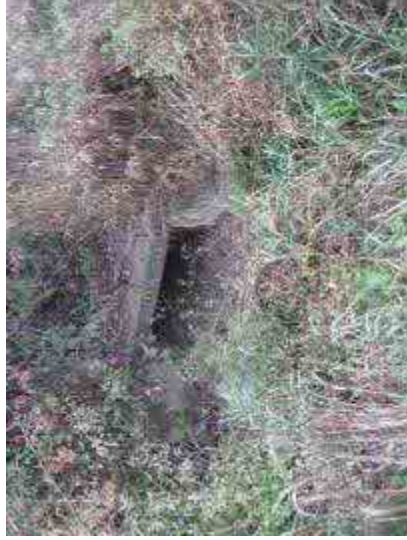
Photograph 1. View of cement culvert ↑

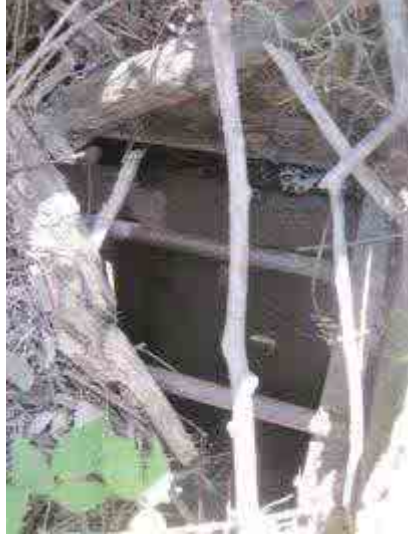
Photograph 2. Tile drain in ditch on north side of Blue Bluff Road. ↑
