Appendix D

Additional Site Investigations Summary Table

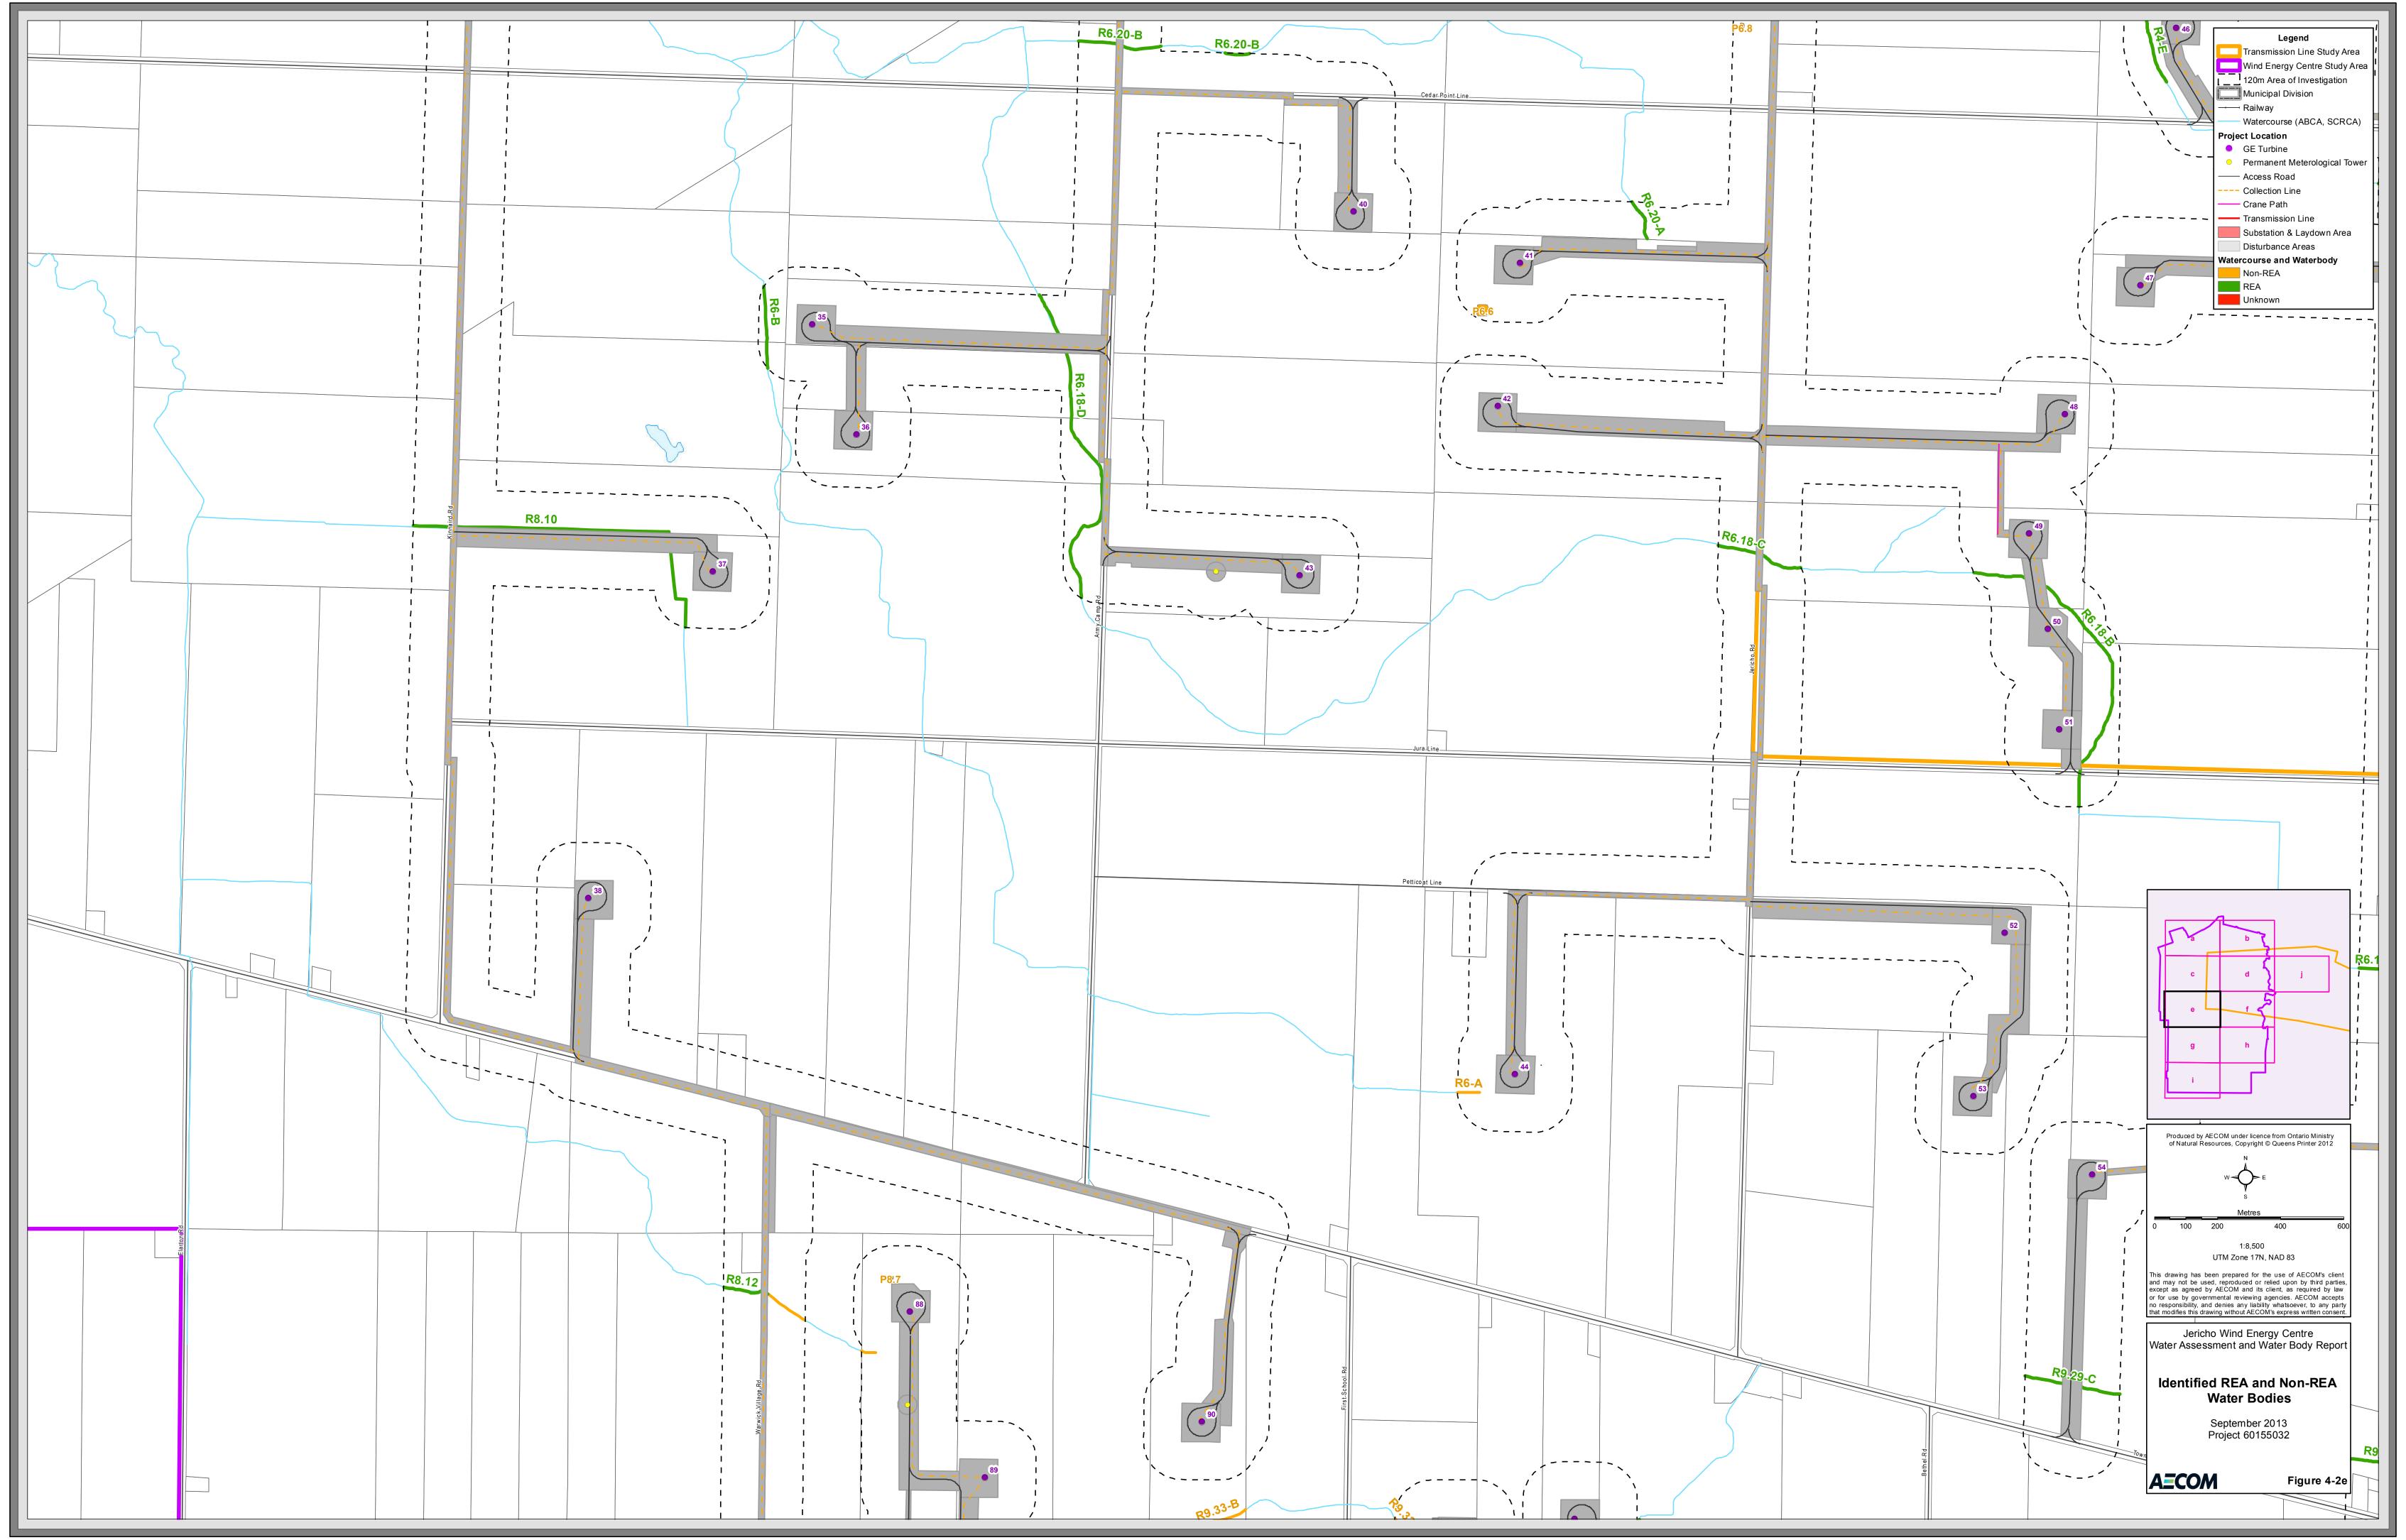
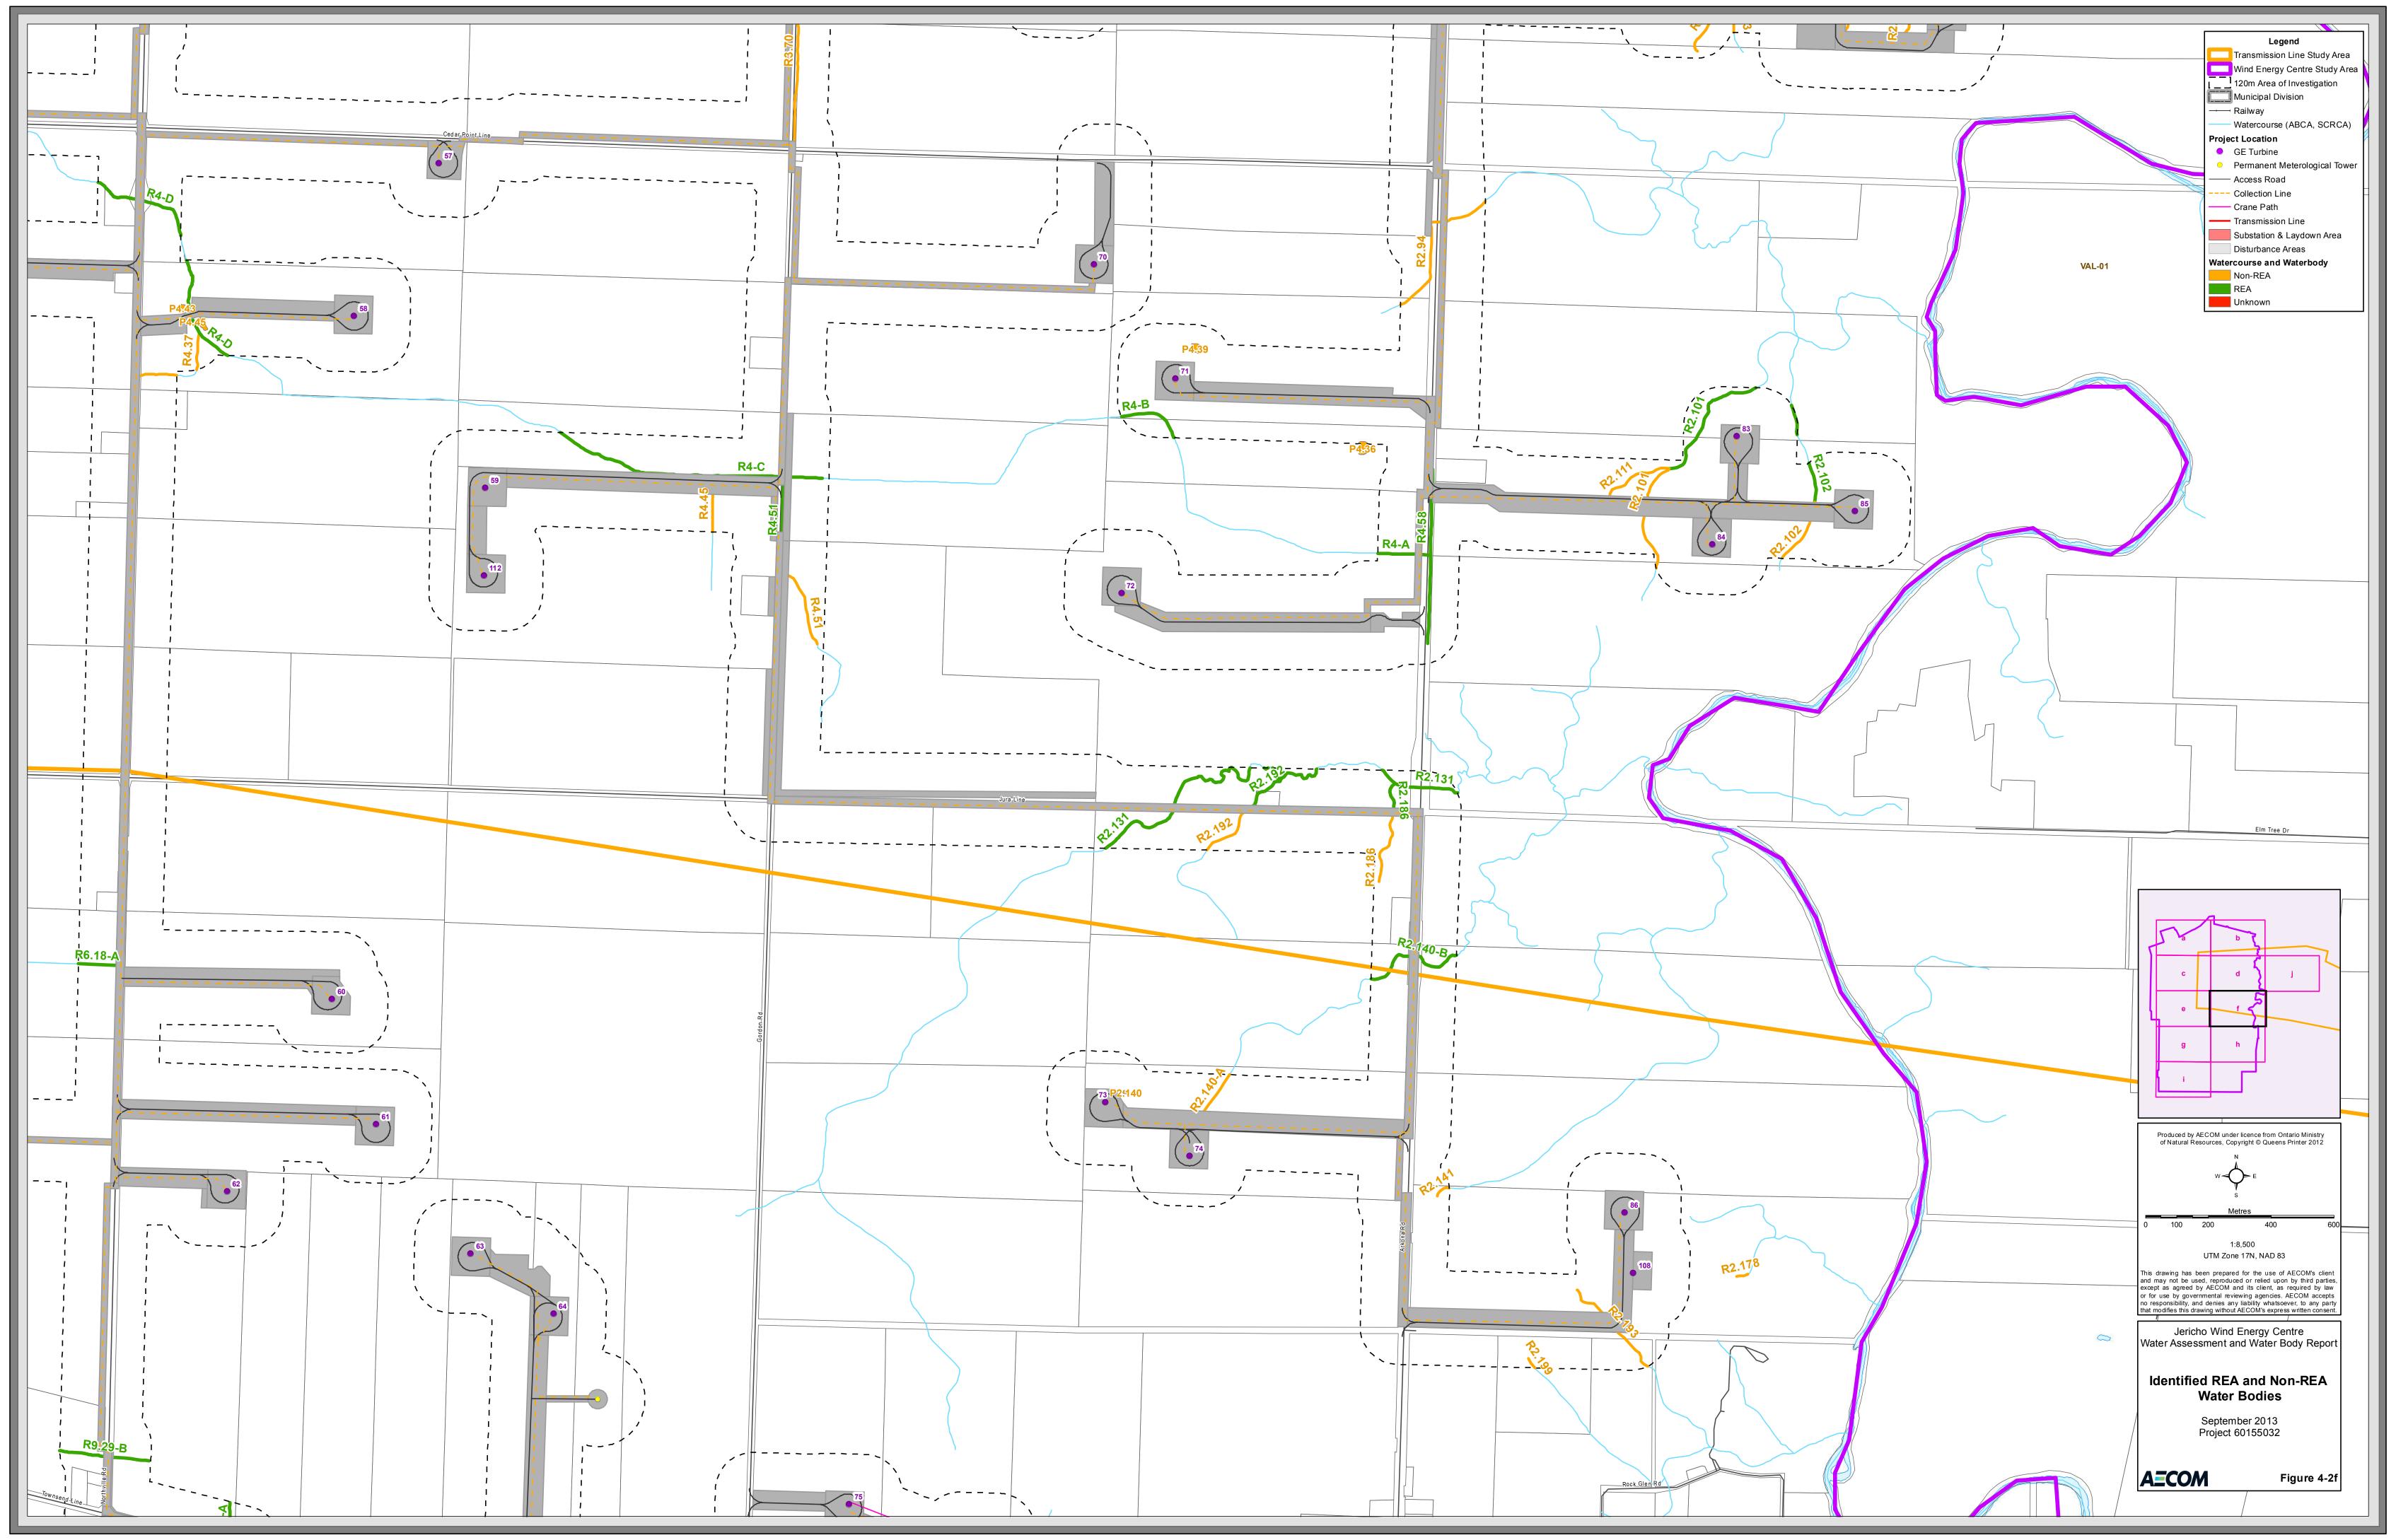
| Feature ID | Project Component | Investigation Date | Description of Site | Feature Descriptions | Feature Sensitivity |
|---|---|---|--|---|---|
| R3-C-1 | Collection Line Buffer | June 19, 2013 | This watercourse runs adjacent to a deciduous forest along Gordon Road, then crosses (south of Widder Road) and runs northwest through the same forest stand. It is channelized along the road then turns into a natural channel after crossing. After road crosses this water course is a natural meandering system with a moderately vegetated bank. The surrounding landscape is slightly sloped and has moderately dense canopy cover. Watercourse Name Decker Creek DFO Drain Classification F | The watercourse is a partially channelized feature that turns into a natural channel downstream. The watercourse is flat with some pooled areas and a natural riffle run sequence. The water was clear and had very slow flow at the time of investigation. Water was cool, with moderate water quality. The banks were slightly unstable and evidence of erosion was observed. Substrate consists mostly of clay, silt and sand with some cobble and a couple boulders. Canopy cover is high consisting mostly of trees and shrubs. Instream cover is moderate and consists of boulder, cobble, very little aquatic vegetation and some woody debris. Minnows were observed during investigation. R3-C-1 R3-C-1 R3-C-1 MWW(m): 0.22 MBW(m): 1 | Moderate |
| | | Photos | | ph 2. Site overview ↑ Photograph 3. View o | f canopy ↑ |
