**B2. Photographic Log of Pre-
construction Dewatering
Monitoring on December 18, 2013**

Appendix B2. Photographic Log of Pre-construction Dewatering Monitoring on December 18, 2013**Monitoring Location M1**

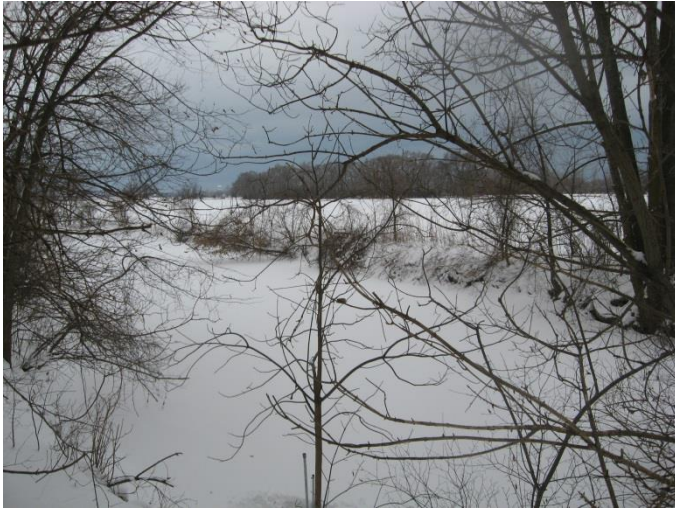
Photograph 1. ↑
Pond and surrounding vegetation covered in snow, facing west.

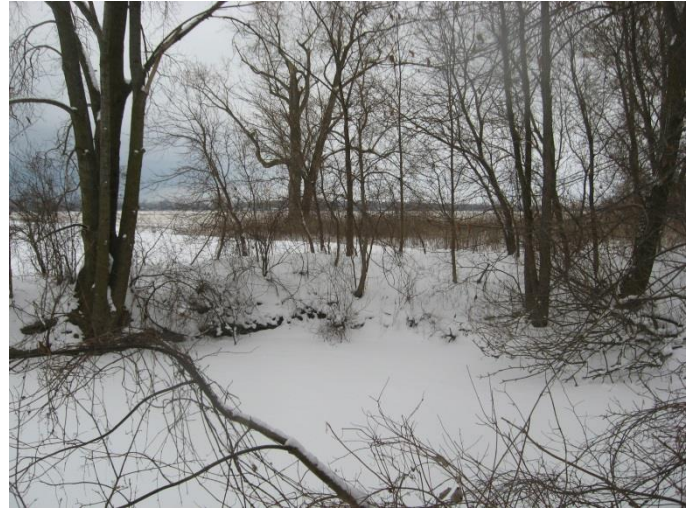
Photograph 2. ↑
East end of pond frozen and covered in snow.

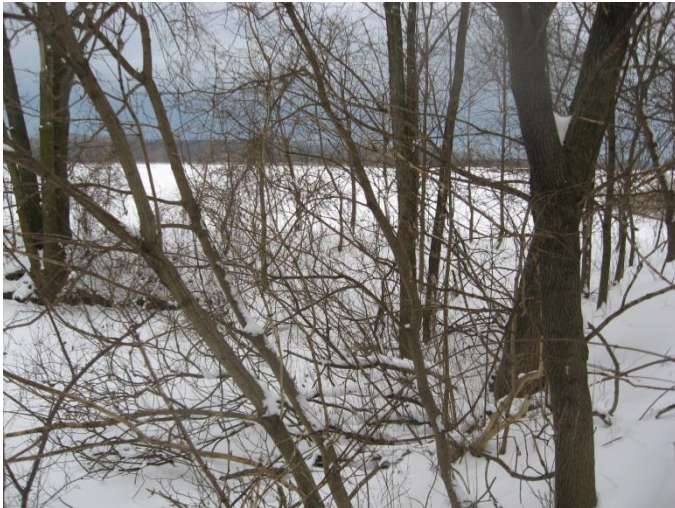
Photograph 3. ↑
Manitoba Maple (*Acer negundo*) trees surrounding pond.

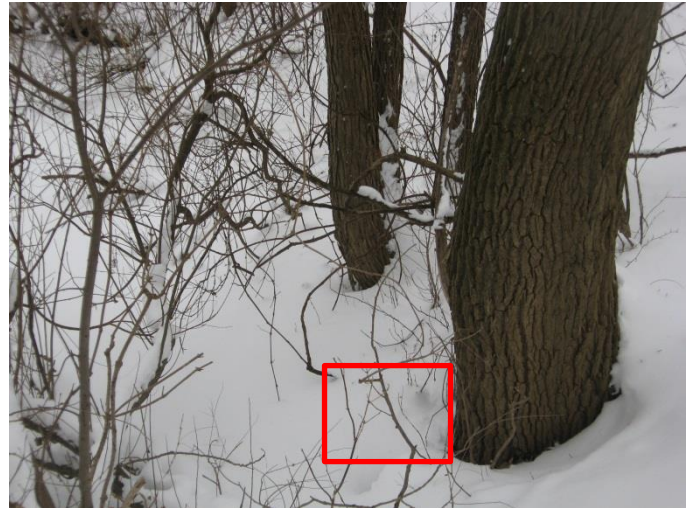
Photograph 4. ↑
Location of culvert on east side of pond covered in snow.

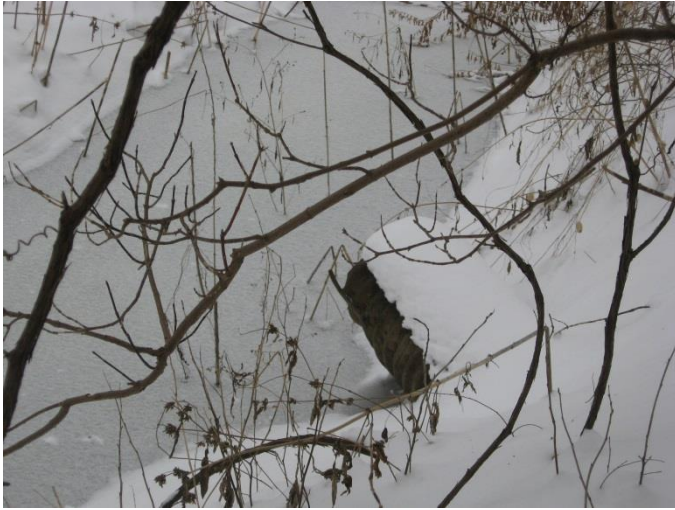
Photograph 5. ↑

Location of culvert draining out into watercourse east of and behind pond. Watercourse behind pond is frozen.

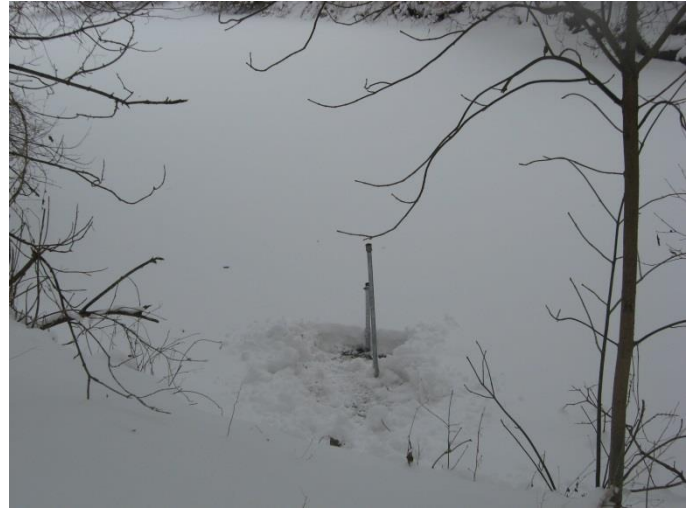
Photograph 6. ↑

Mini-piezometer and staff gauge installed at east end of pond and covered in snow, facing west.

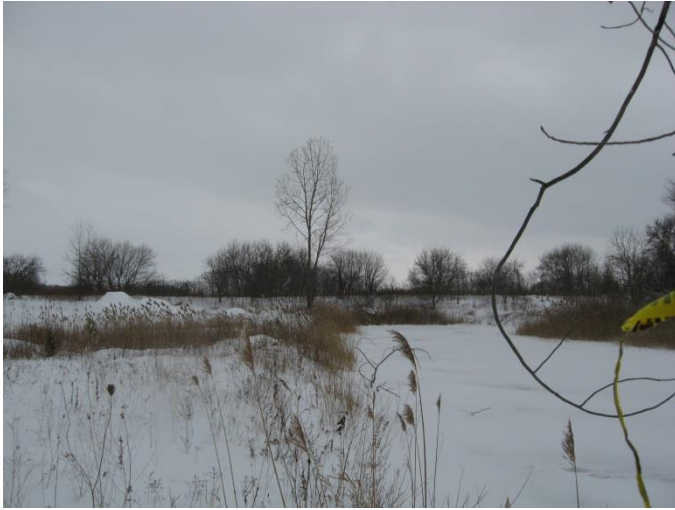
Photograph 7. ↑
Cultural meadows surrounding banks of frozen pond, facing east from monitoring location.

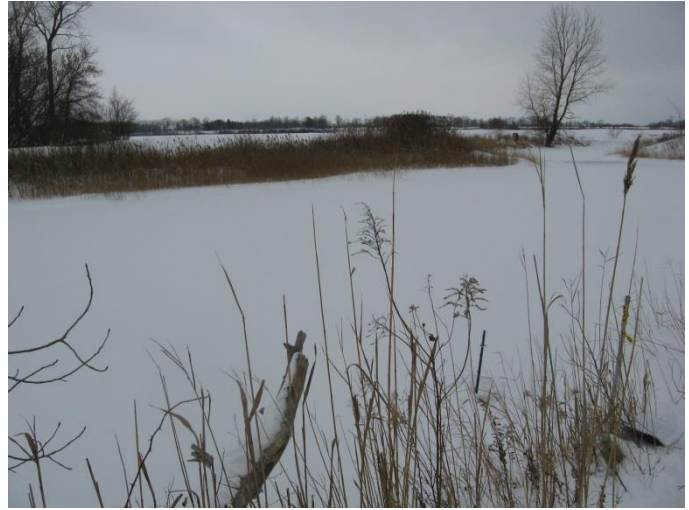
Photograph 8. ↑
Surrounding cultural meadows and Phragmites on banks of pond covered in snow, facing west from monitoring location.

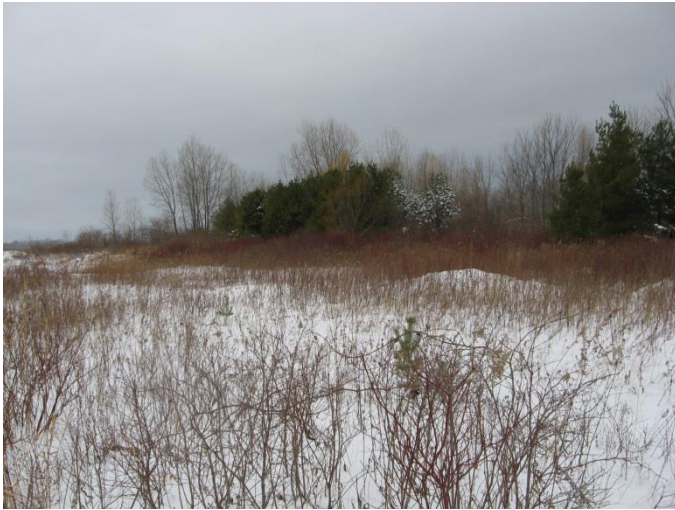
Photograph 9. ↑
Red-osier thicket and cultural meadow on north bank of pond.

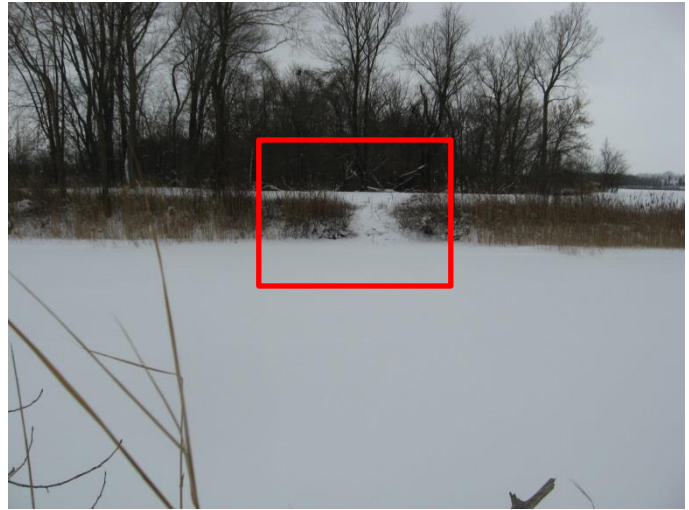
Photograph 10. ↑
Possible snow covered muskrat den located on south bank, across from monitoring location.

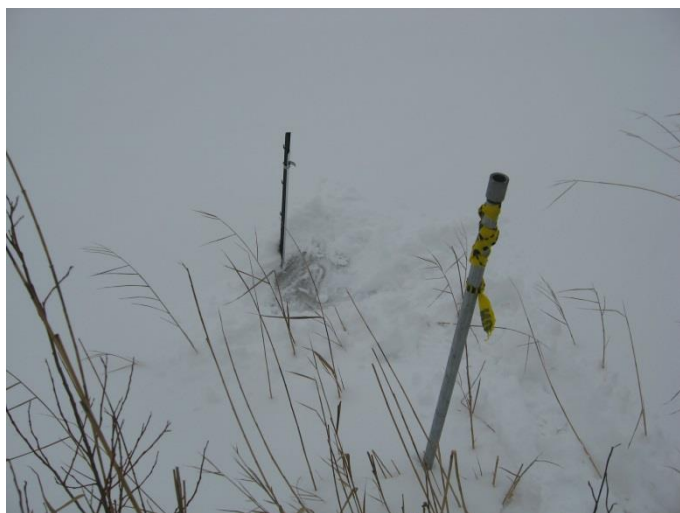
**Photograph 11. ↑**

Mini-piezometer and staff gauge location, ice visible.

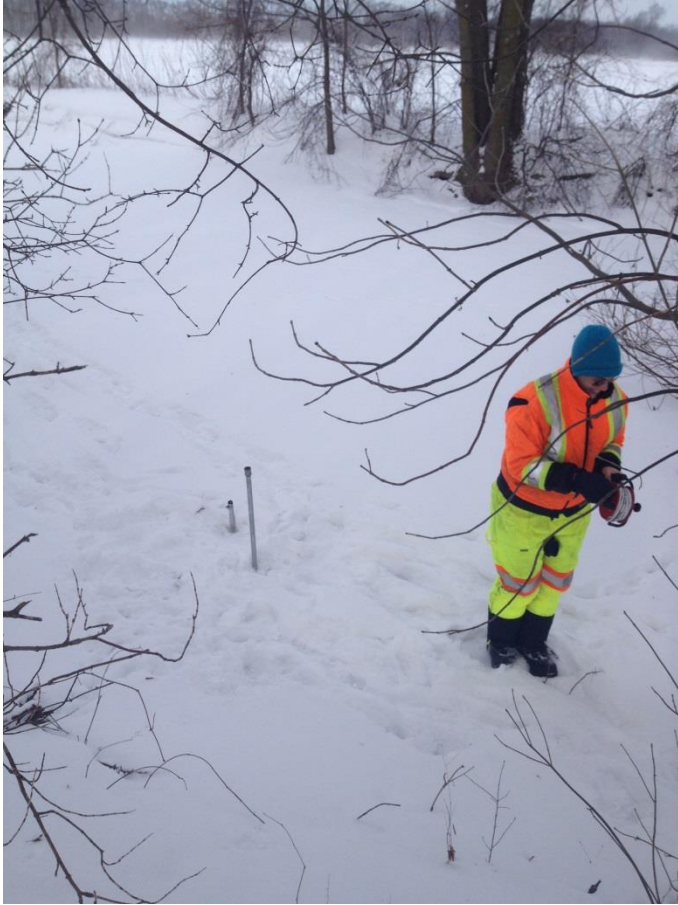
Photograph 1. ↑

Pond and surrounding vegetation covered in snow, facing west.

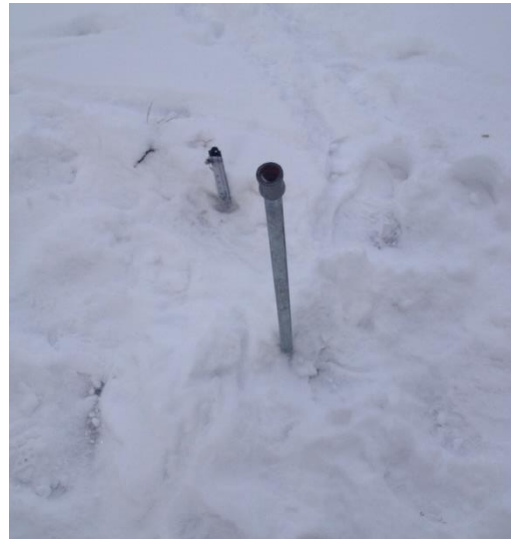
**Photograph 6. ↑**

Mini-piezometer and staff gauge installed at east
end of pond and covered in snow, facing west.

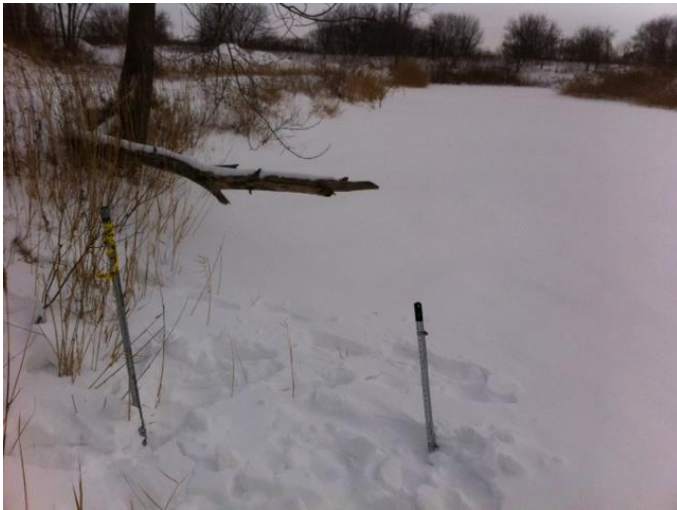
Photograph 7. ↑

Cultural meadows surrounding banks of frozen pond, facing east from monitoring location.

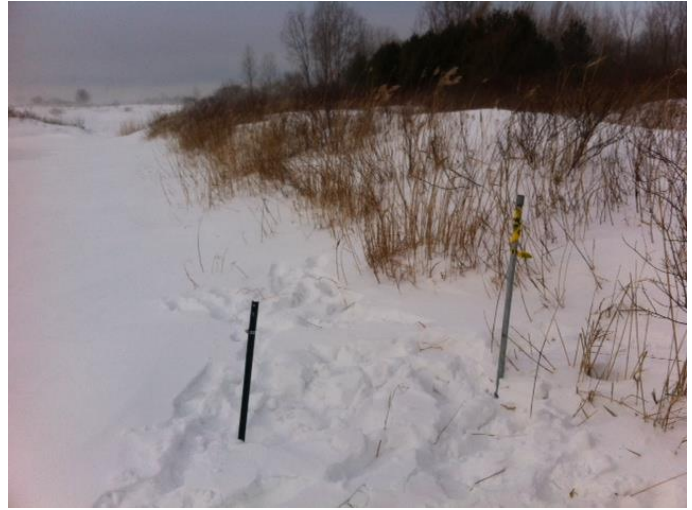
Photograph 8. ↑

Surrounding cultural meadows and Phragmites on banks of pond covered in snow, facing west from monitoring location

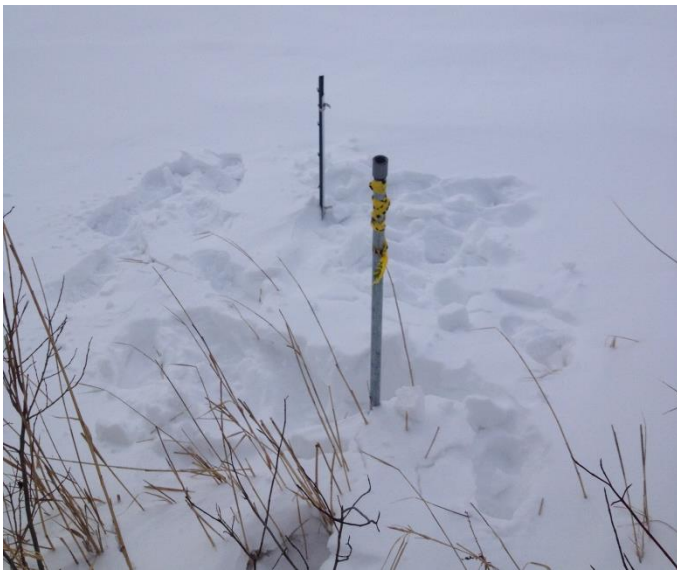
Photograph 11. ↑

Mini-piezometer and staff gauge location, covered in snow.

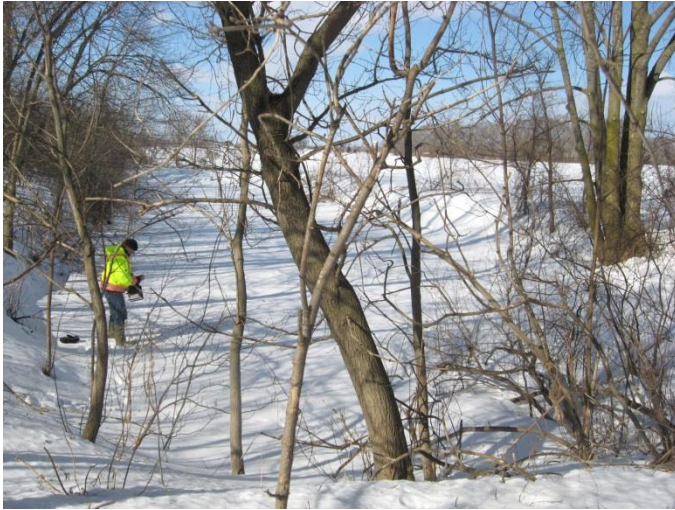
Photograph 1. ↑

Pond and surrounding vegetation covered in snow, facing west.

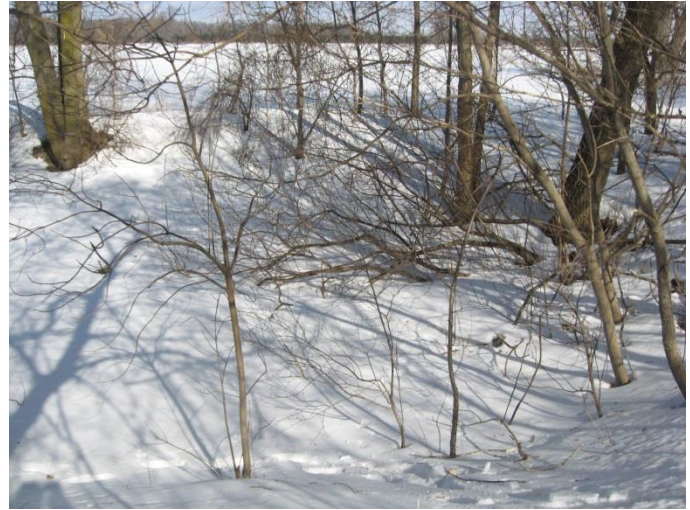
Photograph 2. ↑

East end of pond frozen and cover in snow.

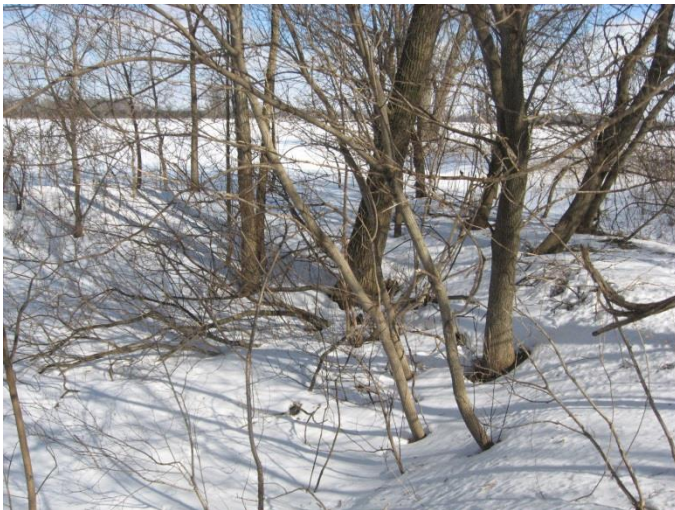
Photograph 3. ↑

Manitoba Maple (*Acer negundo*) trees surrounding pond.

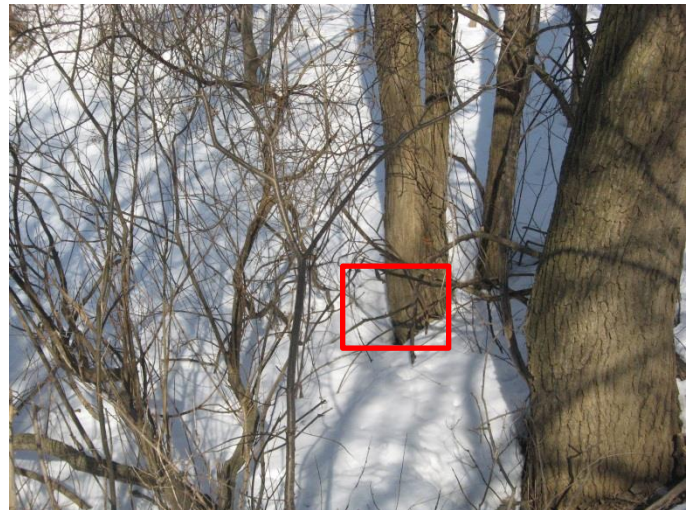
Photograph 4. ↑

Location of culvert on east side of pond covered in snow.

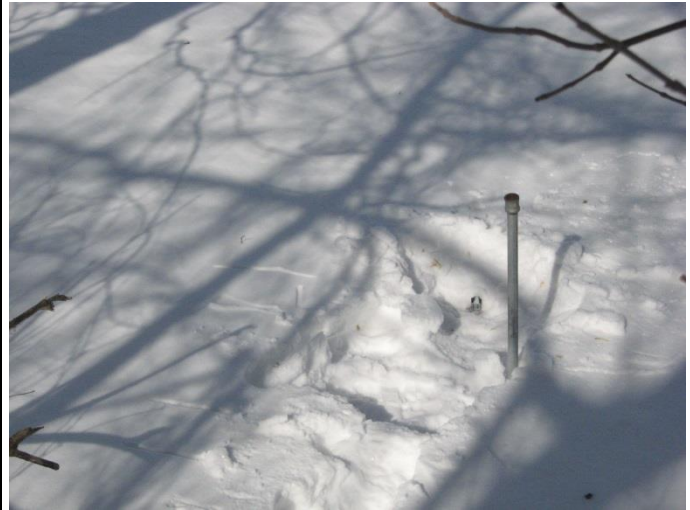
Photograph 6. ↑
Mini-piezometer and staff gauge installed
at east end of pond, facing west.

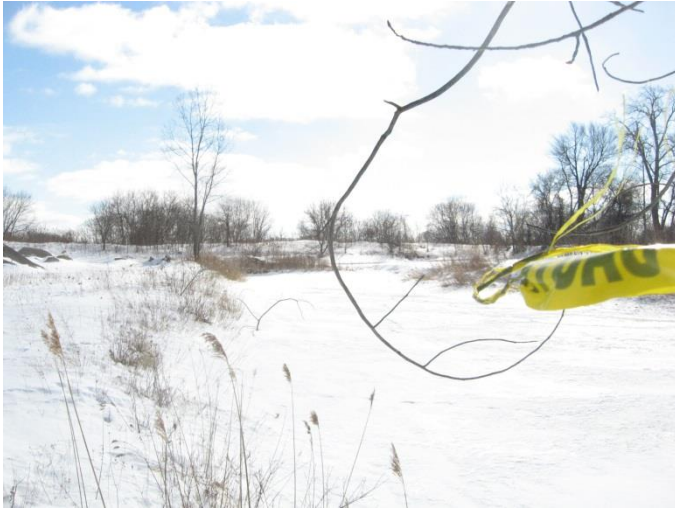
Photograph 7. ↑
Cultural meadows surrounding banks of pond,
facing east from monitoring location.

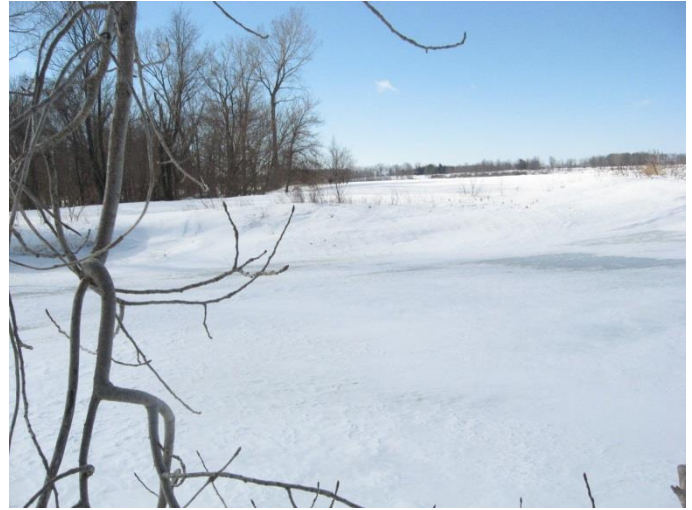
Photograph 8. ↑
Surrounding cultural meadows and Phragmites on
banks of pond, facing west from monitoring location.

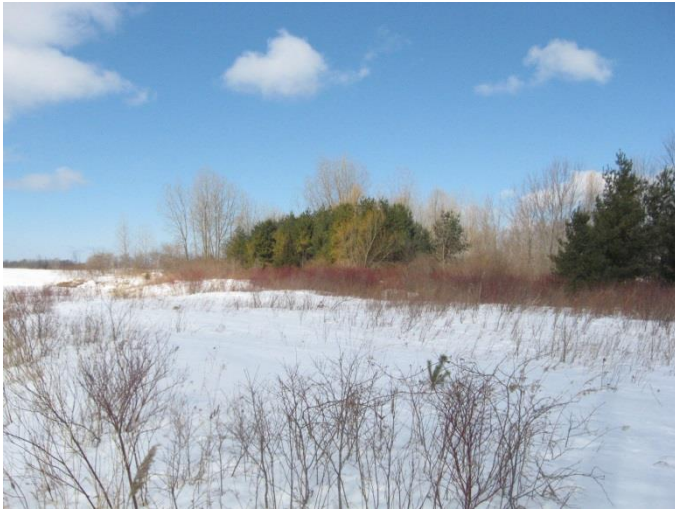
Photograph 9. ↑
Red-osier thicket and cultural meadow
on north bank of pond.

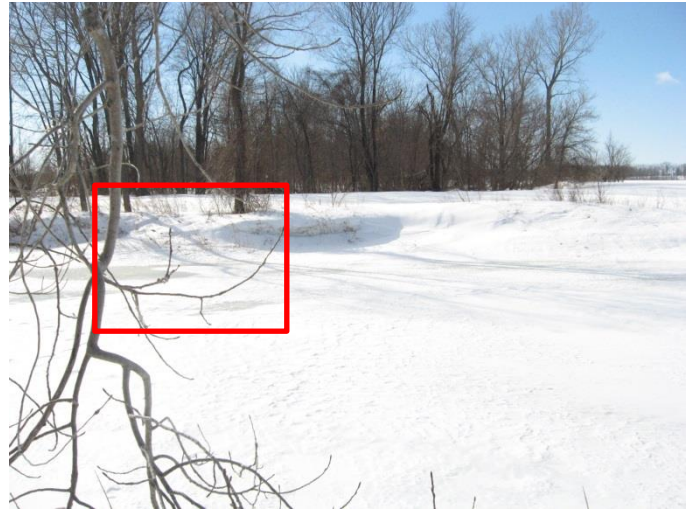
Photograph 10. ↑
Possible muskrat den located on south
bank, across from monitoring location.

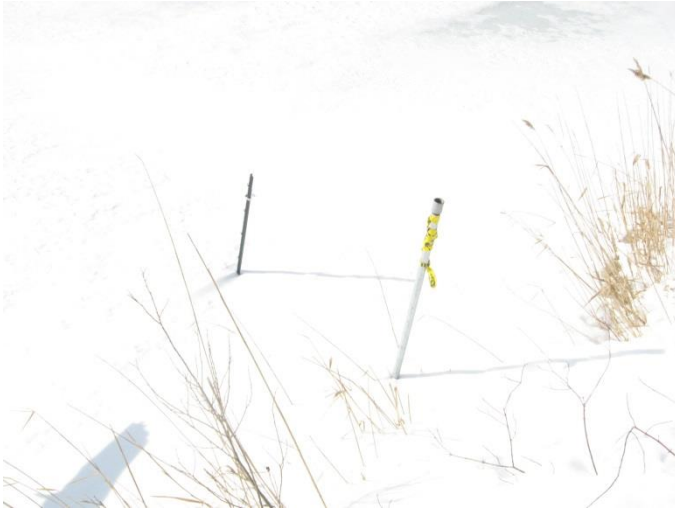
Photograph 11. ↑
Mini-piezometer and staff gauge
location, covered in snow.

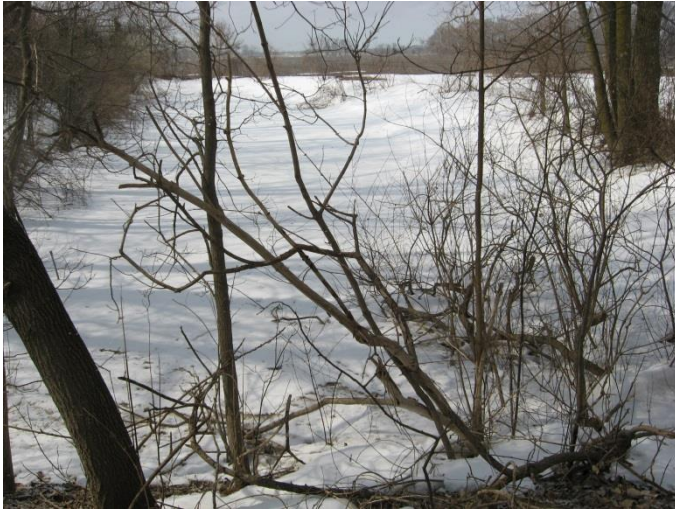
Photograph 1. ↑
Pond and surrounding vegetation covered in snow, facing west.

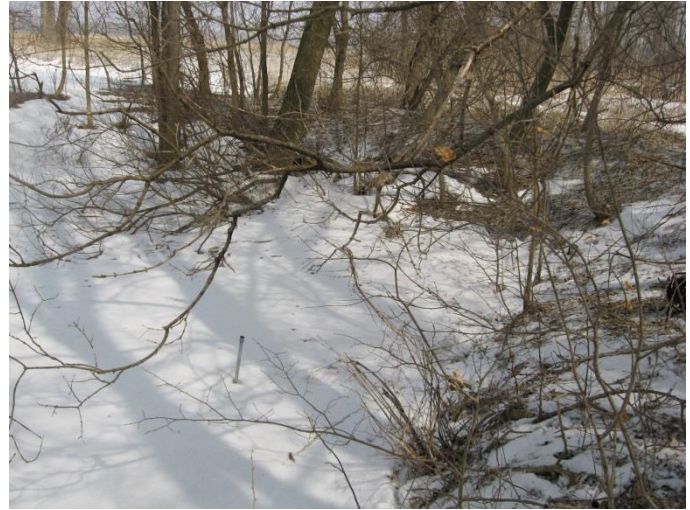
Photograph 2. ↑
East end of pond frozen and cover in snow.

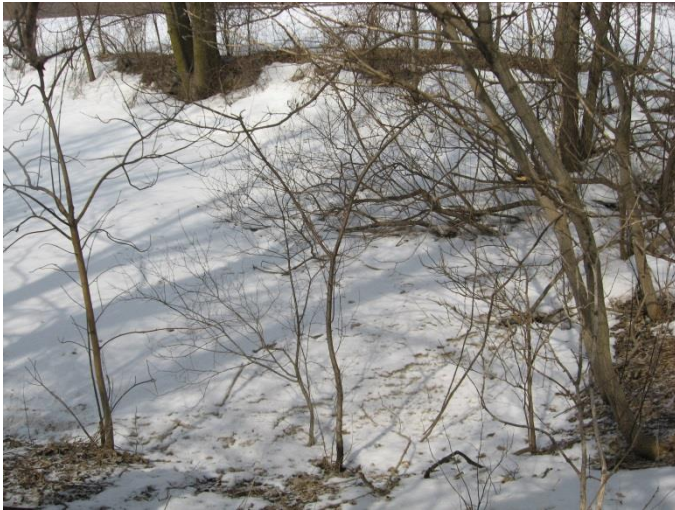
Photograph 3. ↑
Manitoba Maple (*Acer negundo*) trees surrounding pond.

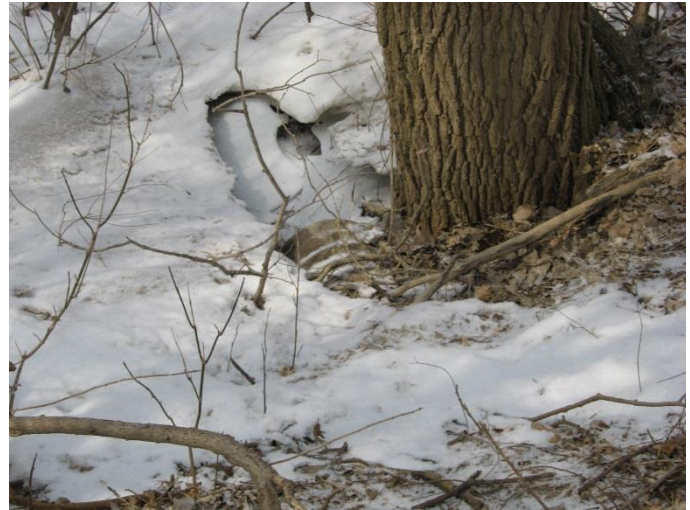
Photograph 4. ↑
Location of culvert on east side of pond partially covered in snow.

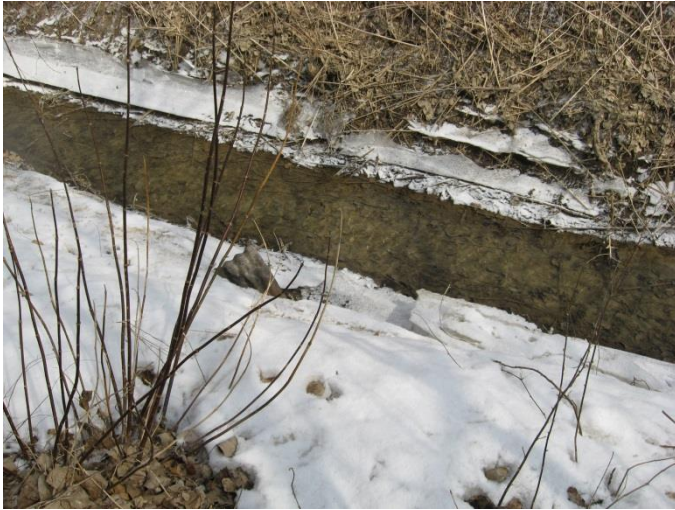
Photograph 5. ↑
Location of culvert draining out into watercourse east of and behind pond.

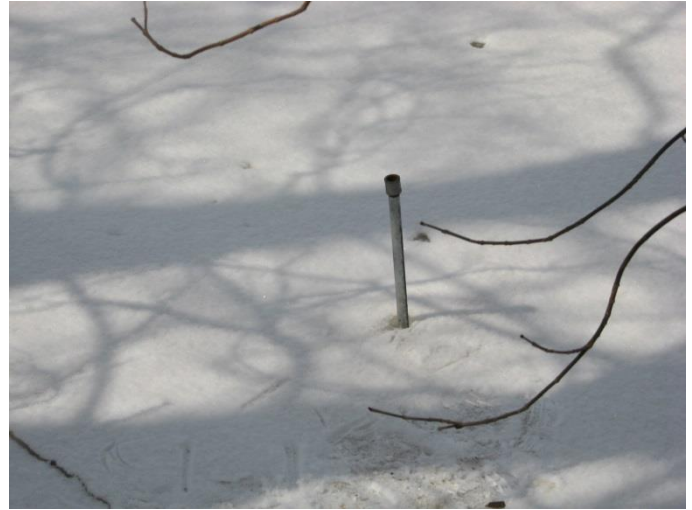
Photograph 6. ↑
Mini-piezometer and staff gauge installed at east end of pond, facing west. Note staff gauge is buried beneath ice.

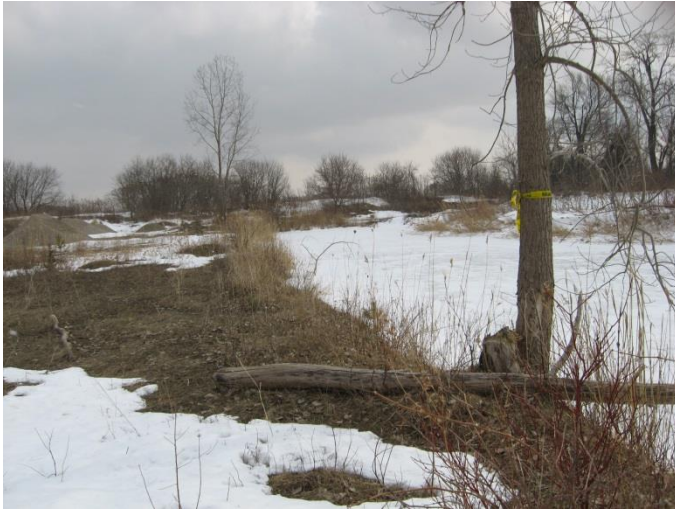
Photograph 7. ↑
Cultural meadows surrounding banks of pond,
facing east from monitoring location.

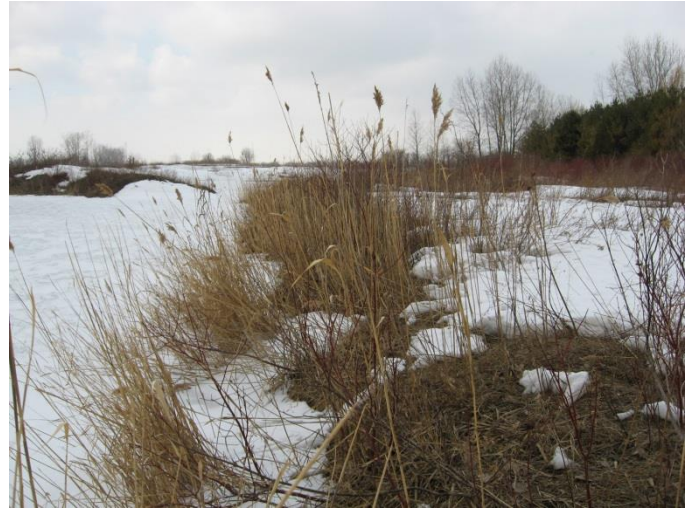
Photograph 8. ↑
Surrounding cultural meadows and Phragmites on
banks of pond, facing west from monitoring location.

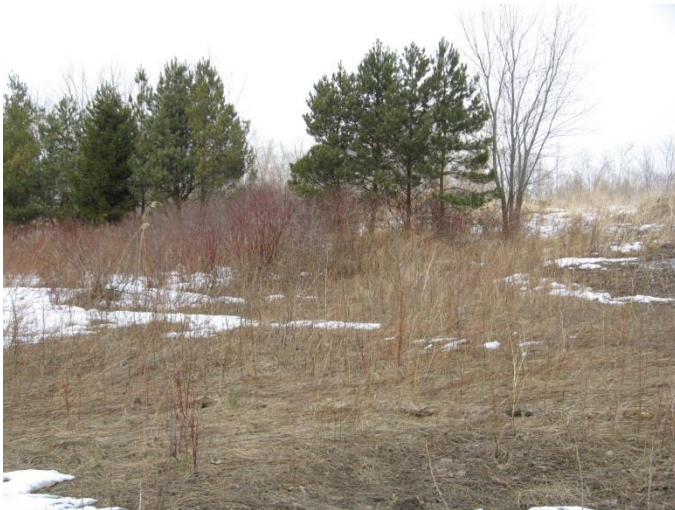
Photograph 9. ↑
Red-osier thicket and cultural meadow
on north bank of pond.

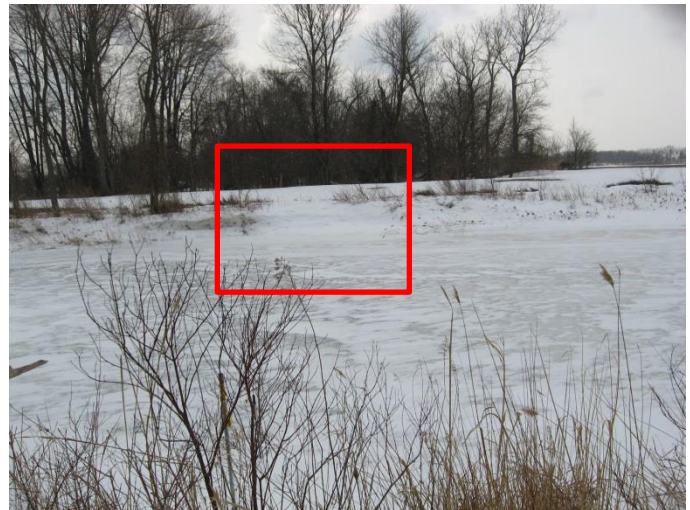
Photograph 10. ↑
Possible muskrat den located on south
bank, across from monitoring location.

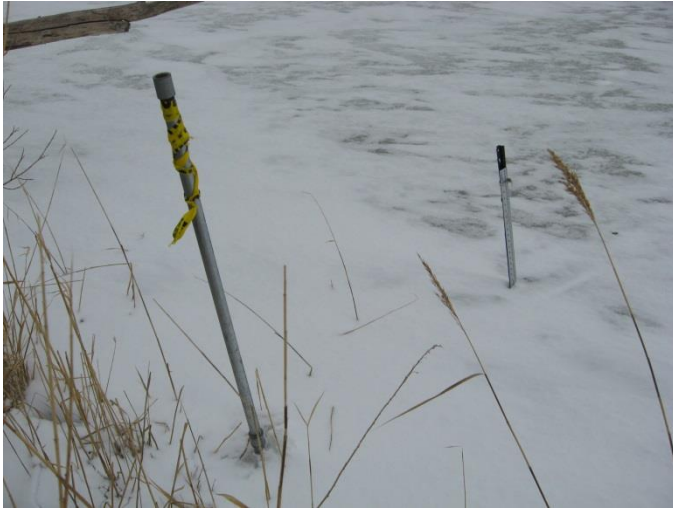
Photograph 11. ↑
Mini-piezometer and staff gauge location.
