**B6. Photographic Log of Pre-
construction Dewatering
Monitoring on April 28, 2014**

Monitoring Location M1

Monitoring Location R1

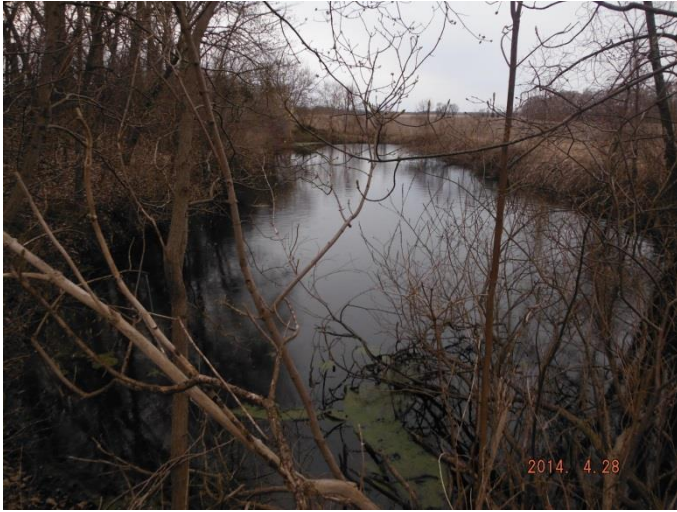
Photograph 1. ↑
Pond and surrounding vegetation, facing west.

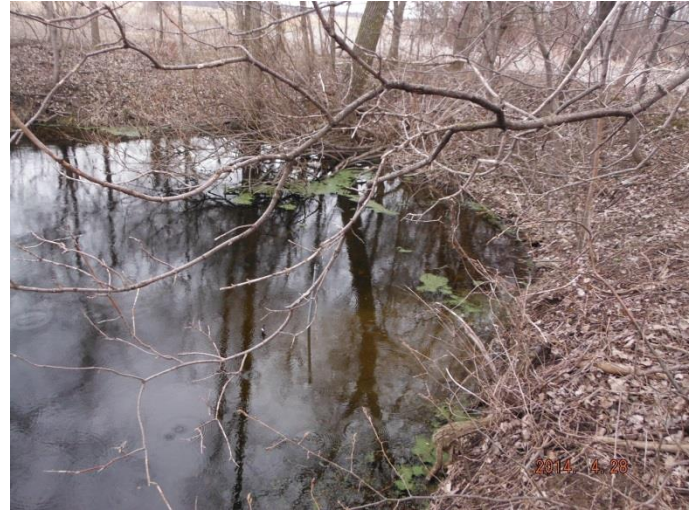
Photograph 2. ↑
Algae present in east end of pond.

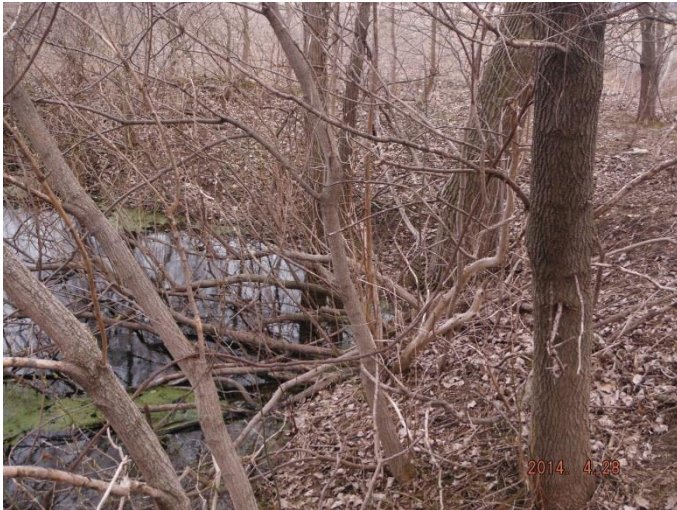
Photograph 3. ↑
Manitoba Maple (*Acer negundo*)
trees surrounding pond.

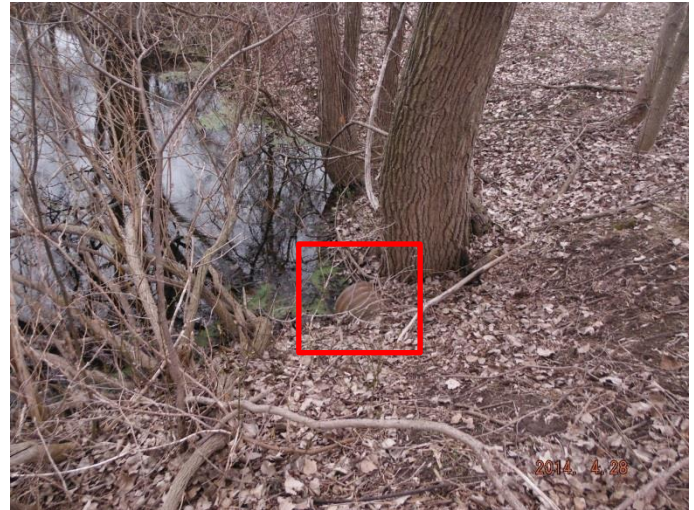
Photograph 4. ↑
Location of culvert on east side of pond.

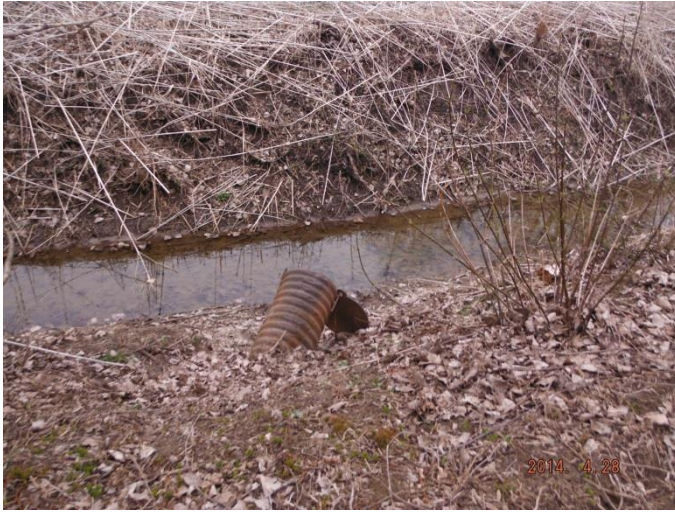
Photograph 5. ↑
Location of culvert draining out into
watercourse east of pond.

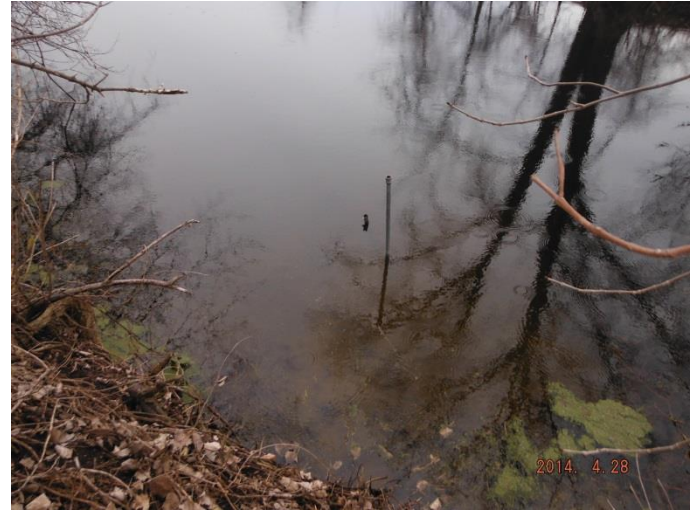
Photograph 6. ↑
Mini-piezometer and staff gauge installed
at east end of pond, facing west.

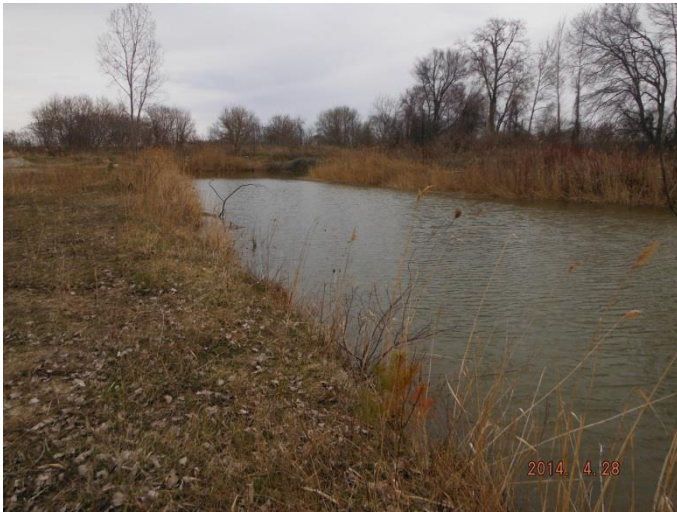
Photograph 7. ↑
Cultural meadows surrounding banks of pond,
facing east from monitoring location.

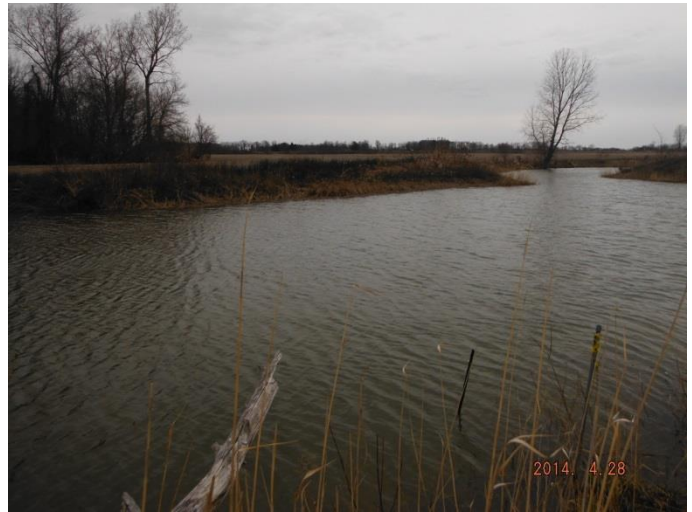
Photograph 8. ↑
Surrounding cultural meadows and Phragmites on
banks of pond, facing west from monitoring location.

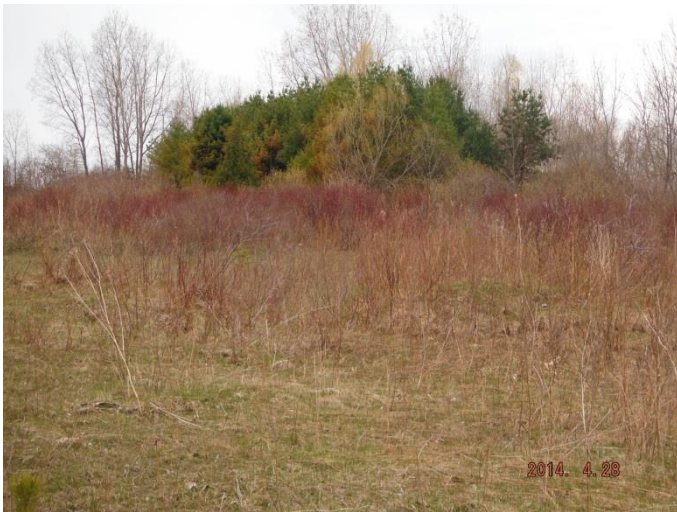
Photograph 9. ↑
Red-osier thicket and cultural meadow
on north bank of pond.

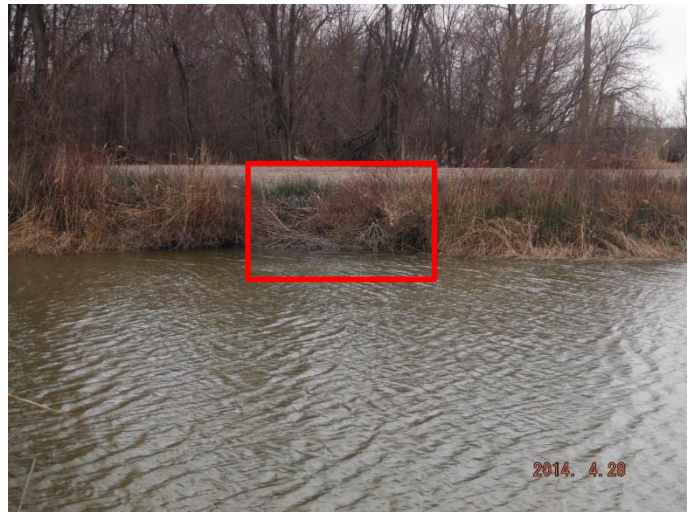
Photograph 10. ↑
Possible muskrat den located on south
bank, across from monitoring location.

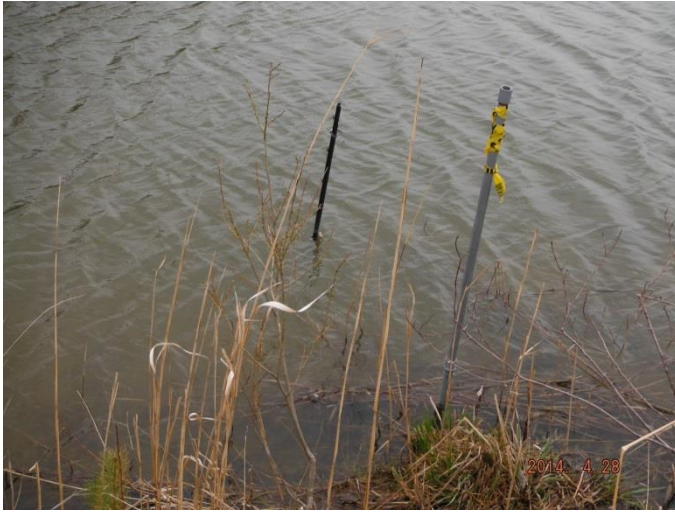
Photograph 11. ↑
Mini-piezometer and staff gauge location.
