Appendix E

Field Notes

Water Bodies Assessment Field Collection Form

Study Area: Jericho Goshen Bluewater Land Parcel# Bgr Site ID: R1.8#2

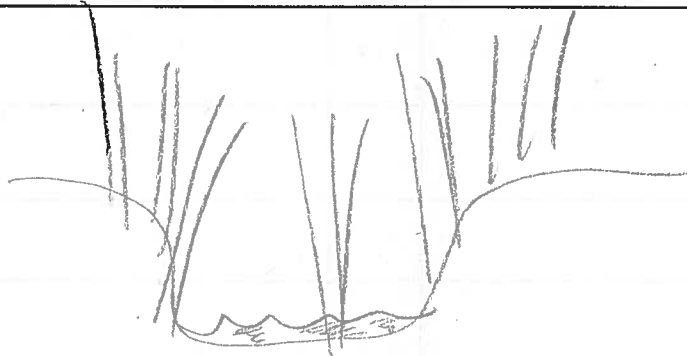
≡ - algae
VI - grasses
H - slumping + narrowing

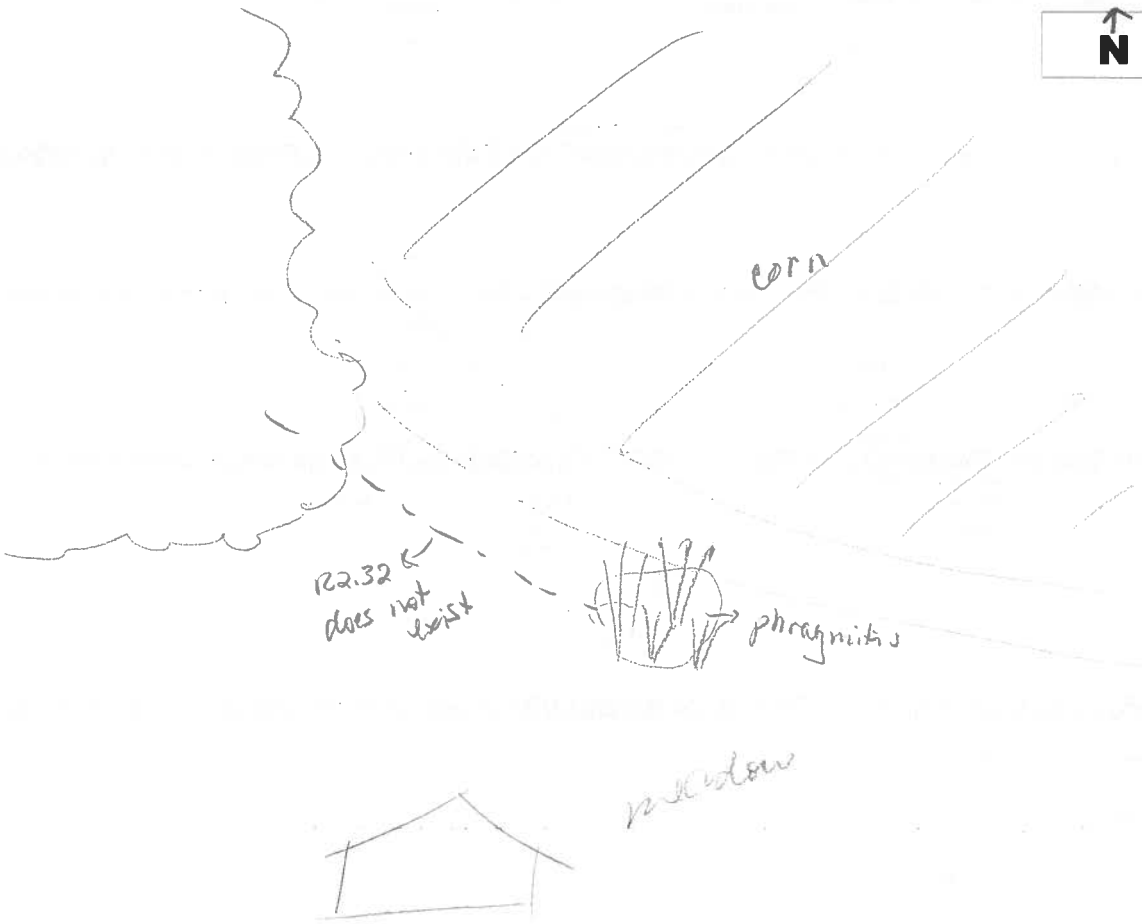
- no channel ~~observed~~ observed going from 1354 to 1842
↳ only one pocket of phragmites on 1354

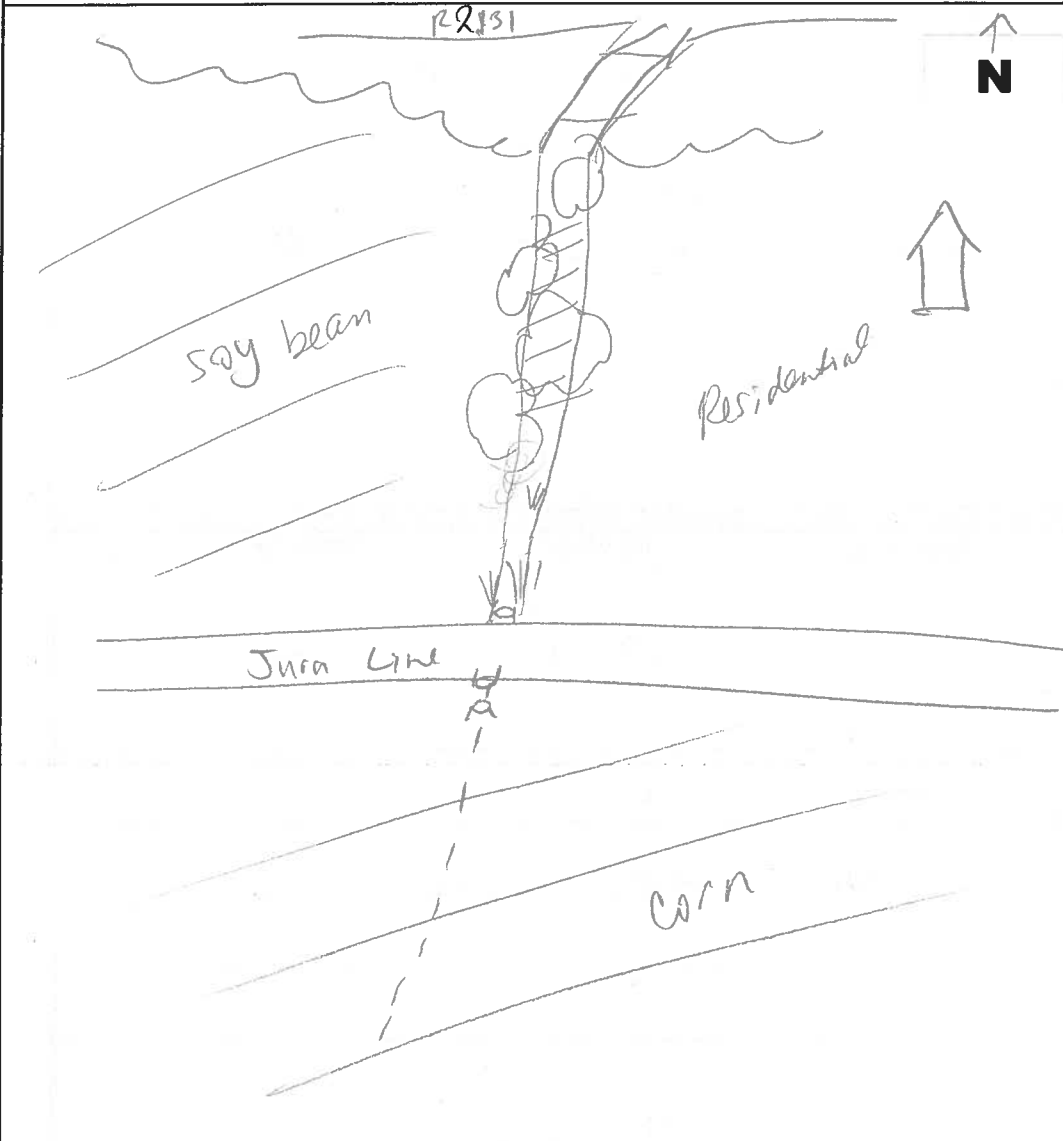
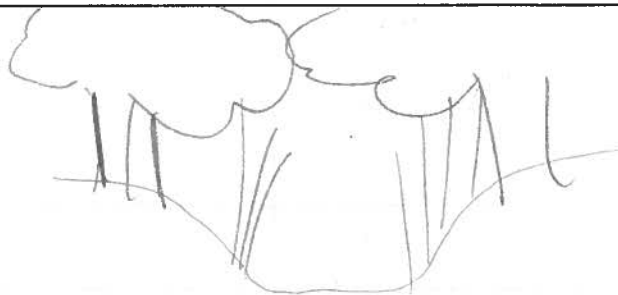
R2.192

- watercourse buried on JER 3632 - outlet pipe observed
- water pooled at roadside on JER 3626 + 3628, could not follow entire way due to access however behind house channel was dry. Nearing the convergence area ~~water~~ water was present in channel but was not flowing into R2.131
