Water Bodies Assessment Field Collection Form

502 1709 / 1724 / 1736
R9B

AECOM

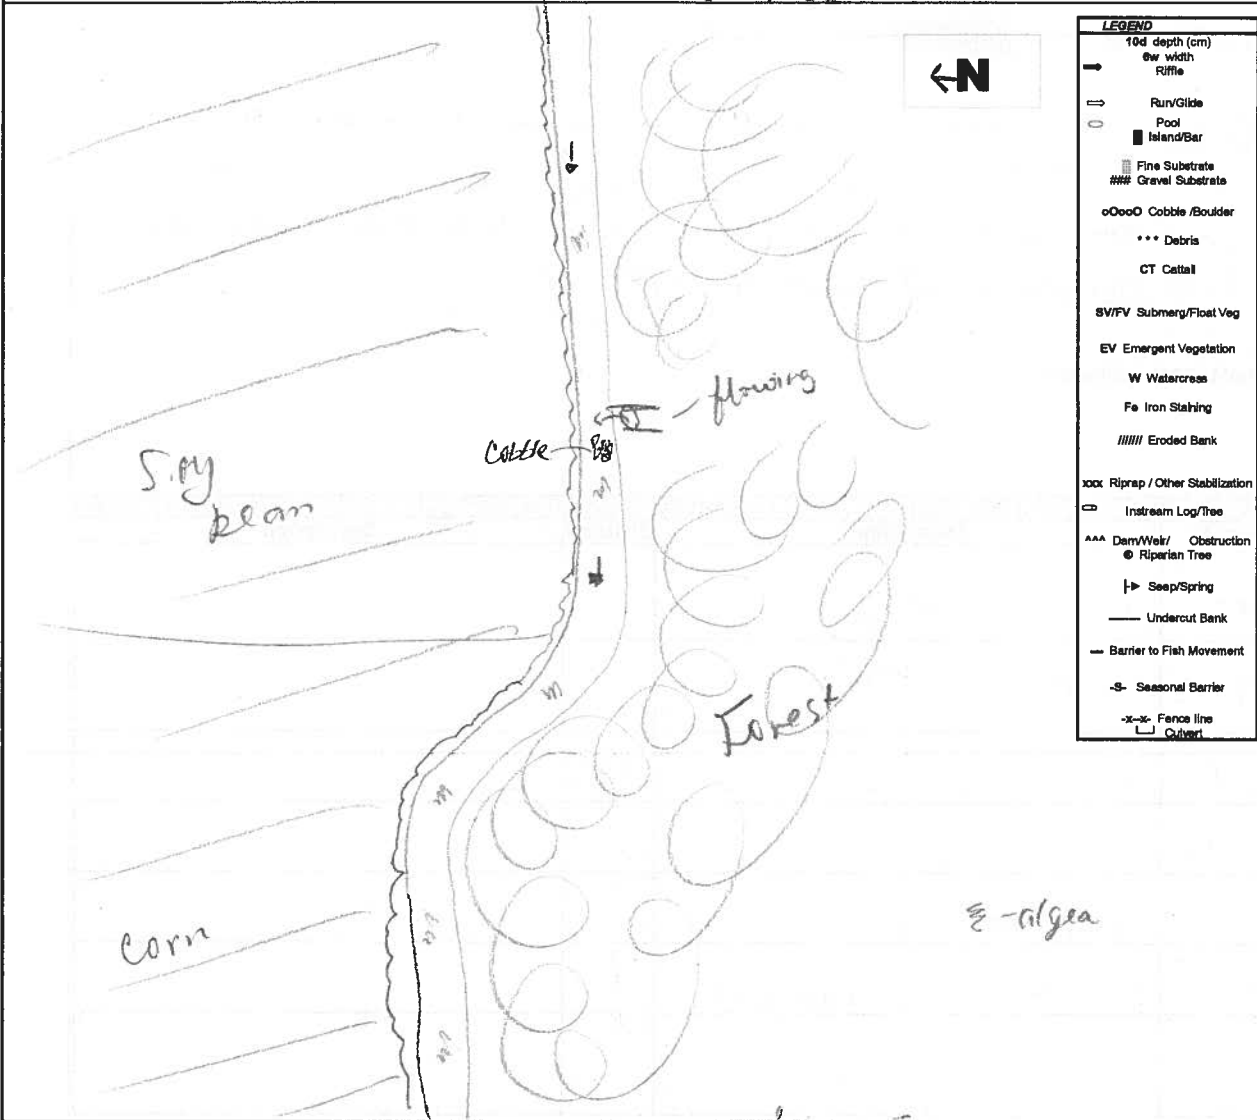
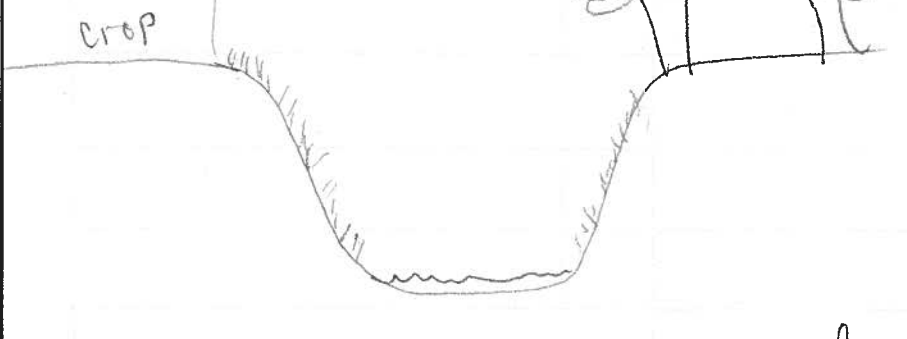
R9B

Watercourse is a channelized ditch - appears to be recently dug out on JER. It is a straight channel w little in-stream cover. The left bank (adjacent to crop field) has been cleared of all trees - cut + burned.

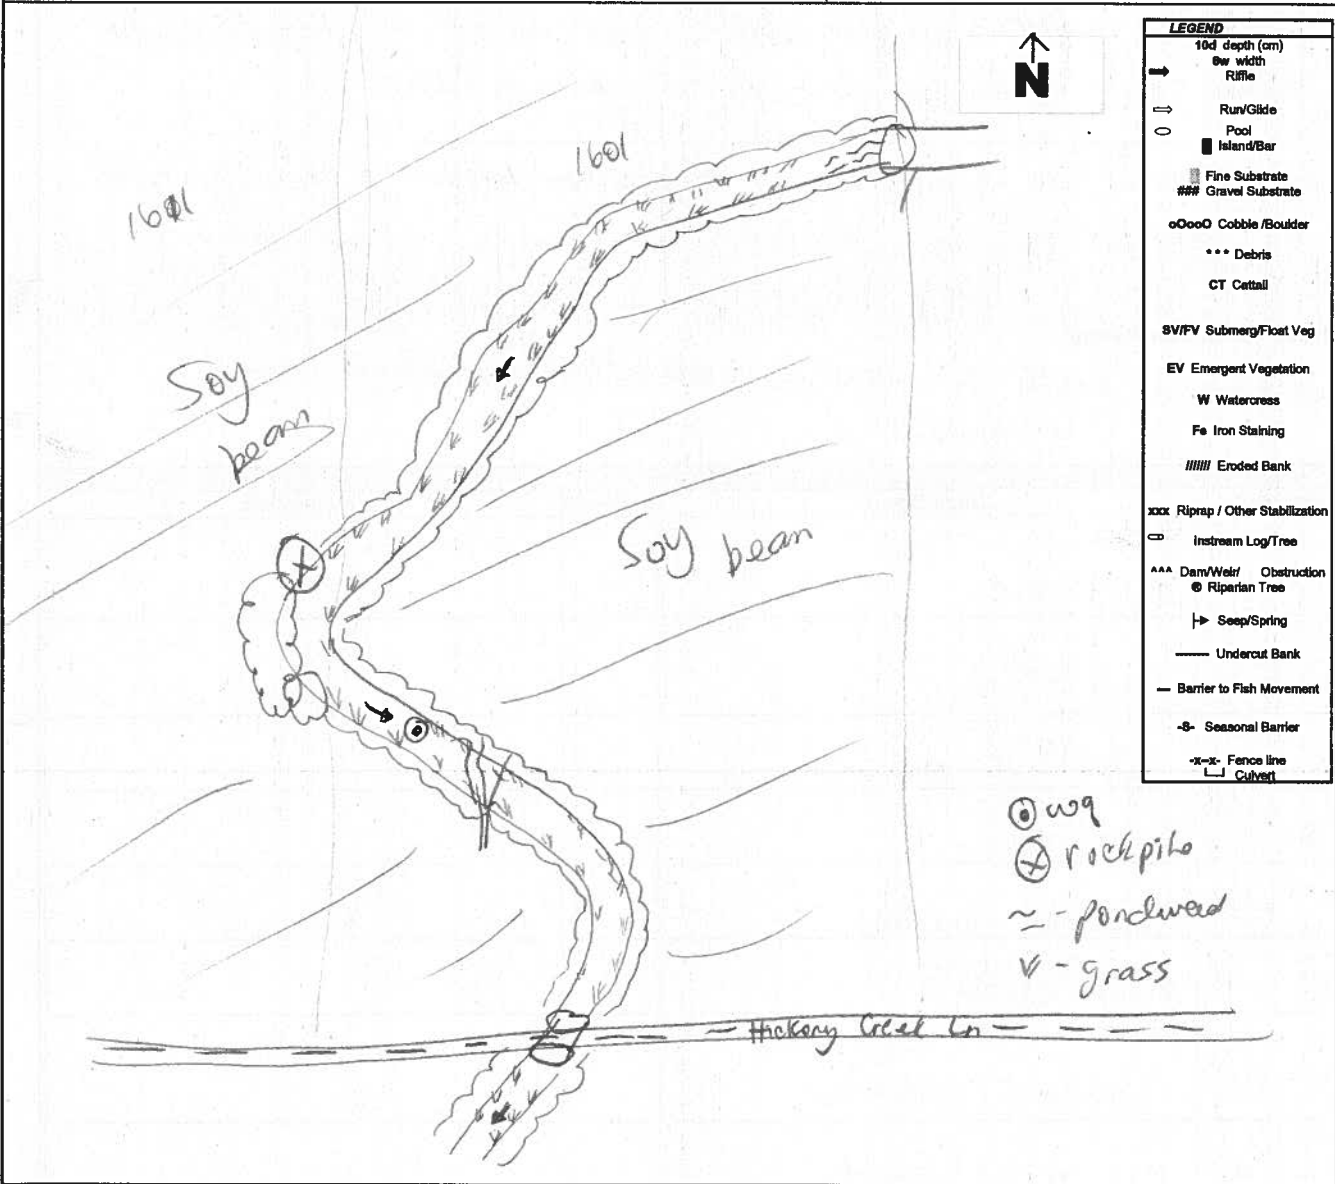
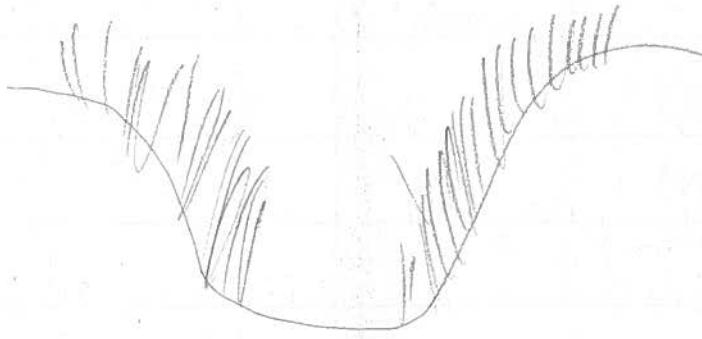
29.29 D

Culvert at road+ property line look recently replaced. Could have had channel dug out at same time

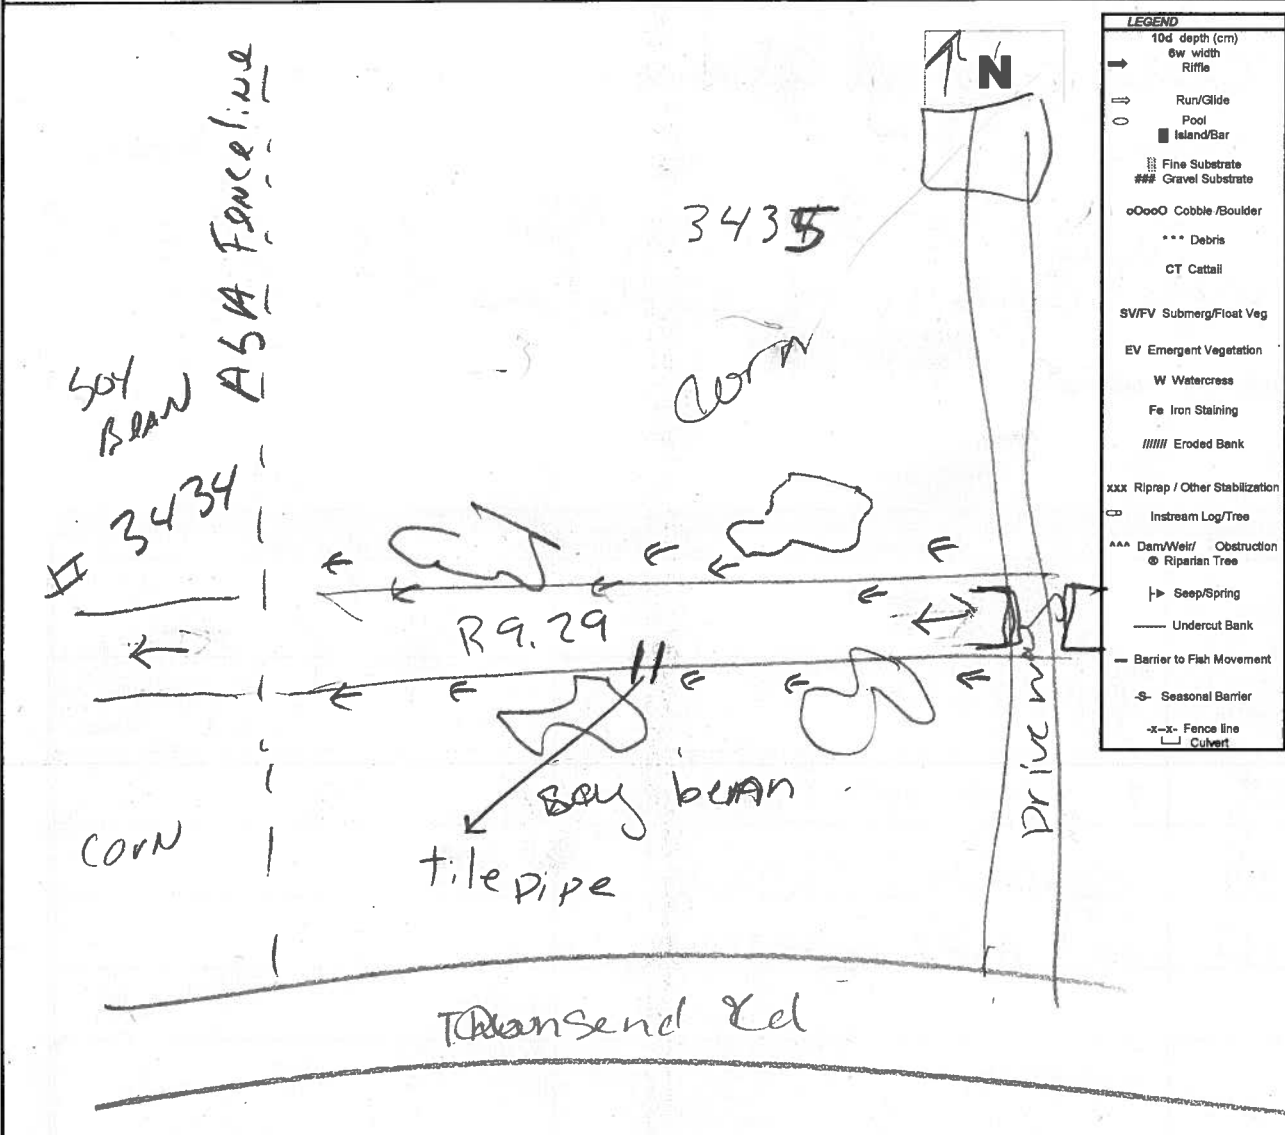
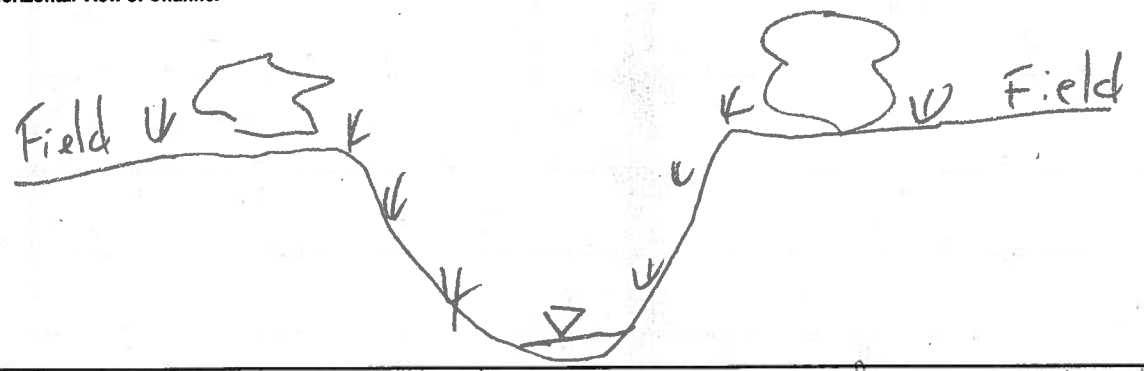
R9.29C

<i>grasses</i>													
Riparian Vegetation													
Width and Description of riparian vegetation:						Types of Cover (% cover)							
LB - 1m - meadow						RB - ~0.5m - meadow							
Overhanging Vegetation Present Y/N <input checked="" type="checkbox"/>						% Overhanging Vegetation:							
Description of Overhanging Vegetation:													
Obstructions to Fish Passage													
None Observed	<input type="checkbox"/>	Man-Made	<input checked="" type="checkbox"/>	Natural	<input type="checkbox"/>	Low Flow Barrier	<input type="checkbox"/>						
Description of Barrier: <i>perched culvert</i>													
Height of Barrier (m) 0.3m						GPS Coordinates: 423639 4769466

- green frog heard calling
- Cyprinids observed (~10), Yoy schools observed - esp in pool by culvert -> culvert possible fish barrier but fish observed both up/s + down/s
