**Assessment of Non-Water Body
(update to mapping required)**

AECOM

Water Bodies Assessment Field Collection Form

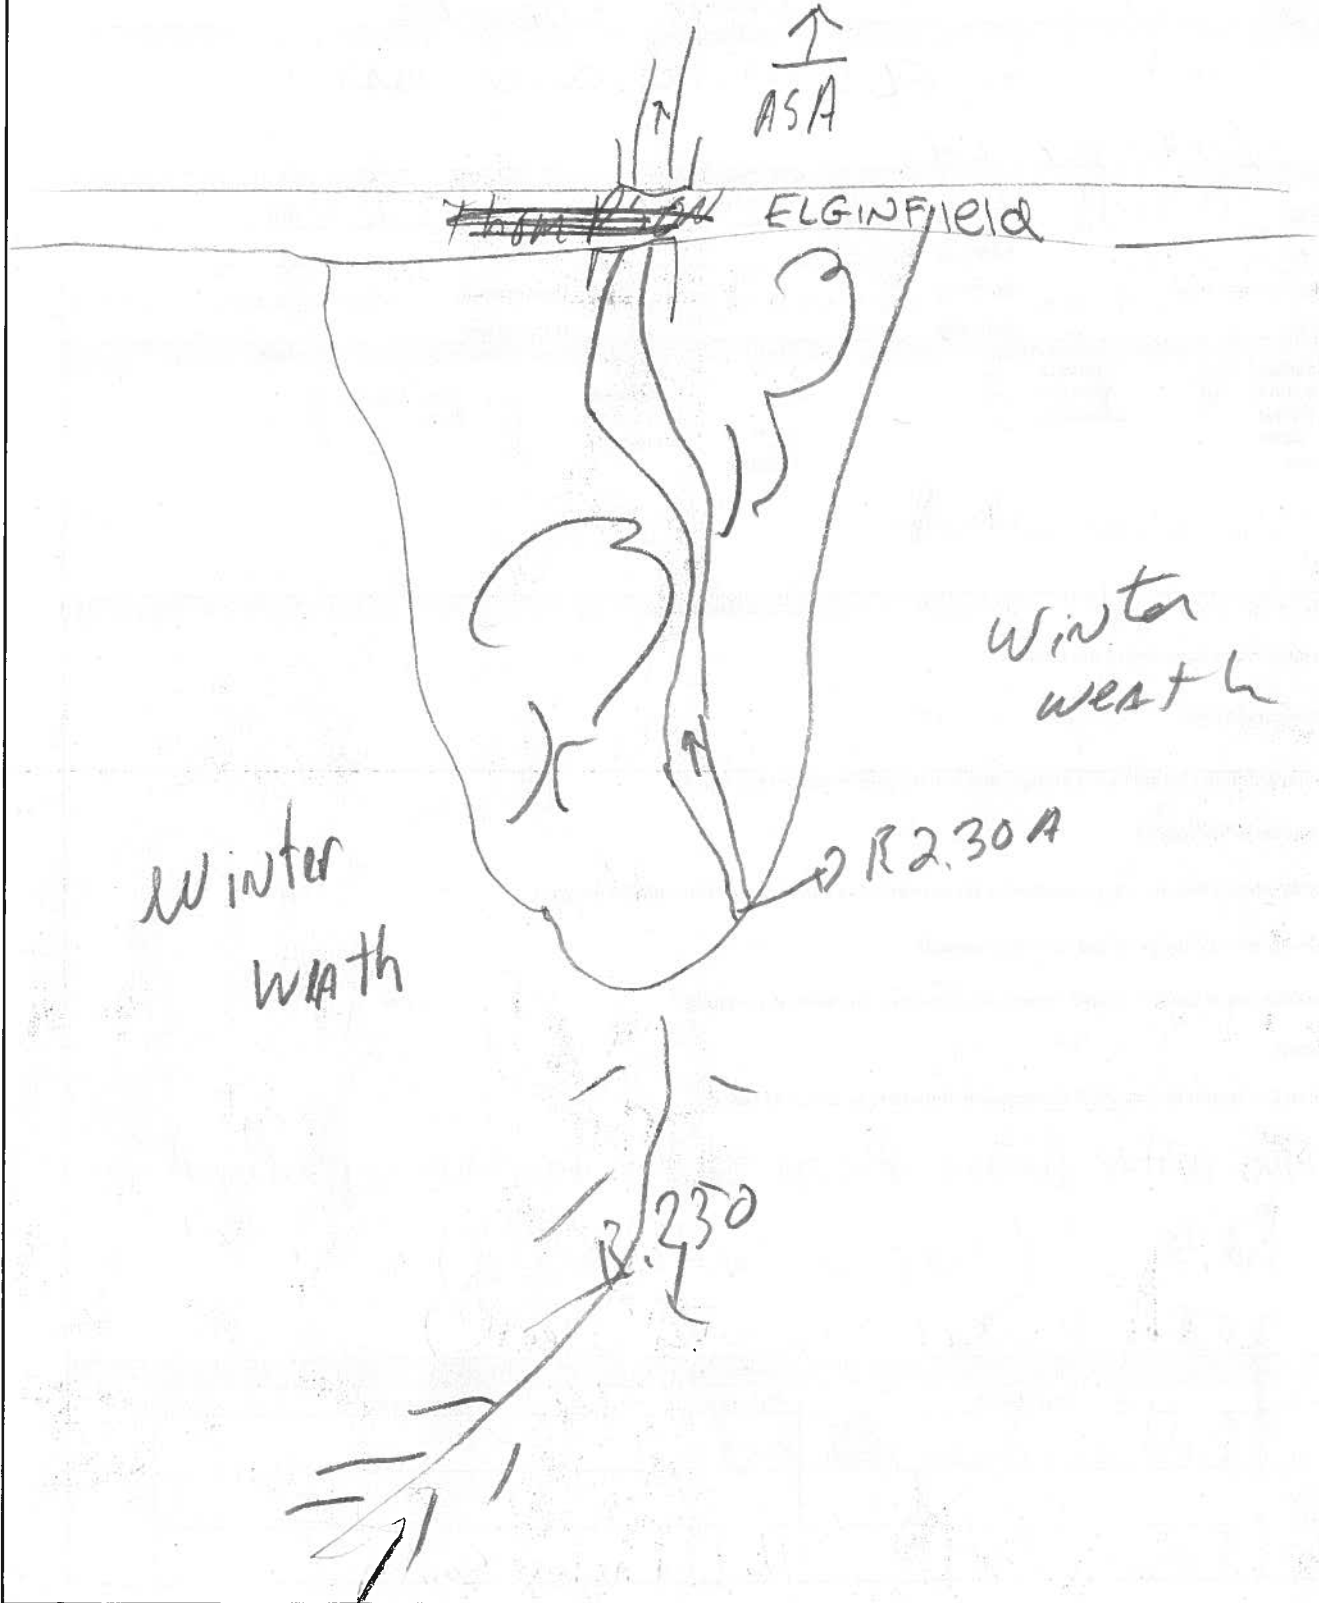
Land Parcel/Site ID: JER3745 / R2.30

→ No water feature from south to the Gps Point Rd. 30. (Section in the Field)
→ all planted (winter weath)

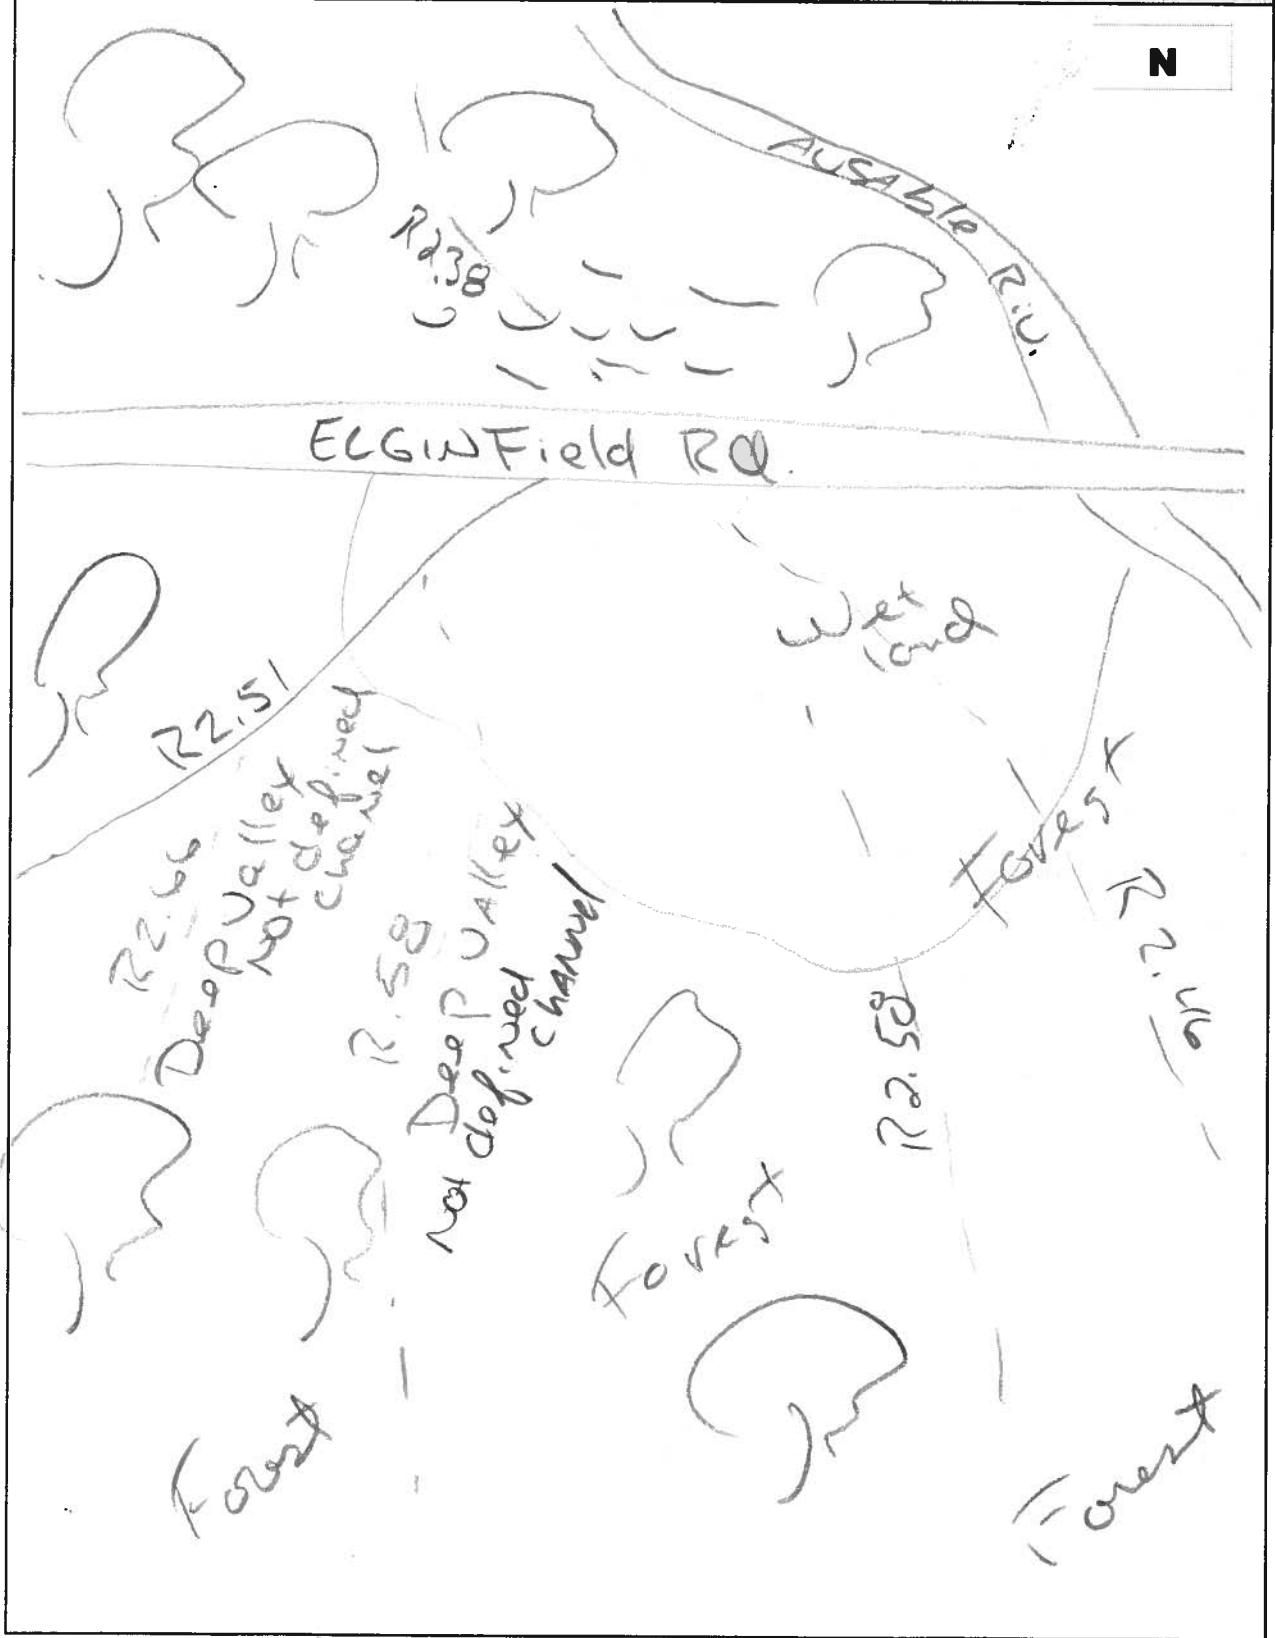
Land Parcel/Site ID: R2.58-JER 3747

Deep valley with no defined channel

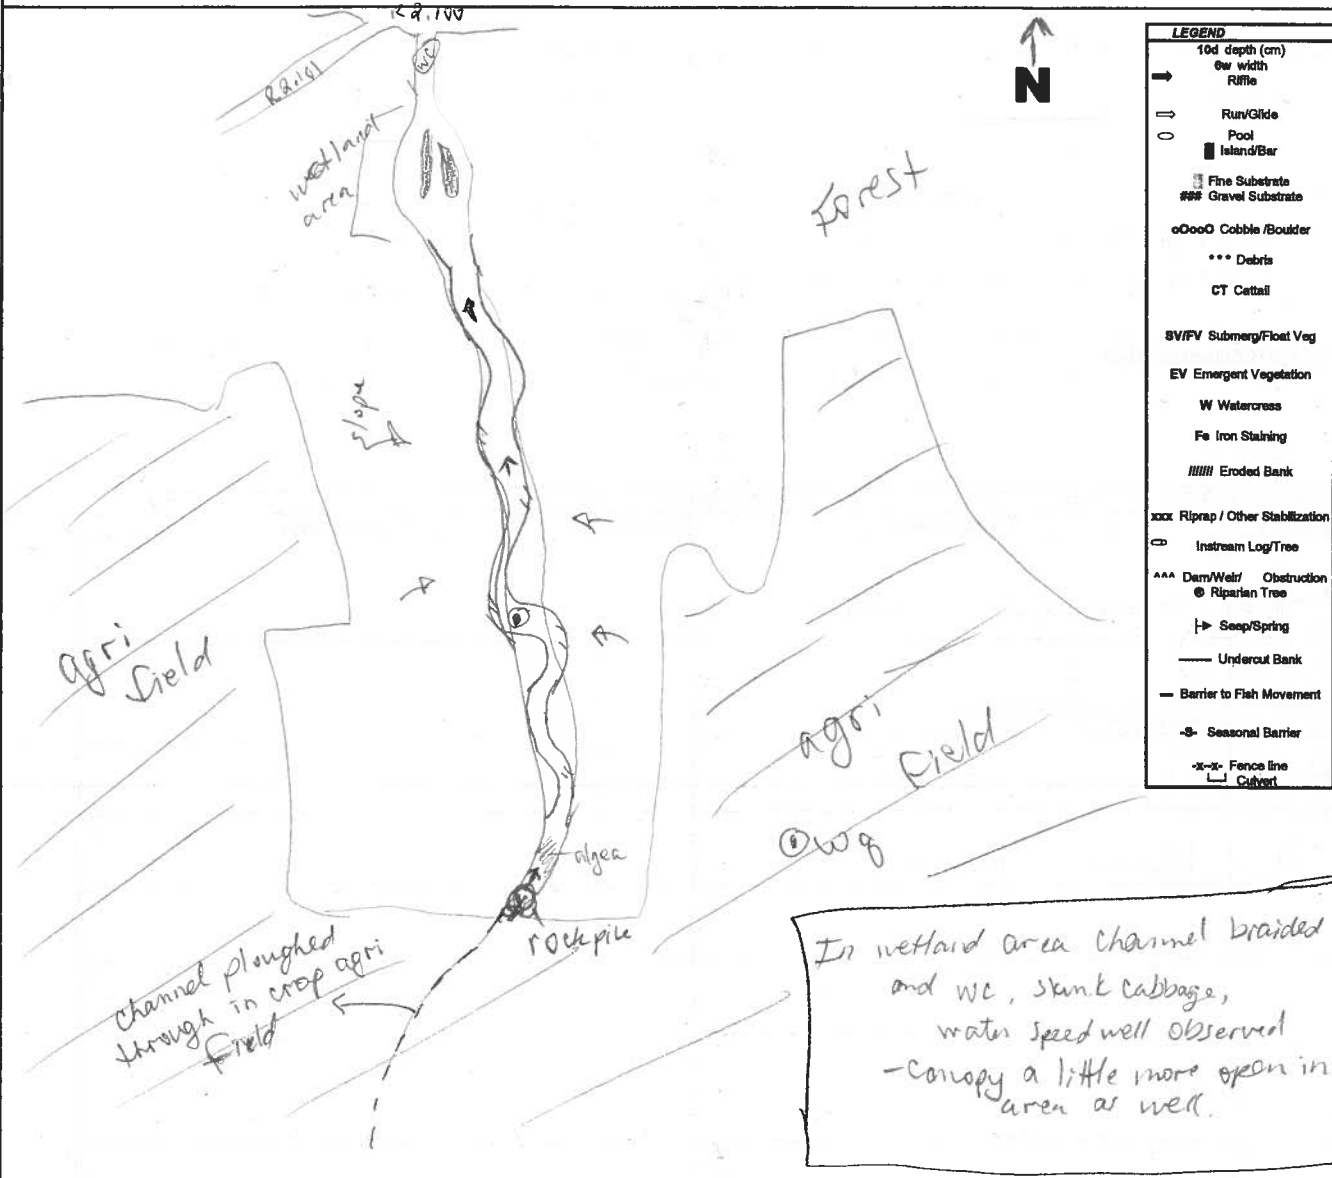
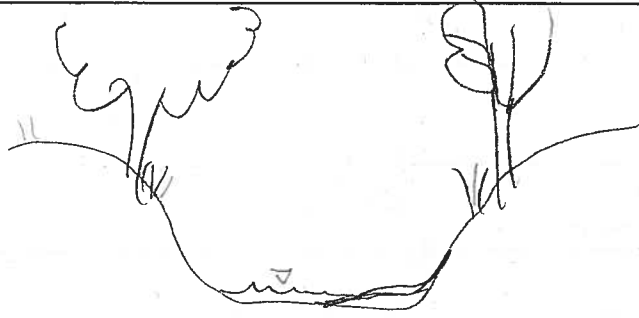
R2.102

Watercress only observed near
 convergence area of 100+101 (north end of
 site)
 water speedwell, stink cabbage
 observed.

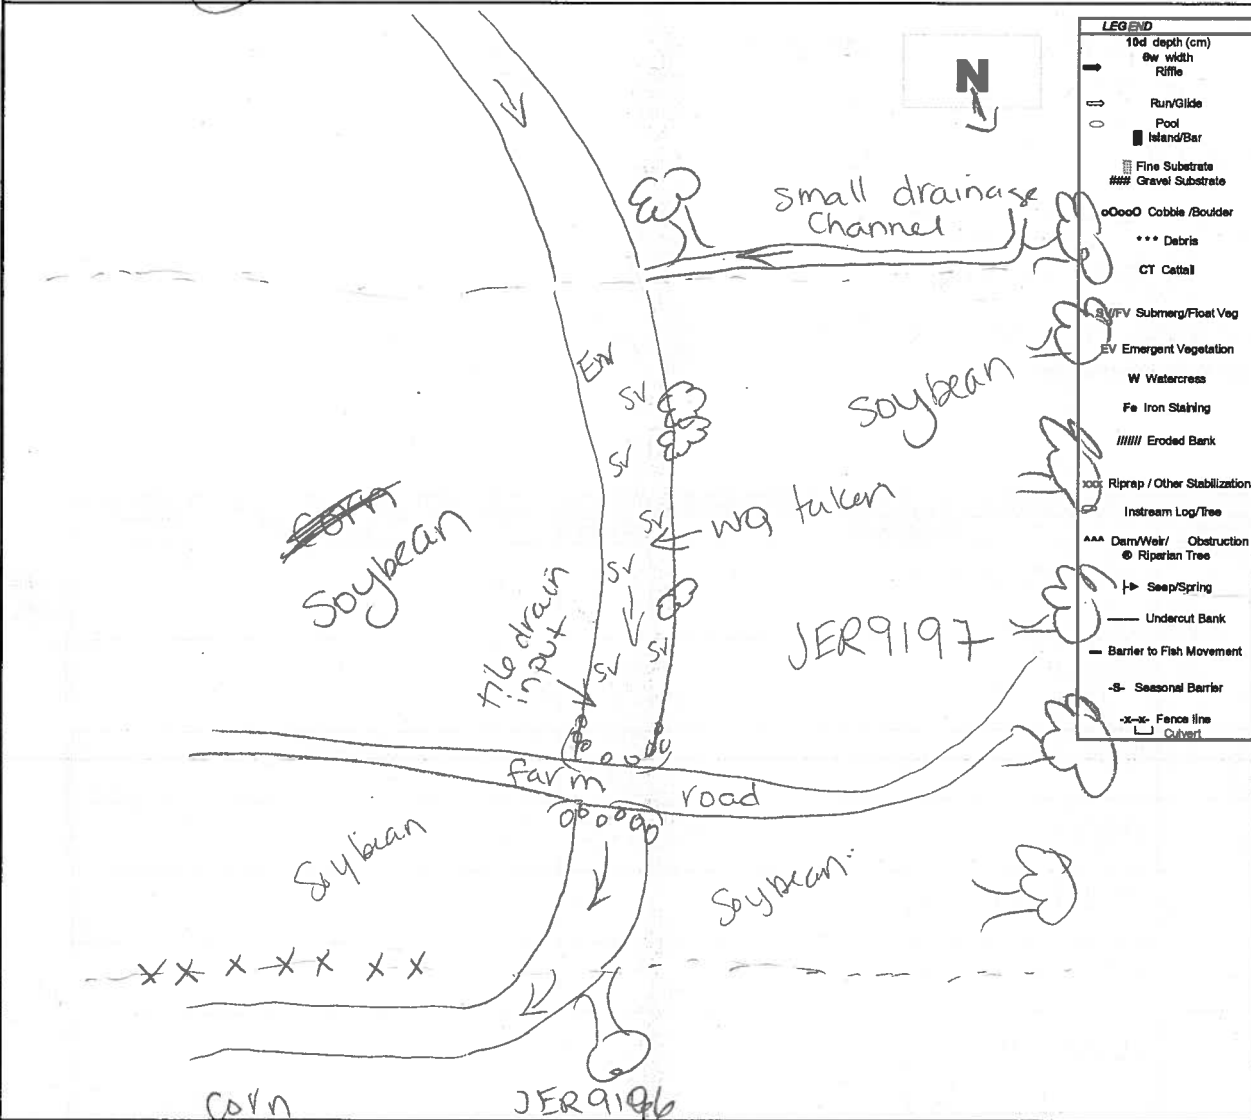
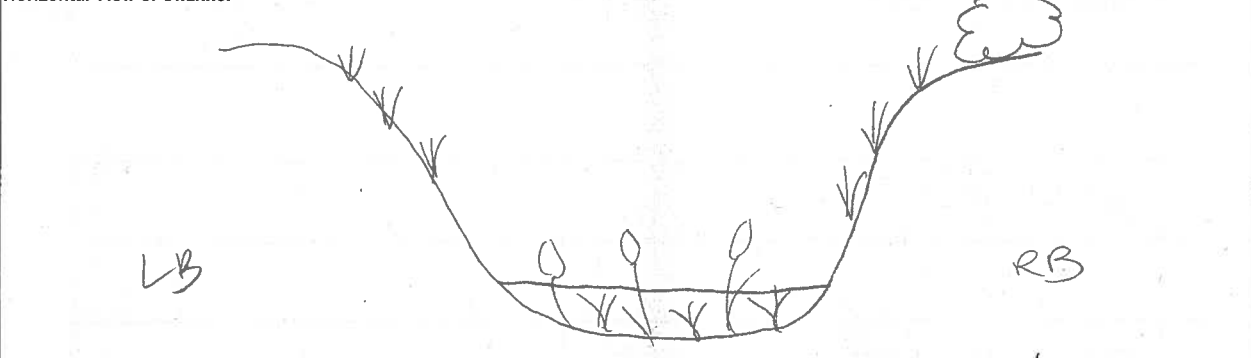
R2.10B

- green frogs observed, cyprinids observed near culvert
- very uniform straightened channel full of emergent, submergent vegetation
- large CSP located under bridge
- d/s ASA very similar to channel JER 9197
- cobble & boulder placed near culvert

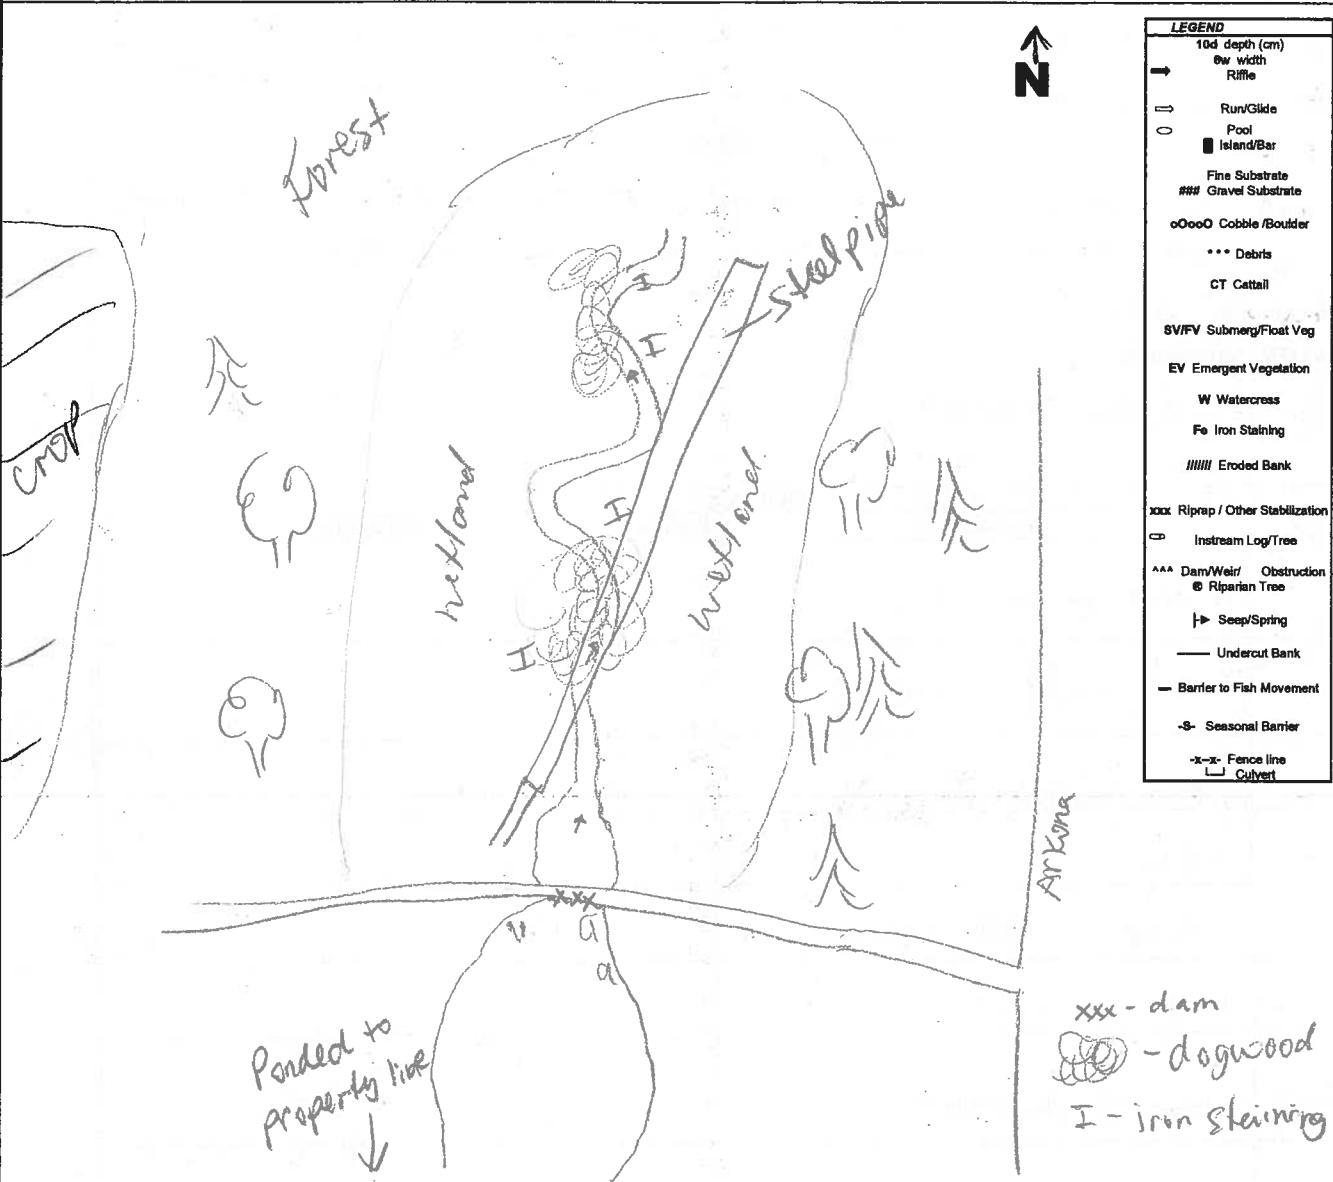
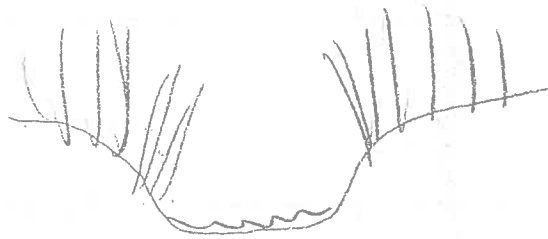
R2.14

iron staining found throughout wetland area

- watercourse is dammed south of driveway and large pond is present. It flows north into a wetland area where the watercourse meanders in a small channel - shallow water. Substrate is much silt. A large steel pipe runs through the wetland and may be a drainage pipe periodically adding water to the wetland area. Also found multiple iron staining areas.

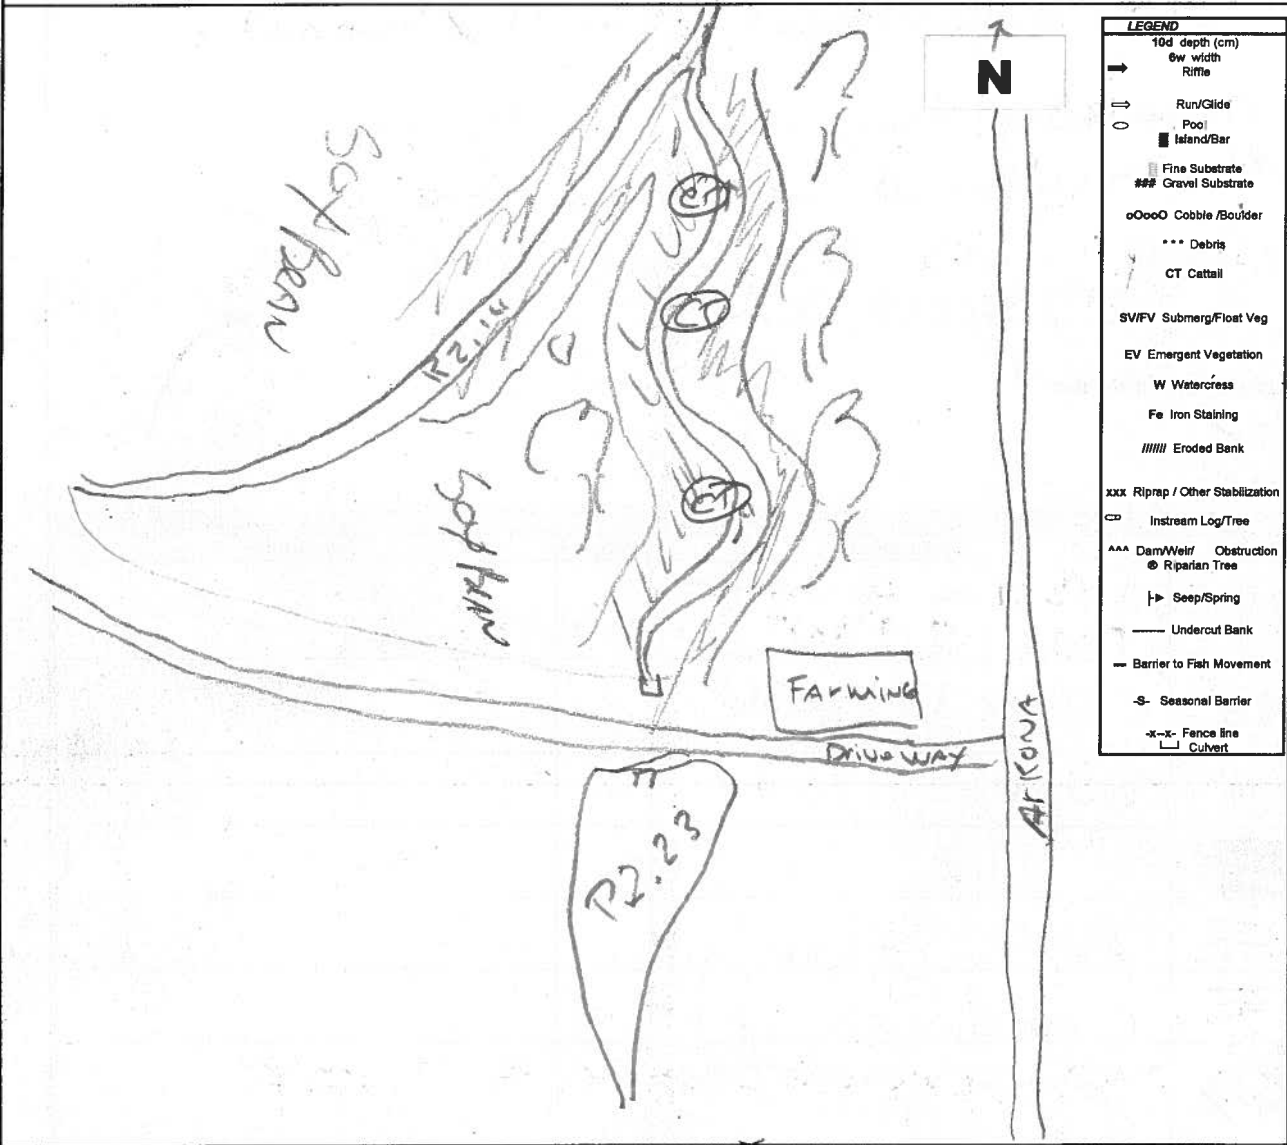
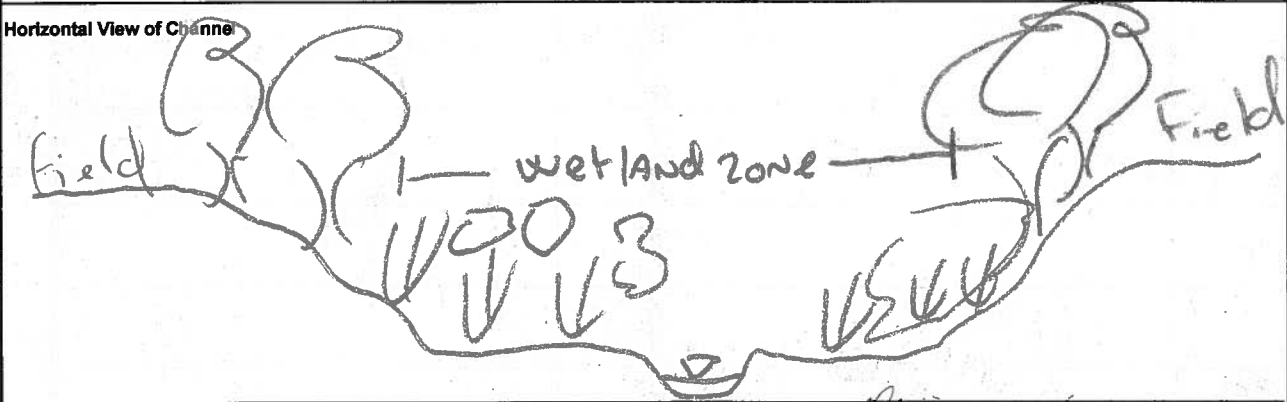
R2.27

- across a wetland, small channel
- meander channel, with no underground water section
- Snapping turtle observed close to the R2.27ST point

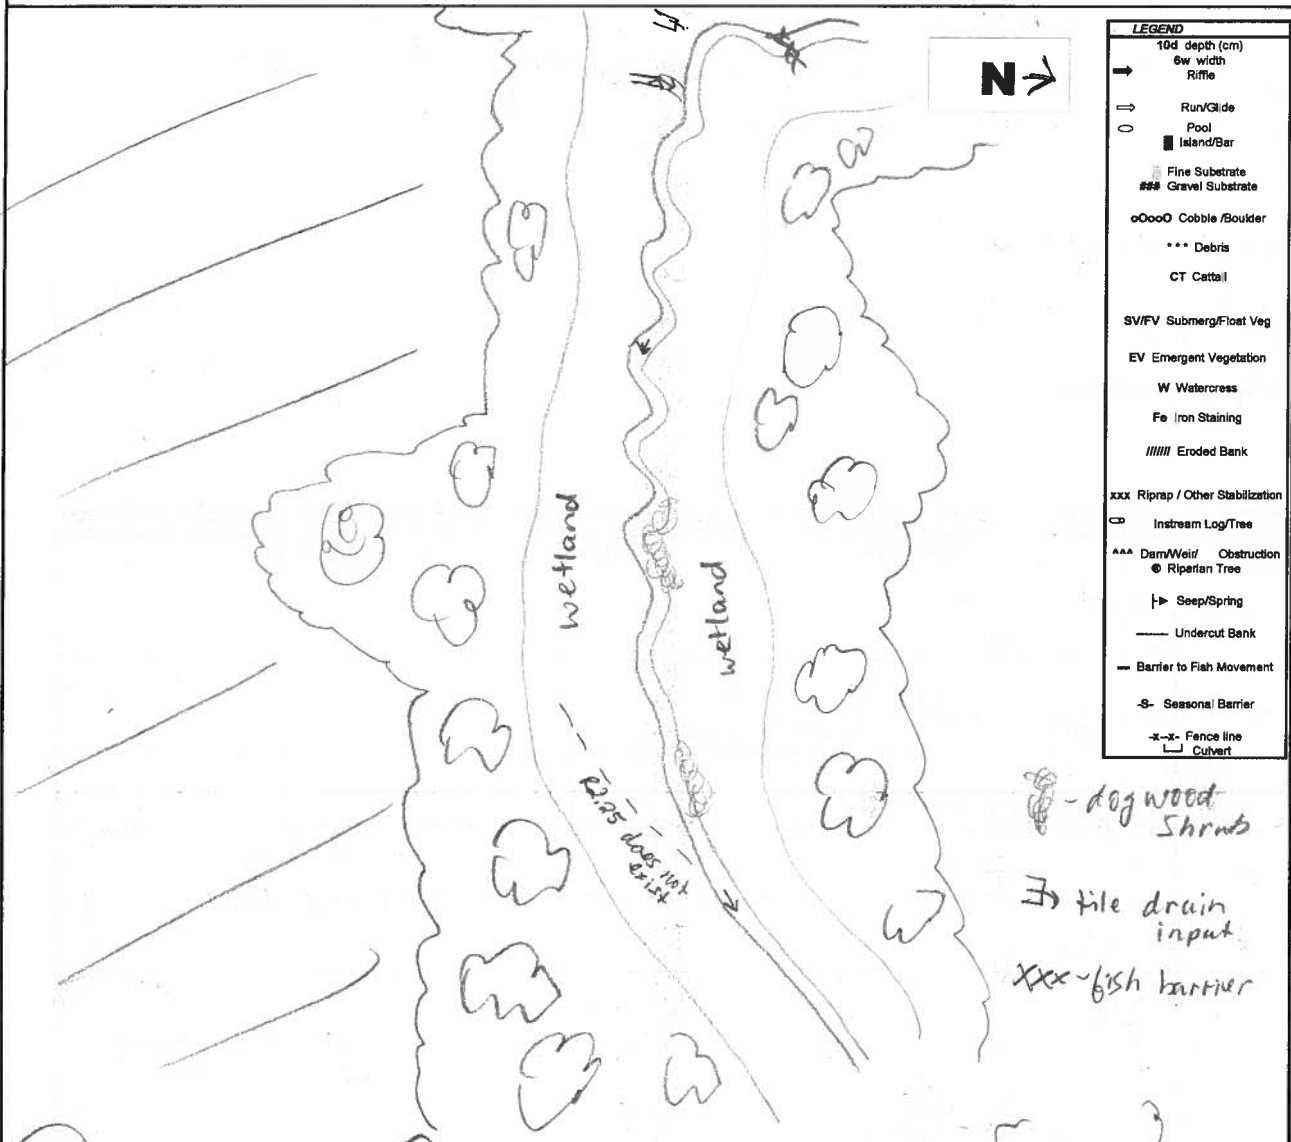
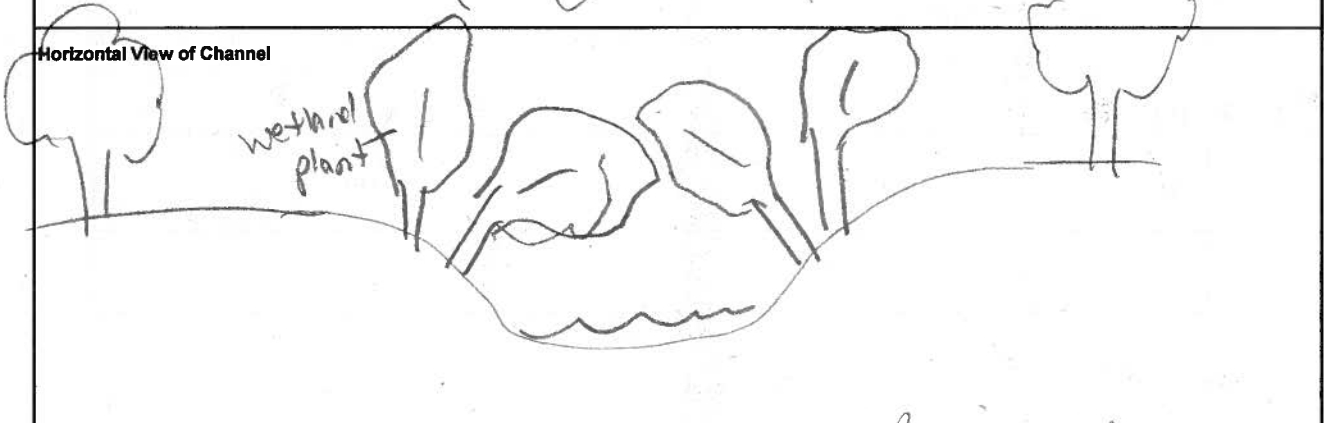
Study Area: Jericho Goshen Bluewater Land Parcel# JER3294 Site ID R2.18

possible seeps -> iron staining observed
-> fish drain input noted at west end of site flowing

⊙ - dogwood shrubs
 ⊢ file drain input
 xxx - fish barrier

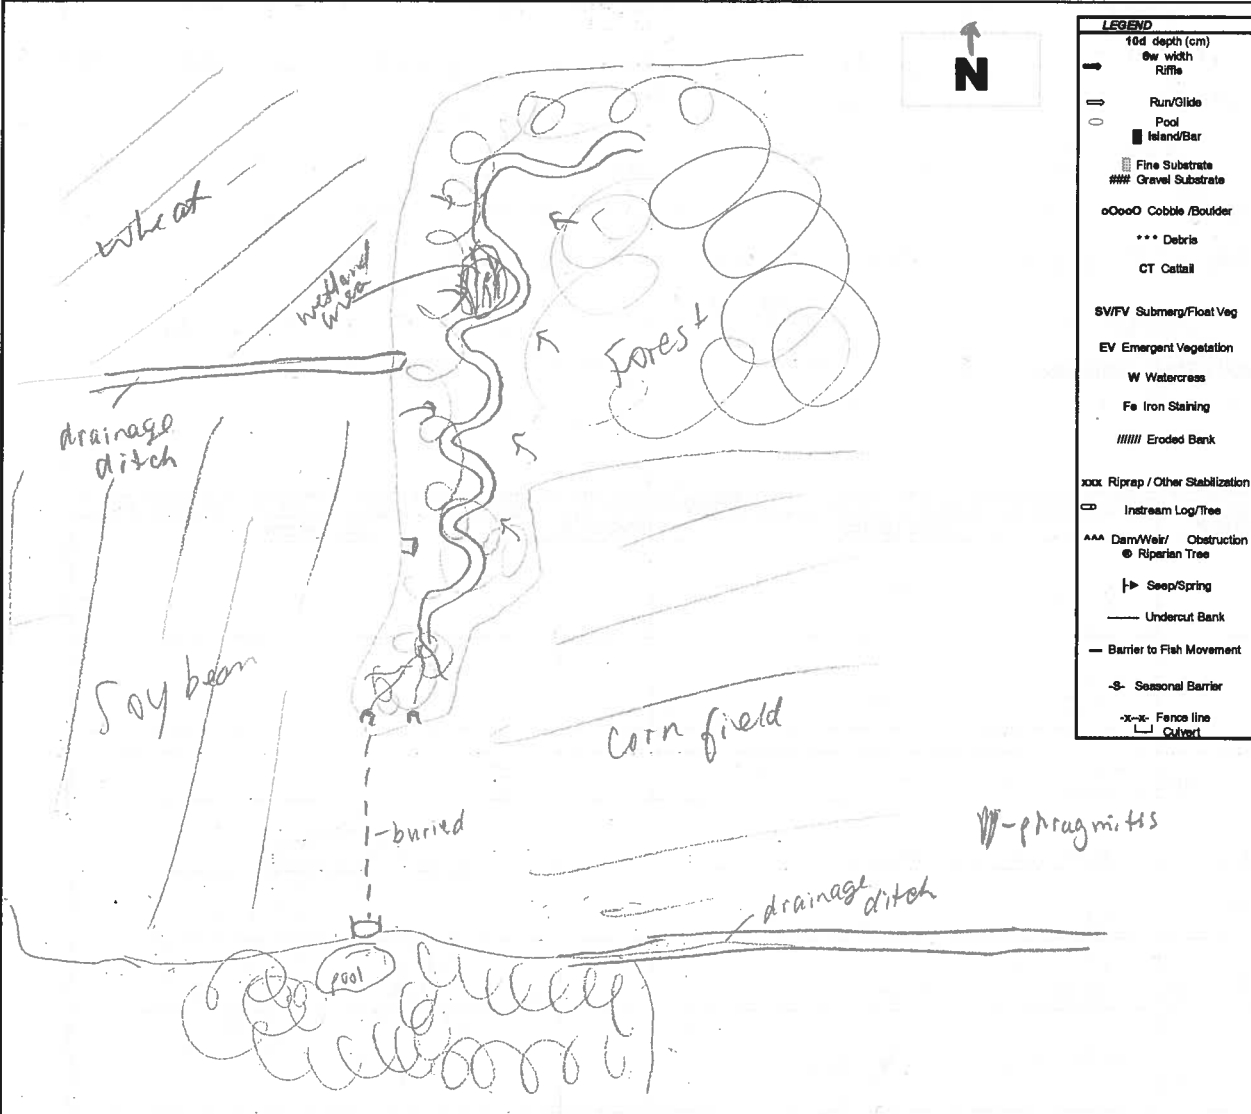
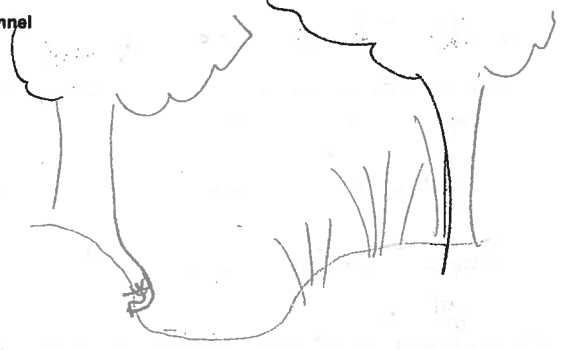
R3.51/R3.28

The assessment began at the fence line of JCR 3494 - it was an outlet area for a tile drain. It was a ponded area (pond) ~5m x 5m. Tadpoles observed in pool. The channel is buried through the soy bean field. There was no defined channel at the southern portion of the forest; as you move north a defined channel appears and it becomes a deep valley area. The watercourse is a shallow channel and a series of long stagnant pools. It meanders and has areas of erosion + undercutting.
