Water Bodies Assessment Field Collection Form

Study Area: Dericho Goshen Bluewater Land Parcel# JUL 9166 Site ID: R3 B
 Date: June 7/12 Start time: 14:00 3588 End Time: 15:10
 Weather Conditions: Sunny, 19°C Field Crew: C. Barros, S. Darciche
 Field Notes By: C. Barros

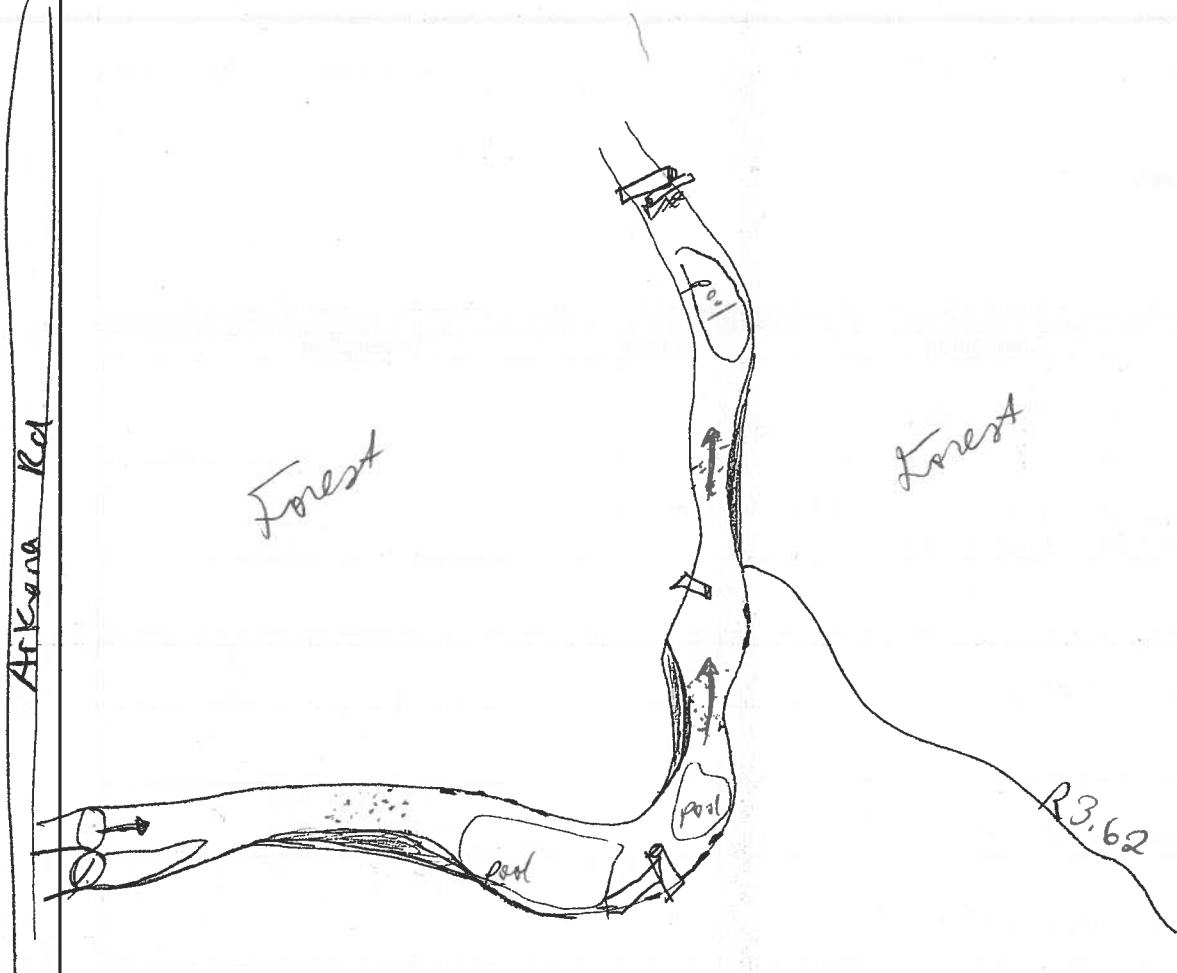
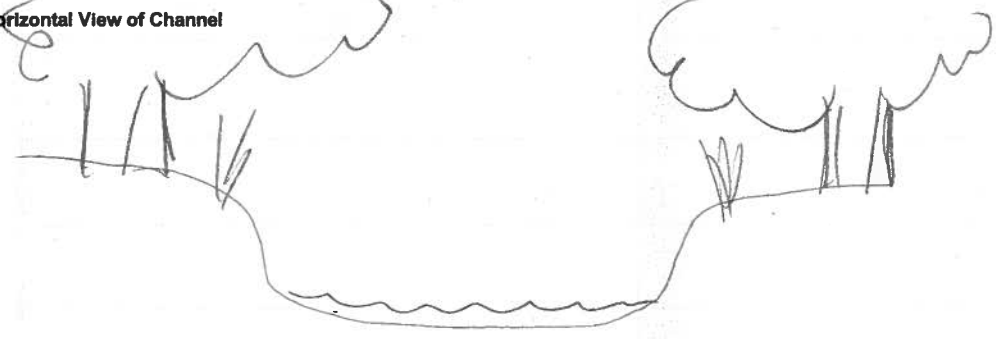
R3 south

Natural watercourse that meanders, has sequences of run, pool (riffle only once) and has a substrate dominated by sand. There is erosion on meander bends and the fallen trees provide good fish habitat cover. Canopy cover is high → mature deciduous forest.

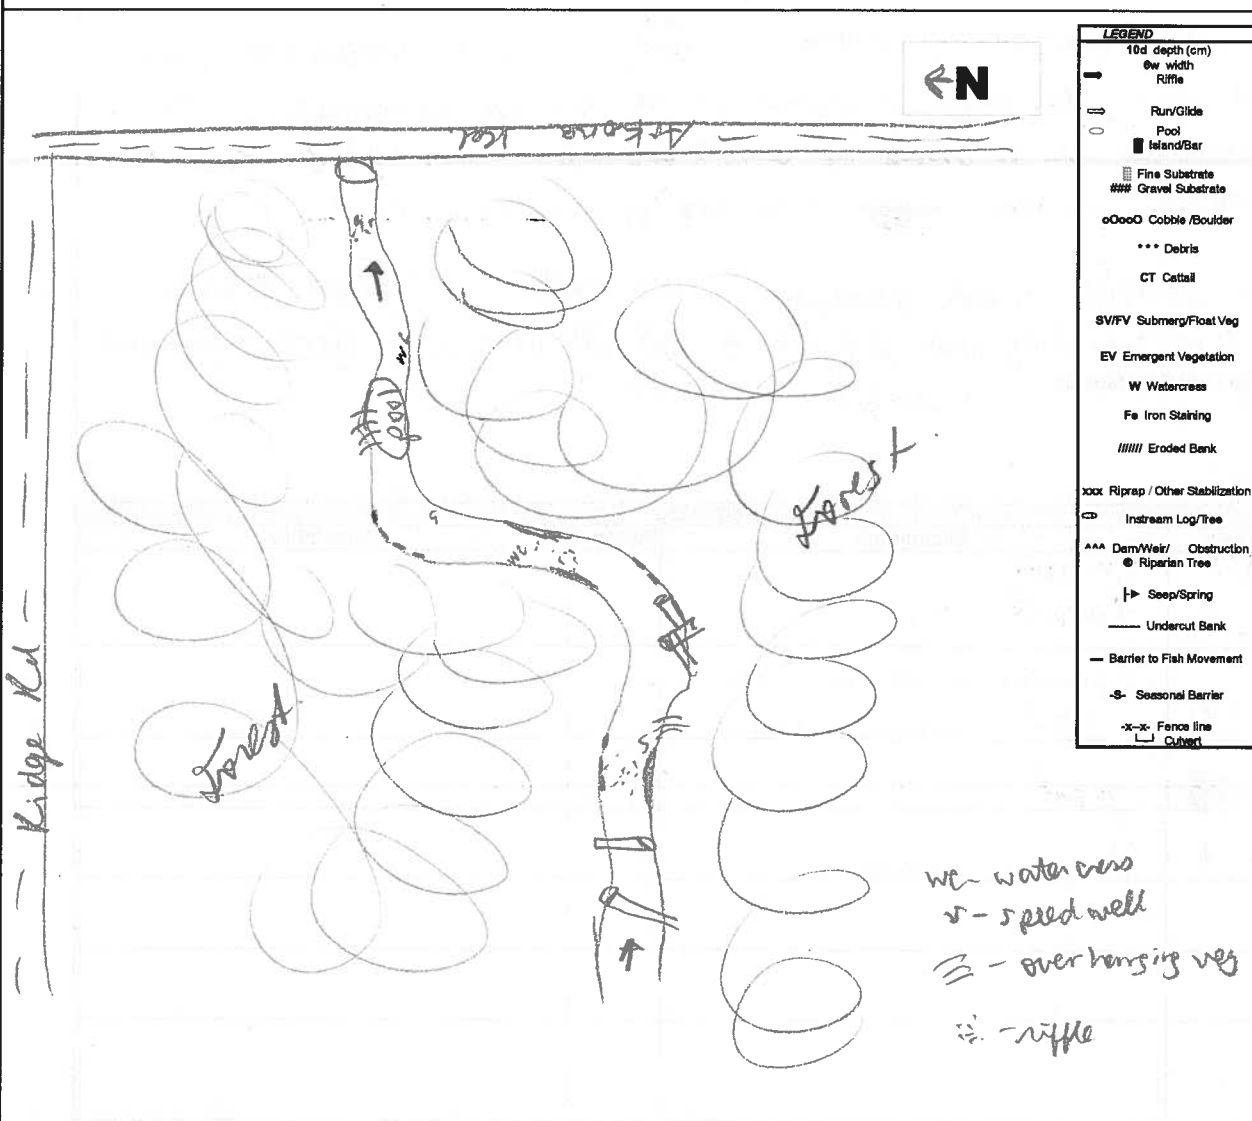
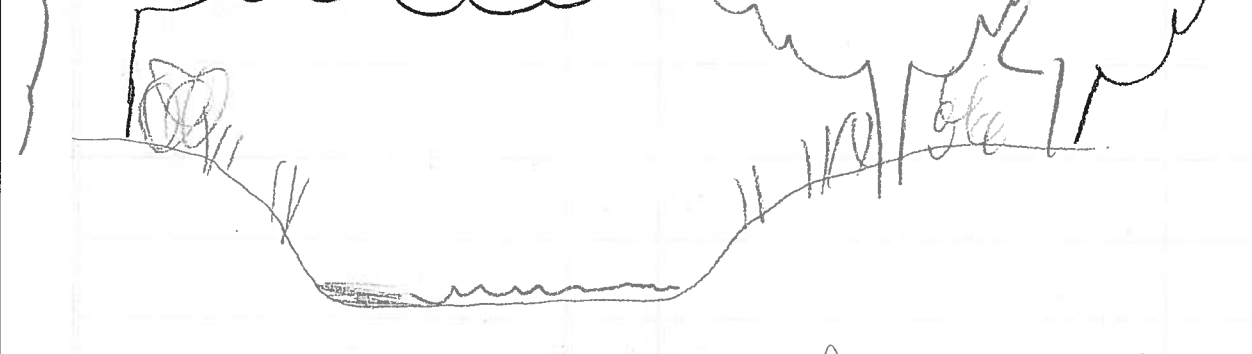
R3B.

Natural meandering stream, riffle, run pool sequence present. It runs through a forest w a thick understory. The substrate is a mix of sa, si, cl, gr + co. Woody debris + algae provide ~~the~~ majority of instream cover.

One large pool observed ~ 3x3 ^m and depth > 60cm.

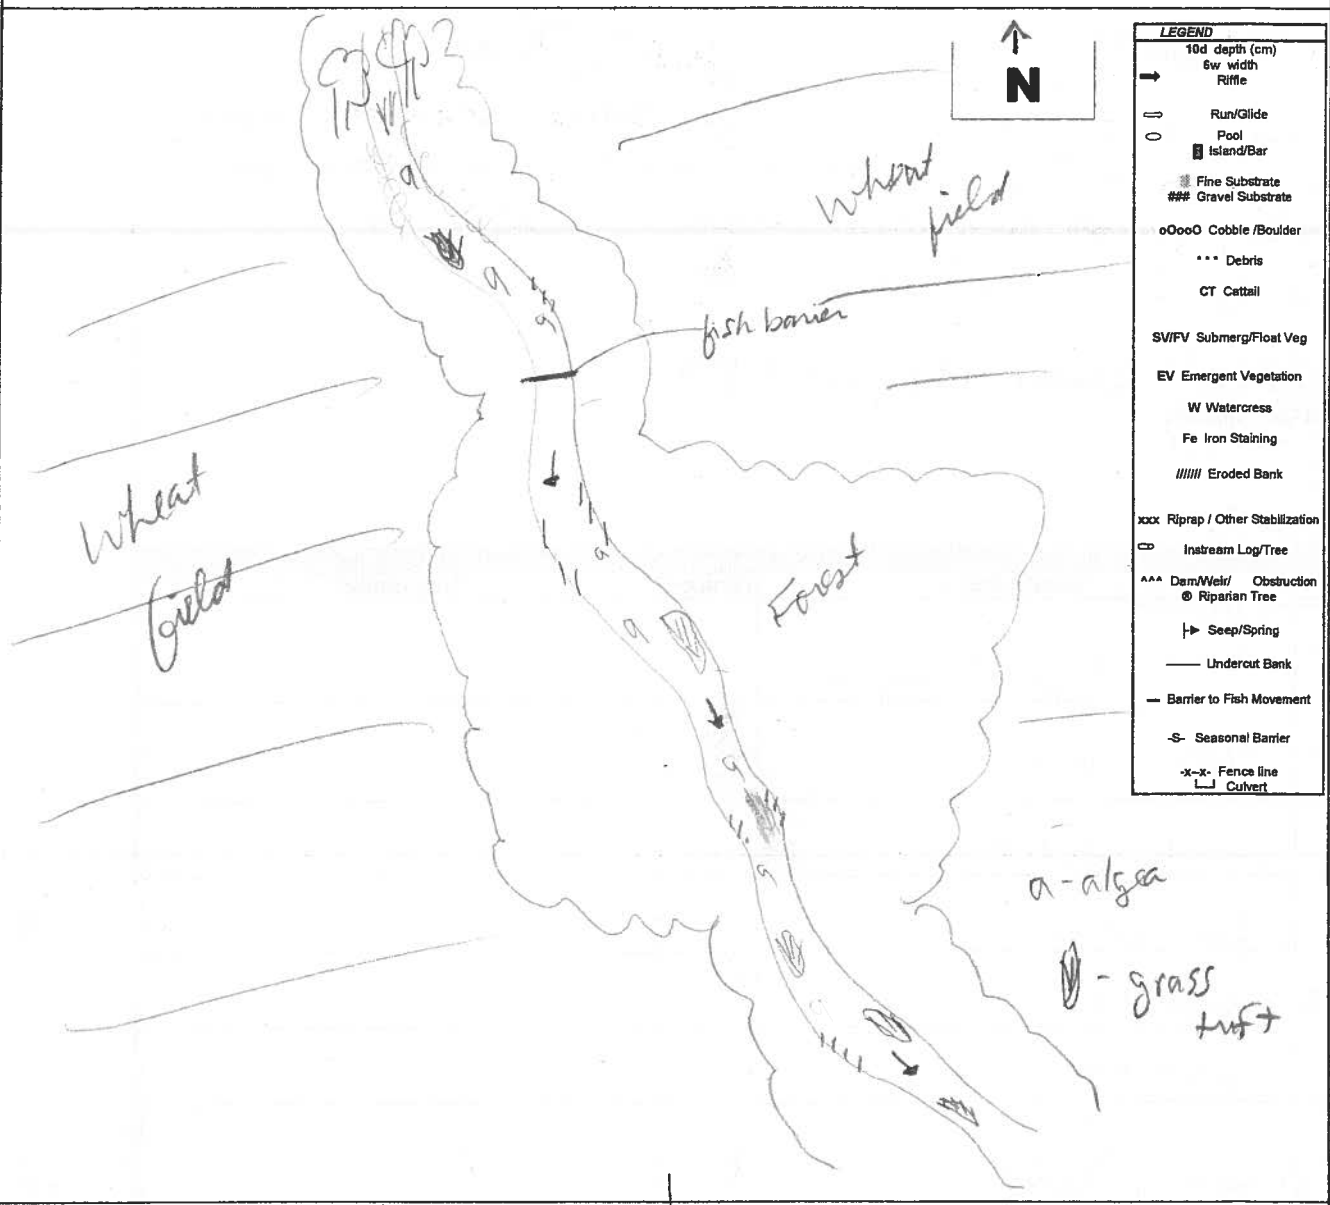
Study Area: Jericho Goshen Bluewater Land Parcel# 3589 Site ID R3,66

- frogs observed
- watercourse starting to meander in larger channel, wetted width narrow at riffle, wider at pools → riffle, run, pool sequence, canopy cover high (shrubs), instream cover mostly algae, substrate a mix.
- No barrier between 3589 and 3591

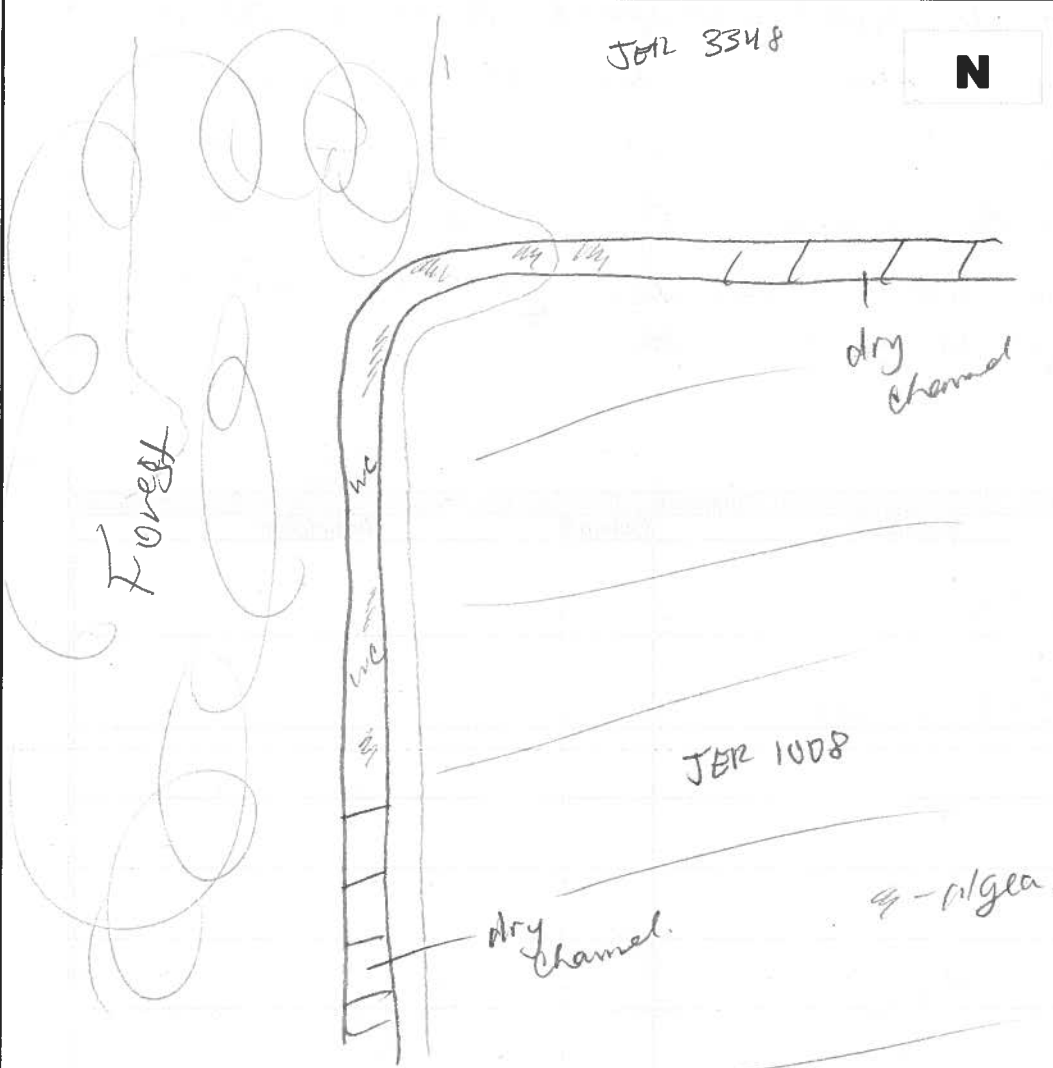
* R4.59

This is on unmapped watercourse found on JER 1008.
It is a channel that runs along the east side of
Feature 213. It is channelized and is most
likely used for overflow - It was ponded in the
corner but becomes dry 20m out to the east and
20m out to the south.

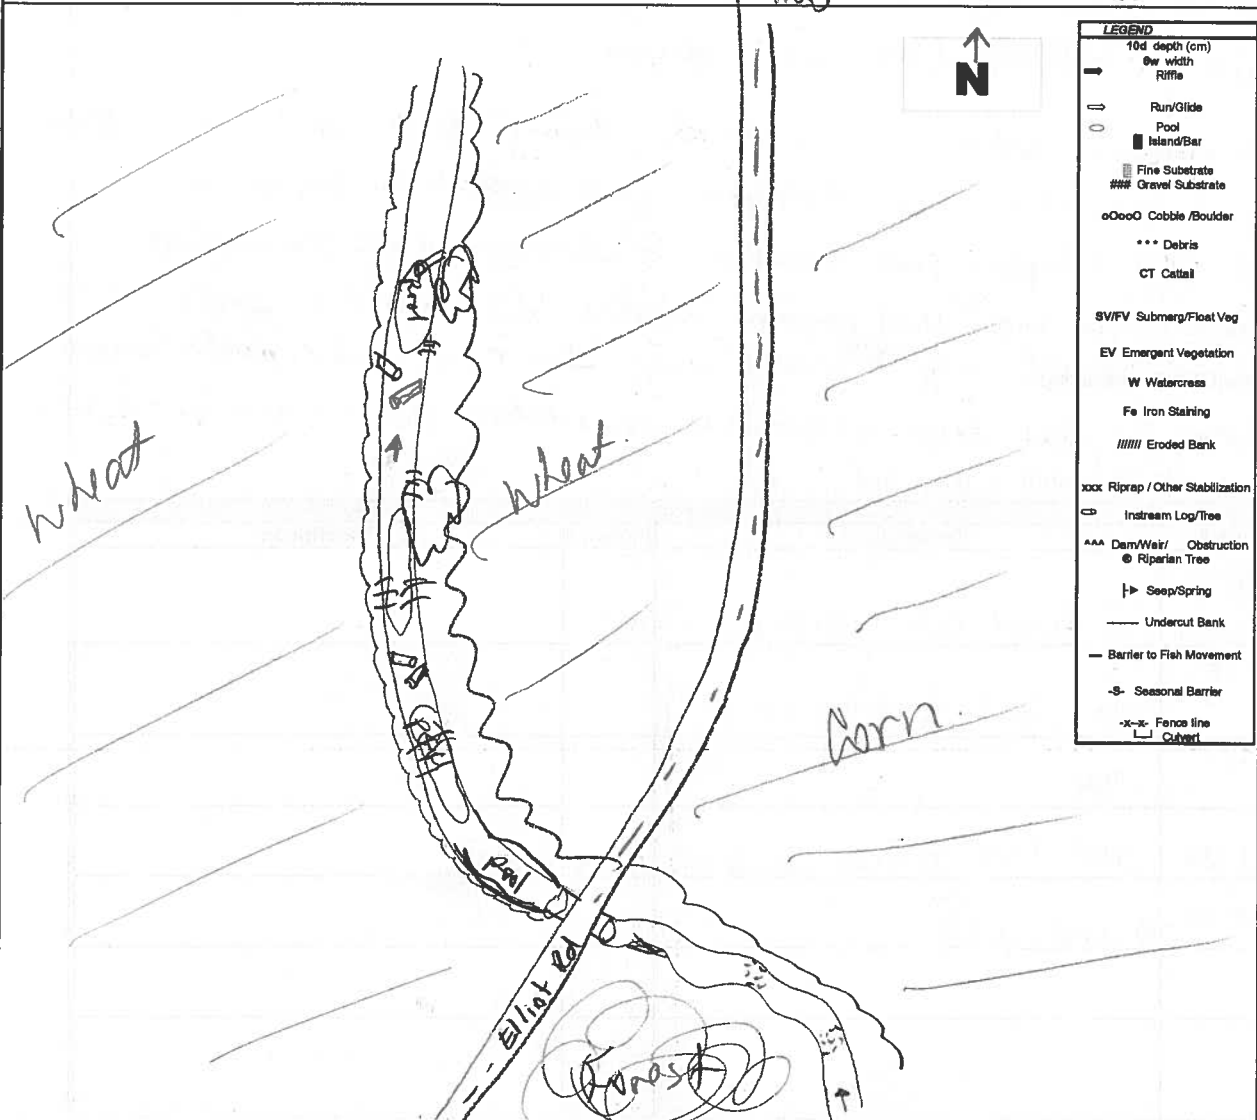
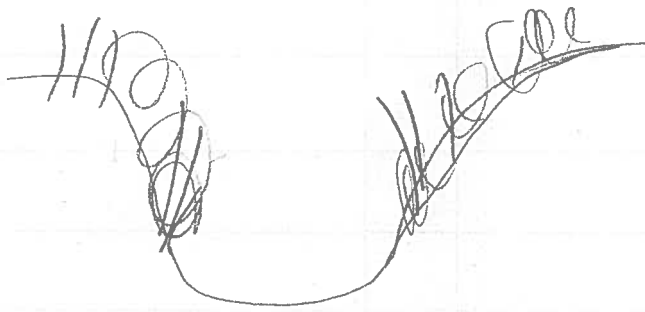
R4, 8 E

Additional UTM Coordinates: Overhanging veg^{and/or} woody debris found in most pools. Canopy cover is less dense. Watercourse is starting to naturalize - blumping + erosion present.
