Assessment of Non-Water Body  
(update to mapping required)

AECOM

**Water Bodies Assessment Field Collection Form**

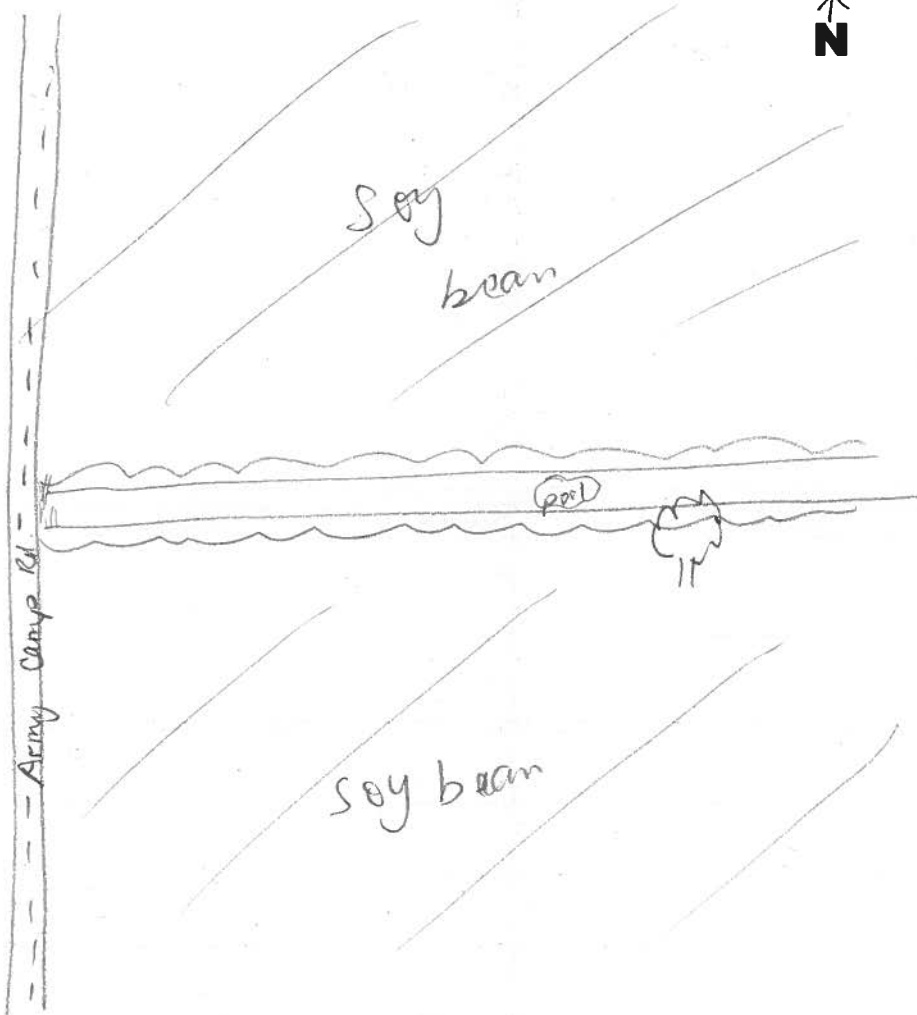
R 4.27

*Channel dry except for one small pool (40m from road). Straight & channelized w well vegetated banks.*

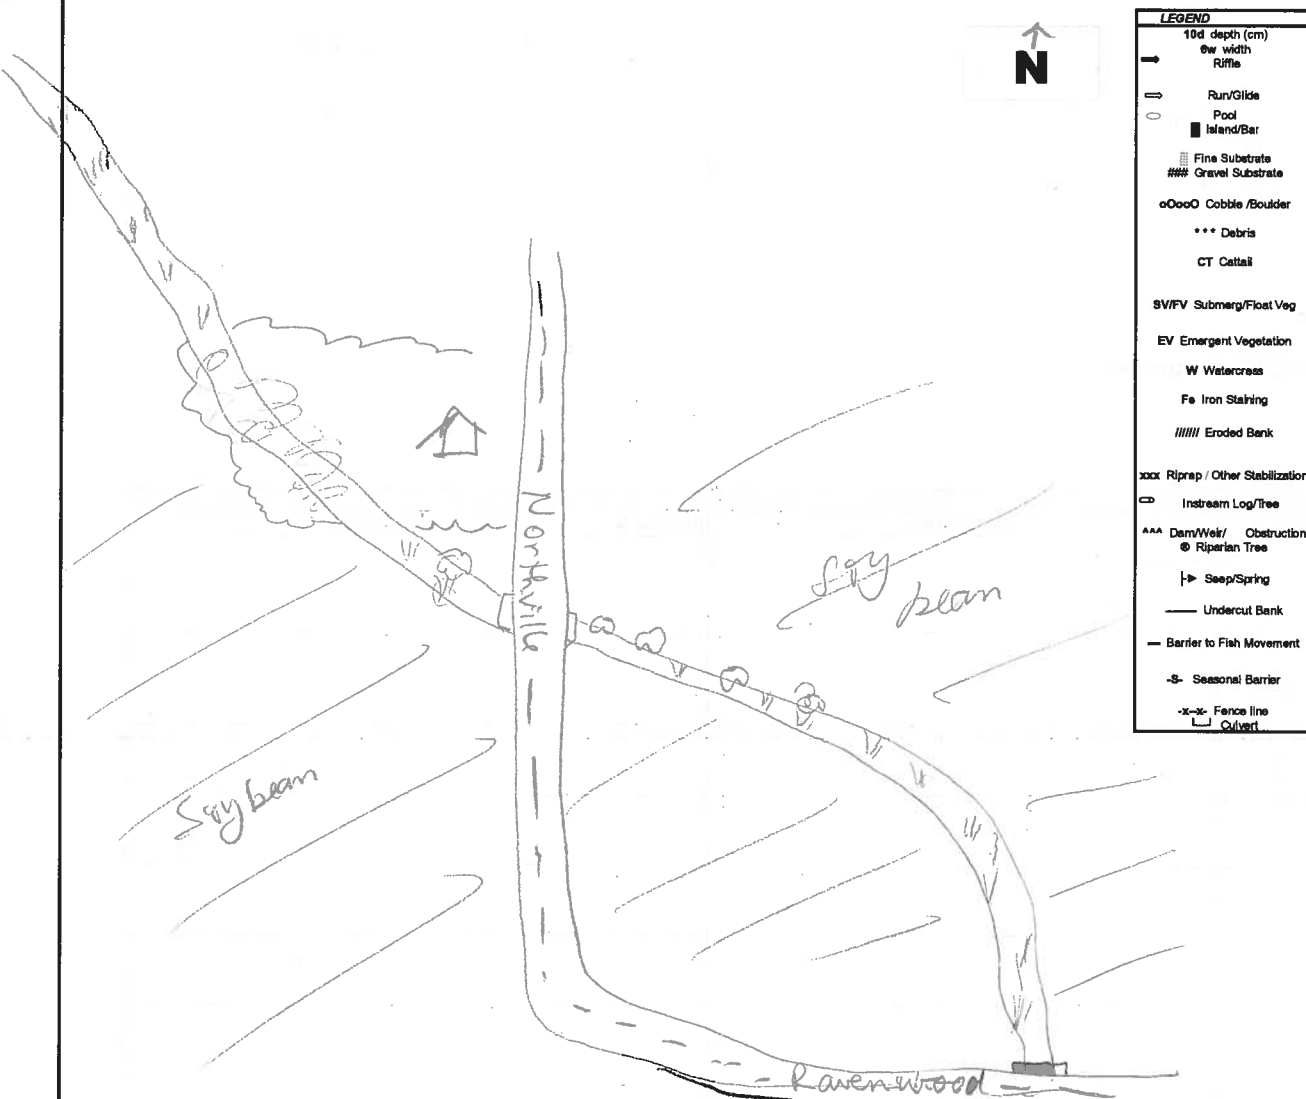
Jericho
~~Goshen~~
Bluewater
Land Parcel#
JSP 3481
Site ID
R48E  
1064/  
3300

*Watercourse dry. Channelized feature that runs through  
agri fields and one section of deciduous forest. Substrate  
bedrock + dry clay w/ rubble + boulder. Banks well vegetated*

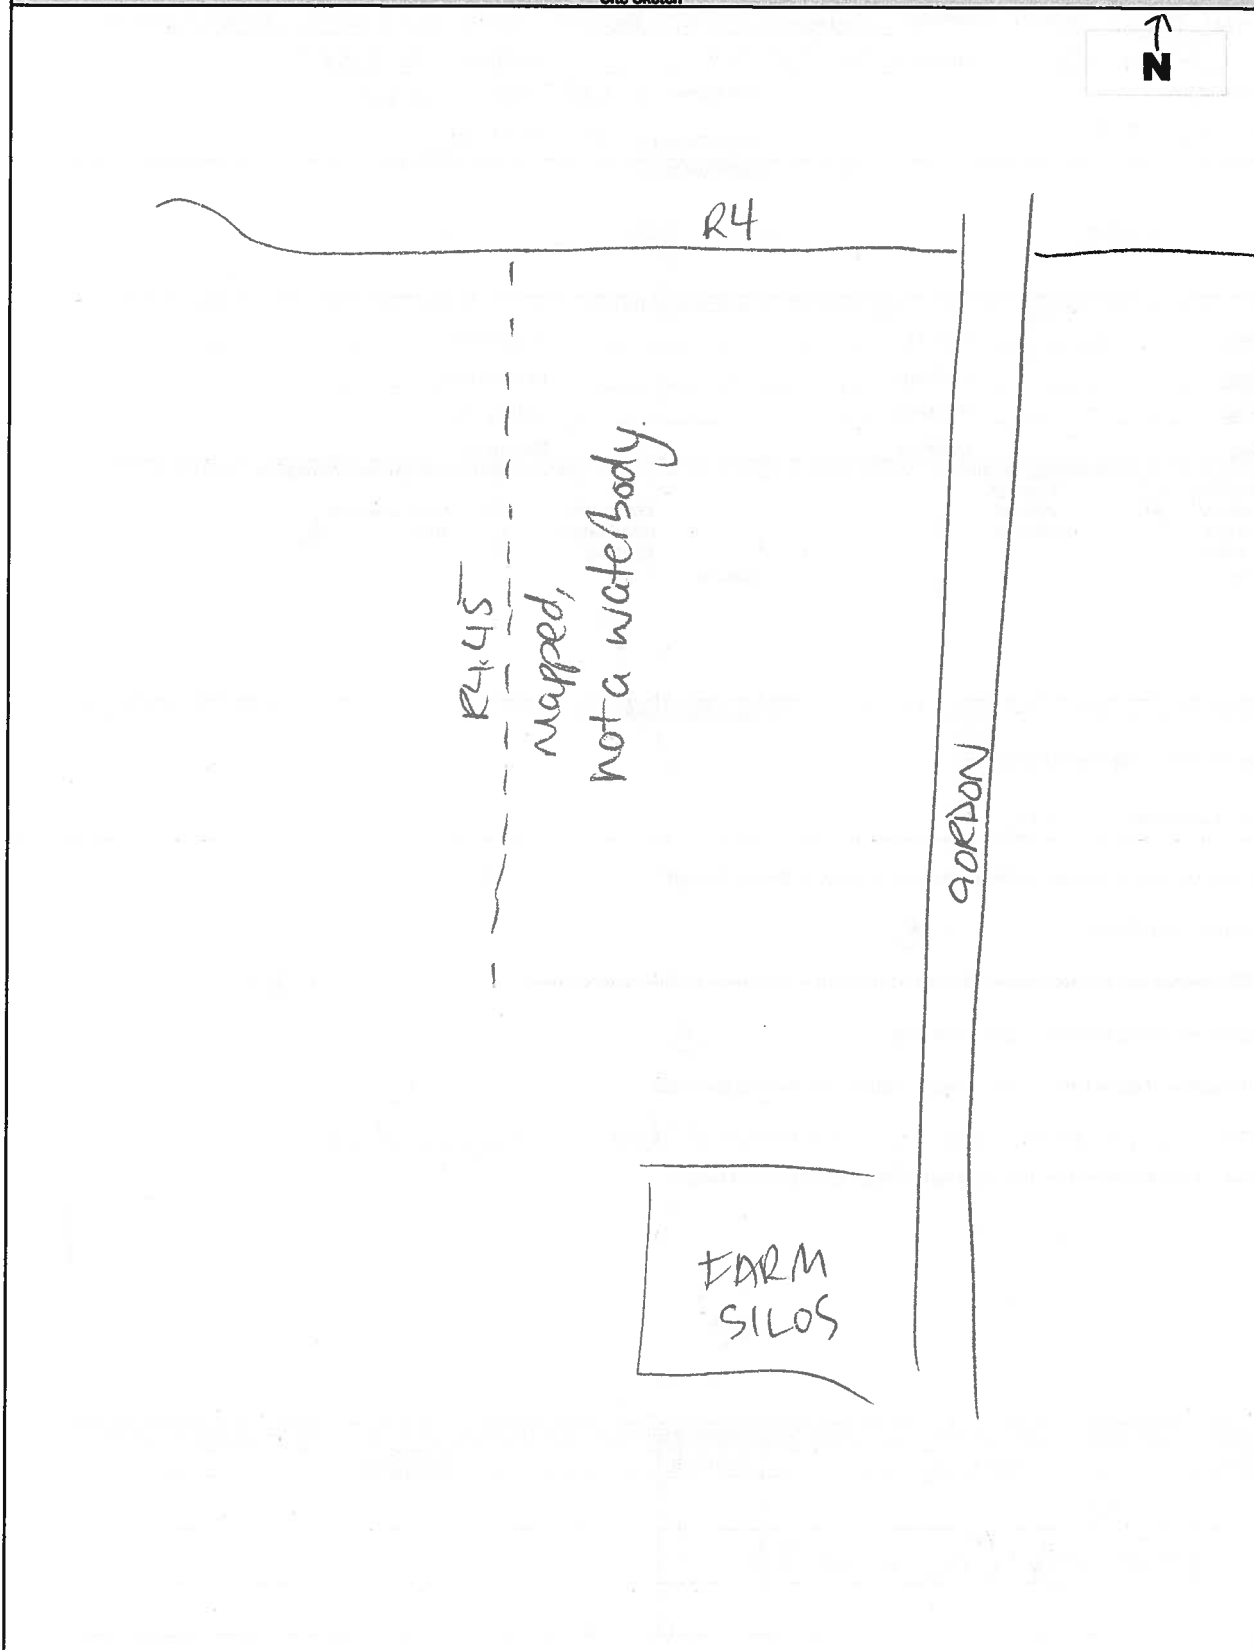
Land Parcel/Site ID: R4.45\_JER3607

- 1) a grassed waterway? Y (N)
- 2) Temporary channel for surface drainage, that can be tilled or driven through? Y (N)
- 3) Rock chutes or spillways? Y (N)
- 4) Roadside ditches that are not connected or do not contain a permanent or intermittent stream? Y (N)
- 5) Temporarily ponded areas that are normally farmed? Y (N)
- 6) Artificial bodies of water intended for storage, treatment for farming purposes? Y (N)
- 8) Any other: no waterbody, remove from mapping

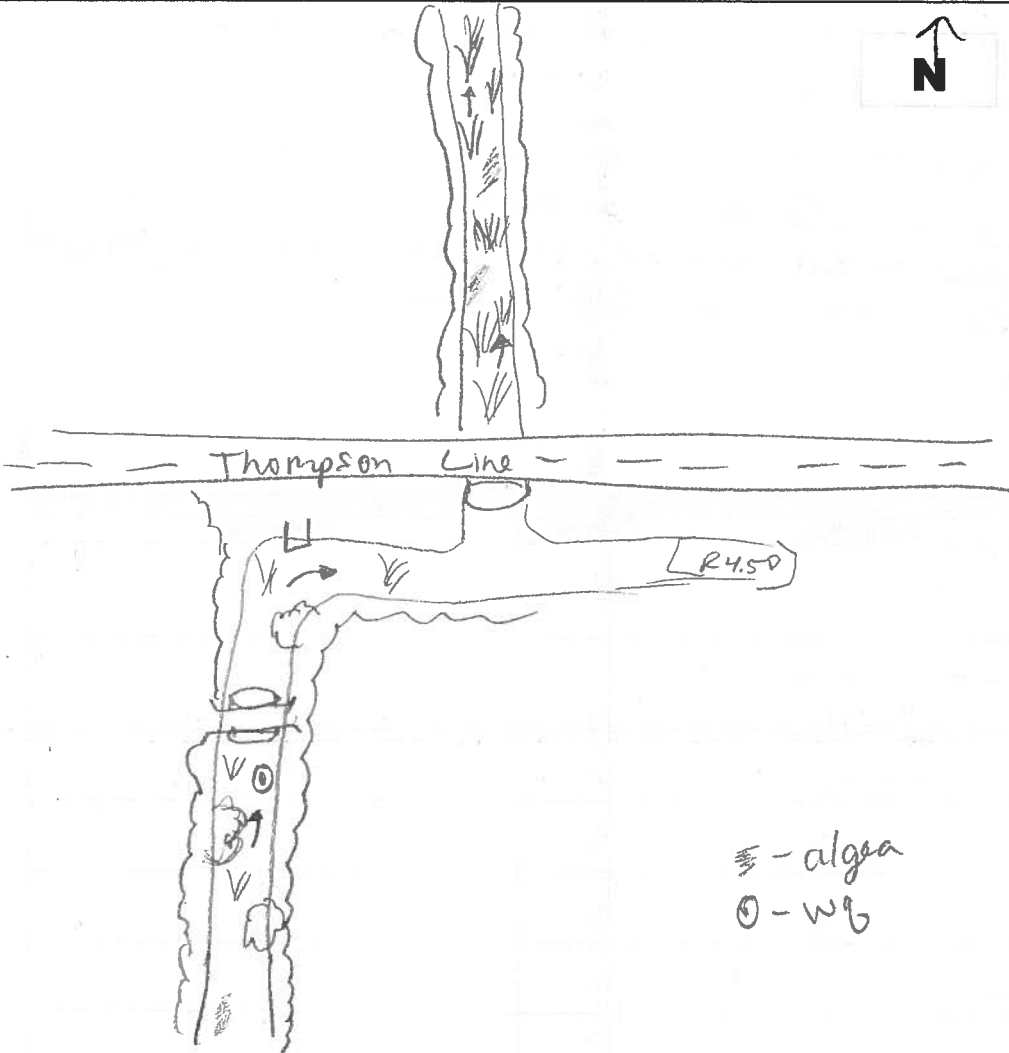
R4.8A

- minnows observed, green frog heard  
 - Watercourse similar 40m north of study area and south  
 - chimney crayfish homes observed on JER 3493

≡ - algae  
○ - WB

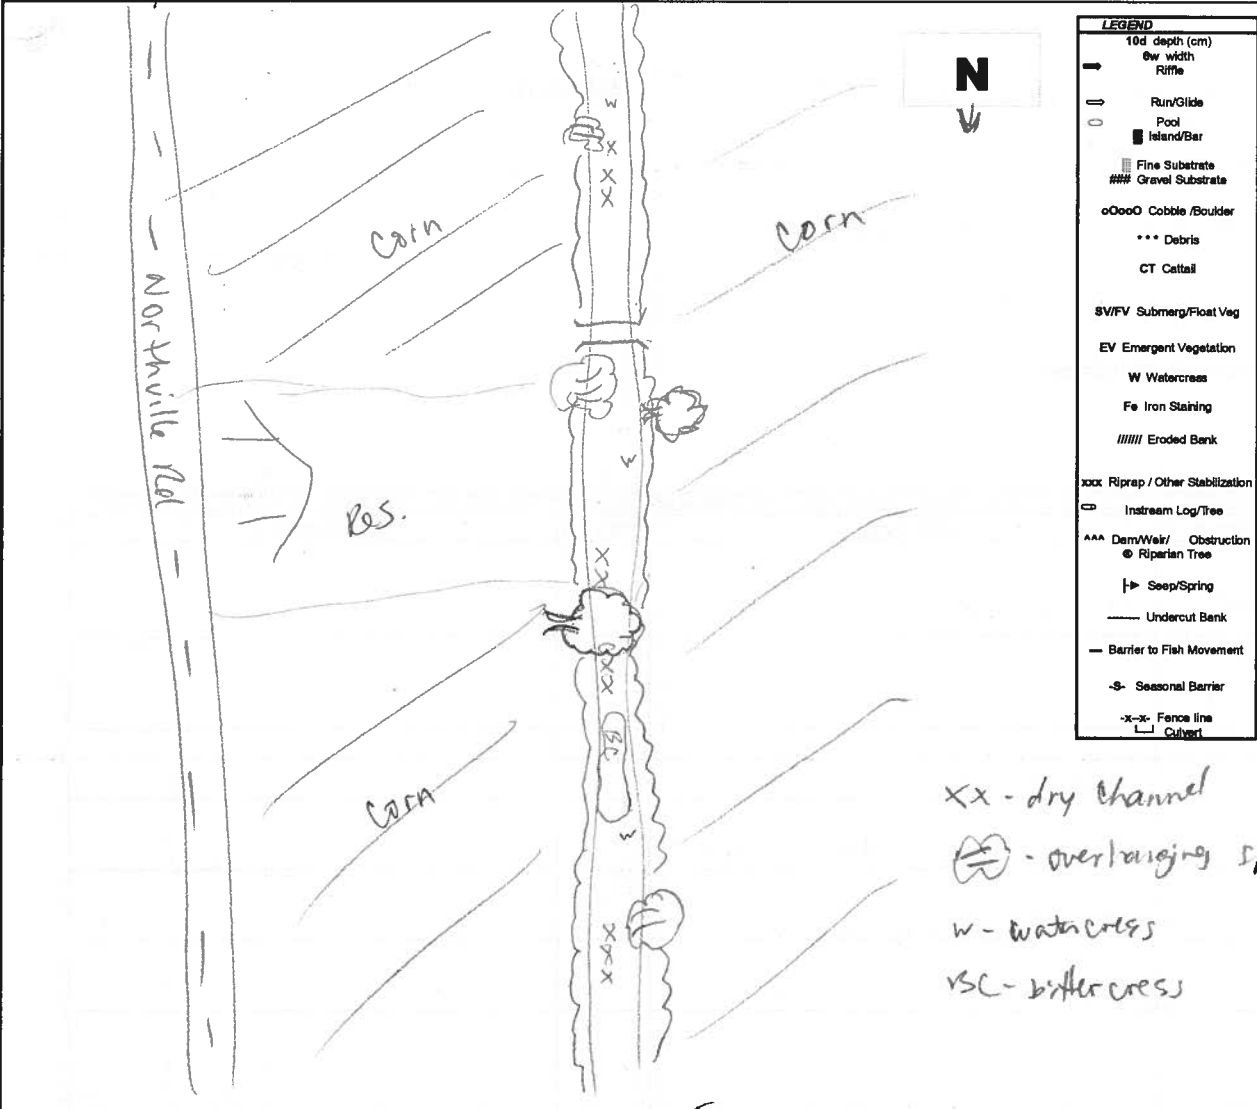
RA.25A

small mats of watercress observed

xx - dry channel  
 (⊖) - overhanging shrub  
 w - watercress  
 vsc - bittercress

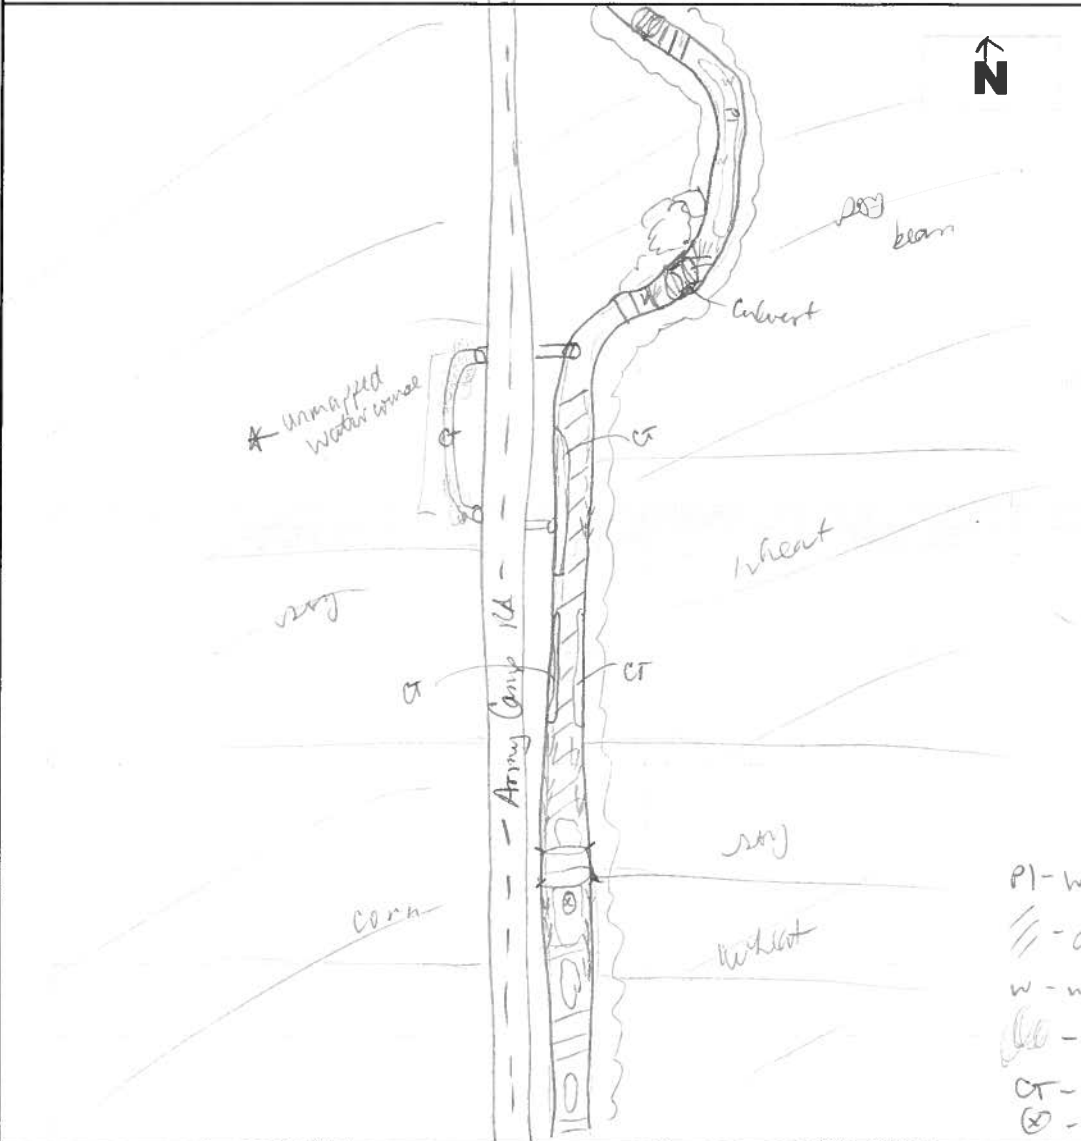
RS11A

Chimney crayfish observed →

P1 - water plantain  
 // - dry channel  
 w - watercress  
 (shrub) - shrubs over-grown  
 CT - cattail  
 ⊗ - wg
