APPENDIX B

Site Investigation Field Notes

Date: 10 Sept 2010	Project #: 10-1181-0085	Weather Conditions: sunny wind 13 km/hr
Collectors: Lasha Mine	Time: 10:15	Time: 10:45
Watercourse Name: 4 (cut) tunnel	30A	55d
Reach ID	003	003
UTM easting and northing (CL of crossing)	0597481 4745158	0580378 4747173
Flow regime (permanent, intermittent, ephemeral)	Permanent	not a waterbody as defined by R.I.P.
Mean Bank width (m)	wet: 2m 2m Full: 5m	wet: N/A Full: no bank
Mean Bank depth (cm)	wet: 50cm Full: 2m	wet: N/A Full: no bank
Substrates (% BE-bedrock, BO-boulder, CO-cobble, GR-gravel, SA-sand, SI-silt, CL-clay, MU-muck, DE-detritus)	SI 60 MU 20. BO 10%. CL 10 water opaque silty	SI CL
Channel morphology (% riffle/run/pool/flat throughout the reach; field swale, straightened/channelized, meandering, braided channel)	meandering stream w some po large pools	not a waterbody, field swale
Bank Stability (stable, slightly stable, unstable, slightly unstable)	Left upstream bank (LUB) slightly stable	LUB unstable

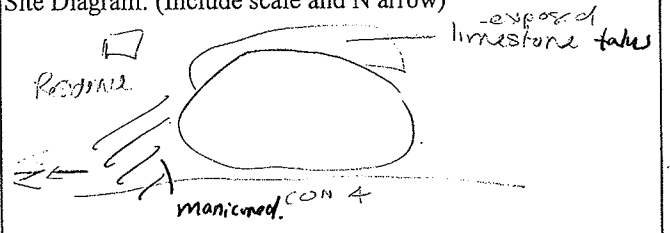
Center
POND NEAR 10 WATER CROSSING 78 OFF OF (304) CON 4. BETWEEN TURBINE 304 27 (MAP FIGURE)

East side of pond steep limestone bank vegetated with *Saxifraga* *serotina*, *nightsshade* sp. and *honeyuckle*. No aquatic vegetation observed other than *algae* *boom* on surface of water. Some callitris to north of pond on bank. West bank of pond low slope, has been manicured (mowed lawn close to edge). Vegetated primarily with grasses & forbs (*gaura* *leucoloba*) & some *coronilla* & *serotina* & *apple* sp. No species observed. some eggs laying into water for breeding potential. Close proximity to roadside for turtle nesting habitat.

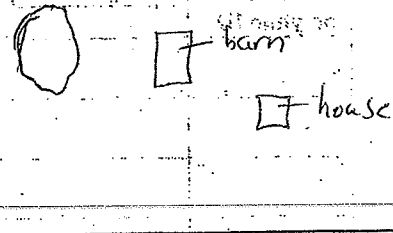
man-made? (managed garden pond)
no visible in/outflow
photo 0259 (to S)

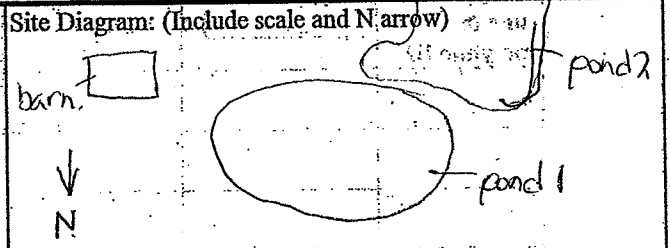
Comments
 man-made dredged channel to S of pond 2
 pond 2 no in/out flow
 pond 1

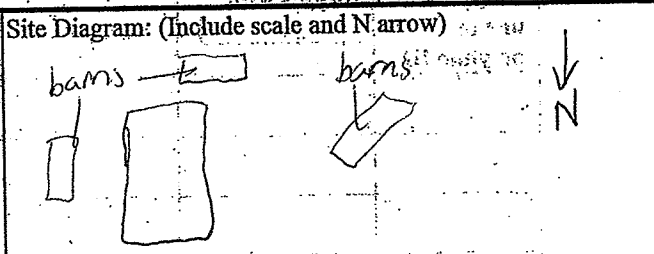
~~Enter~~ Comments
 man-made no in/outflow fenced (no access) surface ~ 75% covered w/ duckweed and residue (unknown) Photo 0244

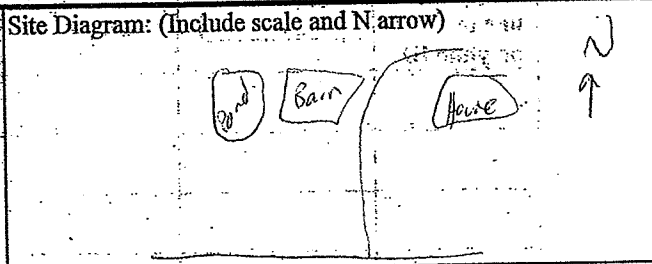
~~Notes~~ Comments:
fenced, man-made
no in/outflow
photo 0242

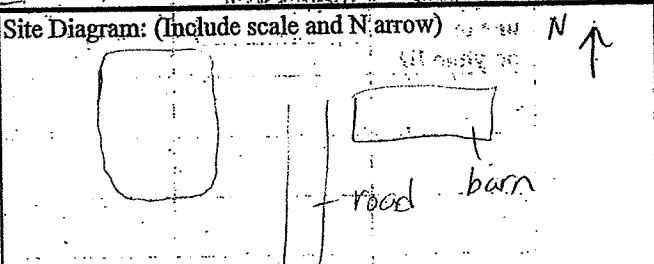
Comments
 choked by cattail
 surrounded by wooden fence
 man-made
 no in/out flow
