This letter identifies changes in the project layout for the Conestogo Wind Energy Centre, Wellington County (Fit-FU99SSXJ) and addresses implications of these changes on the *Detailed Heritage Assessment Report* prepared by Archaeological Services Inc. (November 2010) and which was reviewed by the Ministry of Tourism and Culture (MTC).

**Detailed Heritage Assessment Report:
Built Heritage Resources and Cultural Heritage Landscapes**

**Conestogo Wind Energy Centre
Wellington County, Ontario**

FIT-FU99SSXJ

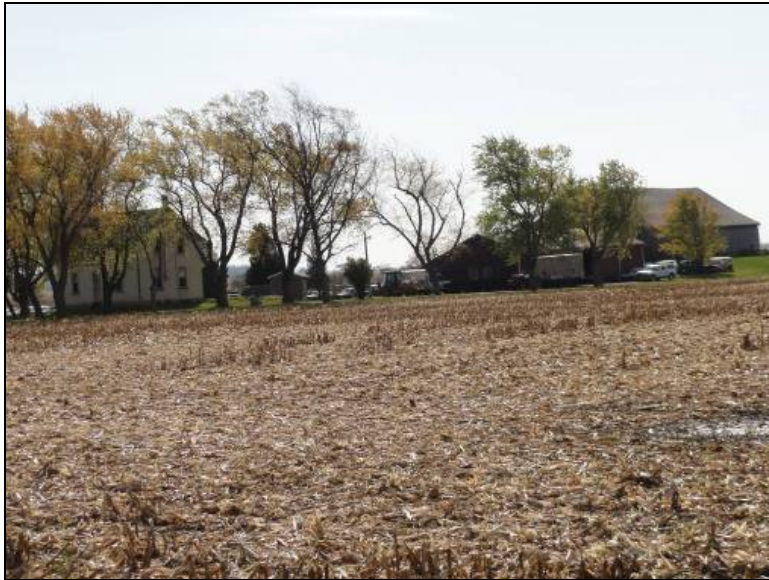
The proposed undertaking has the potential to alter the nineteenth century, agricultural setting of this property through the introduction of Turbine No. 1 and associated access road at the rear of the parcel.
CHL 2	7788 16 th Line	Farm Complex	Identified during the field review.

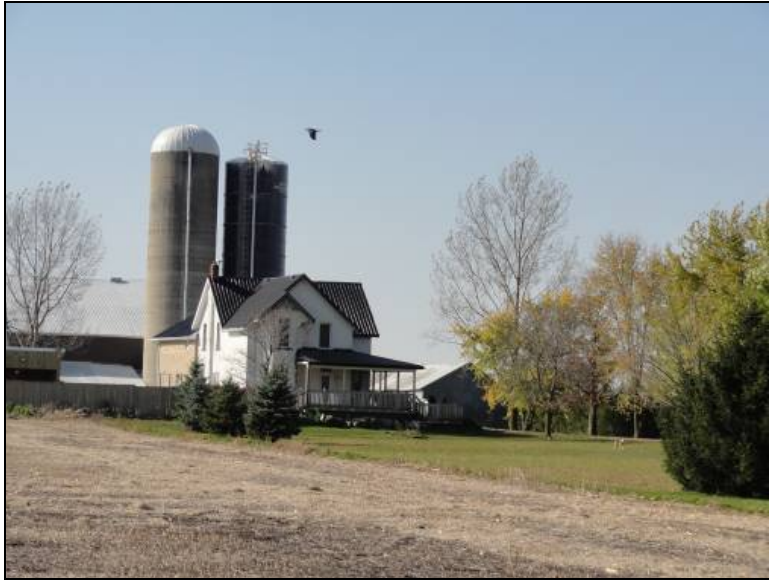
The proposed undertaking has the potential to alter the nineteenth century, agricultural setting of this property though the introduction of: a transformer along its eastern edge approximately 300 – 400 metres east of the agricultural complex; Turbines No. 2 and 3 and access roads at the rear of the parcel; an underground electrical collector along the property’s eastern boundary; a temporary construction laydown area at the rear of the parcel; and a crane path at the rear of the parcel.

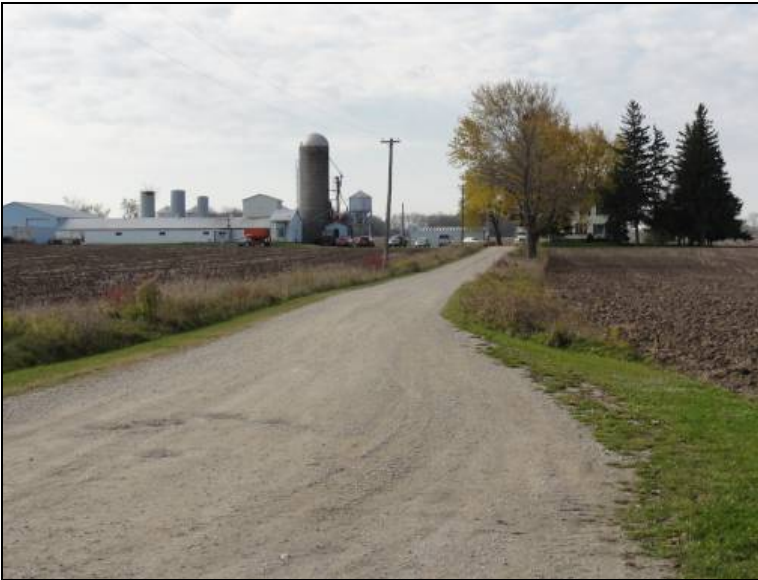
The proposed undertaking has the potential to alter the early twentieth century, agricultural setting of the property through the introduction of Turbine No. 6 and associated access roads.
CHL 4	Sideroad 6	Roadscape	Identified during the field review.

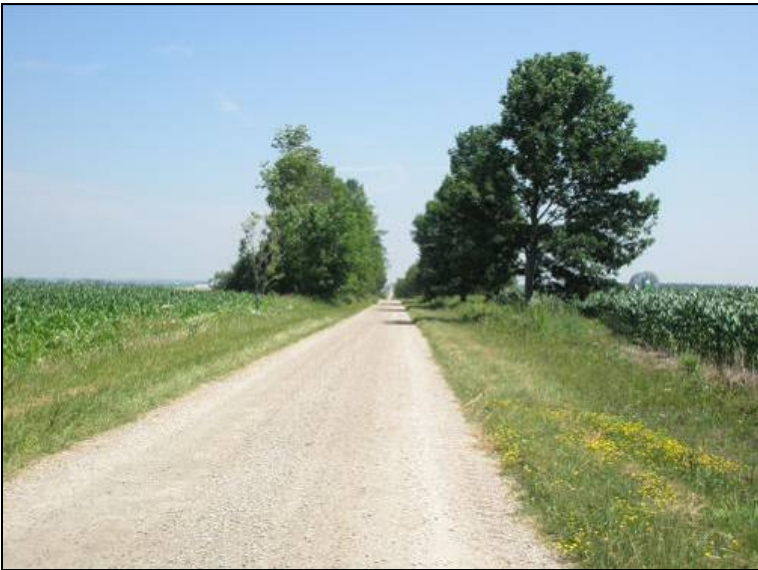
The proposed undertaking has the potential to alter this historic thoroughfare, which continues to function as a roadscape evocative of its nineteenth century origins, through likely upgrading from Sixteenth Line southerly to the access roads for Turbine Nos. 7 and 8. The upgrades will include widening to a width of 6 m and upgrading of culverts if required. The culverts were not identified as individual cultural heritage resources.

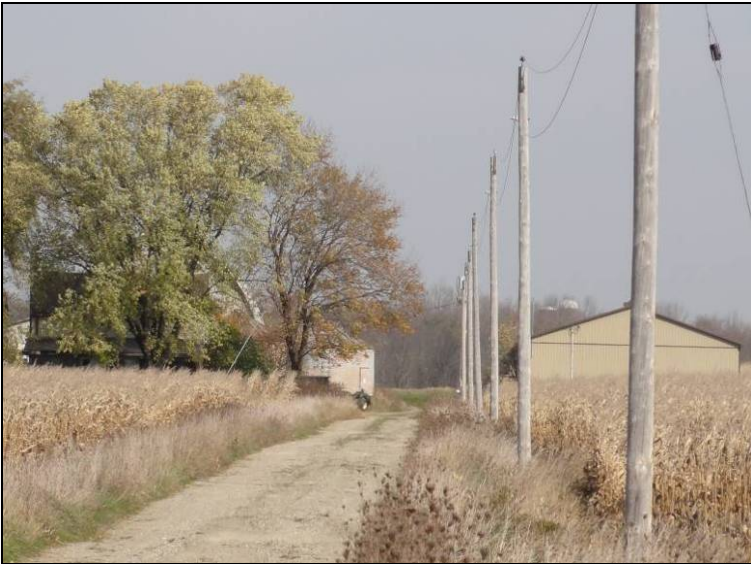
The proposed undertaking has the potential to alter the nineteenth century, agricultural setting of the property through the introduction of: Turbines No. 7 and 8, associated access roads, and crane paths.
CHL 6	14 th Line	Roadscape	Identified during the field review.

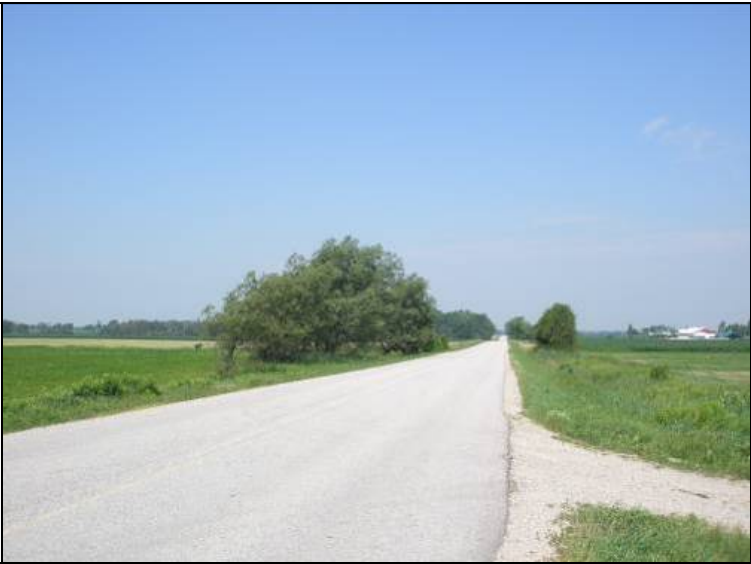
The proposed undertaking has the potential to alter this historic thoroughfare, which continues to function as a roadscape evocative of nineteenth century origins, through potential project construction related alterations.

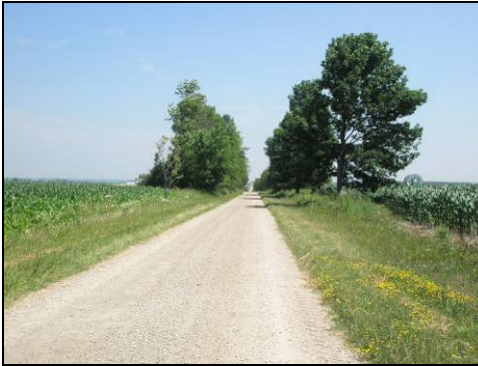
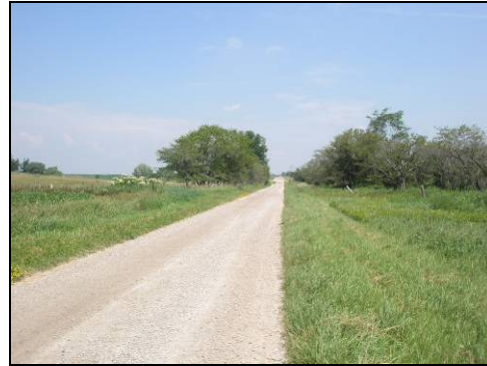
CHL 4	Sideroad 6	Roadscape	This road is a historic thoroughfare and retains features and elements associated with the adjacent rural, nineteenth century setting. The road features: a very narrow right-of-way; gravel surface; lacks curbs, ditches or shoulders; and is framed by various hedgerows, vegetative screening, and mature deciduous trees.	Consideration of criteria contained in Regulation 9/06 confirmed that this feature may be considered to retain cultural heritage value. This road is associated with early settlement activities and is contextually important in defining the agricultural character of the area.

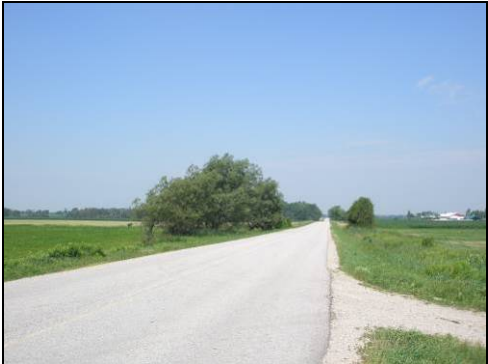
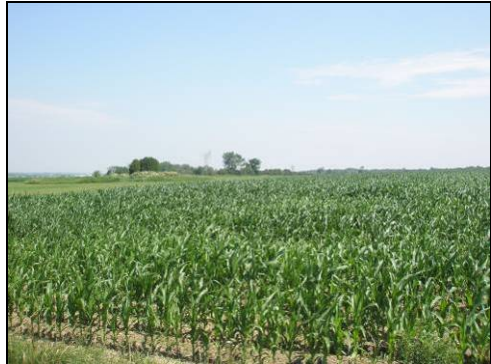
CHL 6		Roadscape	This road is a historic thoroughfare and retains features and elements associated with the adjacent rural, nineteenth century setting. The road features: a very narrow right-of-way; gravel surface; lacks curbs, ditches or shoulders; and is framed by various hedgerows, vegetative screening, and mature deciduous trees.	Consideration of criteria contained in Regulation 9/06 confirmed that this feature may be considered to retain cultural heritage value. This road is associated with early settlement activities and is contextually important in defining the nineteenth century agricultural character of the area.

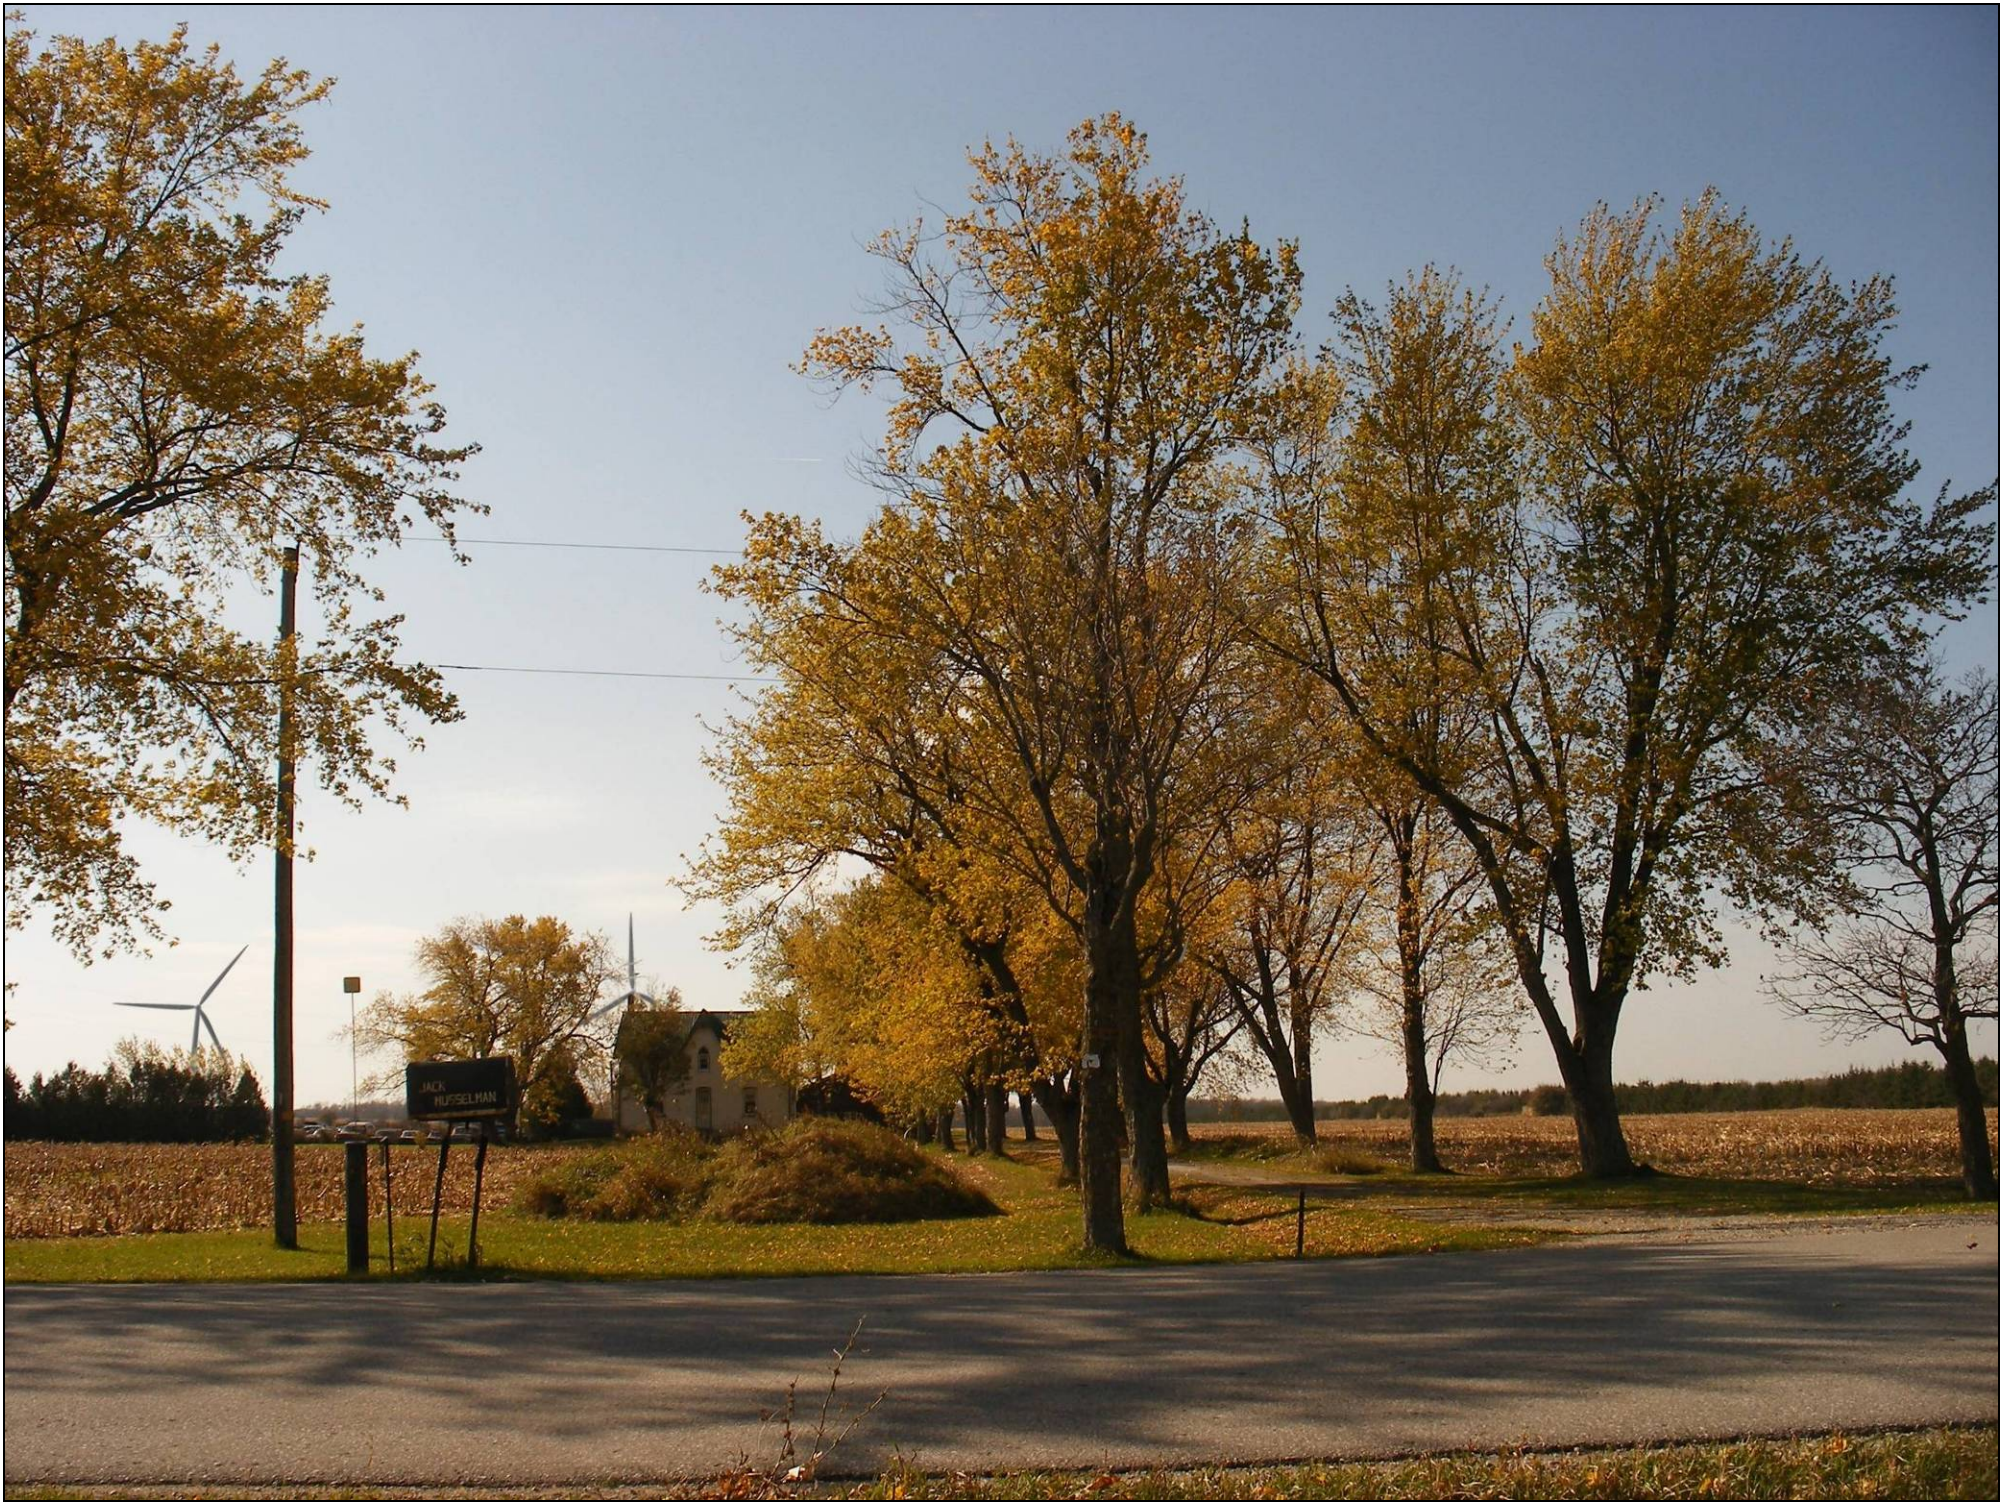
Figure 8: Photomontage looking south, showing proposed turbine #1 (behind house) and turbine #2 to left (east) on CHL 1.

As part of the process of assessing impacts on the four farm complexes in particular, photomontages and cross-section drawings were prepared for the purposes of analyzing the extent of resulting landscape alteration. These drawings can be found in Appendix B. Table 4 provides a summary of the results of impact assessment.

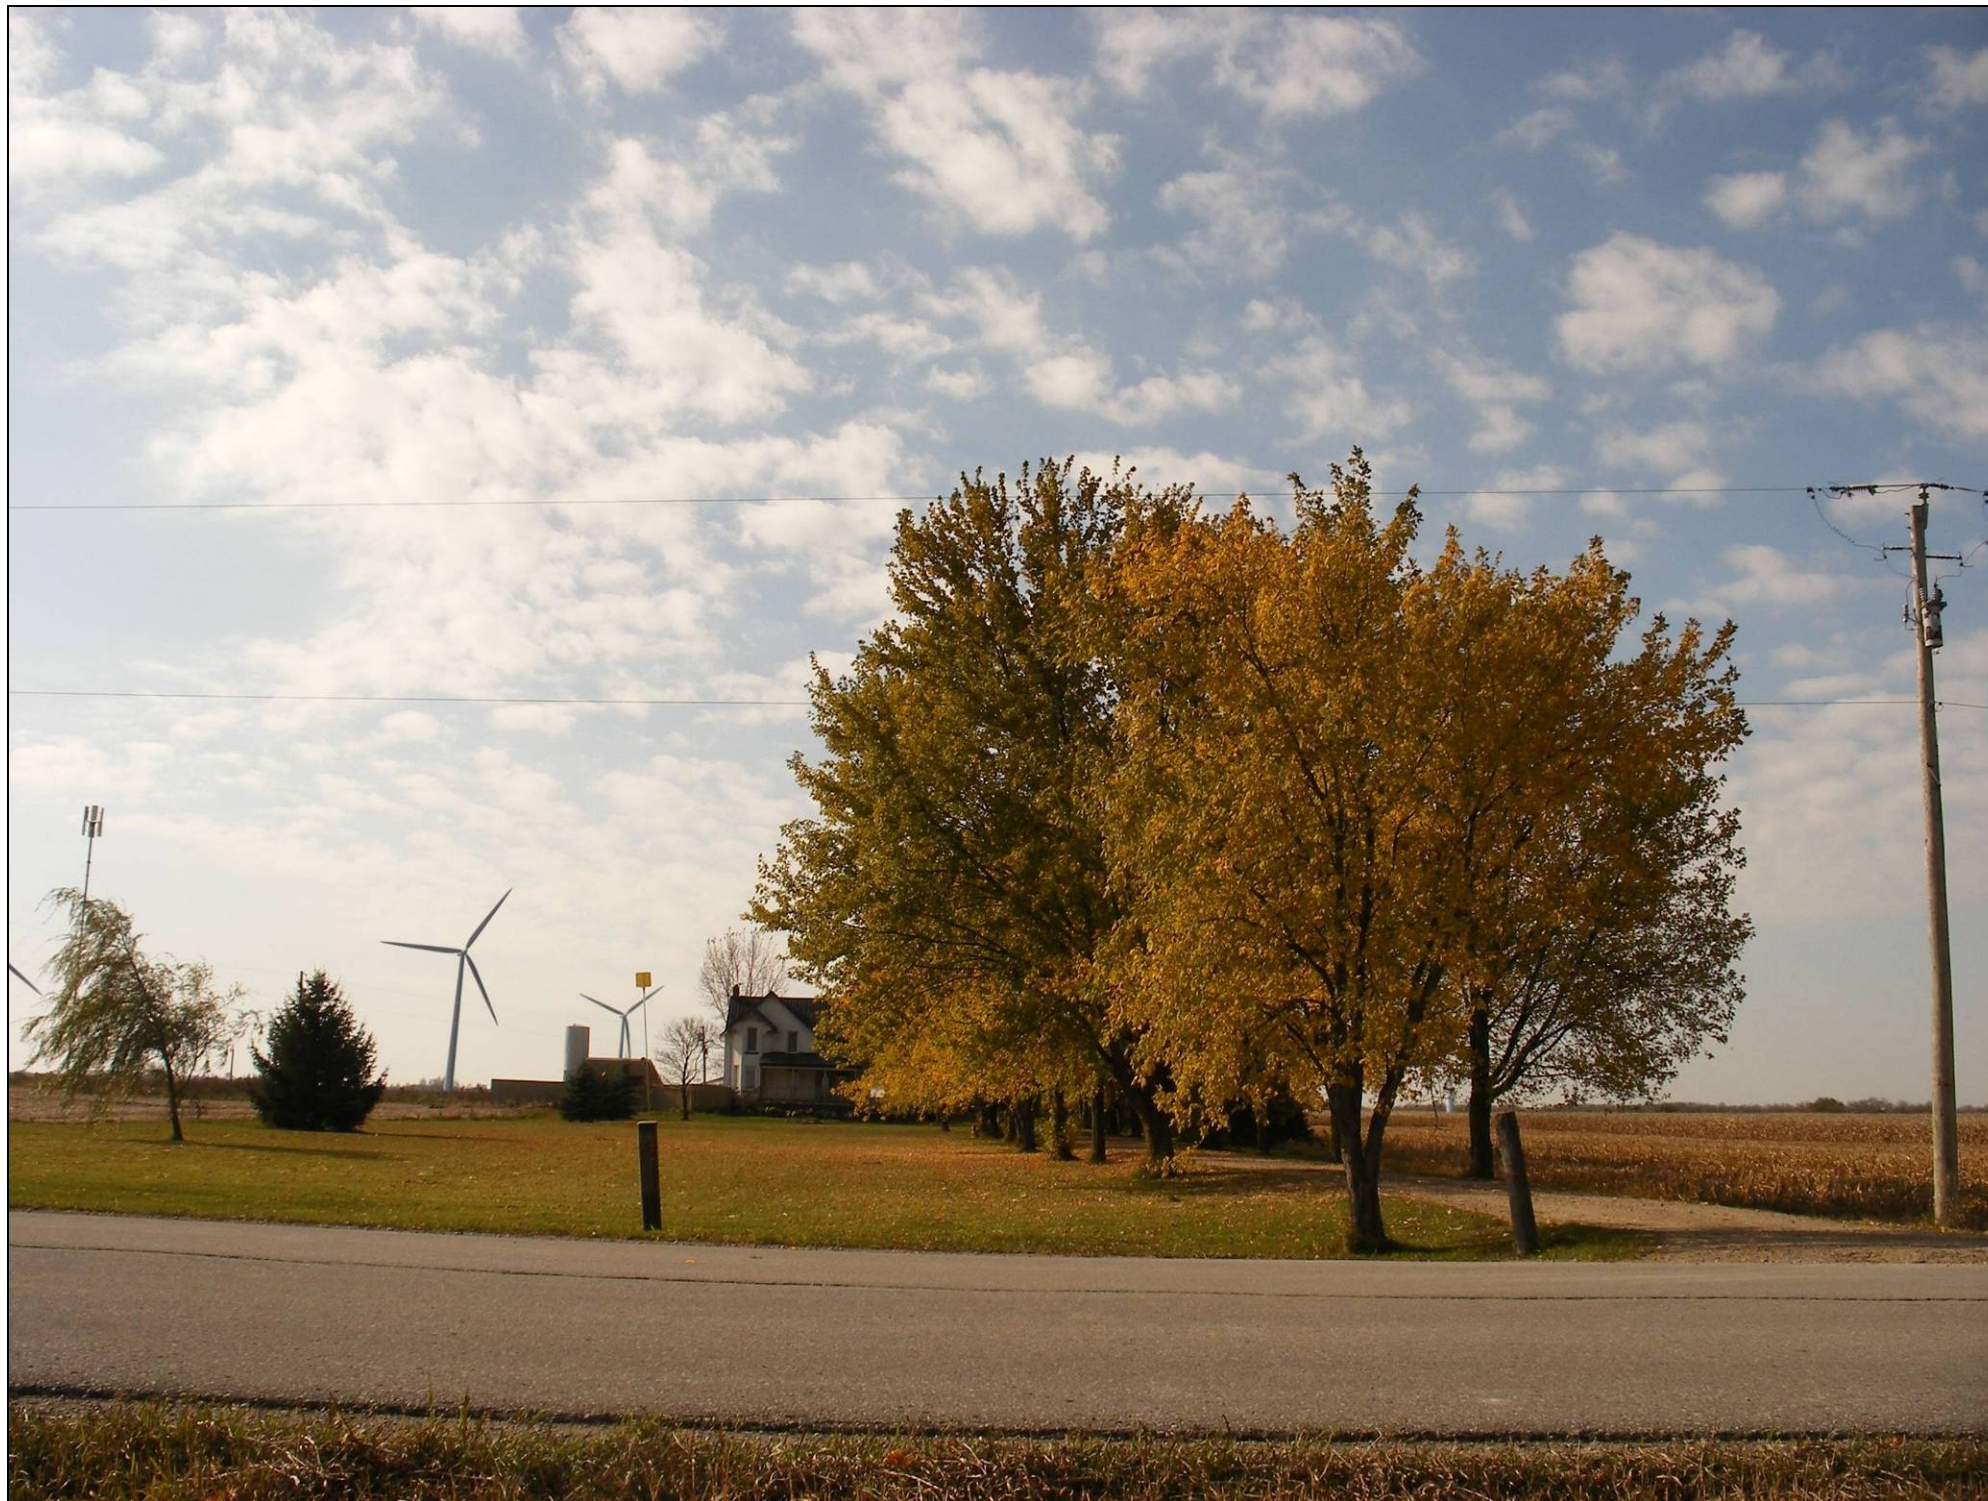
Figure 9: Photomontage looking south showing right to left (west to east) proposed turbines #1, #2 and part of proposed turbine #3 on CHL 2.

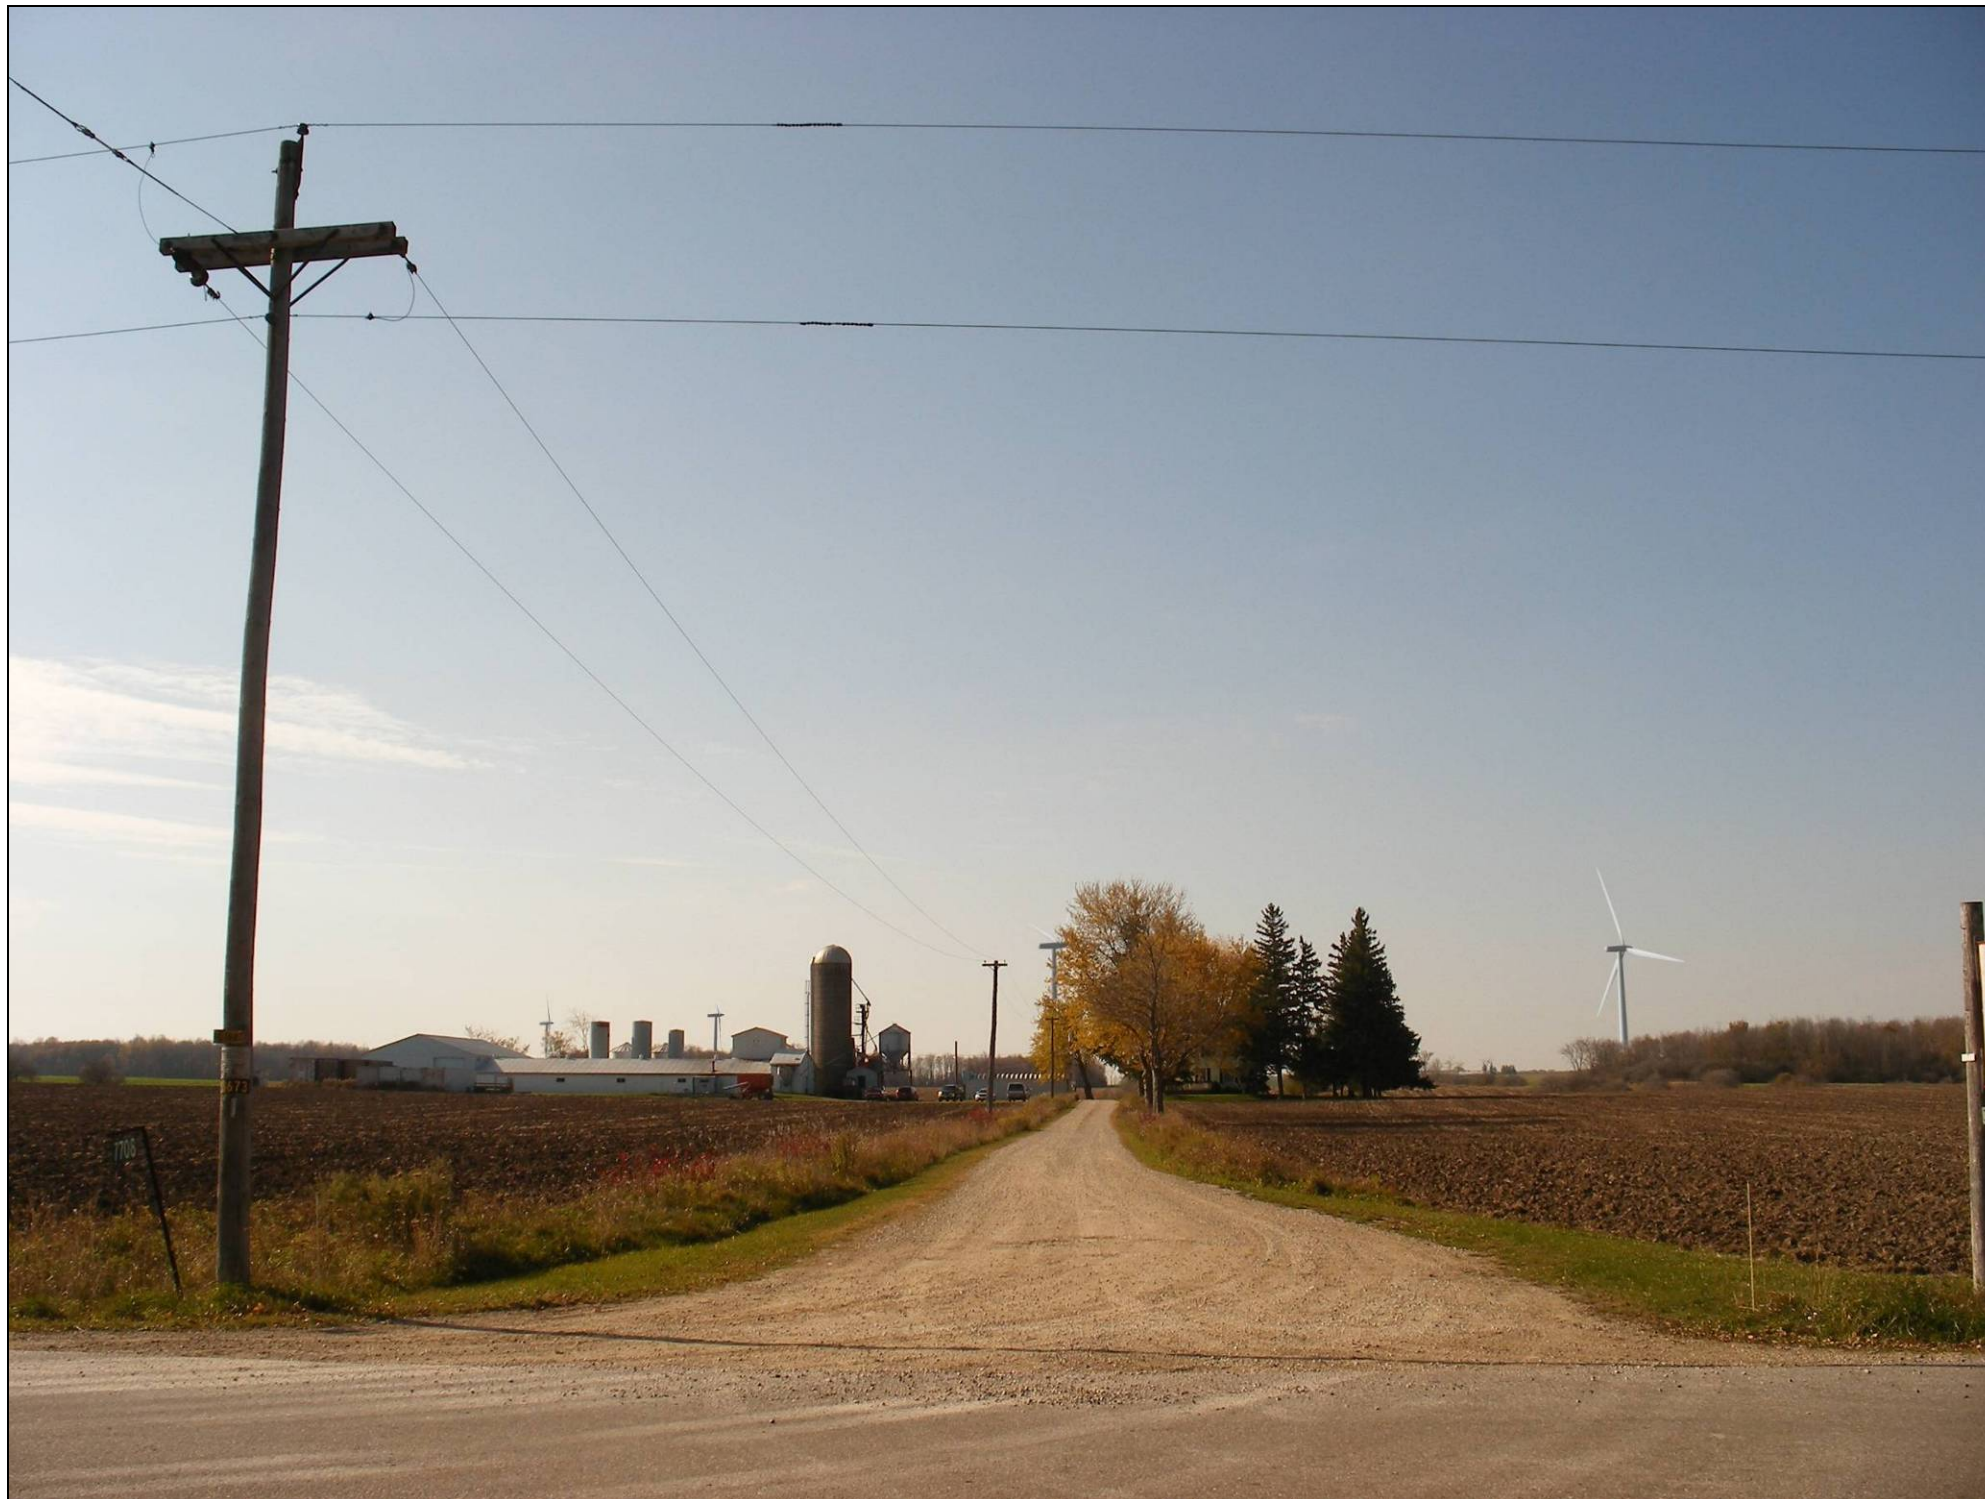
Figure 10: Photomontage looking south showing proposed turbines from right to left (west to east) proposed turbine #5; proposed turbine #6 at left of driveway (obscured); and in distance behind barns, proposed turbines #9 and #10 on CHL 3.

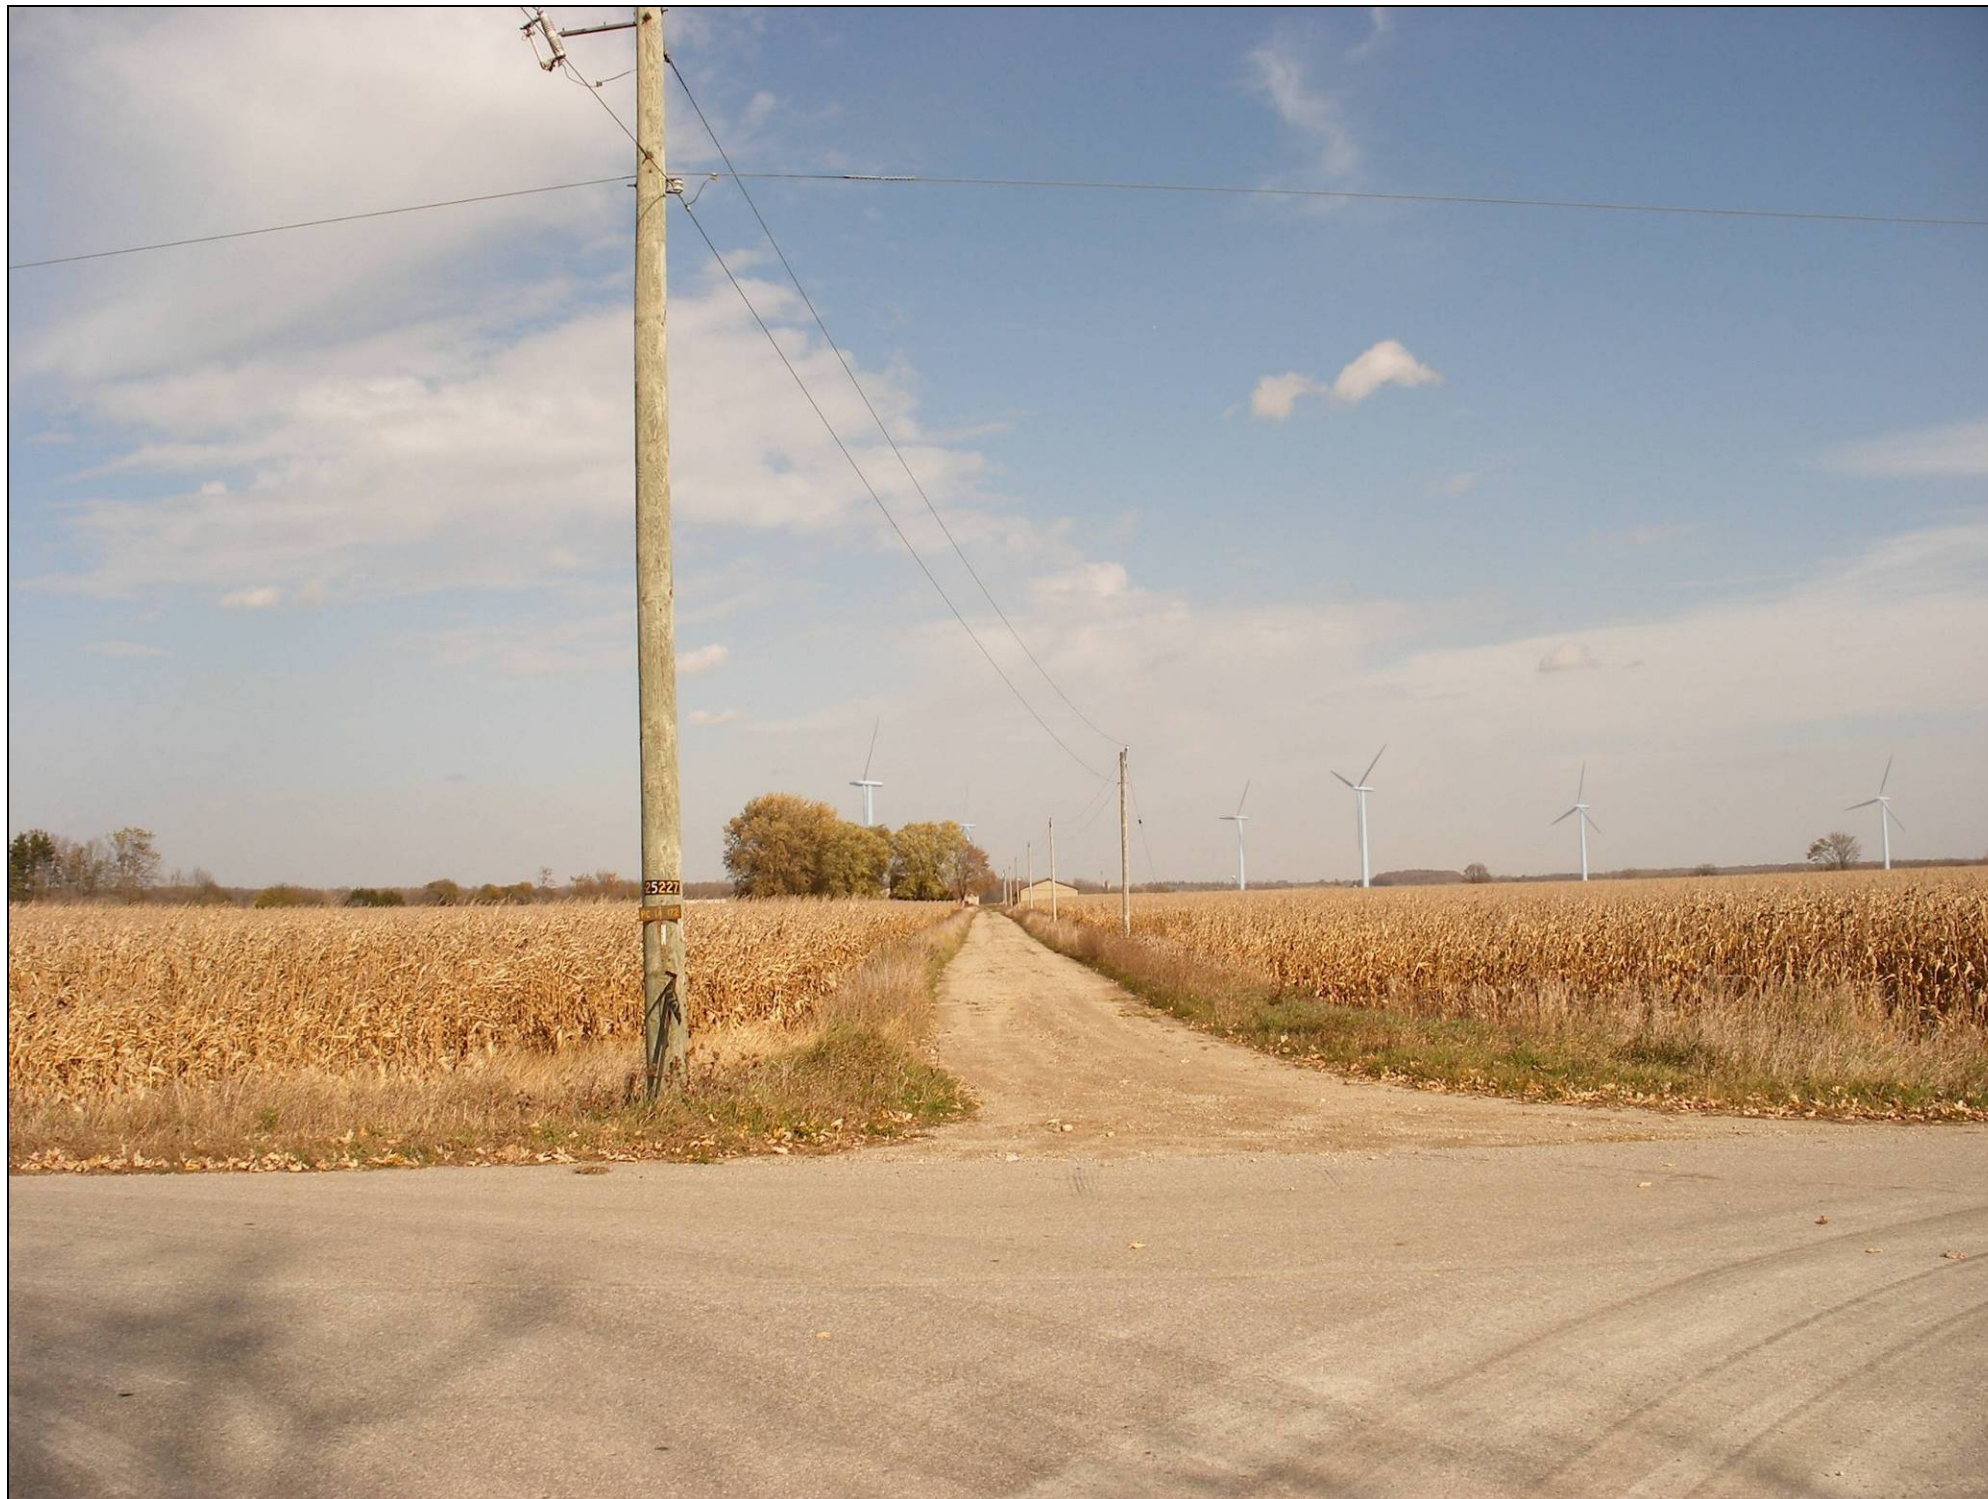
Figure 11: Photomontage looking north showing right to left (east to west) proposed turbines #5, #4, #8, #3, proposed turbine #2 down lane (behind trees) and proposed turbine #7 (behind trees) on CHL 5.

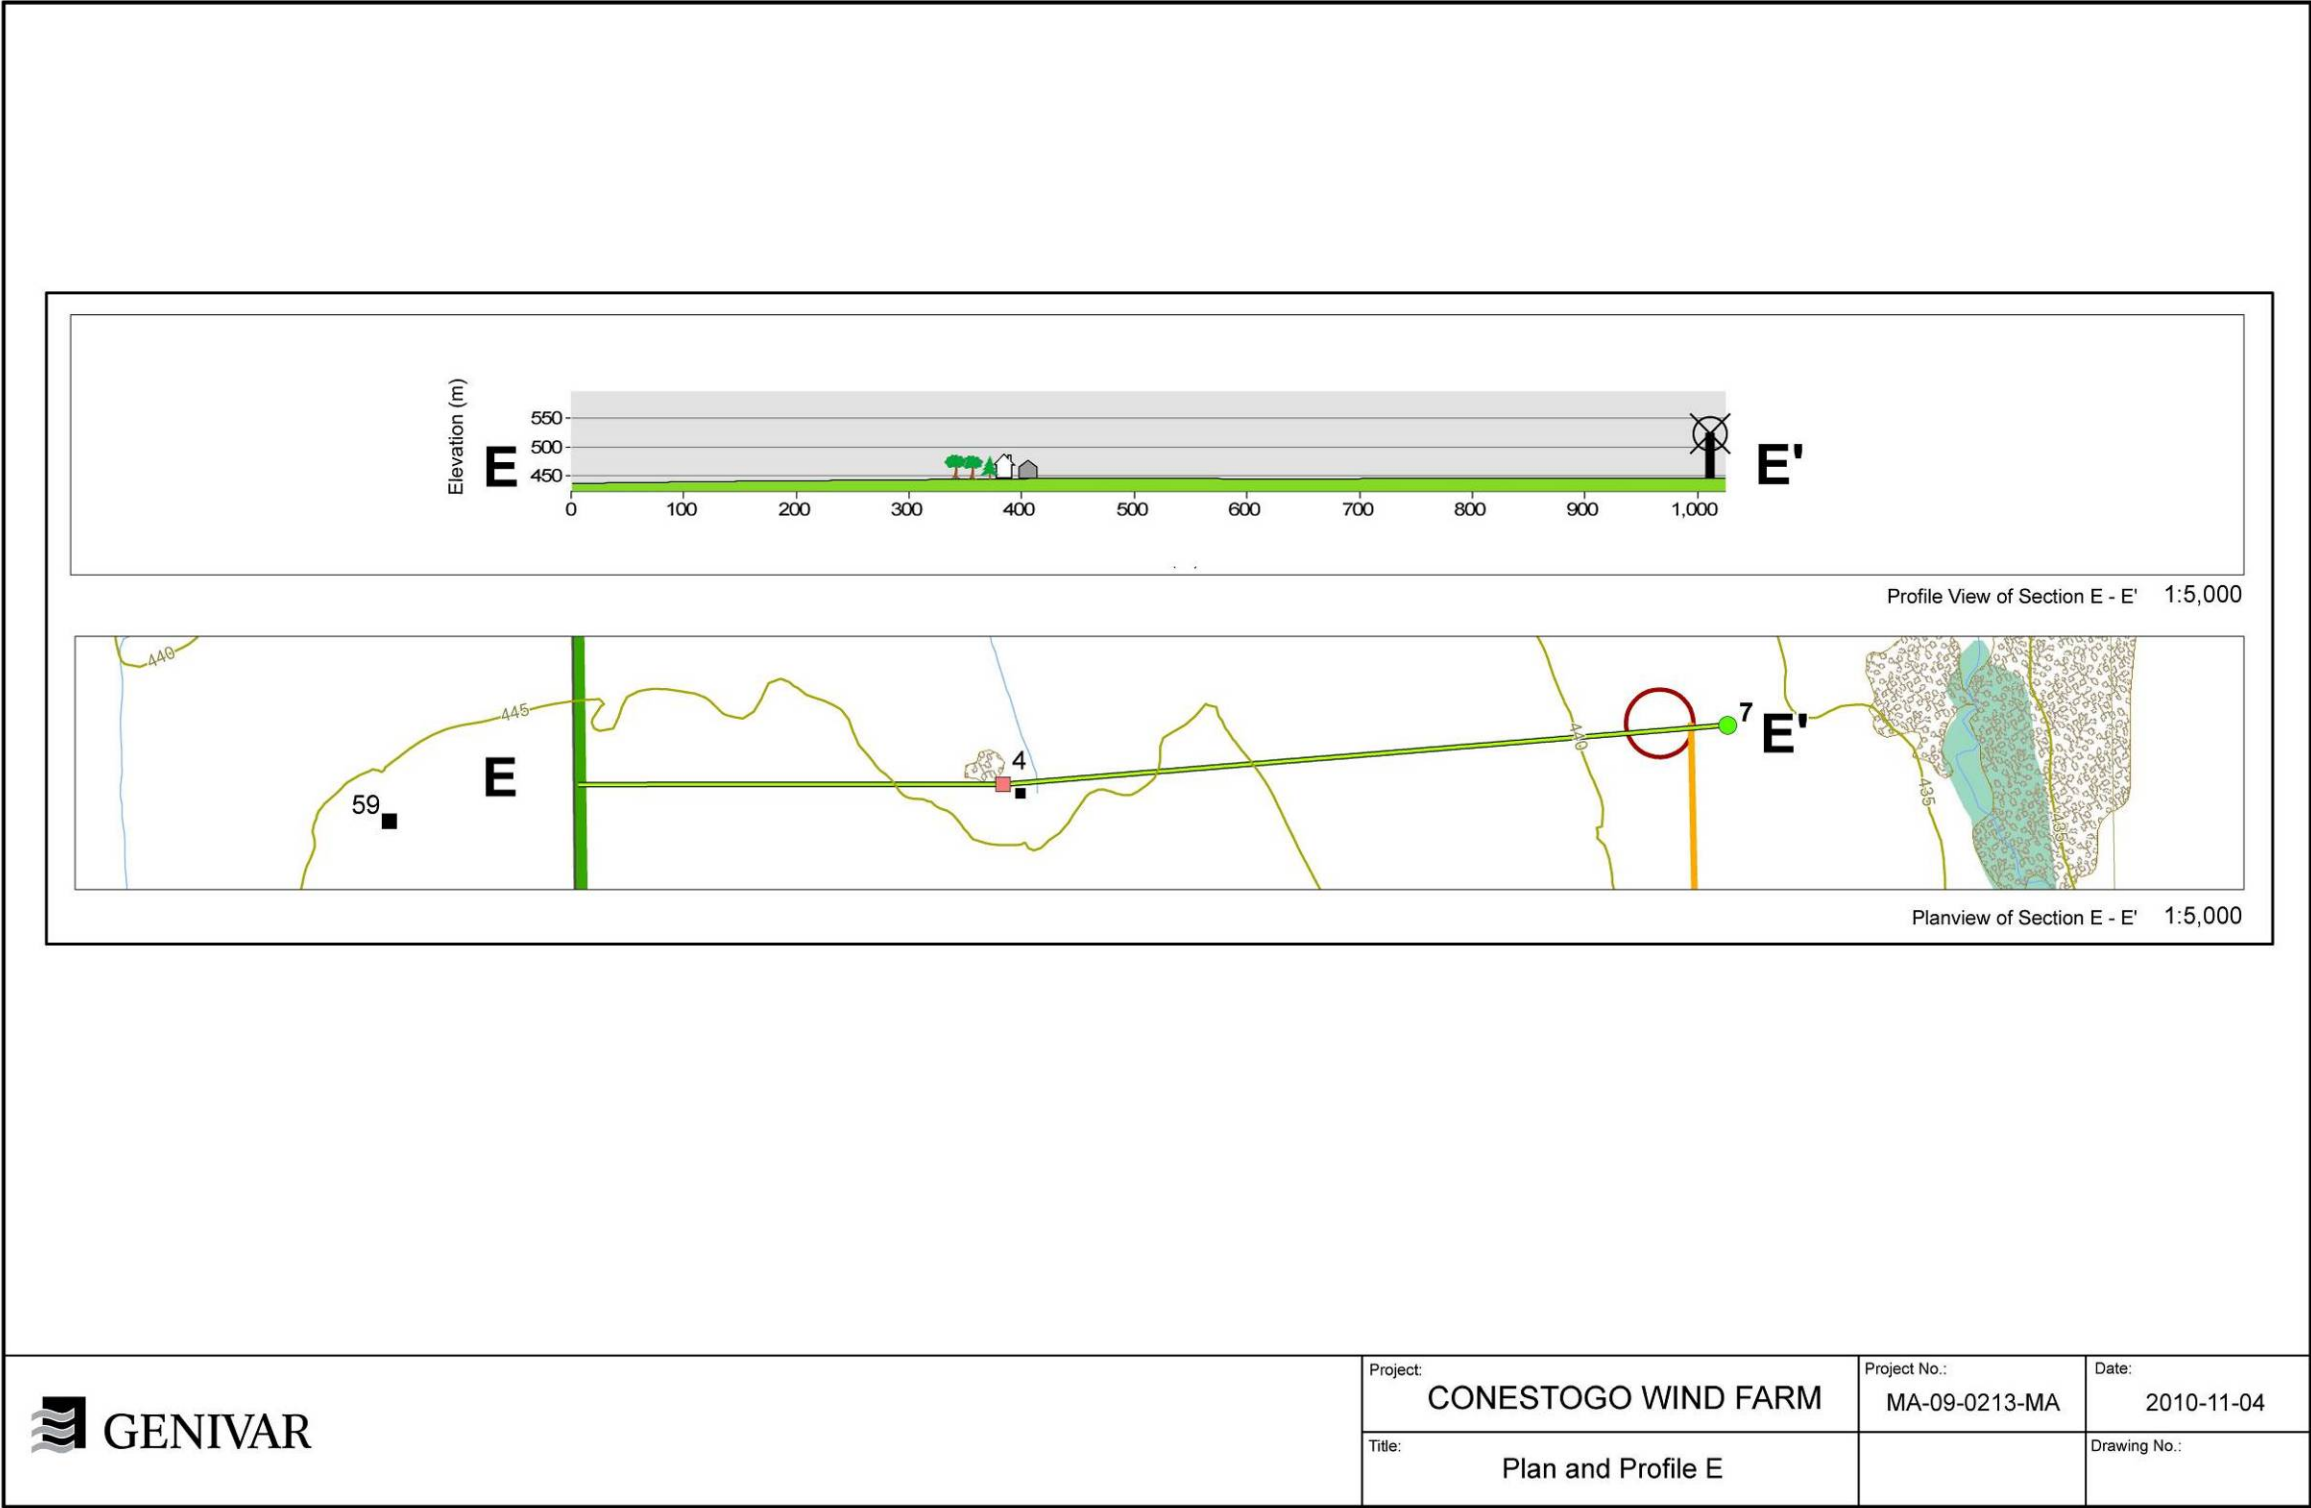
Figure 14: Plan and profile drawings of CHL 5 illustrating general landscape composition of lot with respect to height of existing structures.

Potential Impacts and Recommended Mitigation Measures	CHL 1	CHL 2	CHL 3	CHL 4	CHL 5	CHL 6
	infrastructure. Additionally, cross section drawings illustrate that the height of the wind turbine shaft is not significantly incompatible with heights of existing buildings on the subject and adjacent lots. Although the proposed infrastructure represents a modern intervention in the landscape, these changes are temporary and are not considered to represent significantly adverse and incompatible alterations.	utility infrastructure. Additionally, cross section drawings illustrate that the height of the wind turbine shaft is not significantly incompatible with heights of existing buildings on the subject lot. Although the proposed infrastructure represents a modern intervention in the landscape, these changes are temporary and are not considered to represent significantly adverse and incompatible alterations.	illustrate that the height of the wind turbine shaft is not significantly incompatible with heights of existing buildings on the subject and adjacent lots. Although the proposed infrastructure represents a modern intervention in the landscape, these changes are temporary and are not considered to represent significantly adverse and incompatible alterations.		infrastructure. Additionally, cross section drawings illustrate that the height of the wind turbine shaft is not significantly incompatible with heights of existing buildings on the subject and adjacent lots. Although the proposed infrastructure represents a modern intervention in the landscape, these changes are temporary and are not considered to represent significantly adverse and incompatible alterations.
