Varna Wind, Inc.

Amendment to the Design and Operations Report – Bluewater Wind Energy Centre

Project Number: 60301207

Date: September, 2013

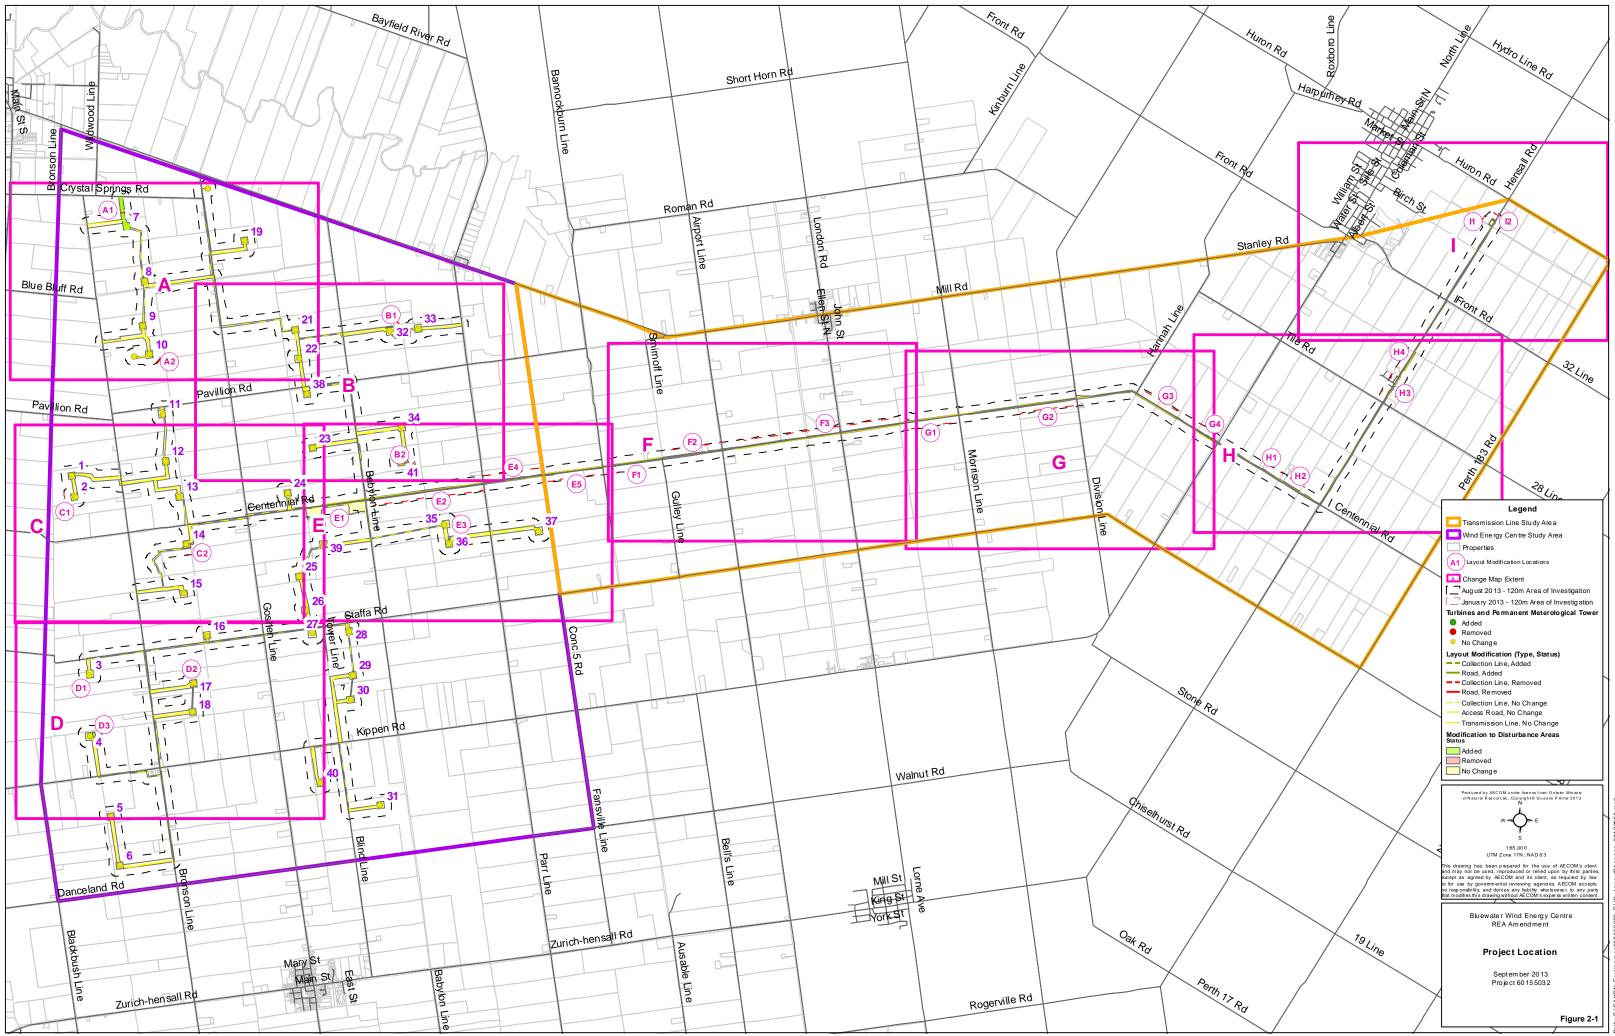
Figure 2-1 illustrates the modified Project Location. **Appendix A** contains a series of figures showing the details for each of the modifications.

The proposed Project is located in the Municipality of Bluewater and the Municipality Huron East in Huron County, Ontario (refer to **Figure 2-1**). The Project Study Area has not changed from the initial REA submission.

Label on Figure 2-1	Proposed Modification	Rationale for Proposed Modification	New Potential Environmental Effects	New Mitigation Measures
A1	Addition of road to Turbine 7 to travel north towards Crystal Springs Road	Infrastructure or construction disturbance area added or changed to optimize project design/ constructability	None – no new natural heritage or water body features within 120 m; area previously studied for cultural heritage	N/A
A2	Removal of construction disturbance area to the south east of Turbine 10	Construction disturbance area modified to reduce or eliminate impacts to Conservation Authority regulation limit	None – no new natural heritage or water body features within 120 m; area previously studied for cultural heritage	N/A
B1	Addition of construction disturbance area to the north of Turbine 32	Construction disturbance area added or changed to optimize project design/ constructability	None – no new natural heritage features within 120 m; area previously studied for cultural heritage and water body features	N/A
