## HERITAGE ASSESSMENT REPORT

**NextEra Energy Canada, ULC  
Bluewater Wind Energy Centre  
Huron County, Ontario**

**Report Number:** 10-1151-0201-3100-R01

## **Built Heritage Inventory**

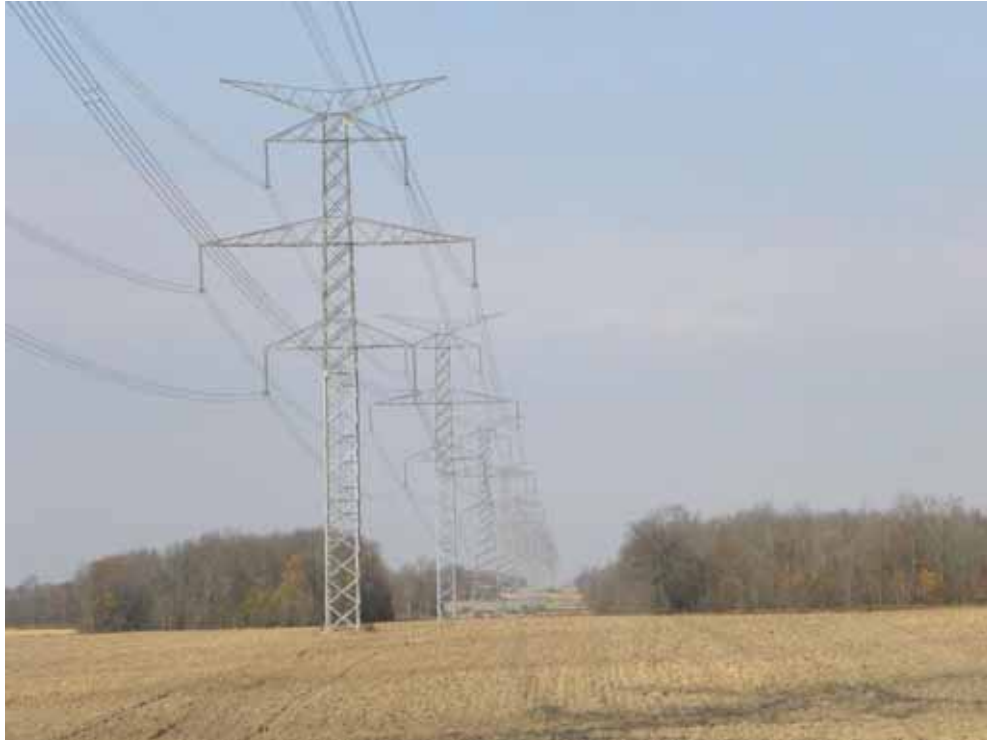
Electric power in Huron County was established at various times. Larger, wealthier municipalities were able to switch to electric power before smaller post office towns and hamlets. Up until the 1900s, most electricity was provided by private companies. A woollen mill in Egmondville had acquired electricity by 1893 although street lamps would not be lit along Main Street until 1907 (Whilsmith, 1985: 197). In 1907 the Ontario Hydroelectric Company was created and many municipalities switched to using this service. The utility was owned by the province, and generated power at Niagara Falls. Transmission lines traverse the study area at various locations. Plate 1 shows a transmission line looking north from the intersection of Staffa Road and Tower Line. The transmission line generally runs north to south from Mill Road through to Danceland Road.

*Plate 1: Transmission line, looking north from the intersection of Staffa Road and Tower Line.*

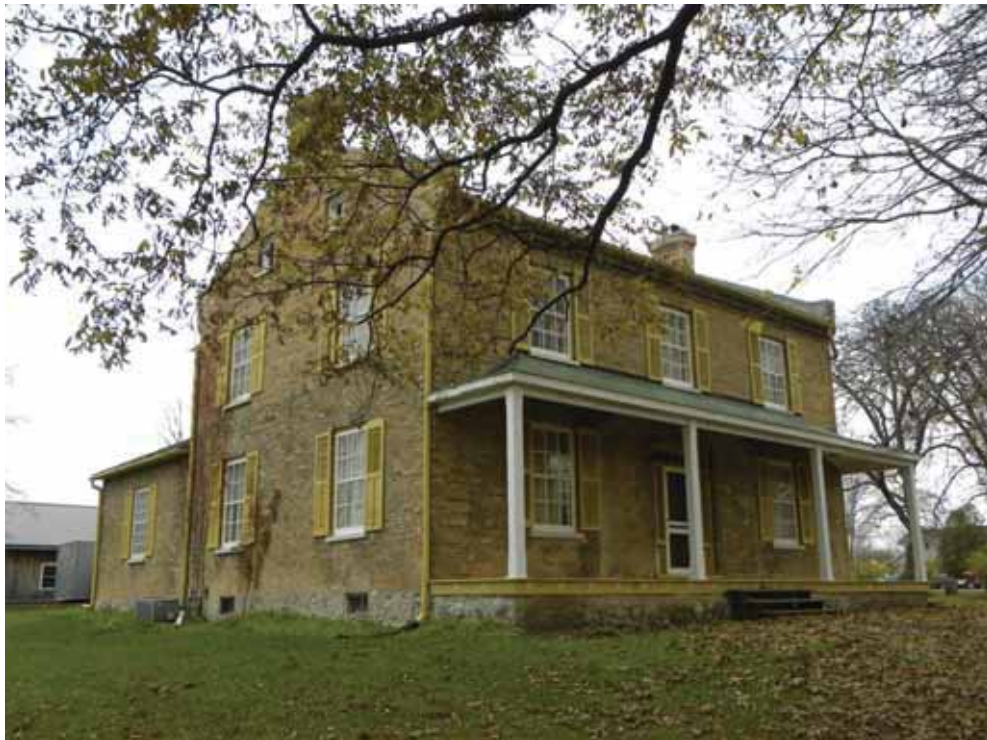
The Van Egmond House was constructed by Constant Van Egmond around 1846. Constant was the son of the infamous Colonel Anthony Van Egmond, road builder, prominent property holder and member of the 1837 Rebellion. It was municipally designated in 1977 for its role as an exemplary example of the early architecture of the region (Plate 8).

*Plate 8: The Van Egmond House, Egmondville*

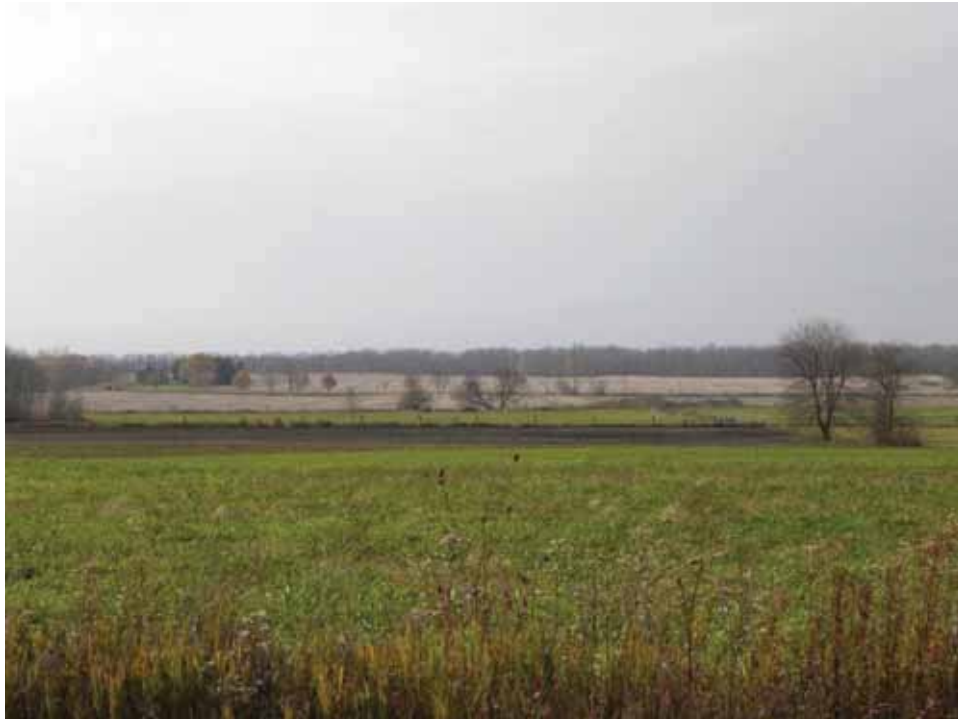
*Plate 9: Looking west from Blind Line, between Kippen and Danceland Roads. The mixed use of the land is apparent as pasture, cash crops and woodlots are evident.*

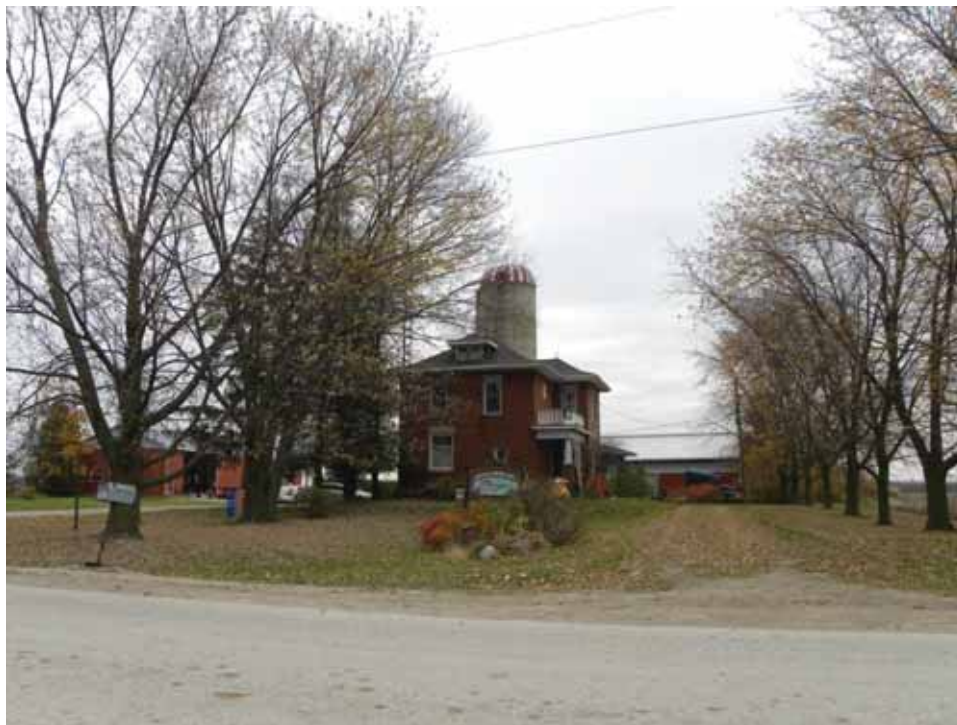
*Plate 11: 74602 Babylon Line (Site #20 in Appendix A). Residence located at the front of the property, typical of residences in the study area, with agricultural fields and woodlots located at the rear of the property.*

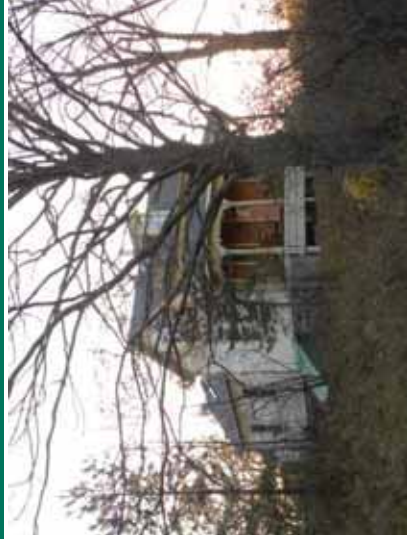
**Site #1 – 75368 Bronson Line (Municipality of Bluewater)**

**Date:** 19<sup>th</sup> century

**Description:** One and one half storey side gabled frame house with one central gabled dormer. House appears to be on a symmetrical plan, wood sided with an asphalt shingled roof and decorative eave brackets on gable ends. Full width asphalt shingled roof porch with decorative spindlework at the roof edge and bracketed wood columns on a wood framed surface.

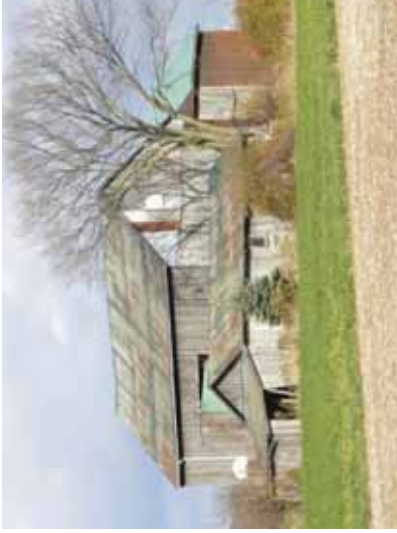
**Date:** 19<sup>th</sup> – 20<sup>th</sup> century

**Description:** Raised, three-bay barn. Metal roof on a timber frame and an undetermined foundation. Rear metal roofed, metal clad gabled addition gives the barn an “L” plan. A separate single-storey front gabled timber clad, metal roofed building with an end gable shed addition with a metal roof near the main barn.

**Mitigation of Negative Impacts:** No negative impacts identified, therefore no further mitigation recommended.

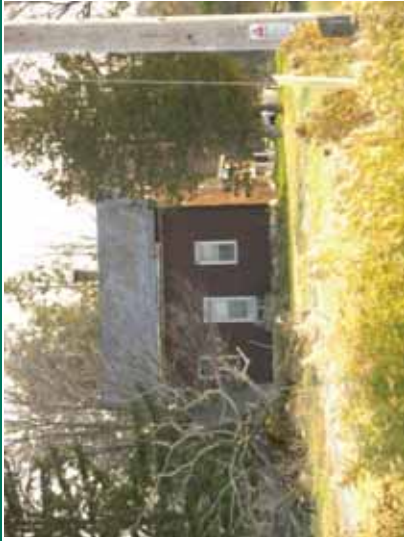
**Site #2 – 75304 Bronson Line (Municipality of Bluewater)**

**Date:** Undetermined (Likely 19<sup>th</sup> century)  
**Description:** One and a half storey frame house with a side gabled asphalt roof and medium pitch. Possibly field stone foundation. Symmetrical in original design. Modifications include rear addition and covering of brick exterior with asphalt brick siding.

**Mitigation of Negative Impacts:** Impacts were not identified, therefore mitigation is not recommended or necessary.

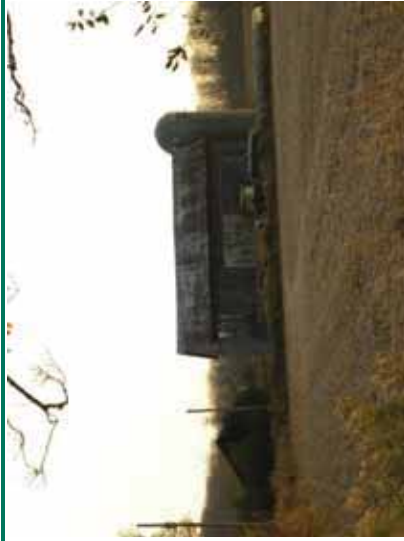
**Date:** 19<sup>th</sup> – 20<sup>th</sup> century  
**Description:** English-styled, three-bay barn. Medium pitched roof on a timber frame adjacent to a single silo. Additional outbuilding visible to the right, possibly a storage shed.

**Mitigation of Negative Impacts:** No negative impacts identified, therefore no further mitigation recommended.

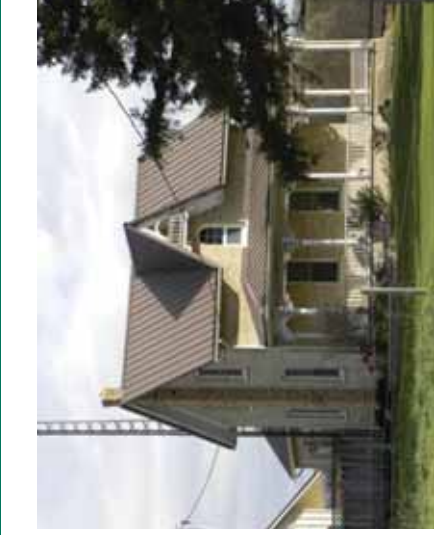
Site #3 – 75232 Bronson Line (Municipality of Bluewater)

**Date:** 1860-1890s

**Description:** One and one-half storey yellow brick house on a field stone foundation. Vernacular Gothic Revival characteristics include steeply pitched centre dormer with rounded arch central window, symmetrical plan with decorative spindlework in dormer. Full house-width porch with ornate wood columns, metal roof, decorative spindlework below roofline and wood railing on a concrete slab. Modern windows and gabled, wood sided, metal roofed addition is attached to the rear.

**Mitigation of Negative Impacts:** No negative impacts identified, therefore no further mitigation recommended.

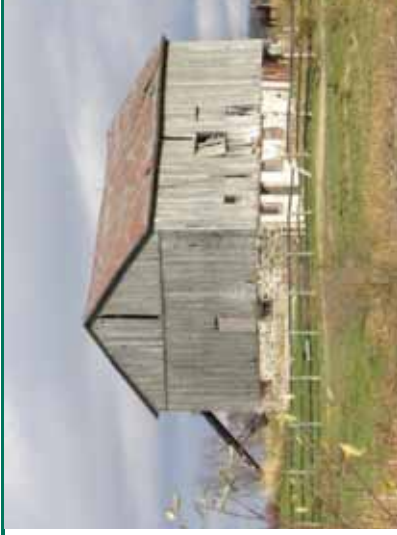
**Date:** 19<sup>th</sup> – 20<sup>th</sup> century

**Description:** Raised, three-bay barn. Metal roof on a timber frame and a field stone foundation.

**Heritage Attributes:** Timber frame construction on field stone foundation. Relationship of structure to residence and road.

**Mitigation of Negative Impacts:** No negative impacts identified, therefore no further mitigation recommended.

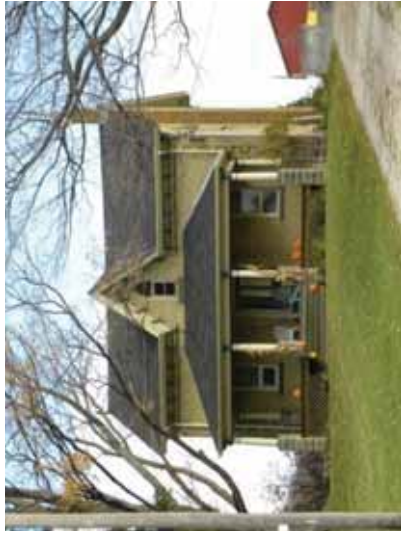
**Site #4 – 75268 Goshen Line (Municipality of Bluewater)**

**Date:** 1860s-1890s

**Description:** One and one-half storey yellow brick house on a cut stone foundation. Vernacular Gothic Revival characteristics include steeply pitched central dormer and peaked arch central window, symmetrical plan, yellow brick with integral yellow brick quoins and decorative inset frieze and eave brackets. Full-width hipped roof porch supported by wood columns on decorative cast concrete blocks. Windows could be original. Roof covered in asphalt shingles.

**Mitigation of Negative Impacts:** No negative impacts identified, therefore no further mitigation recommended.

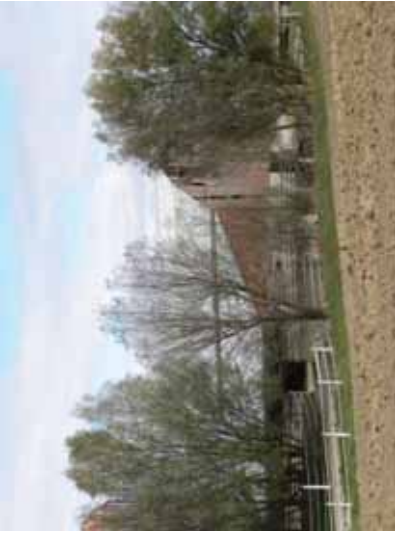
**Date:** 19<sup>th</sup> – 20<sup>th</sup> century

**Description:** Gambrel-roof, red-painted, timber-framed barn with modern white-painted metal roof on a field stone foundation. Metal-roofed, sky-lighted shed-roofed addition extending length of barn.

- 1) Design or Physical Value:** 19<sup>th</sup> – early 20<sup>th</sup> century example of timber barn which, although common throughout the study area, is increasingly rare throughout the province.
  - 2) Historical or Associate Value:** None identified.
  - 3) Contextual Value:** Supports the agricultural character of the surrounding vernacular rural landscape.
- Heritage Attributes:** Gambrel roof design with timber frame construction on a field stone foundation. Relationship of structure to residence and road.

**Mitigation of Negative Impacts:** No negative impacts identified, therefore no further mitigation recommended.

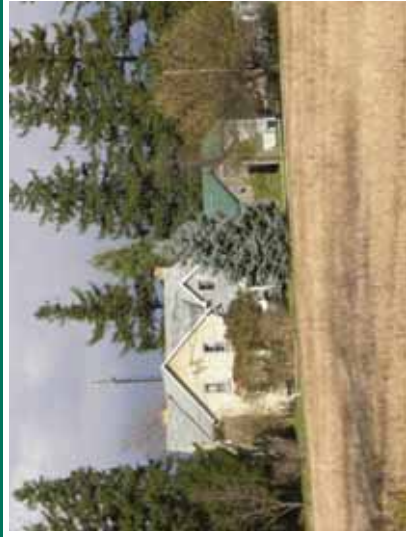
**Site #5 – 75172 Bronson Line (Municipality of Bluewater)**

**Date:** 1860-1890s

**Description:** One and one-half storey yellow brick house with steeply pitched central dormer on a stone foundation. Symmetrical plan with asphalt shingle roof. Later framed, wood sided, asphalt shingled addition with a low pitch dormer in at least one side gave structure a “T” plan. Appears to be two timber-frame, front gabled, metal roof, storage or garage structures on the property.

**Mitigation of Negative Impacts:** Impacts were not identified, therefore mitigation is not recommended or necessary.

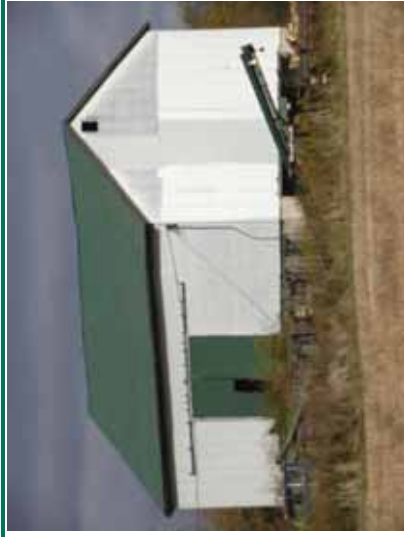
**Date:** Early 20<sup>th</sup> century

**Description:** Raised three-bay barn on a concrete foundation. Structure covered in white painted metal vertical siding and roof and metal sliding doors covered in green painted metal cladding.

- 1) **Design or Physical Value:** 19<sup>th</sup> – early 20<sup>th</sup> century example of timber barn which, although common throughout the study area, is increasingly rare throughout the province.
  - 2) **Historical or Associate Value:** None identified.
  - 3) **Contextual Value:** Supports the agricultural character of the surrounding vernacular rural landscape.
- Heritage Attributes:** Timber frame construction on concrete stone foundation. Relationship of structure to residence and road.

**Mitigation of Negative Impacts:** No negative impacts identified, therefore no further mitigation recommended.

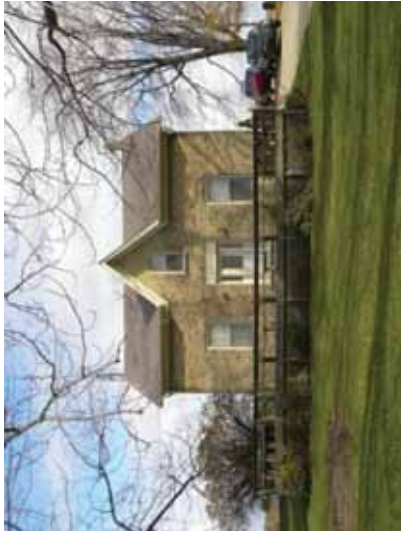
**Site #6 – 75184 Goshen Line (Municipality of Bluewater)**

**Date:** 1860s-1890s

**Description:** One and one-half storey yellow brick house with Vernacular Gothic Revival characteristics including a steeply pitched central dormer and rounded arch central window. Symmetrical plan, modern metal roof with covered edges and eaves. Modern door surrounded by sidelights and transom, likely modern windows, and uncovered deck-front porch. Foundation is not visible.

**Mitigation of Negative Impacts:** No negative impacts identified, therefore no further mitigation recommended.

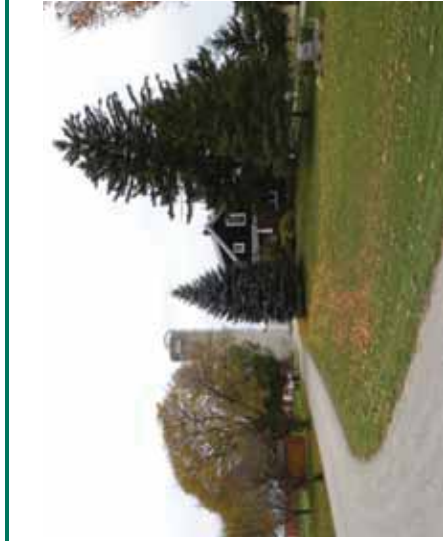
**Site #7 – 75493 Babylon Line (Municipality of Bluewater)**

**Date:** 1890s-1920s

**Description:** One and one-half storey brick and asphalt shingle house with a medium pitched front gabled roof and a rusticated concrete block foundation. A single large shed dormer is located on one side. Lower storey appears to be constructed of red brick. Upper half storey is clad in asphalt siding. Modifications include some updated windows and metal roof. Multiple out buildings on property, including a single silo.

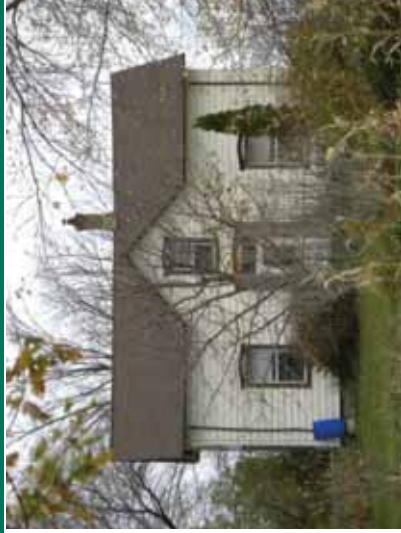
**Site #8 – 75018 Bronson Line (Municipality of Bluewater)**

**Date:** 1860-1890s

**Description:** One and one half storey house with low pitched centre gable on a stone foundation. Modern siding with asphalt shingle roof. Modern windows and doors and symmetrical design.

**Potential Direct and Indirect Impacts to the Heritage Attributes:** None anticipated.

**Mitigation of Negative Impacts:** No negative impacts identified, therefore no further mitigation recommended.

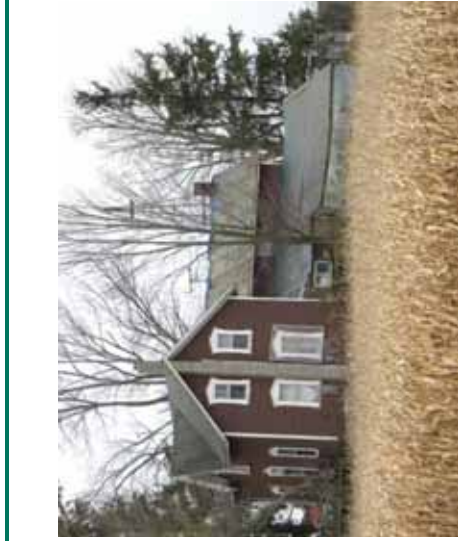
**Site #9 – 75333 Babylon Line (Municipality of Bluewater)**

**Date:** 1860 – 1890s

**Description:** One and a half storey frame house with a steeply pitched centre gabled roof and a cut stone foundation. Vernacular Gothic Revival characteristics include decorated bargeboard in the centre gable, a rounded/pointed arch window with decorative detailing, cut-out window frames which suggest a pointed-arch effect. A rear addition is apparent at the rear of the house as are multiple outbuildings. The chimney is modern concrete block and the roof is asphalt shingle.

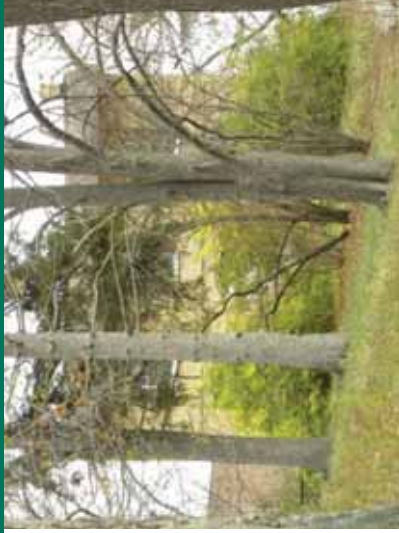
**Site #10 – 75094 Bronson Line (Municipality of Bluewater)**

**Date:** 19<sup>th</sup> century  
**Description:** Two storey, side gabled house with yellow brick on an undetermined foundation. Centre entrance on symmetrical plan. Modern windows and asphalt shingles.

**Mitigation of Negative Impacts:** No negative impacts identified, therefore no further mitigation recommended.

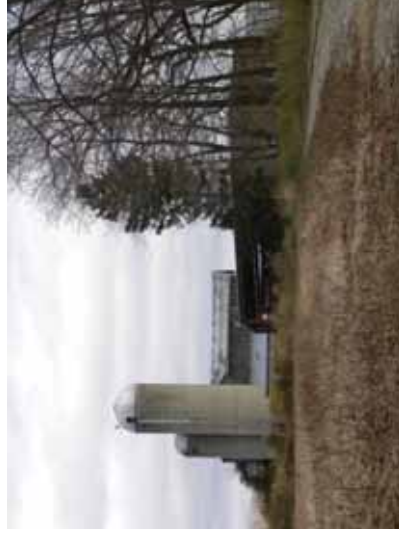
**Date:** 19<sup>th</sup> – 20<sup>th</sup> century  
**Description:** Multiple building barn complex. Original barn is a front gabled timber framed structure with modern metal roof and a rear gable, obscured by silos, that may give the original barn a “T” or “L” layout. A modern single storey metal-clad addition attached to original barn side wall, but interrupted by two concrete silos. There appear to be at least two modern metal frame, metal clad garage/shop buildings and one metal framed, metal roofed shed on the property.

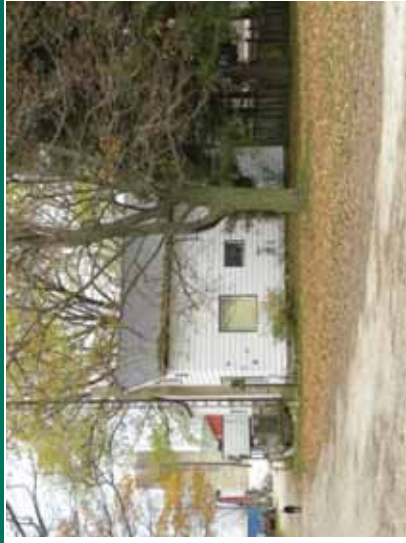
**Site #11 – 75251 Babylon Line (Municipality of Bluewater)**

**Date:** Undetermined (Possibly 1890 - 1930)

**Description:** One and one half storey frame house with a medium pitch side gabled roof and rusticated concrete block foundation. Decorative brackets visible. Extensive modifications include modern metal roof, rear addition, modified facade with relocated front door, modern concrete block chimney and modern windows.

**Potential Direct and Indirect Impacts to the Heritage Attributes:** CHVI was not identified, therefore impacts were not assessed.

**Mitigation of Negative Impacts:** Impacts were not identified, therefore mitigation is not recommended or necessary.

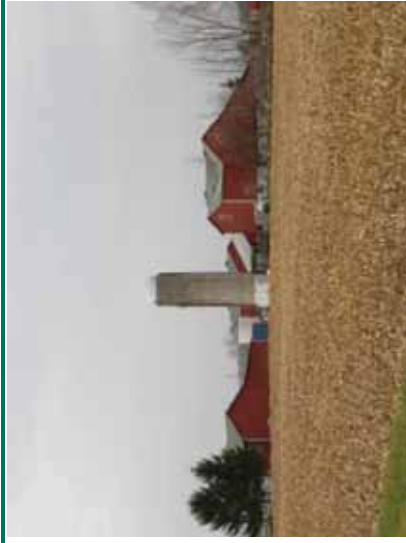
**Date:** Various dates (19<sup>th</sup> – 20<sup>th</sup> century)

**Description:** Multiple barns and stave silos present. Main barn is eclectic with numerous additions and has collapsed at the centre. Primary structure appears to have been a three gable frame structure with a field stone foundation.

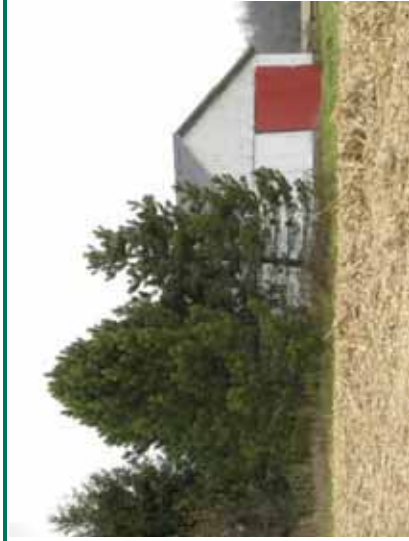
**Site #12 – (Municipality of Bluewater)**

**Date:** 20<sup>th</sup> century

**Description:** Vernacular drive shed, although foliage coverage makes identification difficult.

**Potential Direct and Indirect Impacts to the Heritage Attributes:** None anticipated.

**Mitigation of Negative Impacts:** No negative impacts identified, therefore no further mitigation recommended.

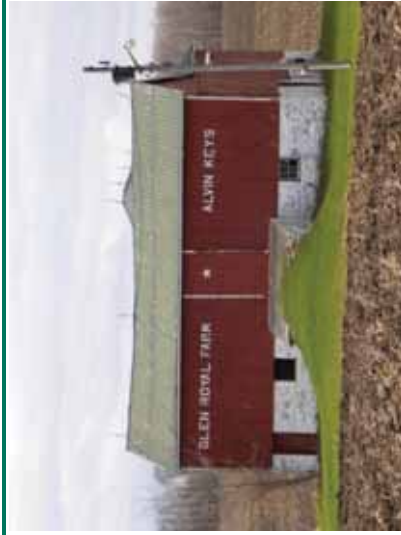
**Date:** 19<sup>th</sup> – 20<sup>th</sup> century

**Description:** Raised three-bay barn with red-painted timber frame on a white painted cut stone foundation with modern gray-painted metal roof. Rear addition appears to create an “L” plan.

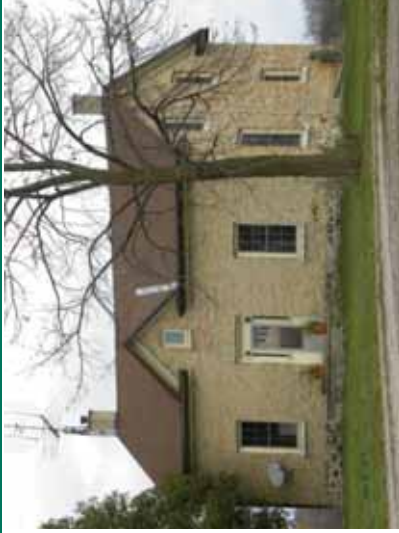
**Site #14 – 74784 Bronson Line (Municipality of Bluewater)**

**Date:** 1860s – 1890s

**Description:** One and one half storey yellow brick house with low-peaked gabled, centre dormer with a single pane replacement window on a fieldstone foundation. Symmetrical plan with modern entry door with sidelights and transom. Likely modern windows, asphalt covered roof and small concrete block and slab, uncovered porch.

**Potential Direct and Indirect Impacts to the Heritage Attributes:** None anticipated.

**Mitigation of Negative Impacts:** No negative impacts identified, therefore no further mitigation recommended.

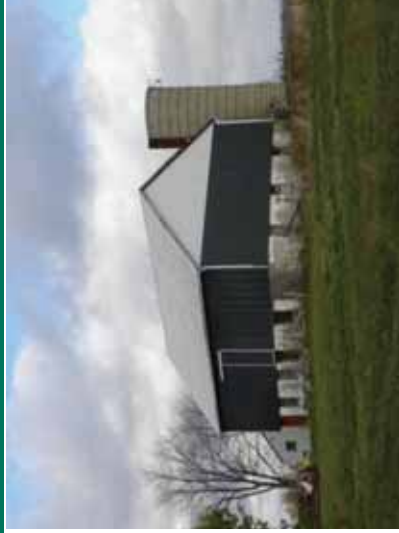
**Date:** 19<sup>th</sup> – 20<sup>th</sup> century

**Description:** Side gabled raised three-bay timber frame barn with modern blue/gray-painted metal siding and silver-painted metal roof on a concrete foundation. A single-storey shed-roofed addition attached to one gabled end and a banded, likely concrete block, silo attached to rear.

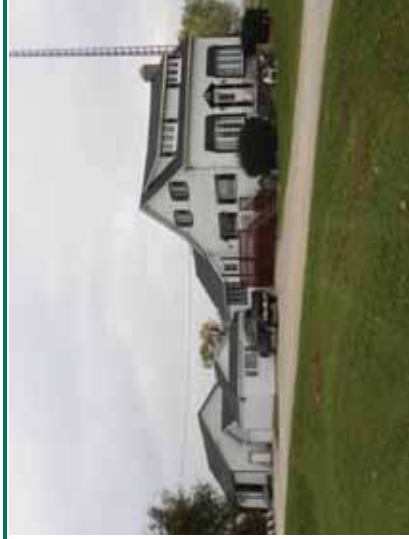
**Site #15 – 74811 Babylon Line (Municipality of Bluewater)**

**Date:** 1900-1920s

**Description:** One and one half storey side gabled house with medium pitch and front shed dormer on field stone foundation. Symmetrical design with central front door. Modifications include extensive rear additions, vinyl siding throughout, modern windows and doors, concrete block chimney and front porch.

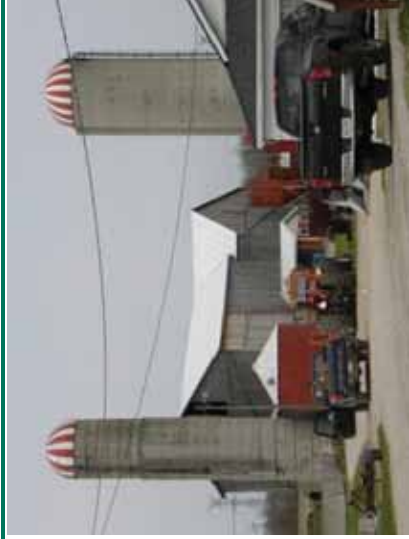
**Date:** 19<sup>th</sup> – 20<sup>th</sup> century

**Description:** Raised three-bay barn with rear addition. A metal roof on a timber frame with an undetermined foundation. Two stave silos and various other outbuildings present.

**Mitigation of Negative Impacts:** No negative impacts identified, therefore no further mitigation recommended.

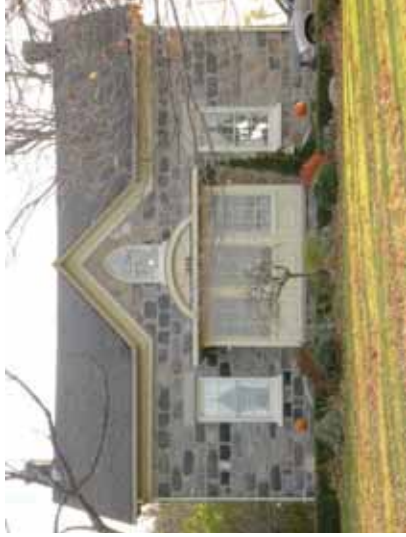
**Site #16 – Bronson Line (Municipality of Bluewater)**

**Date:** 1860s – 1890s

**Description:** One and one half storey side gabled stone house with prominent centre gable and medium roof pitch. Symmetrical in design with Vernacular Gothic Revival influences including pointed arch central window extending into the dormer, and paired chimneys. Apparent rear addition incorporated similar materials.

- 1) Design or Physical Value:** Representative of Vernacular Gothic Revival design and mid-19<sup>th</sup> century construction material which, although found throughout the study area, is increasingly rare throughout southwestern Ontario.
  - 2) Historical or Associate Value:** None identified.
  - 3) Contextual Value:** Popular style of 19th century construction supports the character of the surrounding vernacular rural landscape.
- Heritage Attributes:** One and one half storey stone construction; symmetrical design; pointed arch window in central dormer; and paired chimneys. Relationship of structure to outbuildings and road.

**Potential Direct and Indirect Impacts to the Heritage Attributes:** None anticipated.

**Mitigation of Negative Impacts:** No negative impacts identified, therefore no further mitigation recommended.

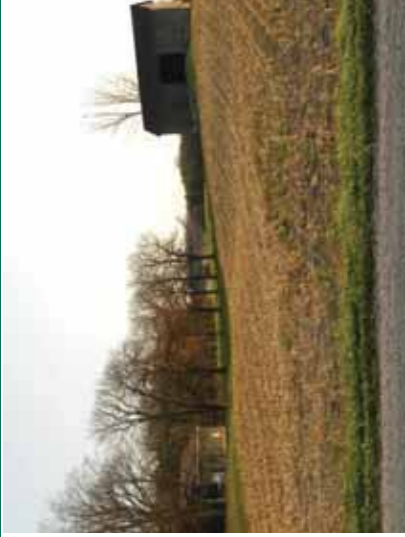
**Date:** 19<sup>th</sup> – 20<sup>th</sup> century

**Description:** Timber barn with a metal roof on a timber frame and field stone foundation.

- 1) Design or Physical Value:** 19<sup>th</sup> – early 20<sup>th</sup> century example of a small timber barn which, although common throughout the study area, is increasingly rare throughout the province.
  - 2) Historical or Associate Value:** None identified.
  - 3) Contextual Value:** Supports the agricultural character of the surrounding vernacular rural landscape.
- Heritage Attributes:** Two-bay timber frame construction on field stone foundation. Relationship of structure to residence and road.

**Mitigation of Negative Impacts:** No negative impacts identified, therefore no further mitigation recommended.

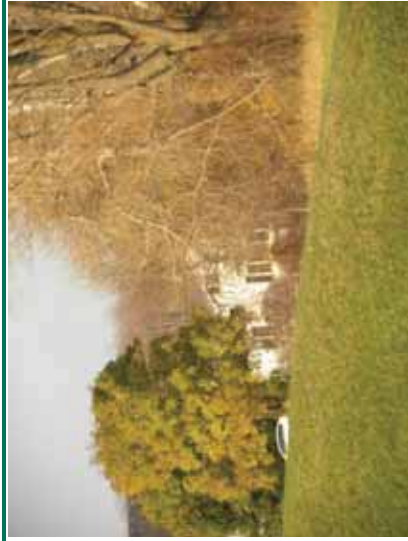
**Site #17 – 74603 Bronson Line (Municipality of Bluewater)**

**Date:** Undetermined.

**Description:** Extensive vegetation coverage. House appears to be a one and one half storey L-shape house with front gable (possibly cross-gable). The roof pitch is medium and the foundation is undetermined. House is clad in modern siding and has a rear addition.

**Potential Direct and Indirect Impacts to the Heritage Attributes:** None anticipated.

**Mitigation of Negative Impacts:** No negative impacts identified, therefore no further mitigation recommended.

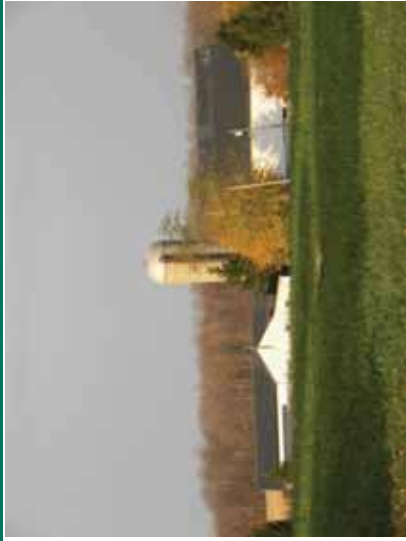
**Date:** Undetermined.

**Description:** Multiple barns and silos on site. Primary barn appears to be a large three-bay barn with addition and stave silo at the rear. Rolling landscape restricted detailed identification of all structures.

**Mitigation of Negative Impacts:** No negative impacts identified, therefore no further mitigation recommended.

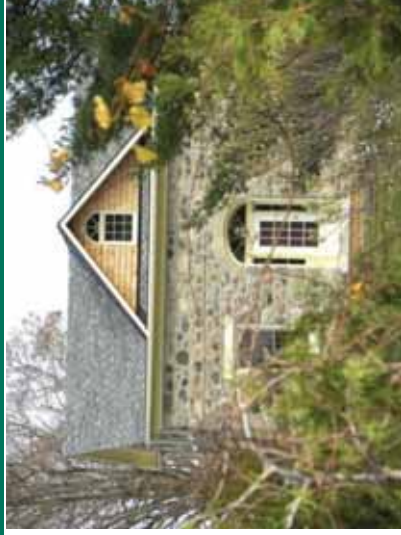
**Site #18 – 74626 Bronson Line (Municipality of Bluewater)**

**Date:** 1860s – 1890s

**Description:** One and one half storey, side gabled fieldstone house with low-medium pitched roof, wood-shingled, modern gabled central dormer with single window and fan light. Symmetrical plan with modern centre door in historic location with sidelights and fan light. Other windows appear modern. Roof clad with asphalt shingles.

- 1) **Design or Physical Value:** Representative of mid-19<sup>th</sup> century construction material which, although found throughout the study area, is increasingly rare throughout southwestern Ontario.
  - 2) **Historical or Associate Value:** None identified.
  - 3) **Contextual Value:** None identified.
- Heritage Attributes:** One and one half storey stone construction.

**Potential Direct and Indirect Impacts to the Heritage Attributes:** None anticipated.

**Mitigation of Negative Impacts:** No negative impacts identified, therefore no further mitigation recommended.

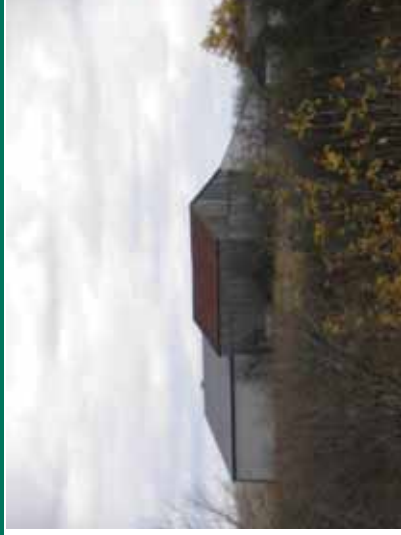
**Date:** 19<sup>th</sup> – 20<sup>th</sup> century

**Description:** Raised three-bay, timber frame barn with wood siding and metal roof on an undetermined foundation. Modern shed roofed addition attached to barn side and modern metal sided and roofed gabled addition attached to rear.

**Mitigation of Negative Impacts:** No negative impacts identified, therefore no further mitigation recommended.

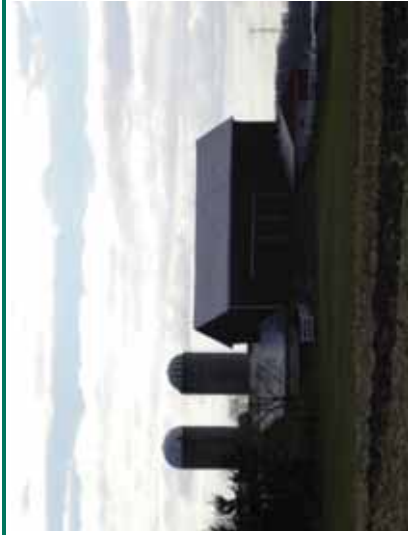
### Site #19 – 74587 Babylon Line (Municipality of Bluewater)

**Date:** 19<sup>th</sup> – 20<sup>th</sup> century

**Description:** Raised three-bay side gabled, timber frame barn with modern blue/gray-painted metal siding and silver-painted metal roof on a stone foundation. A single-storey gable-roofed addition attached to one gabled end and a single-storey gabled addition attached to front creating an “L” plan. Both additions appear to have modern metal roofs. Several additional buildings and two silos are obscured by the barn.

- 1) Design or Physical Value:** 19<sup>th</sup> – early 20<sup>th</sup> century example of timber barn which, although common throughout the study area, is increasingly rare throughout the province.
  - 2) Historical or Associate Value:** None identified.
  - 3) Contextual Value:** Supports the agricultural character of the surrounding vernacular rural landscape.
- Heritage Attributes:** Timber frame construction on stone foundation. Relationship of structures to field patterns and road.

**Mitigation of Negative Impacts:** No negative impacts identified, therefore no further mitigation recommended.

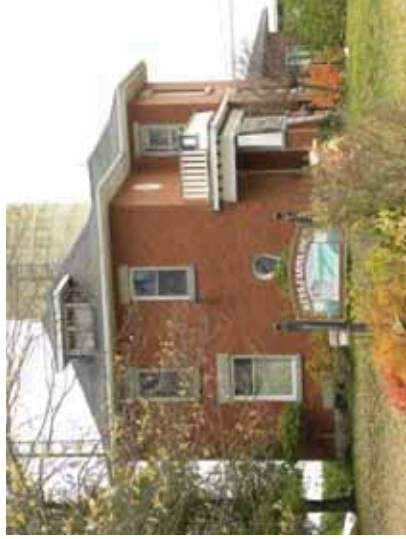
**Site #20 – 74602 Babylon Line (Municipality of Bluewater)**

**Date:** 1890s – 1920s

**Description:** Two storey foursquare with side addition red brick house with a dual pitched asphalt shingled hipped roof, central hipped dormer and a rusticated concrete block foundation. Windows in front dormer appear original as well as key stone window on front facade and ocular window on the south side. Extensive out buildings apparent including at least one stave silo.

**Mitigation of Negative Impacts:** No negative impacts identified, therefore no further mitigation recommended.

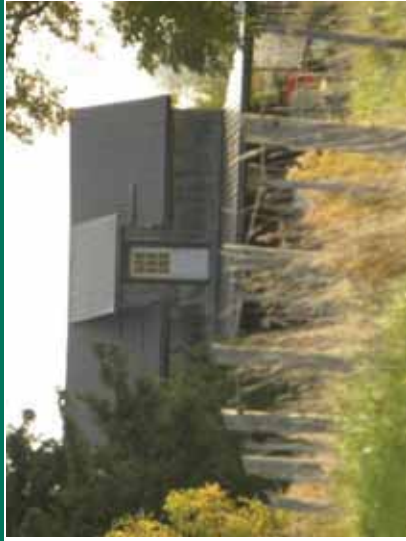
**Site #21 – 74528 Bronson Line (Municipality of Bluewater)**

**Date:** Undetermined.  
**Description:** One and one half storey timber frame side gabled house with modern metal roof, wrap around side porch and front shed dormer converted into a doorway. Extensive foliage restricts further identification.

**Potential CHVI According to O. Reg. 9/06:**  
Due to extensive foliage coverage, cultural heritage value or interest could not be determined. However, there are no anticipated potential direct and indirect impacts to the structure.

**Mitigation of Negative Impacts:** No negative impacts identified, therefore no further mitigation recommended.

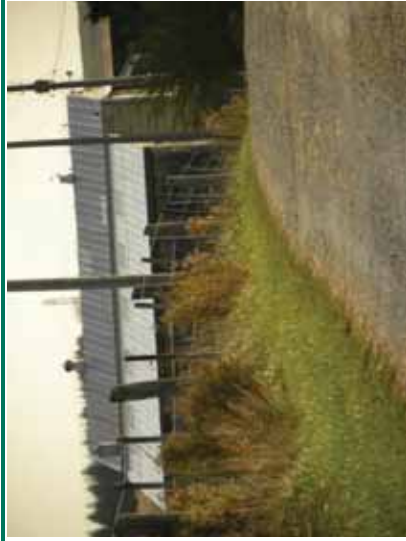
**Date:** Undetermined.  
**Description:** Extensive farm complex visible from aerial photo. Rolling landscape restricted detailed identification of structures.

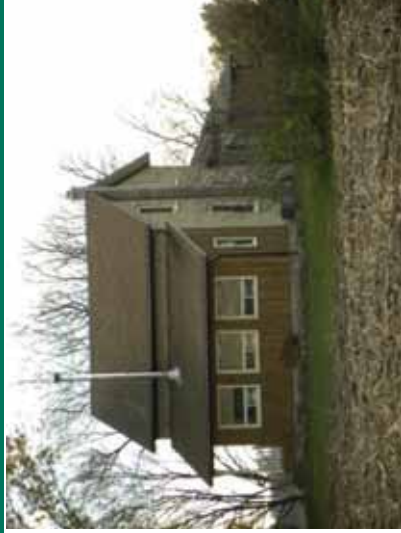
**Site #22 – 73319 Bronson Line (Municipality of Bluewater)**

**Date:** 1860-1890s

**Description:** One and one half storey side gabled yellow brick house with a modern full width single storey wood clad shed roof addition on one side and two single storey wood clad, stepped down gable roofed additions on the other side. Windows appear to be modern.

**Potential Direct and Indirect Impacts to the Heritage Attributes:** None anticipated.

**Mitigation of Negative Impacts:** No negative impacts identified, therefore no further mitigation recommended.

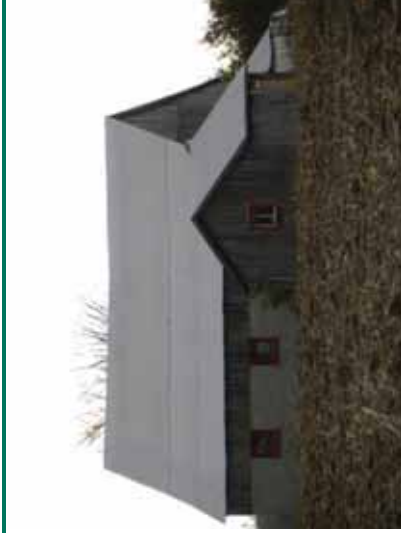
**Date:** 20<sup>th</sup> century

**Description:** Side gabled, timber framed barn on an undetermined foundation. First storey walls made of concrete block with upper walls and gable ends clad in wood. Roof sheathed in metal panels. A single storey metal clad shed roof addition attached to one gabled end and a wood clad, metal roofed, out building close to the barn.

**Mitigation of Negative Impacts:** No negative impacts identified, therefore no further mitigation recommended.

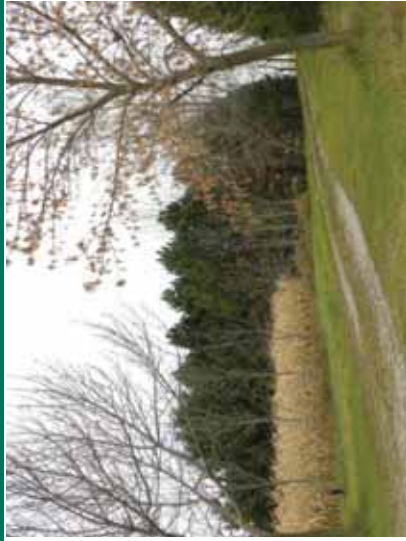
**Site #23 – 74445 Goshen Line (Municipality of Bluewater)**

**Date:** Undetermined.

**Description:** Due to extensive foliage, the structure could not be identified from the roadway.

**Mitigation of Negative Impacts:** No negative impacts identified, therefore no further mitigation recommended.

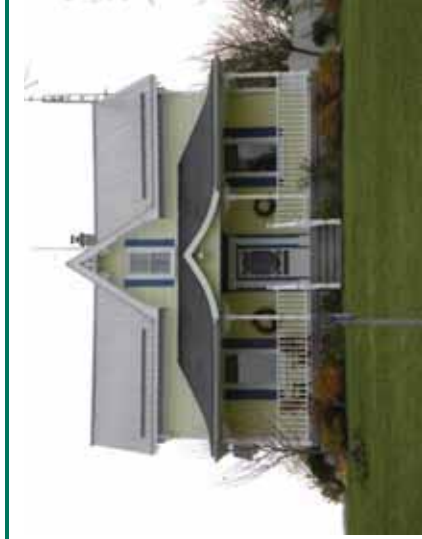
### Site #24 – 74440 Goshen Line (Municipality of Bluewater)

**Date:** 1860s – 1890s

**Description:** One and one half storey frame house with a steep pitched centre gabled roof and an undetermined foundation. Vernacular Gothic Revival characteristics include decorative bargeboard and finials throughout, decorative brackets along exterior walls and at the junction of each porch pier. Rear addition is apparent as are multiple outbuildings. Modern chimney, concrete block foundation, siding and metal roof.

**Mitigation of Negative Impacts:** No negative impacts identified, therefore no further mitigation recommended.

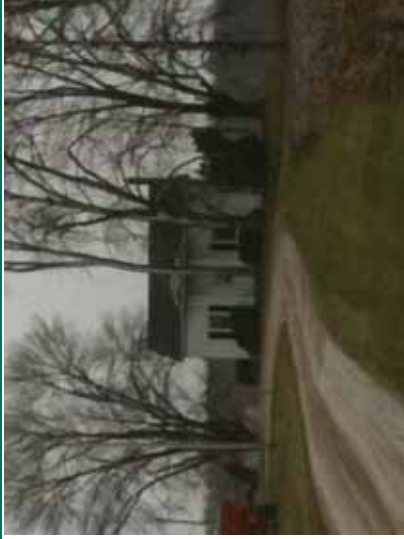
**Site #25 – 74460 Babylon Line (Municipality of Bluewater)**

**Date:** 1860s – 1890s

**Description:** One and one half storey side gabled house with a medium roof pitch, undetermined siding and undetermined foundation. House appears symmetrical in design with a full height porch.

**Potential Direct and Indirect Impacts to the Heritage Attributes:** CHVI was not identified, therefore impacts were not assessed.

**Mitigation of Negative Impacts:** Impacts were not identified, therefore mitigation is not recommended or necessary.

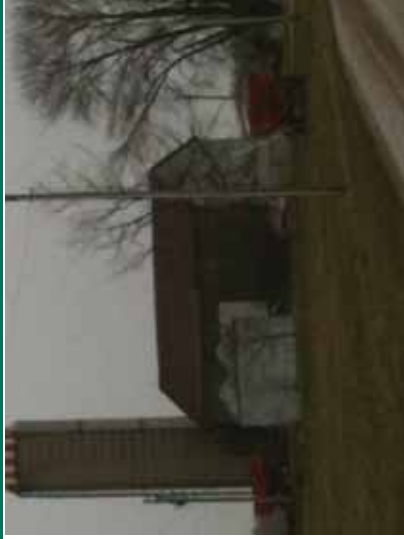
**Date:** 19<sup>th</sup> – 20<sup>th</sup> century

**Description:** English-styled two-bay barn. Medium pitched roof on a timber frame adjacent to a stave silo and multiple metal silos. Additional modern buildings onsite.

**Mitigation of Negative Impacts:** No negative impacts identified, therefore no further mitigation recommended.

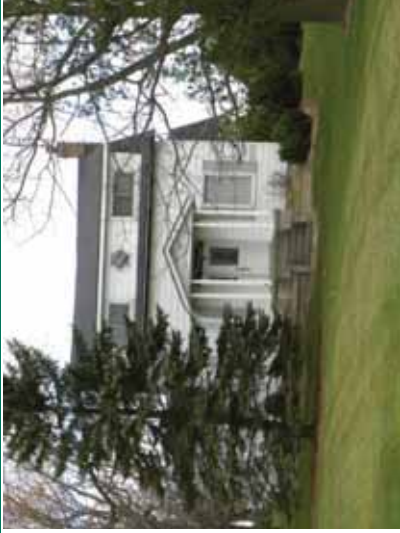
**Site #26 – 74356 Bronson Line (Municipality of Bluewater)**

**Date:** 1900-1920s

**Description:** One and one half storey side gabled house with continuous dormer across the front with two room windows and hexagonal centre window on an indeterminate foundation. Aluminium sided with asphalt shingle roof. Symmetrical plan with modern doors and windows and a pseudo-Greek revival porch roof with four columns over a raised concrete slab porch and steps.

**Mitigation of Negative Impacts:** Impacts were not identified, therefore mitigation is not recommended or necessary.

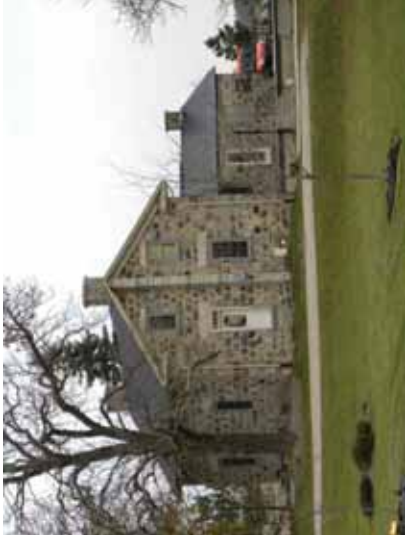
### Site #27 – 74300 Goshen Line (Municipality of Bluewater)

**Date:** 1860s – 1870s

**Description:** One and one half storey side gabled coarse stone house with medium roof pitch. Vernacular Gothic Revival influences include symmetrical chimneys and pointed arch central window extending into the dormer. Single storey rear addition/extension incorporated the same materials.

**1) Design or Physical Value:** Representative of Vernacular Gothic Revival design and mid-19th century construction material which, although found throughout the study area, is increasingly rare throughout southwestern Ontario.

**Mitigation of Negative Impacts:** No negative impacts identified, therefore no further mitigation recommended.

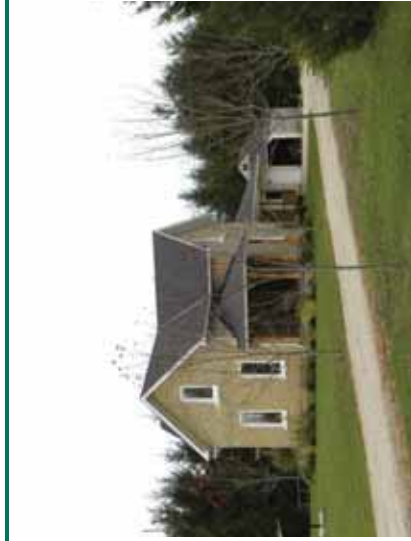
**Site #28 – 74303 Babylon Line (Municipality of Bluewater)**

**Date:** 1880s – 1920s

**Description:** One and one half storey cross-gabled yellow brick house with a medium pitched roof. Possibly cross floor plan, although appears to be a front facing T-plan. Vernacular design with simplistic design details including subtly rounded window crowns. Modifications include a modern addition at rear as well as modern windows, asphalt shingles and front porch.

**Mitigation of Negative Impacts:** Impacts were not identified, therefore mitigation is not recommended or necessary.

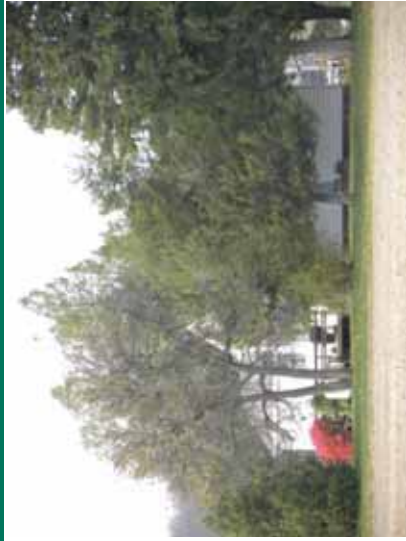
**Site #29 – 74279 Parr Line (Municipality of Bluewater)**

**Date:** Undetermined (Likely 19<sup>th</sup> century)

**Description:** One and one half storey frame house with a medium pitched side gabled roof. Design details obstructed by foliage although a vernacular design is apparent. Undetermined foundation. Modern rear addition, vinyl siding and asphalt shingles.

**Potential Direct and Indirect Impacts to the Heritage Attributes:** None anticipated.

**Mitigation of Negative Impacts:** No negative impacts identified, therefore no further mitigation recommended.

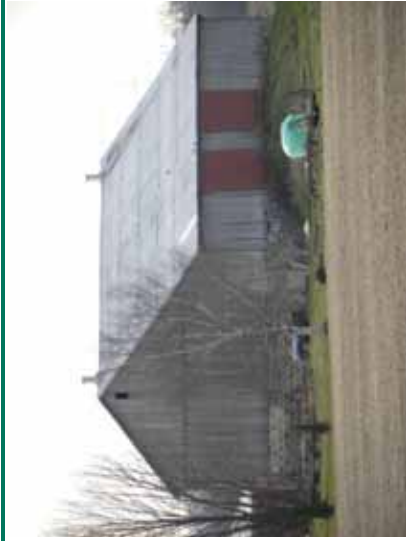
**Date:** 19<sup>th</sup> – 20<sup>th</sup> century

**Description:** Raised three-bay barn. Metal roof on a timber frame on a raised coarse stone foundation with shed roof extension. Two additional outbuildings onsite.

- 1) **Design or Physical Value:** 19<sup>th</sup> – early 20<sup>th</sup> century example of timber barn which, although common throughout the study area, is increasingly rare throughout the province.
  - 2) **Historical or Associate Value:** None identified.
  - 3) **Contextual Value:** Supports the agricultural character of the surrounding vernacular rural landscape.
- Heritage Attributes:** Timber frame construction on a coarse stone foundation. Relationship of structures to residence and road.

**Mitigation of Negative Impacts:** No negative impacts identified, therefore no further mitigation recommended.

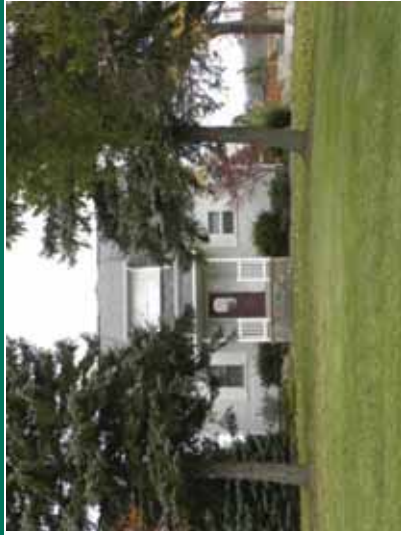
**Site #30 – 74186 Bronson Line (Municipality of Bluewater)**

**Date:** 1900-1920s

**Description:** One and one half storey gambrel roofed house with a single central shed dormer on an indeterminate foundation. Modern siding with asphalt roof shingles and modern doors and windows.

**Potential Direct and Indirect Impacts to the Heritage Attributes:** CHVI was not identified, therefore impacts were not assessed.

**Mitigation of Negative Impacts:** Impacts were not identified, therefore mitigation is not recommended or necessary.

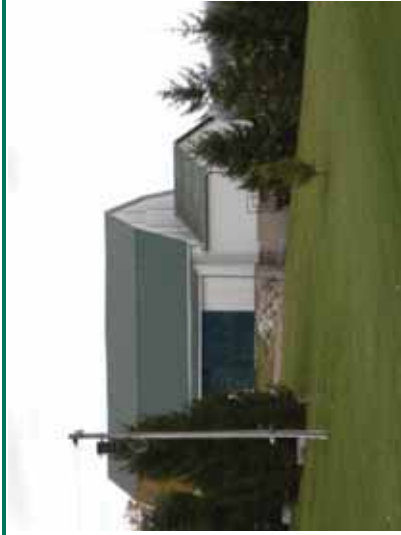
**Date:** 19<sup>th</sup> – 20<sup>th</sup> century

**Description:** Gambrel roofed barn clad with white-painted metal panel siding and green-painted metal panel roof on a concrete foundation. One gabled addition attached to end of barn and one narrow shed-roofed addition attached to barn side.

- 1) **Design or Physical Value:** 19<sup>th</sup> – early 20<sup>th</sup> century example of timber barn which, although common throughout the study area, is increasingly rare throughout the province.
  - 2) **Historical or Associate Value:** None identified.
  - 3) **Contextual Value:** Supports the agricultural character of the surrounding vernacular rural landscape.
- Heritage Attributes:** Timber frame construction on concrete foundation. Relationship of structures to residence and road.

**Mitigation of Negative Impacts:** No negative impacts identified, therefore no further mitigation recommended.

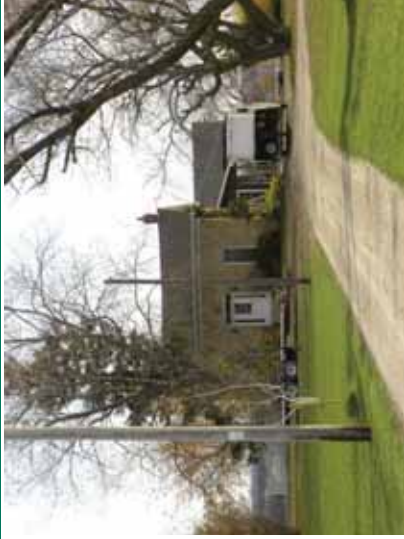
**Site #31 – 74224 Goshen Line (Municipality of Bluewater)**

**Date:** 1860s – 1890s

**Description:** One and one half storey side gabled yellow brick house with low-medium roof pitch. Symmetrical in design with central doorway flanked by single windows and two chimneys. Undetermined foundation. Decorative quoin-like brick work on corners, subtle window arches and sidelights and transom framing the central doorway. Modern addition at the rear as well as modern windows and doors.

**Potential Direct and Indirect Impacts to the Heritage Attributes:** None anticipated.

**Mitigation of Negative Impacts:** No negative impacts identified, therefore no further mitigation recommended.

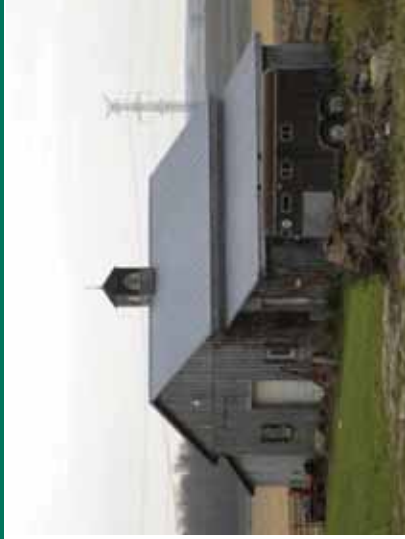
**Date:** Undetermined (likely 20<sup>th</sup> century)

**Description:** Small medium pitched gable end frame barn with flanking sheds. Metal roof with cupola on a timber frame and undetermined foundations. Appears to be relatively modern construction.

**Mitigation of Negative Impacts:** No negative impacts identified, therefore no further mitigation recommended.

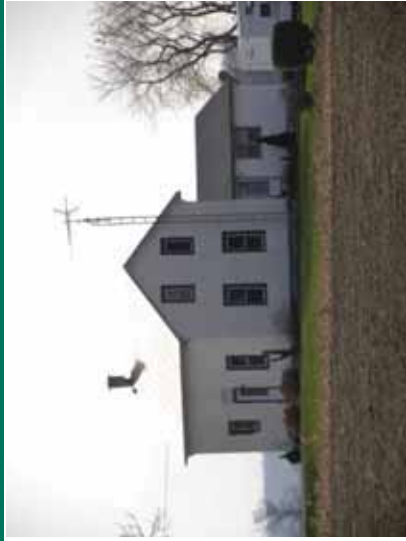
**Site #32 – 74203 Parr Line (Municipality of Bluewater)**

**Date:** 1860s – 1890s

**Description:** One and a half storey frame house with side gabled metal roof and medium pitch. Symmetrical in original design although heavily modified with modern windows, doors, extensive addition at rear, vinyl siding throughout, and concrete foundation.

**Potential Direct and Indirect Impacts to the Heritage Attributes:** CHVI was not identified, therefore impacts were not assessed.

**Mitigation of Negative Impacts:** Impacts were not identified, therefore mitigation is not recommended or necessary.
