## HERITAGE ASSESSMENT REPORT

**NextEra Energy Canada, ULC  
Bluewater Wind Energy Centre  
Huron County, Ontario**

**Report Number:** 10-1151-0201-3100-R01

## **Built Heritage Inventory**

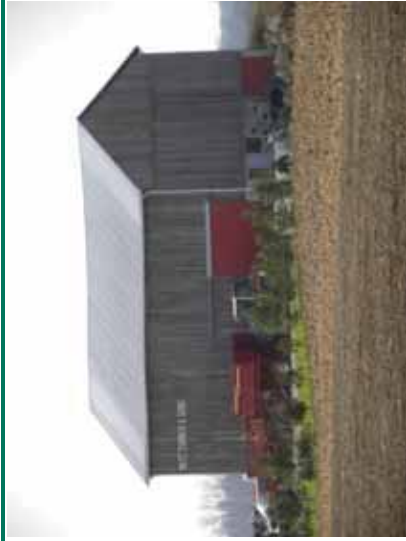
**Date:** 19<sup>th</sup> – 20<sup>th</sup> century

**Description:** Raised three-bay barn. Metal roof on a timber frame and apparent field stone foundation.

- 1) **Design or Physical Value:** 19<sup>th</sup> – early 20<sup>th</sup> century example of timber barn which, although common throughout the study area, is increasingly rare throughout the province.
  - 2) **Historical or Associate Value:** None identified.
  - 3) **Contextual Value:** Supports the agricultural character of the surrounding vernacular rural landscape.
- Heritage Attributes:** Timber frame construction on apparent field stone foundation. Relationship of structures to residence and road.

**Mitigation of Negative Impacts:** No negative impacts identified, therefore no further mitigation recommended.

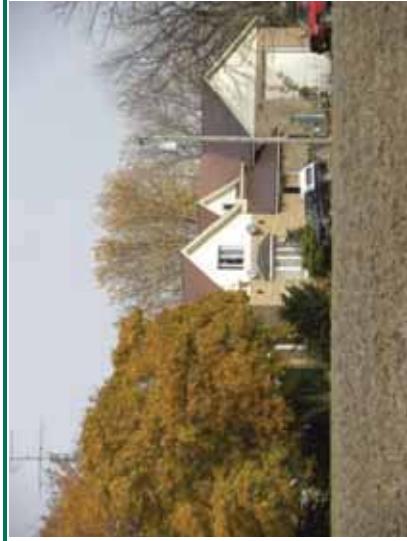
**Site #33 – 74202 Parr Line (Municipality of Bluewater)**

**Date:** Undetermined (20th century estimated)

**Description:** Original core building obscured by foliage. Rear appears to be one and a half storey house with side gabled metal roof. Undetermined foundation. Heavily modified with modern siding, windows, doors, and extensive addition at rear including garage.

**Mitigation of Negative Impacts:** No negative impacts identified, therefore no further mitigation recommended.

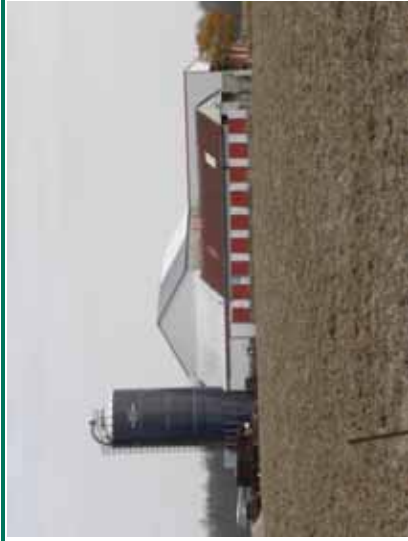
**Date:** 19<sup>th</sup> and 20<sup>th</sup> century

**Description:** Primary barn appears to be a raised three-bay barn with various additions including metal silo.

**Mitigation of Negative Impacts:** No negative impacts identified, therefore no further mitigation recommended.

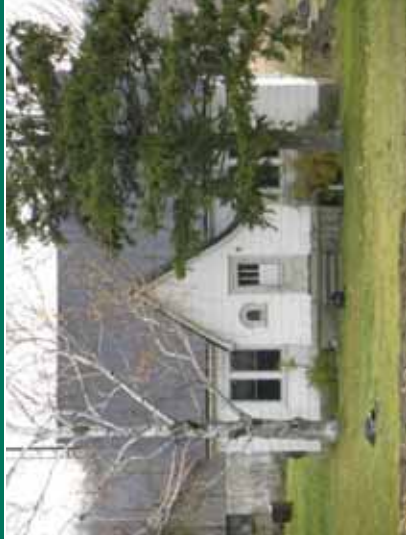
**Site #34 – 74124 Goshen Line (Municipality of Bluewater)**

**Date:** Early to mid 20<sup>th</sup> century

**Description:** One and one half storey side gabled frame house with front gable projection. Vernacular English cottage influences include front projection with sloped roof line and round arched window with wood constructed hood mould. Modifications include modern metal roof and modern windows.

**Mitigation of Negative Impacts:** No negative impacts identified, therefore no further mitigation recommended.

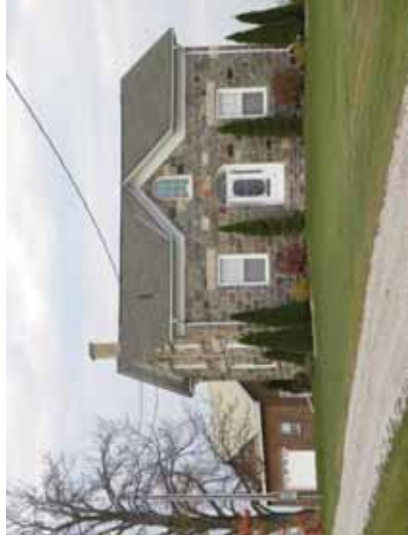
**Site #35 – 74051 Goshen Line (Municipality of Bluewater)**

**Date:** 1860s – 1880s

**Description:** One and one half storey side gabled cut stone house with prominent centre gable and medium roof pitch. Symmetrical in design with gothic revival influences including rounded arch central window extending into the dormer and central door flanked by matching six over six windows. Apparent rear addition incorporated similar materials. Modifications include modern windows, door in historic location and asphalt shingled roof.

- 1) Design or Physical Value:** Representative of 19<sup>th</sup> century construction material which, although found throughout the study area, is increasingly rare throughout southwestern Ontario.
  - 2) Historical or Associate Value:** None identified.
  - 3) Contextual Value:** None identified.
- Heritage Attributes:** One and one half storey stone construction; symmetrical design; rounded arch central window extending into the central dormer; and central door flanked by six over six windows. Relationship of structure to outbuildings and road.

**Mitigation of Negative Impacts:** No negative impacts identified, therefore no further mitigation recommended.

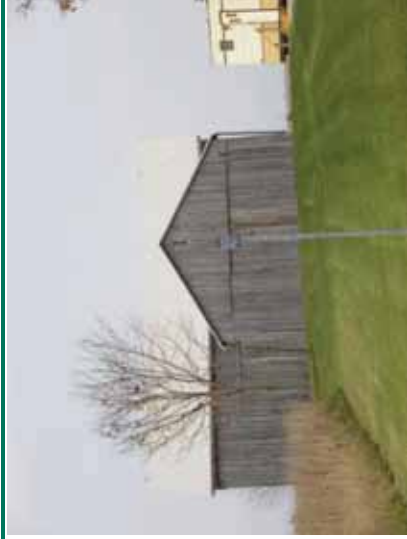
**Date:** 19<sup>th</sup> – 20<sup>th</sup> century

**Description:** Three-gable barn. Metal roof on a timber frame and undetermined foundations.

**Mitigation of Negative Impacts:** No negative impacts identified, therefore no further mitigation recommended.

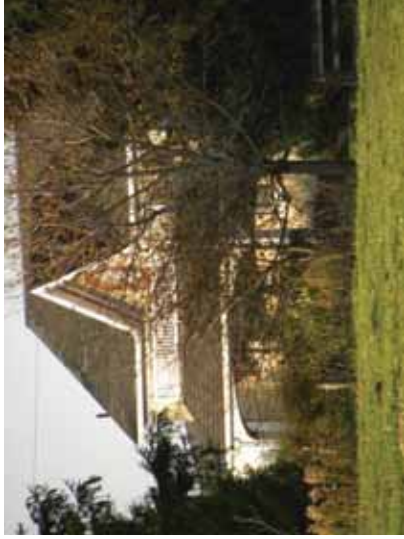
**Site #36 – 37337 Staffa Road (Municipality of Bluewater)**

**Date:** 1860s – 1870s

**Description:** One and one-half storey side gabled cut stone house with steep central dormer and medium roof pitch. Vernacular Gothic Revival influences include central pointed arch window extending into the dormer. Full house-width porch with wood columns and asphalt roof. Modifications include modern asphalt roof, windows and apparent stucco finish on front facade.

**Mitigation of Negative Impacts:** No negative impacts identified, therefore no further mitigation recommended.

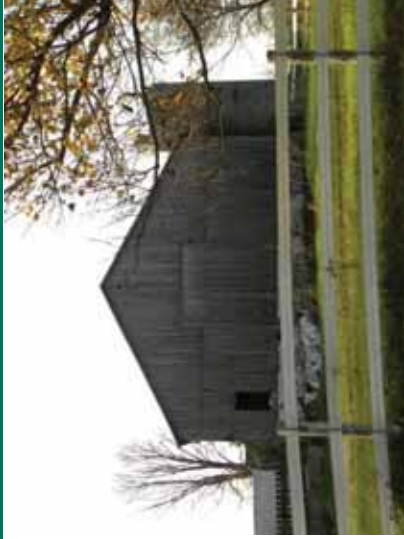
**Date:** 19<sup>th</sup> – 20<sup>th</sup> century

**Description:** Raised three-bay barn. Modern metal roof on timber frame and rubble stone foundation

- 1) **Design or Physical Value:** 19<sup>th</sup> – early 20<sup>th</sup> century example of timber barn which, although common throughout the study area, is increasingly rare throughout the province.
  - 2) **Historical or Associate Value:** None identified.
  - 3) **Contextual Value:** Supports the agricultural character of the surrounding vernacular rural landscape.
- Heritage Attributes:** Timber frame construction on rubble stone foundation. Relationship of structures to residence and road.

**Mitigation of Negative Impacts:** No negative impacts identified, therefore no further mitigation recommended.

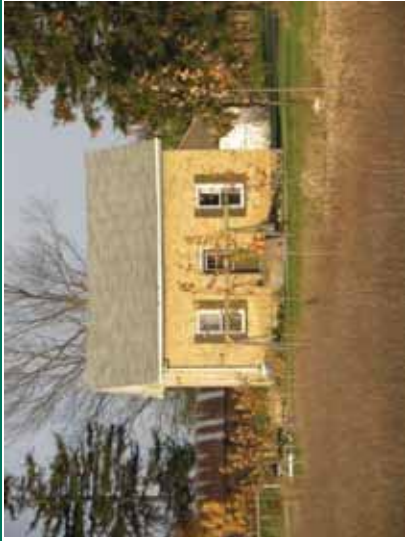
**Site #37 – 73957 Bronson Line (Municipality of Bluewater)**

**Date:** Undetermined (Likely 19<sup>th</sup> century)

**Description:** One and a half storey yellow brick house with side gabled medium pitched roof and cut stone foundation. Symmetrical in original design although modified with modern windows and doors.

**Mitigation of Negative Impacts:** Impacts were not identified, therefore mitigation is not recommended or necessary.

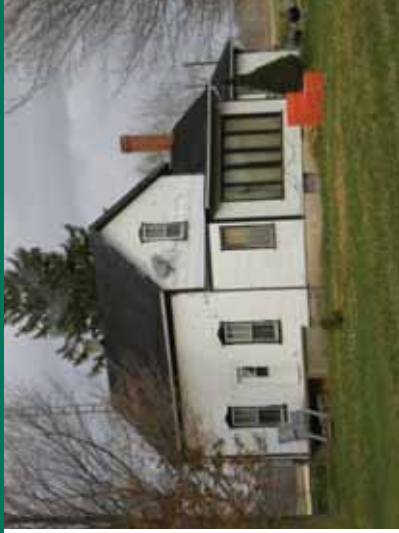
**Site #38 – 73944 Bronson Line (Municipality of Bluewater)**

**Date:** Undetermined (Likely 19<sup>th</sup> century)

**Description:** One and one half story side gabled house clad in white-painted tin shingles on a cut stone foundation. One single-storey shed roofed addition attached to one gable end and a single storey addition attached to house rear resulting in an “L” plan. Windows and doors appear to be replacement.

**Mitigation of Negative Impacts:** Impacts were not identified, therefore mitigation is not recommended or necessary.

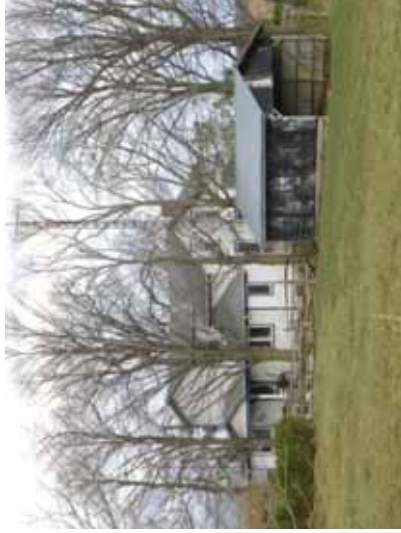
**Site #39 – 73946 Goshen Line (Municipality of Bluewater)**

**Date:** 19<sup>th</sup> – 20<sup>th</sup> century

**Description:** One and one half storey frame house on an indeterminate foundation. Multiple gables give the house a “T” or cross pattern with at least three of the cruxes filled in with single storey additions. House clad in aluminum siding and asphalt roof shingles. Some replacement windows although there appear to be some original windows. One end gabled timber and metal clad shed/garage on the property.

**Mitigation of Negative Impacts:** Impacts were not identified, therefore mitigation is not recommended or necessary.

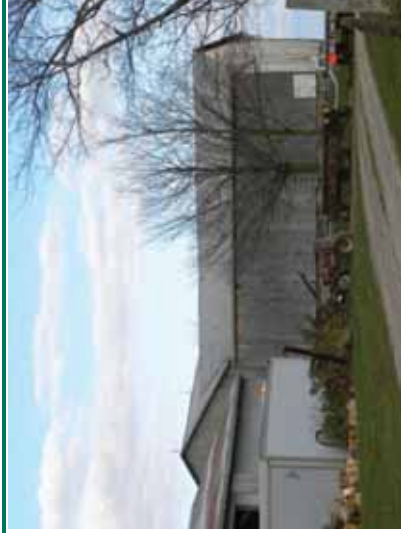
**Date:** 19<sup>th</sup> – 20<sup>th</sup> century

**Description:** Three-gabled timber frame, metal-panel roofed, and wood clad barn with gabled addition giving the barn “L” plan layout on a field stone foundation. A side gabled, timber frame, metal clad and roofed out building sits near the original barn.

- 1) **Design or Physical Value:** 19<sup>th</sup> – early 20<sup>th</sup> century example of timber barn which, although common throughout the study area, is increasingly rare throughout the province.
  - 2) **Historical or Associate Value:** None identified.
  - 3) **Contextual Value:** Supports the agricultural character of the surrounding vernacular rural landscape.
- Heritage Attributes:** Timber frame construction on field stone foundation. Relationship of structures to residence and road.

**Mitigation of Negative Impacts:** No negative impacts identified, therefore no further mitigation recommended.

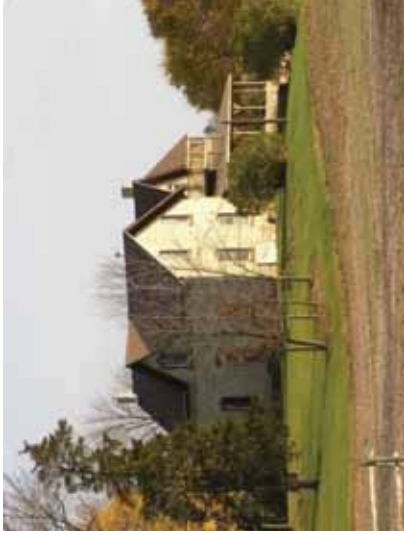
**Site #40 – 73880 Bronson Line (Municipality of Bluewater)**

**Date:** 1860s – 1890s

**Description:** One and a half storey yellow brick house with a medium pitched centre gabled roof, central steeply pitched dormer and a cut stone foundation. Vernacular Gothic Revival characteristics include a central, tripart, rounded window extending into the central dormer, door surround and decorative brickwork surrounding central door, cornices and quoin like detailing. The chimney is modern concrete block and the roof is asphalt shingle.

**Mitigation of Negative Impacts:** No negative impacts identified, therefore no further mitigation recommended.

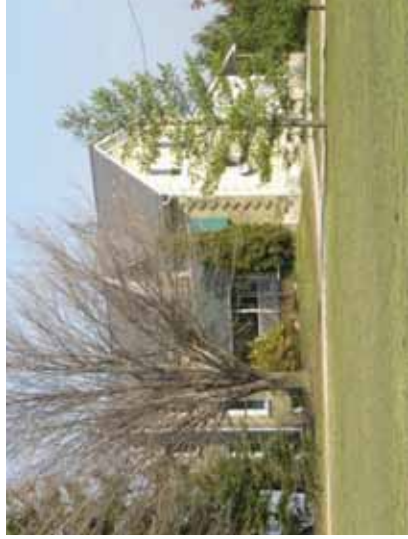
**Site #41 – 73838 Tower Line (Municipality of Bluewater)**

**Date:** 1860s – 1890s

**Description:** One and one half storey cross gabled yellow brick house with a medium roof pitch and multiple steeply pitched cross gables. Apparent course stone foundation. Asymmetrical design appears to be a T-plan with Vernacular Gothic Revival influences including brick detailing along the corners and cornices and open eaves. Modifications include extensive rear additions, modern windows, metal roof and replacement chimney.

**Mitigation of Negative Impacts:** No negative impacts identified, therefore no further mitigation recommended.

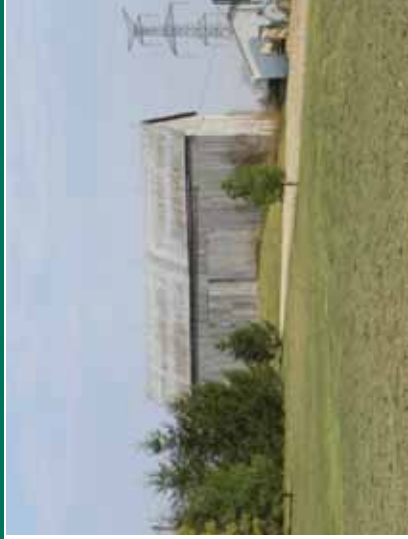
**Date:** 19<sup>th</sup> – 20<sup>th</sup> century

**Description:** Raised three-bay barn. Metal roof on timber frame and stone foundation.

- 1) Design or Physical Value:** 19<sup>th</sup> – early 20<sup>th</sup> century example of timber barn which, although common throughout the study area, is increasingly rare throughout the province.
  - 2) Historical or Associate Value:** None identified.
  - 3) Contextual Value:** Supports the agricultural character of the surrounding vernacular rural landscape.
- Heritage Attributes:** Timber frame construction on a stone foundation. Relationship of structures to residence and road.

**Mitigation of Negative Impacts:** No negative impacts identified, therefore no further mitigation recommended.

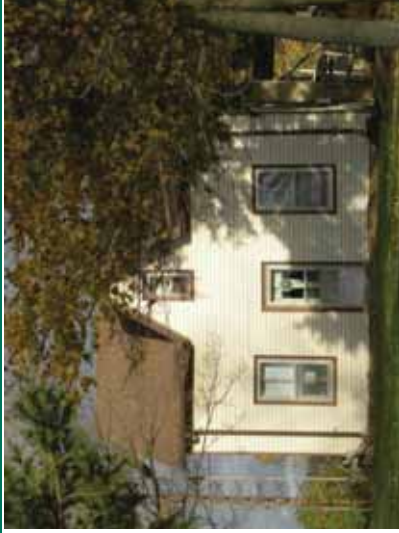
**Site #42 – 73812 Bronson Line (Municipality of Bluewater)**

**Date:** 1860 – 1890s

**Description:** One and one half storey house with high pitched centre gable on an indeterminate foundation. Modern siding with asphalt shingle roof. Windows and doors could be original but likely replacement in the early 20<sup>th</sup> century. Symmetrical design.

**Mitigation of Negative Impacts:** Impacts were not identified, therefore mitigation is not recommended or necessary.

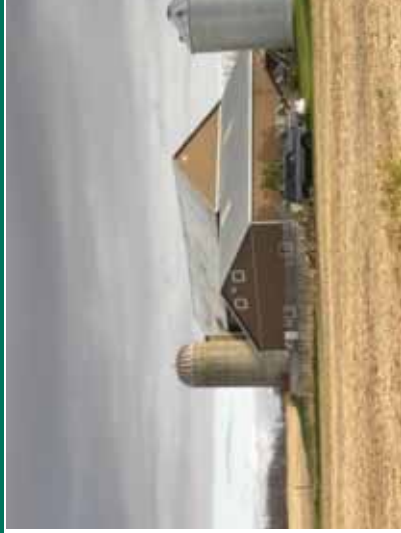
**Date:** Various (19<sup>th</sup> and 20<sup>th</sup> century)

**Description:** Side gabled, timber-framed barn with brown-painted metal panel siding and roofs on an indeterminate foundation. Modern brown painted metal panel clad and silver painted metal panel roofed gabled addition added to barn rear giving it an “L” plan. Concrete and metal silos operate near the barn.

- 1) **Design or Physical Value:** 19<sup>th</sup> – early 20<sup>th</sup> century example of timber barn which, although common throughout the study area, is increasingly rare throughout the province.
  - 2) **Historical or Associate Value:** None identified.
  - 3) **Contextual Value:** Supports the agricultural character of the surrounding vernacular rural landscape.
- Heritage Attributes:** Timber frame construction on concrete foundation. Relationship of structures to residence and road.

**Mitigation of Negative Impacts:** No negative impacts identified, therefore no further mitigation recommended.

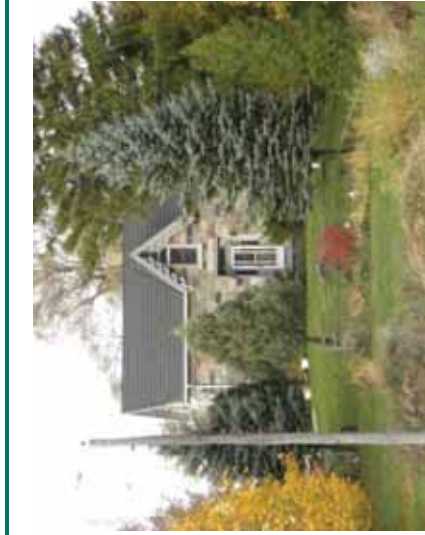
**Site #43 – 37342 Kippen Road (Municipality of Bluewater)**

**Date:** 1860s – 1870s

**Description:** One and one half storey side gabled cut stone house with high peaked central dormer with a single central window with fan light and decorative spindle work. Black tile roof. Modern front door with side and pediment lights. Concrete steps lead from front door without a porch.

**1) Design or Physical Value:** Representative of Vernacular Gothic Revival design and mid-19th century construction material which, although found throughout the study area, is increasingly rare throughout southwestern Ontario.

**Mitigation of Negative Impacts:** No negative impacts identified, therefore no further mitigation recommended.

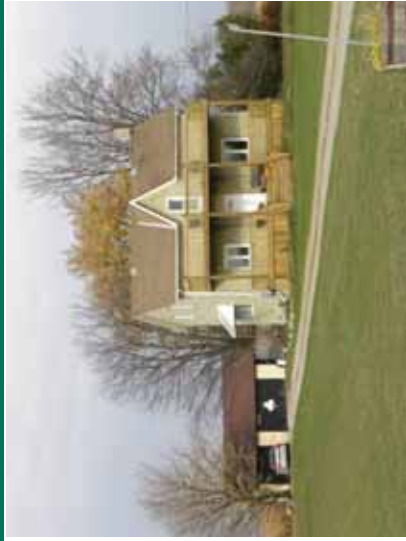
**Site #44 – 38242 Kippen Road (Municipality of Bluewater)**

**Date:** Undetermined (19<sup>th</sup> century estimated)

**Description:** One and one half storey yellow brick house with a medium roof pitch and steeply pitched central gable. Vernacular Gothic Revival influences include modified central door, formerly a window, extending into the dormer. Modifications include modern asphalt roof, windows, bay window on the west facade (left) and double porch addition.

**Mitigation of Negative Impacts:** Impacts were not identified, therefore mitigation is not recommended or necessary.

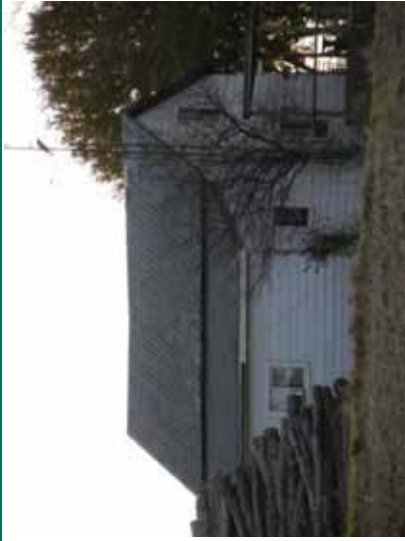
**Site #45 – 37419 Kippen Road (Municipality of Bluewater)**

**Date:** Undetermined (19<sup>th</sup> century estimated)

**Description:** One and one half story frame house with medium roof pitch. Unidentified foundation. Highly modified with vinyl siding, modern windows, metal roof and removed central dormer.

**Mitigation of Negative Impacts:** Impacts were not identified, therefore mitigation is not recommended or necessary.

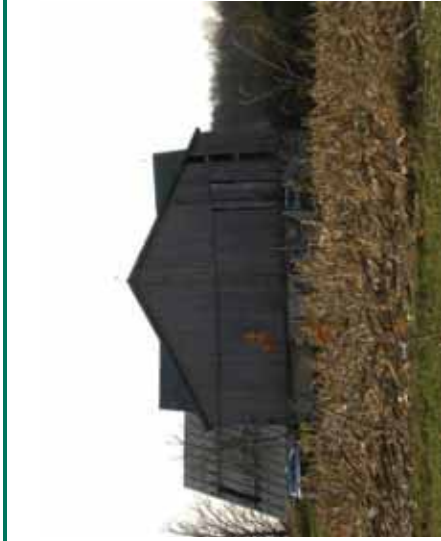
**Site #46 – 37535 Kippen Road (Municipality of Bluewater)**

**Date:** 19<sup>th</sup> – 20<sup>th</sup> century

**Description:** Three-gable barn with a metal roof on a timber frame and rubble stone foundation with cut stone quoins.

- 1) **Design or Physical Value:** 19<sup>th</sup> – early 20<sup>th</sup> century example of timber barn which, although common throughout the study area, is increasingly rare throughout the province.
  - 2) **Historical or Associate Value:** None identified.
  - 3) **Contextual Value:** Supports the agricultural character of the surrounding vernacular rural landscape.
- Heritage Attributes:** Timber frame construction on a rubble stone foundation with cut stone quoins. Relationship of structures to field patterns and road.

**Mitigation of Negative Impacts:** No negative impacts identified, therefore no further mitigation recommended.

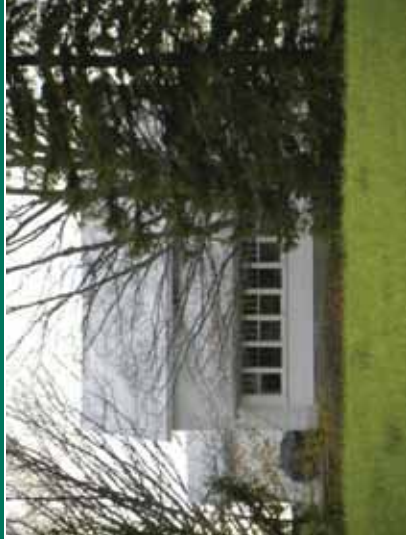
**Site #48 – 73401 Road (Municipality of Bluewater)**

**Date:** 1860 – 1890s

**Description:** One and one half storey side gabled house on an undetermined foundation. House clad in white painted aluminum siding and what appear to be metal roof shingles. A large single-storey enclosed porch or addition attached to house side with a hipped, metal shingled roof.

**Mitigation of Negative Impacts:** Impacts were not identified, therefore mitigation is not recommended or necessary.

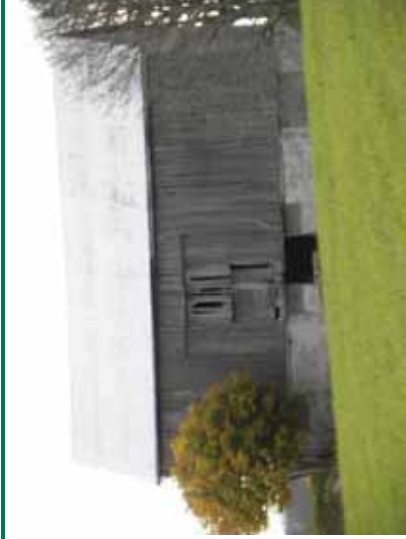
**Date:** 19<sup>th</sup> – 20<sup>th</sup> century

**Description:** Side gabled, timber-framed, wood-clad, metal-roofed barn on concrete or concrete-clad foundation.

**Mitigation of Negative Impacts:** No negative impacts identified, therefore no further mitigation recommended.
