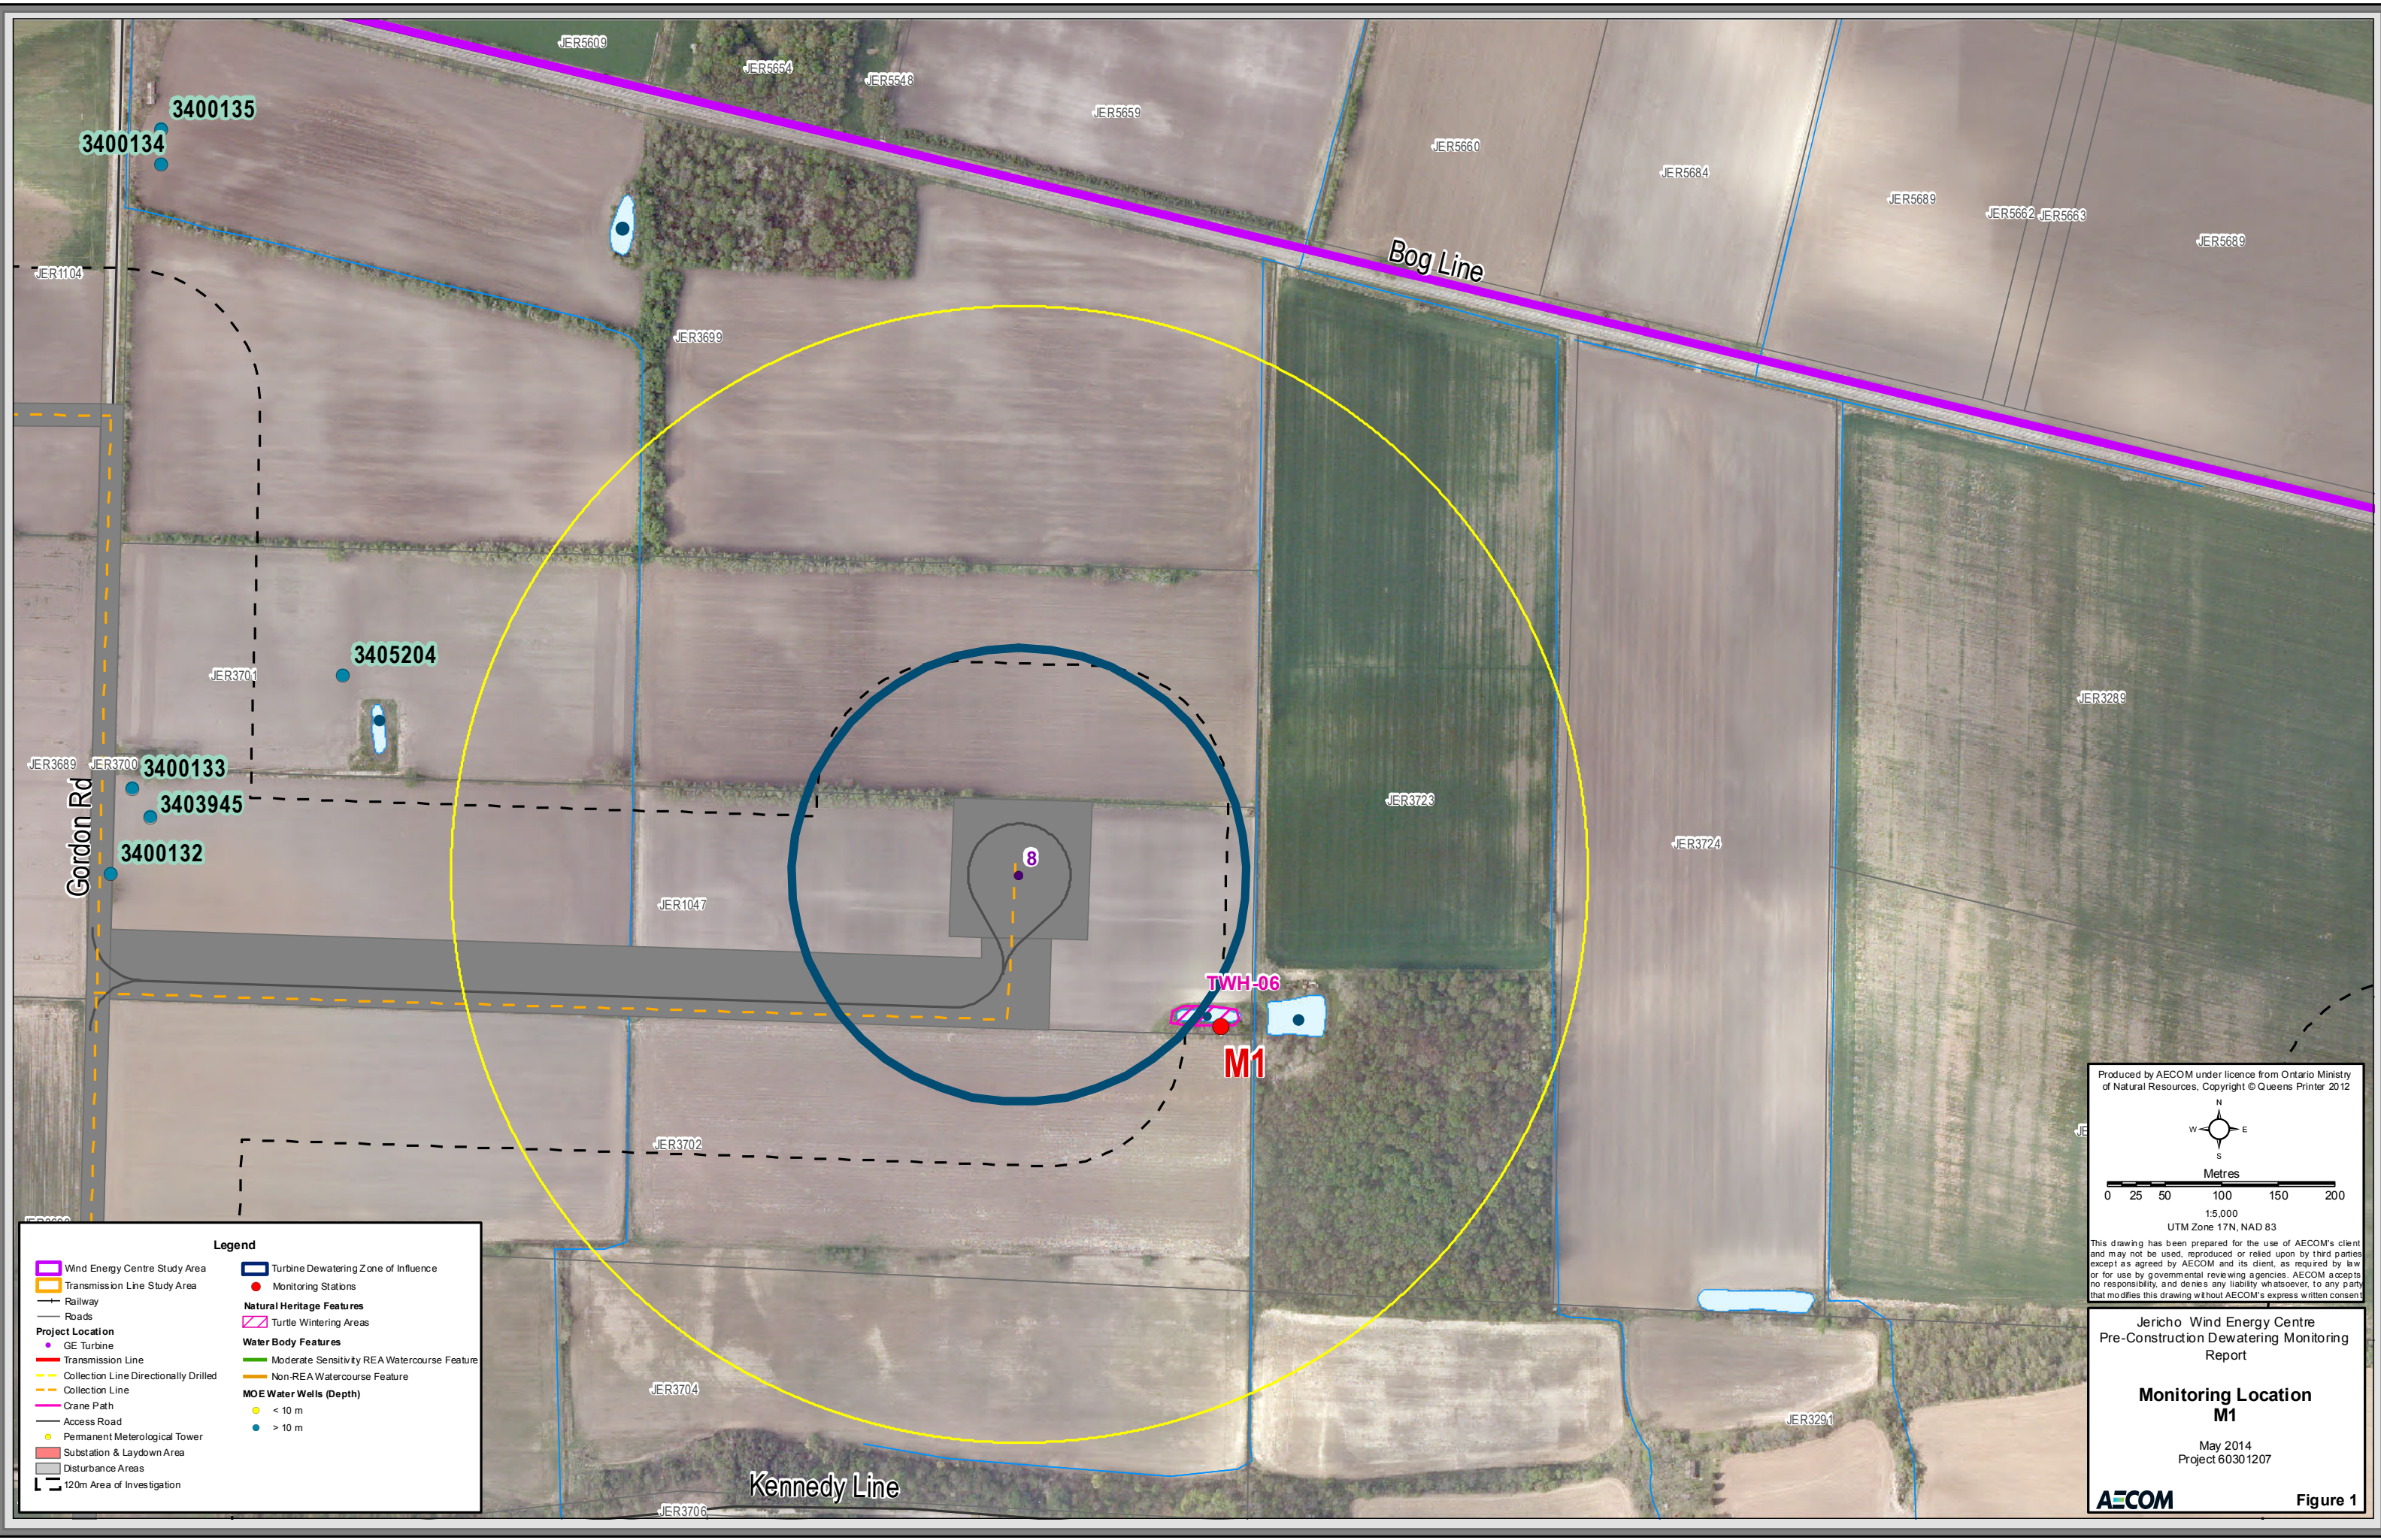
AECOM Figure 1

Monitoring Location M1 includes a dug-out pond identified as Significant Turtle Wintering Habitat Feature TWH-06 (refer to **Figure 1** for location). This pond is located in an agricultural field and has naturalized banks with mature overhanging trees and shrubs. Surrounding vegetation is dominated by Manitoba Maple (*Acer negundo*), Common Buckthorn (*Rhamnus cathartica*), Eastern Cottonwood (*Populus deltoides*) and Red-osier Dogwood (*Cornus sericea*). Pond Duckweed (*Lemna minor*) was observed in the east end of the pond near the installed mini-piezometers. Evaluation of Significance Pre-construction Monitoring surveys conducted in May 2013 reported a Snapping Turtle (*Chelydra serpentina*) basking near this pond as described in the *Jericho Wind Energy Centre Natural Heritage Assessment and Environmental Impact Study Report Third Addendum* (AECOM, 2013c).

One mini-piezometer (MP-M1) was installed in a pond identified as TWH-06 as part of the hydrogeological baseline investigations at Turbine 8. The mini-piezometer is installed approximately 230 m southeast of Turbine 8, within the predicted turbine foundation dewatering zone of influence (**Figure 1**).

A total of two Monitoring Locations (M1 and R1) were selected to be monitored for potential dewatering effects (refer to **Figures 1 and 2**). Monitoring Location M1 contains the pond identified as Significant Turtle Wintering Habitat Feature TWH-06 located within the dewatering zone of influence for Turbine 8. Monitoring Location R1 contains a pond identified as Significant Turtle Wintering Habitat Feature TWH-05 located outside of any dewatering zones of influence and was selected to be monitored to establish a reference for normal conditions of a Significant Turtle Wintering Habitat Feature with similar characteristics to TWH-06.

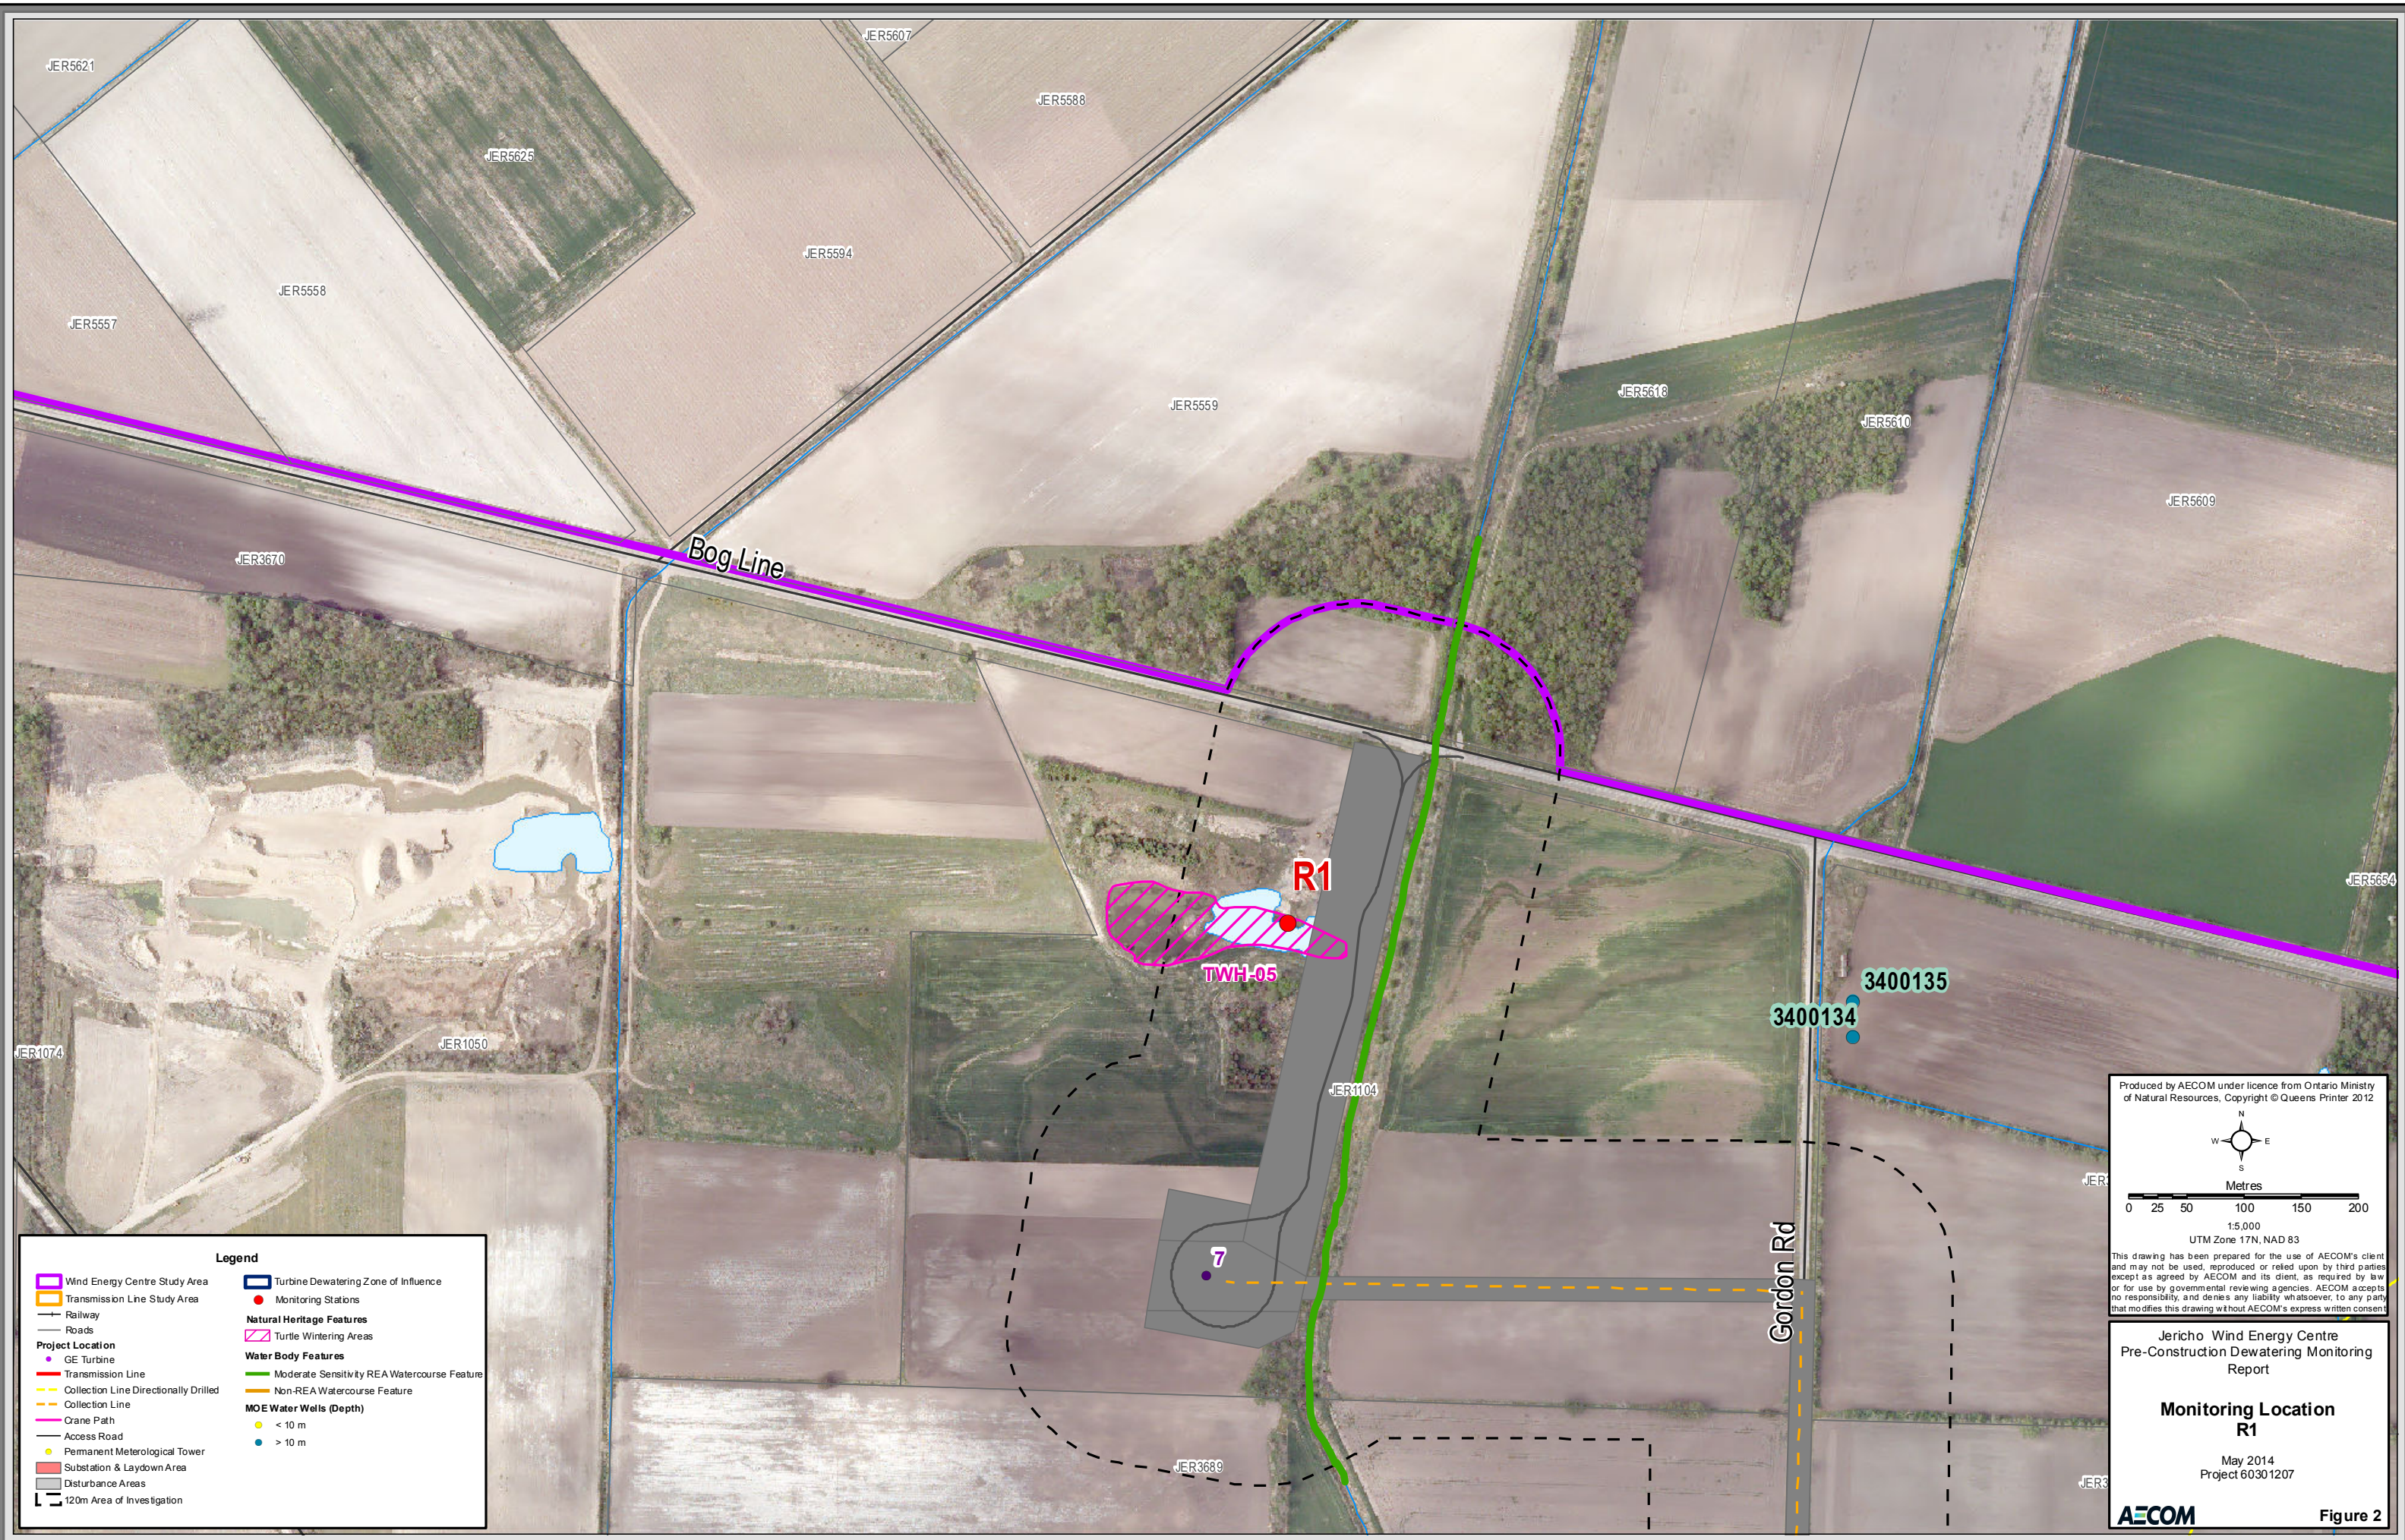
AECOM Figure 2

Monitoring location R1 includes a dug-out pond identified as Significant Turtle Wintering Habitat Feature TWH-05 and was monitored as a reference for normal conditions for Feature TWH-06 at Monitoring Location M1 (refer to **Figure 2** for location). This pond is located in a cultural savannah near a topsoil processing facility. Riparian vegetation is dominated by Red-osier Dogwood, Common Reed (*Phragmites australis*) and Goldenrods (*Solidago* species). Evaluation of Significance Pre-construction Monitoring surveys conducted in May 2013 reported a Snapping Turtle travelling around the gravel pit towards the pond as described the *Jericho Wind Energy Centre Natural Heritage Assessment and Environmental Impact Study Report Third Addendum* (AECOM, 2013c).

One mini-piezometer (MP-R1) was installed in a pond identified as TWH-05 in order to provide background monitoring information for Monitoring Location M1. The mini-piezometer is installed approximately 31 m north of Turbine 7, outside any predicted turbine foundation dewatering zone of influence (**Figure 2**).

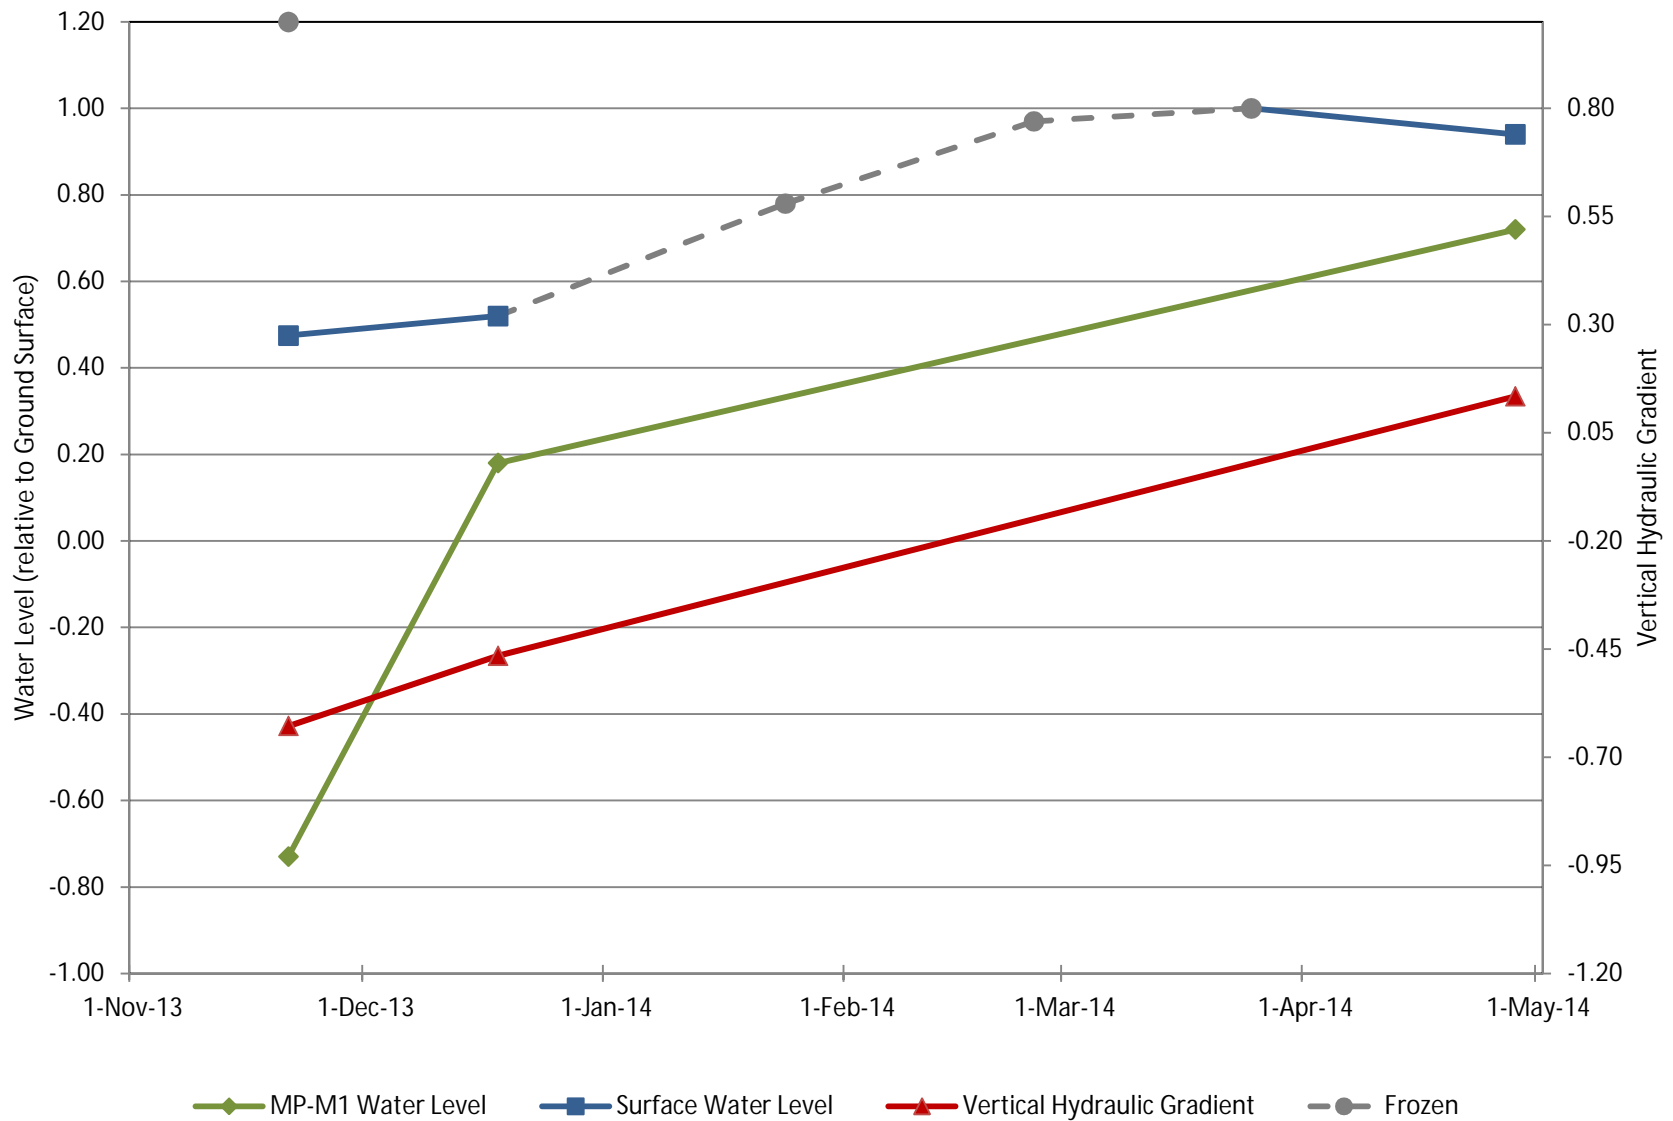
Figure 3

MP-M1 Hydrograph
Jericho Pre-Construction Dewatering Monitoring Report

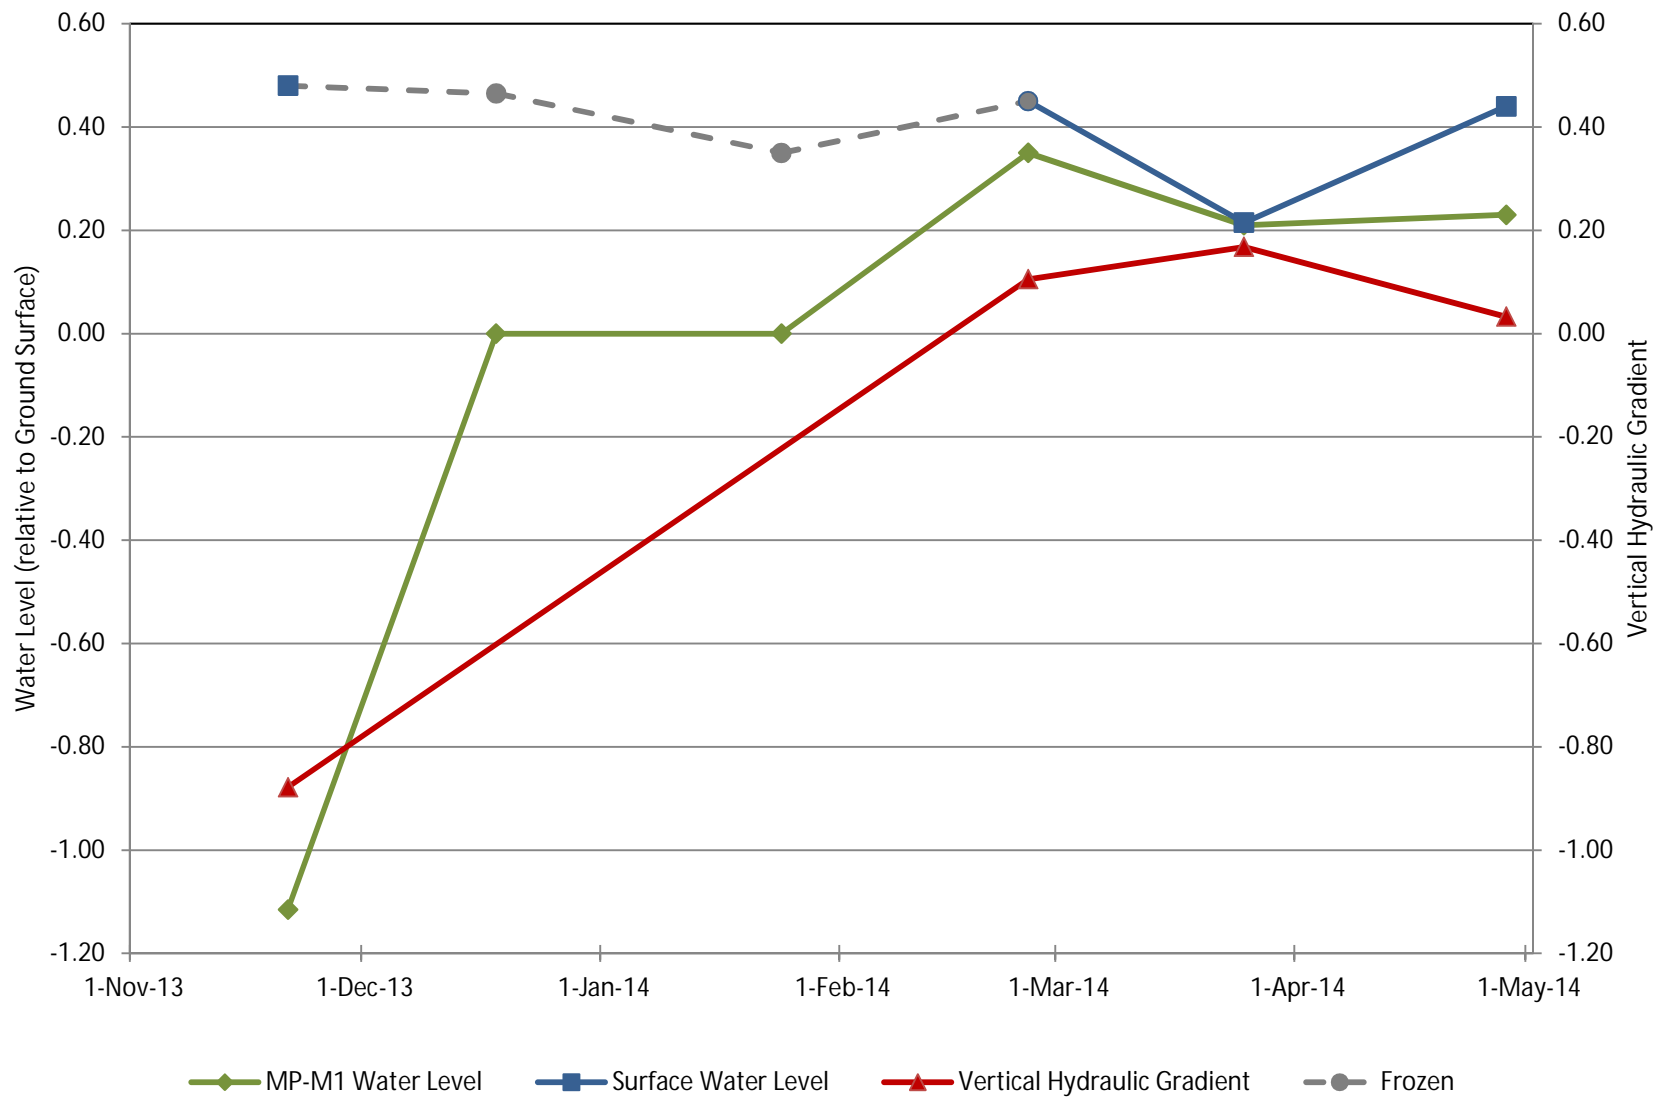
MP-R1 Hydrograph
Jericho Pre-Construction Dewatering Monitoring Report
