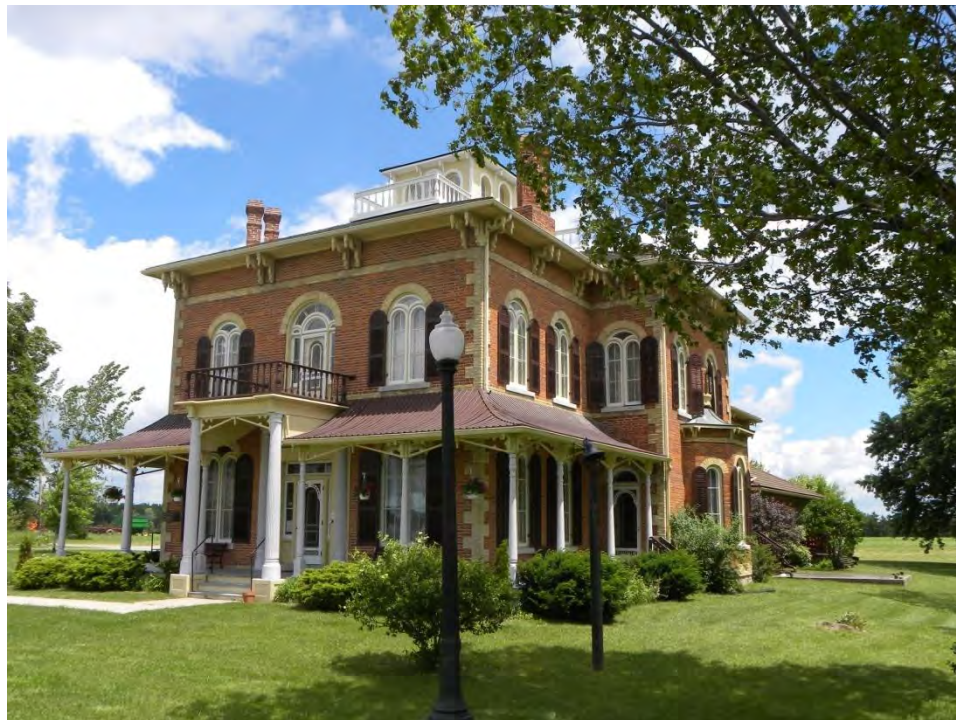
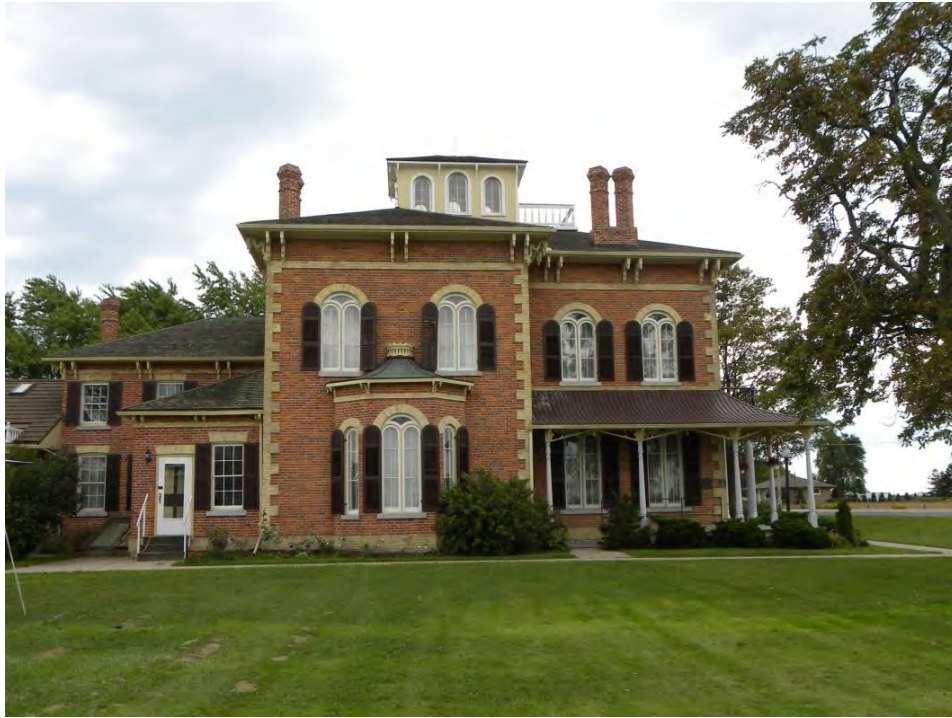
Plate 7: Cottonwood Mansion, Looking Northeast

Plate 8: Cottonwood Mansion, Looking South

The Cottonwood Mansion is located on Regional Road 53, north of Concession Road 4, on an approximately five acre parcel of land, which has been severed from the original 200 acre farm. Cottonwood is not at the Project Location or adjacent to or abutting the Project Location (Figure 6). The mansion is located two parcels away from the Project Location. Overhead collector cables are proposed to run along Regional Road 53, on the opposite side of the road from the mansion, on municipal property, along pre-existing hydro poles. Due to the fact that Cottonwood Mansion is not adjacent to, or abutting the Project Location, additional impact analysis is not required.

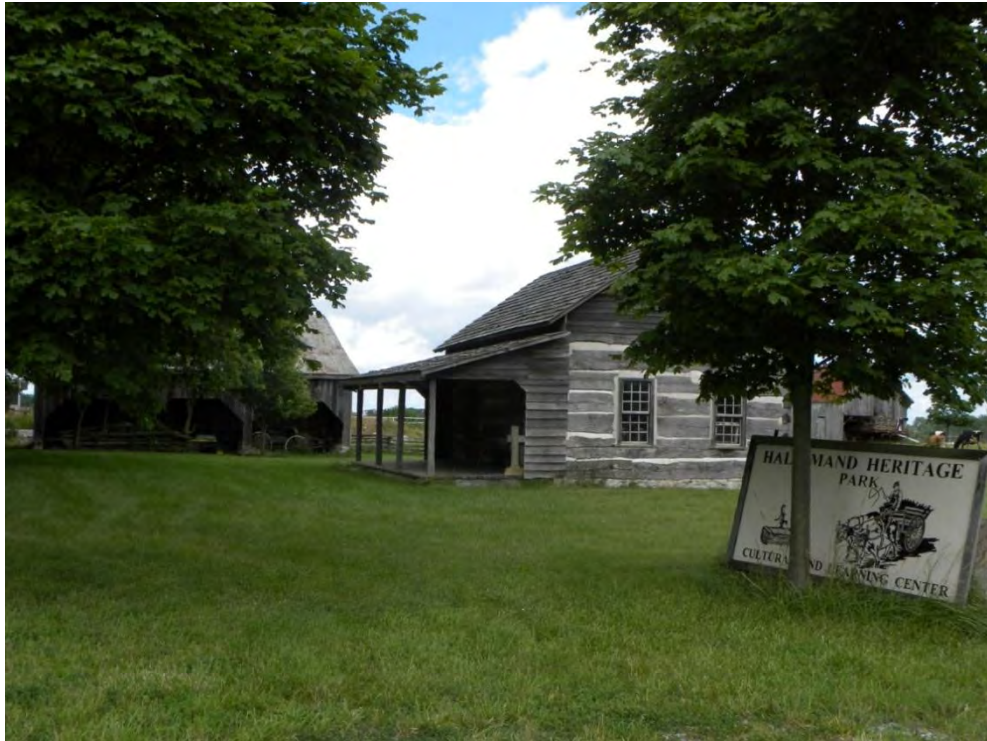
Plate 9: Hoover Log House

The Hoover Log House was built by Daniel Hoover's family in circa. 1793. This building was designated a heritage structure due to the fact that it is one of the oldest remaining log homes in Haldimand County. The house was originally located close to the Lake Erie shoreline, in Rainham Township on the lot owned by the Daniel Hoover family (Figure 4). During the early part of the 19th century, this log cabin had a larger frame home constructed around it. In 1994, a fire consumed the frame house and the Hoover log cabin which stood inside of it was partially salvaged. What remained of the log home following the fire was dismantled and moved to Bill Fletcher's farm where it was reassembled and stands today (Haldimand County 2010 and B. Fletcher, personal communication September 17, 2010).

The Hoover Log House is located on Concession Road 4, east of Regional Road 53. This log house is not at the Project Location, but it is on a property located adjacent to the Project Location (Figure 6). Due to the fact that this heritage building is located adjacent to the Project Location a comprehensive Heritage Impact Assessment is required under O. Reg. 359/09. This assessment can be found in Section 5.0 of this report.

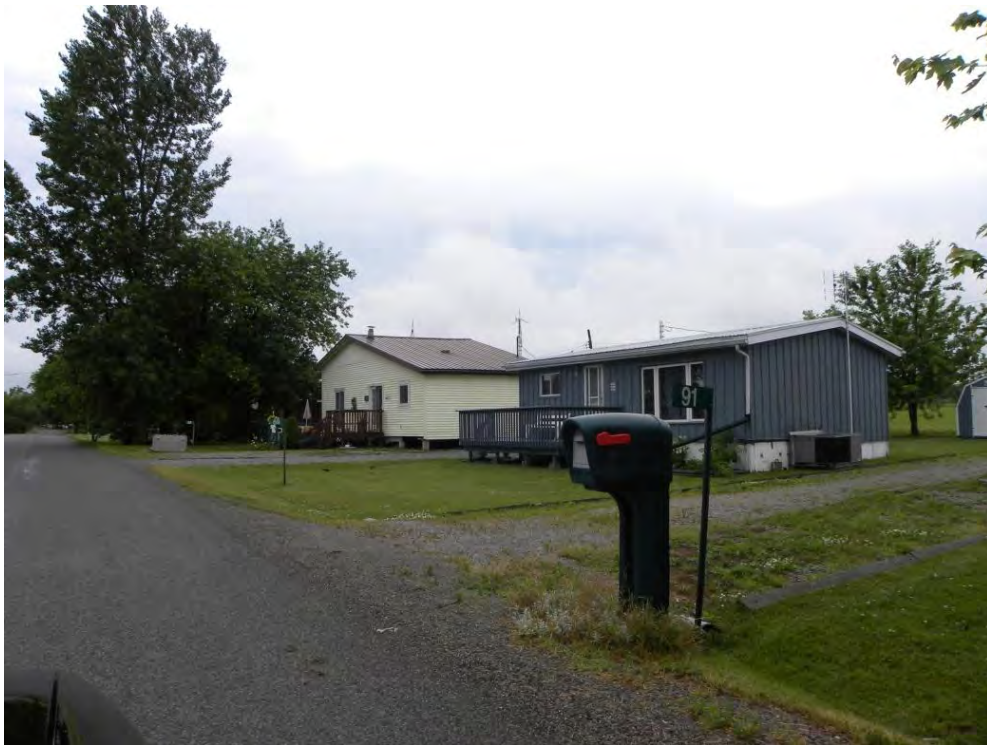
Plate 10: Example of Vernacular Cottage Landscape of Study Area

The vernacular cottage landscape developed during the 20th century and occurred on the opposite side of the road allowance from the earlier farm settlements. The Lake Shore Road is today dotted with cottages that were constructed throughout the 20th century. These rows of tightly packed cottages form the vernacular cottage landscape which separates the shoreline from the early farm lots located on Concession 1 in Rainham Township (Plate 10).

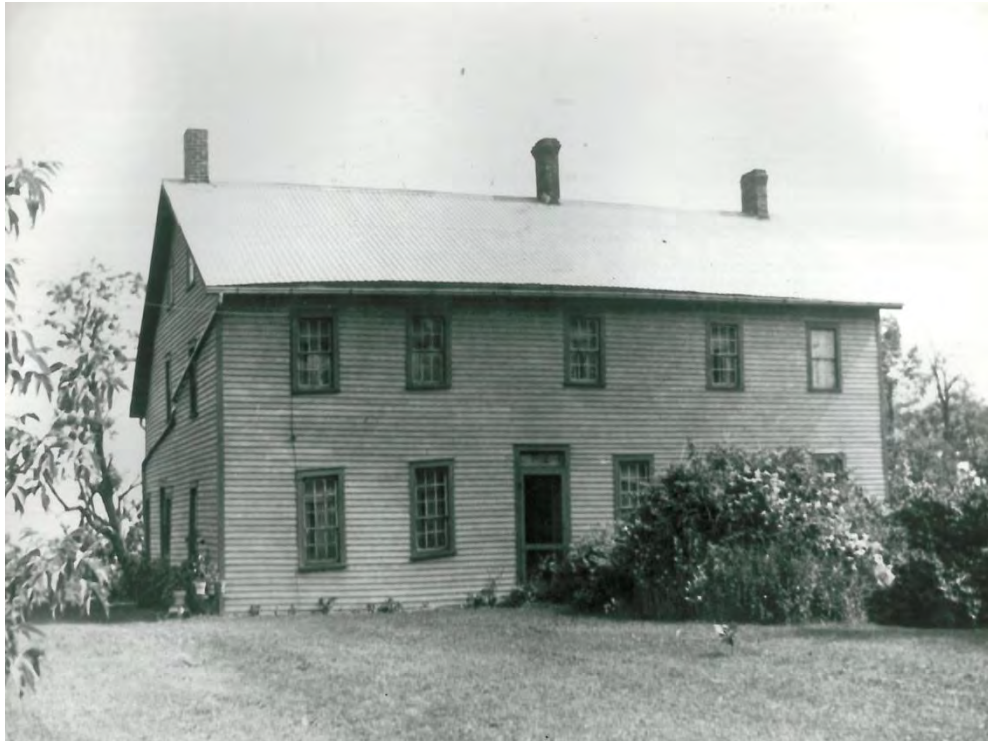
Plate 11: The Hoover Frame House, circa. Late Nineteenth Century, built around the Hoover log cabin which was located on the left side of the house as seen in this photograph

Plate 11 is a photograph that was taken during the late nineteenth century, showing the Hoover frame house. The log cabin was incorporated into the southeast corner of the frame house which appears on the left side of this photograph (Plate 11). The two windows located to the left of the front door correspond with the south facing end of the cabin as it stands today (see Plate 9). The two windows and the door that were located on the left end of the frame house in Plate 11, correspond with the location of the front door and windows of the log cabin as it currently stands (Plate 9). Bill Fletcher explained that the left side of the frame house (Plate 11) appeared askew, due to the incorporation of the log cabin into the design and the lack of a singular foundation for the home (B. Fletcher, personal communication December, 2010). Plate 12 shows the Daniel Hoover Homestead as it appeared around circa.1900 along the Lake Erie shoreline. The log cabin was located at the far end of the frame home as it appears in this photograph (B. Fletcher, personal communication December, 2010).

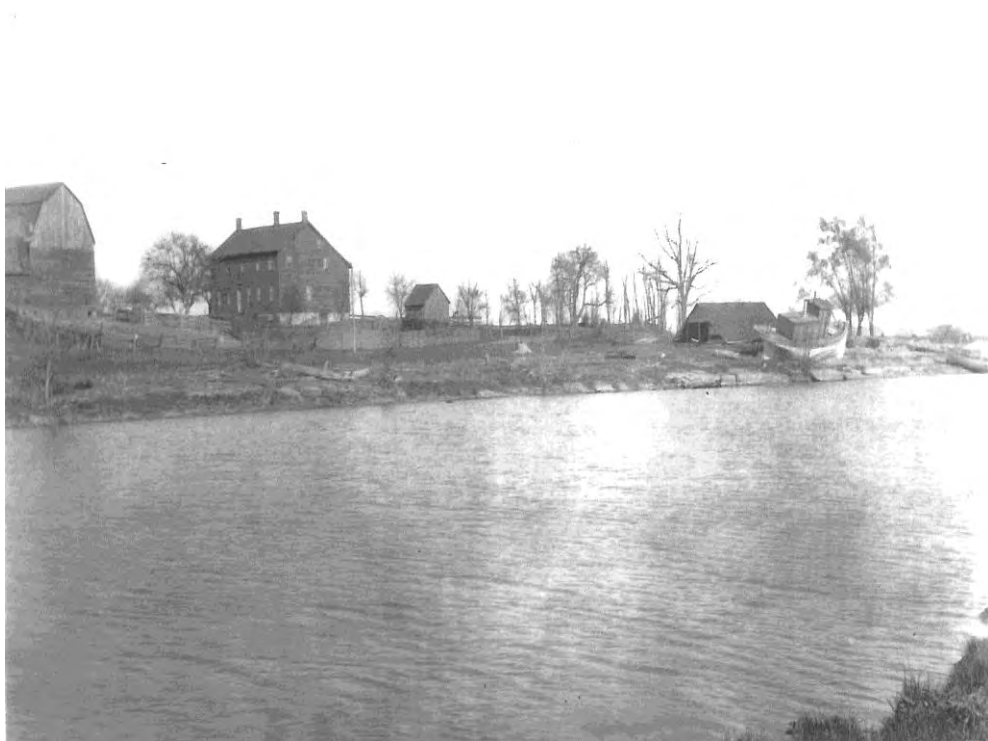
Plate 12: The Hoover Homestead, circa. 1900 and original location of the Hoover Log House

The Hoover Log House was built circa.1793 by the Hoover family, who were one of the first families of European descent to settle in the Haldimand County area (Haldimand County 2010). The house was originally located close to the Lake Erie shoreline, in Rainham Township. On the 1877 map of Rainham Township the owner of the lot where the house was located is indicated as Daniel Hoover (Figure 4). Shortly following the initial construction of the cabin, the Hoover family grew substantially in numbers and therefore in circa. 1803 a larger frame home was constructed around the cabin to provide additional living space (N. Feerman, personal communication December, 2010). Descendants of the Daniel Hoover family occupied the frame house through to the second half of the nineteenth century. Several other families owned and occupied the home from the late nineteenth century through to the second half of the twentieth century (B. Fletcher and N. Feerman, personal communications December, 2010). In 1994, a fire destroyed the frame house which at that time stood vacant. Following the fire, it was discovered that the Hoover log cabin, which still stood inside of the larger frame home, was partially salvageable (B. Fletcher, personal communication December 9, 2010). What remained of the log home was dismantled and moved to Bill Fletcher's farm where it was reassembled and stands today (Haldimand County 2010 and B. Fletcher, personal communication September 17, 2010).

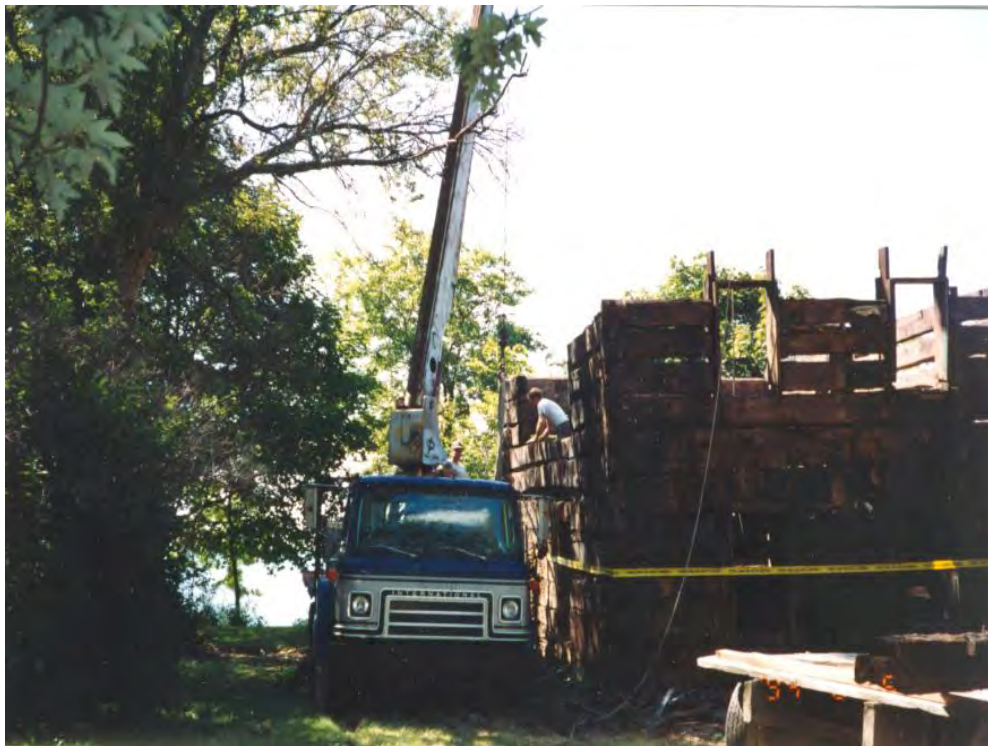
Plate 13: Portion of the Hoover Log Cabin that remained following the fire in 1994

Plate 13 is a photograph that was taken in 1994 following the fire and shows what remained of the original log cabin. As can be seen in the photograph the log cabin was originally a two storey structure. Due to the damage from the fire, the upper logs from the second storey could not be salvaged (B. Fletcher, personal communication December, 2010). The salvageable logs from the first storey and the floor were disassembled and moved to Bill Fletcher's farm to be reassembled. Prior to the dismantling of the structure the logs were numbered (B. Fletcher, personal communication December, 2010). The new location where the cabin was reconstructed on the Fletcher farm is located approximately seven kilometres north and inland from where it was originally situated along the Lake Erie shore line (Figure 6, see location on map of Plate 9).

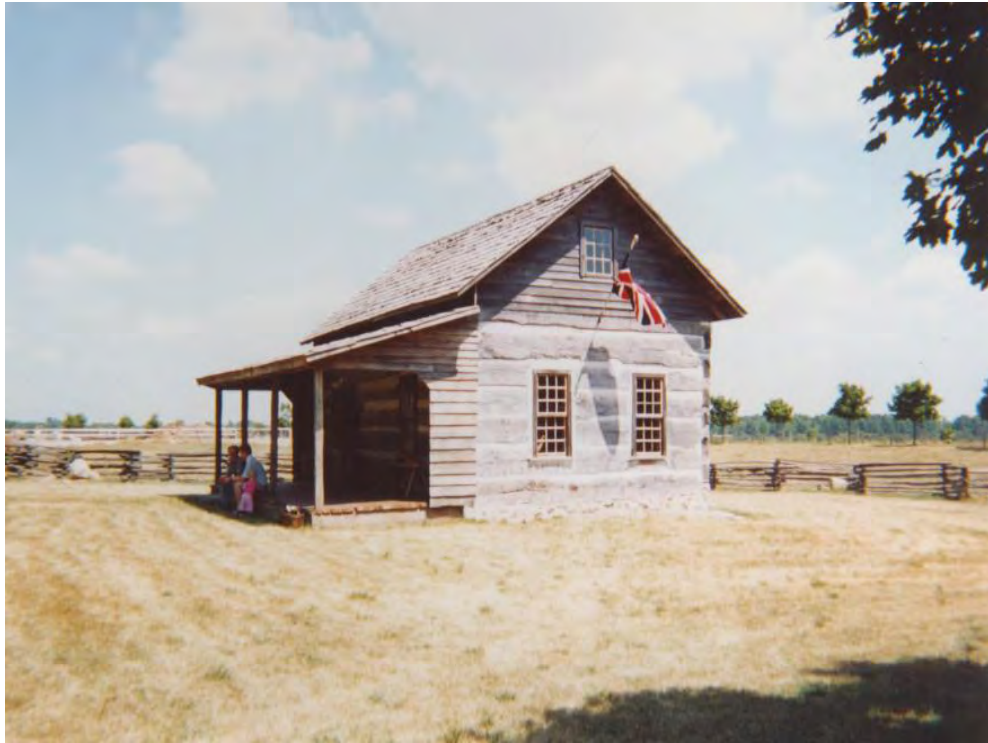
Plate 14: Hoover Log House following the Reconstruction

When the Hoover log home was reassembled on Bill Fletcher's property the original floor boards were reused and the logs from the ground floor were reassembled in the same order, with the original openings for the door and windows maintained. A half storey addition was added to the structure using new materials, along with a new roof, window frames, window panes and door. A porch which was also not original to the home was added on the west side of the structure (B. Fletcher, personal communication December, 2010). Plate 14 shows the state of the log cabin after it was reassembled at its new location in 1998. The only change that has occurred since the reconstruction in 1995 is that the new lumber that was used to rebuild the home has weathered to the same gray as the logs (Plate 9).

- the only original features that have been maintained are the floor and logs from the first storey
- appearance has been greatly altered; original structure was a two storey building and now is a one and a half storey building; addition of porch which was not original to the building; new materials used entirely on half storey addition, roof, window frames, window panes, door and porch addition

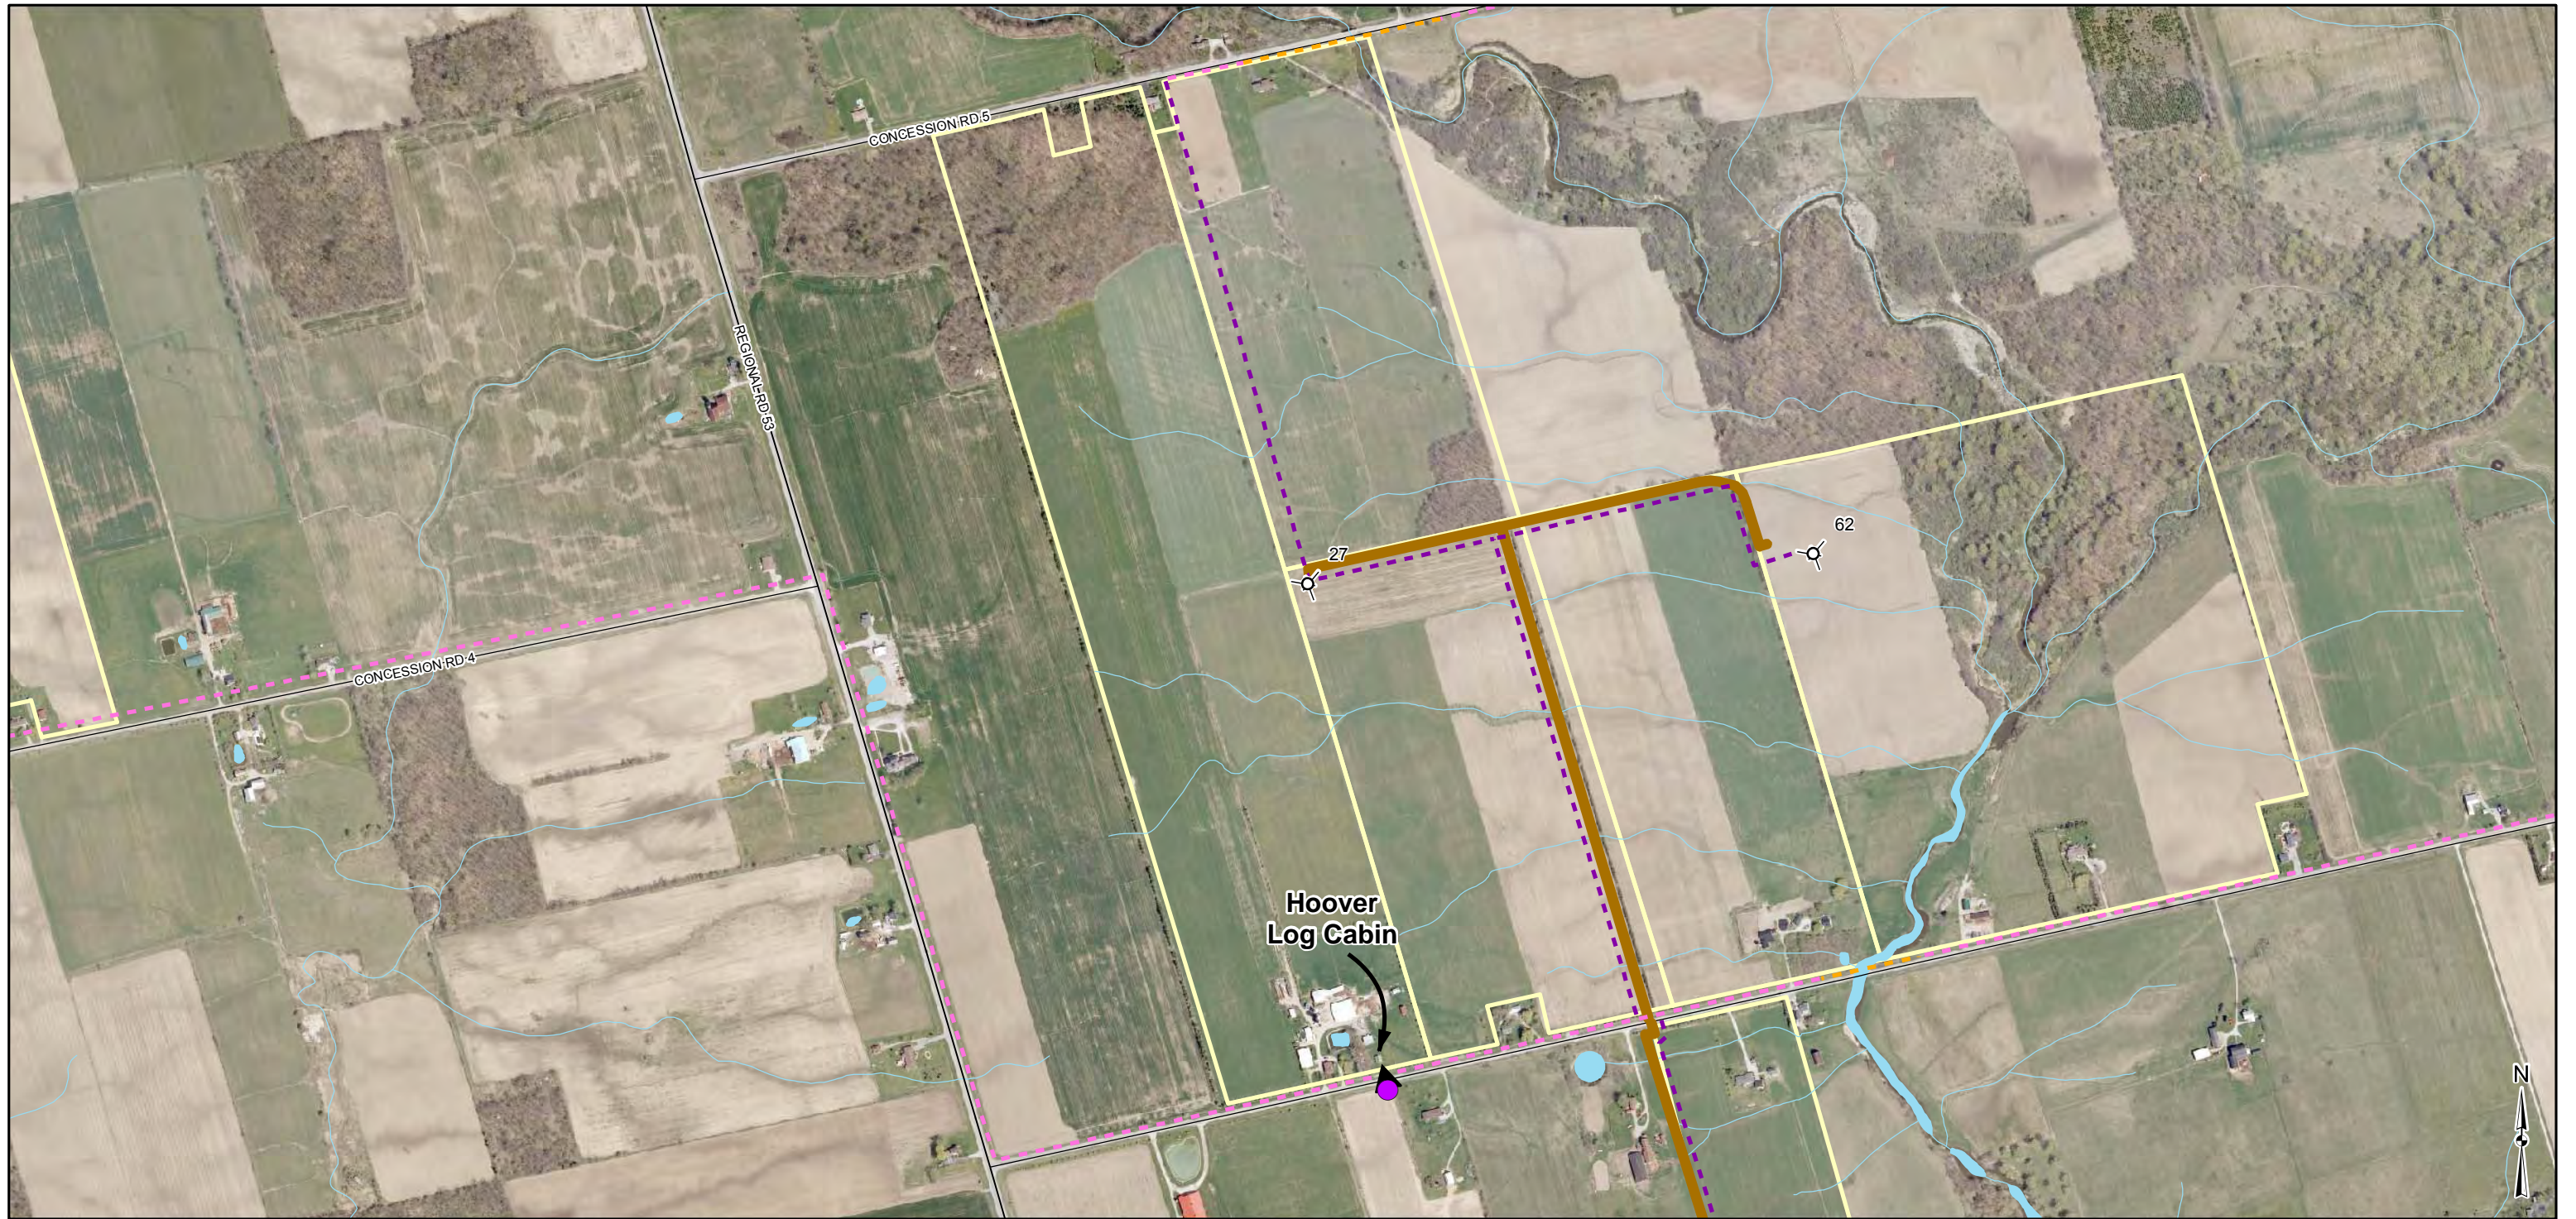
PROJECT		Summerhaven Wind Energy Centre	
TITLE		DETAIL OF PROJECT INFRASTRUCTURE ADJACENT TO THE HOOVER LOG CABIN	
PROJECT NO.	10-1151-0035	SCALE AS SHOWN	REV.
DESIGN	JR 27 Aug. 2010	 Mississauga, Ontario	FIGURE: 7
GIS	BC 22 Nov. 2010		
CHECK	PP 22 Nov. 2010		
REVIEW

Direct Impacts (structure will be physically impacted by an undertaking)	Relevance to the Hoover Log House	Mitigation Measures
	collector cables to be located 358m to the east of the house (Figure 7)	
Alteration - that is not sympathetic, or is incompatible, with the historic fabric or appearance	not applicable: no alterations anticipated	none recommended

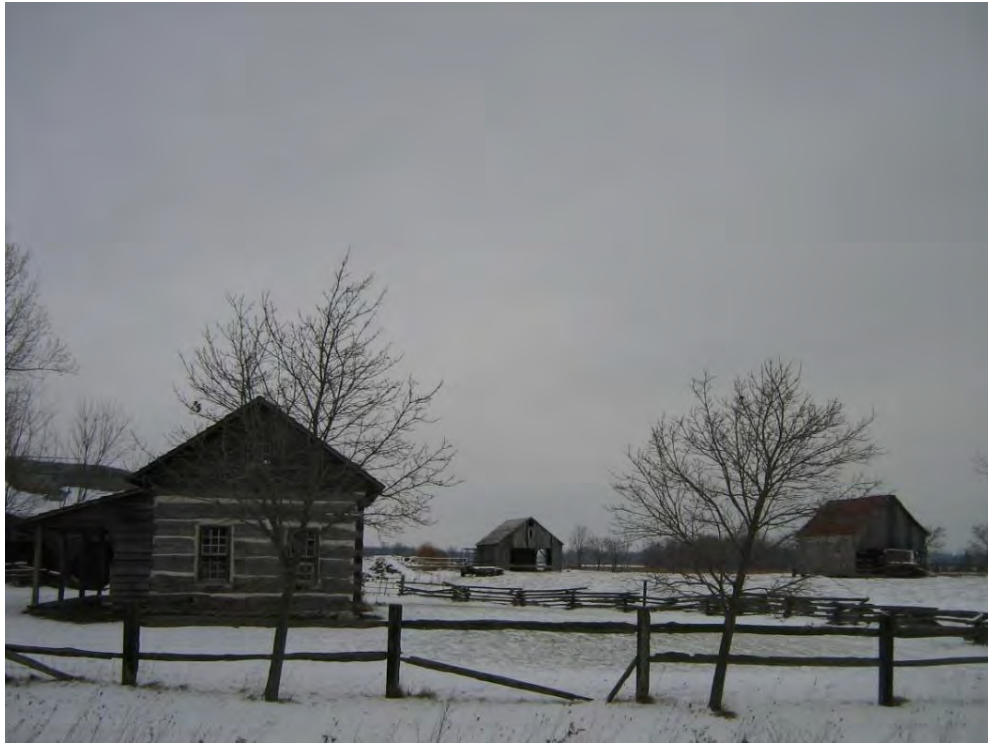
Plate 15: Contemporary View of Hoover Log House from Roadside

Due to the fact that this heritage structure has been moved from its original location, and is now situated in a completely different landscape setting (surrounded by a nineteenth century farmhouse and a combination of nineteenth and twentieth century farm out buildings) than was intended when it was built, it is the opinion of Golder that the view of the cabin from a close proximity, or from the immediate roadside is the only view of significance. The log house has local historical significance, so minimizing the visual impact for visitors to the site is what has been determined to be of importance. Therefore, due to the fact that the Hoover log house is no longer located in its original context, mitigation measures are recommended to minimize the visual impact of Turbine 27 to the log house only as seen from a close proximity (ie. the adjacent roadside).

It is recommended that a hedgerow of coniferous trees (in order to provide year round screening) be planted behind and to the east of the Hoover log cabin in order to mitigate the visual impact of Turbine 27 in the background and retain an appropriate setting for the building. These trees should be approximately 10m high, with smaller saplings interspersed to provide for future mitigation. The hedgerow should be planted approximately 10m directly behind the log house and extending to the east in order to provide maximum coverage (see Plate 18). Plate 15 shows the contemporary view of the Hoover log house, taken from the roadside looking in the immediate direction of the proposed location of Turbine 27 (Figure 7). Plate 16 has been modified using GIS techniques in order to place the turbine behind the log house at the exact location where it is proposed to be situated. Plate 17 illustrates with exact proportions how a hedgerow of coniferous trees located to the east of the log house would help to screen the visual impact of the proposed turbine. The trees that have been added to Plate 17 are 10m high. Finally, Plate 18 shows an aerial view of the log house and surrounding area and indicates where the recommended hedgerow should be planted in order to provide maximum screening from the proposed Turbine 27. This recommended mitigation would have to be agreed upon with the property owner and owner of the Hoover log house, Mr. Bill Fletcher (or current owner at the time of project construction).
