Flat Creek Solar

94-C Exhibit 8

**Visual Impacts Minimization and  
Mitigation Plan (VIMMP)**

**PLAN 7A - LANDSCAPE PLAN**

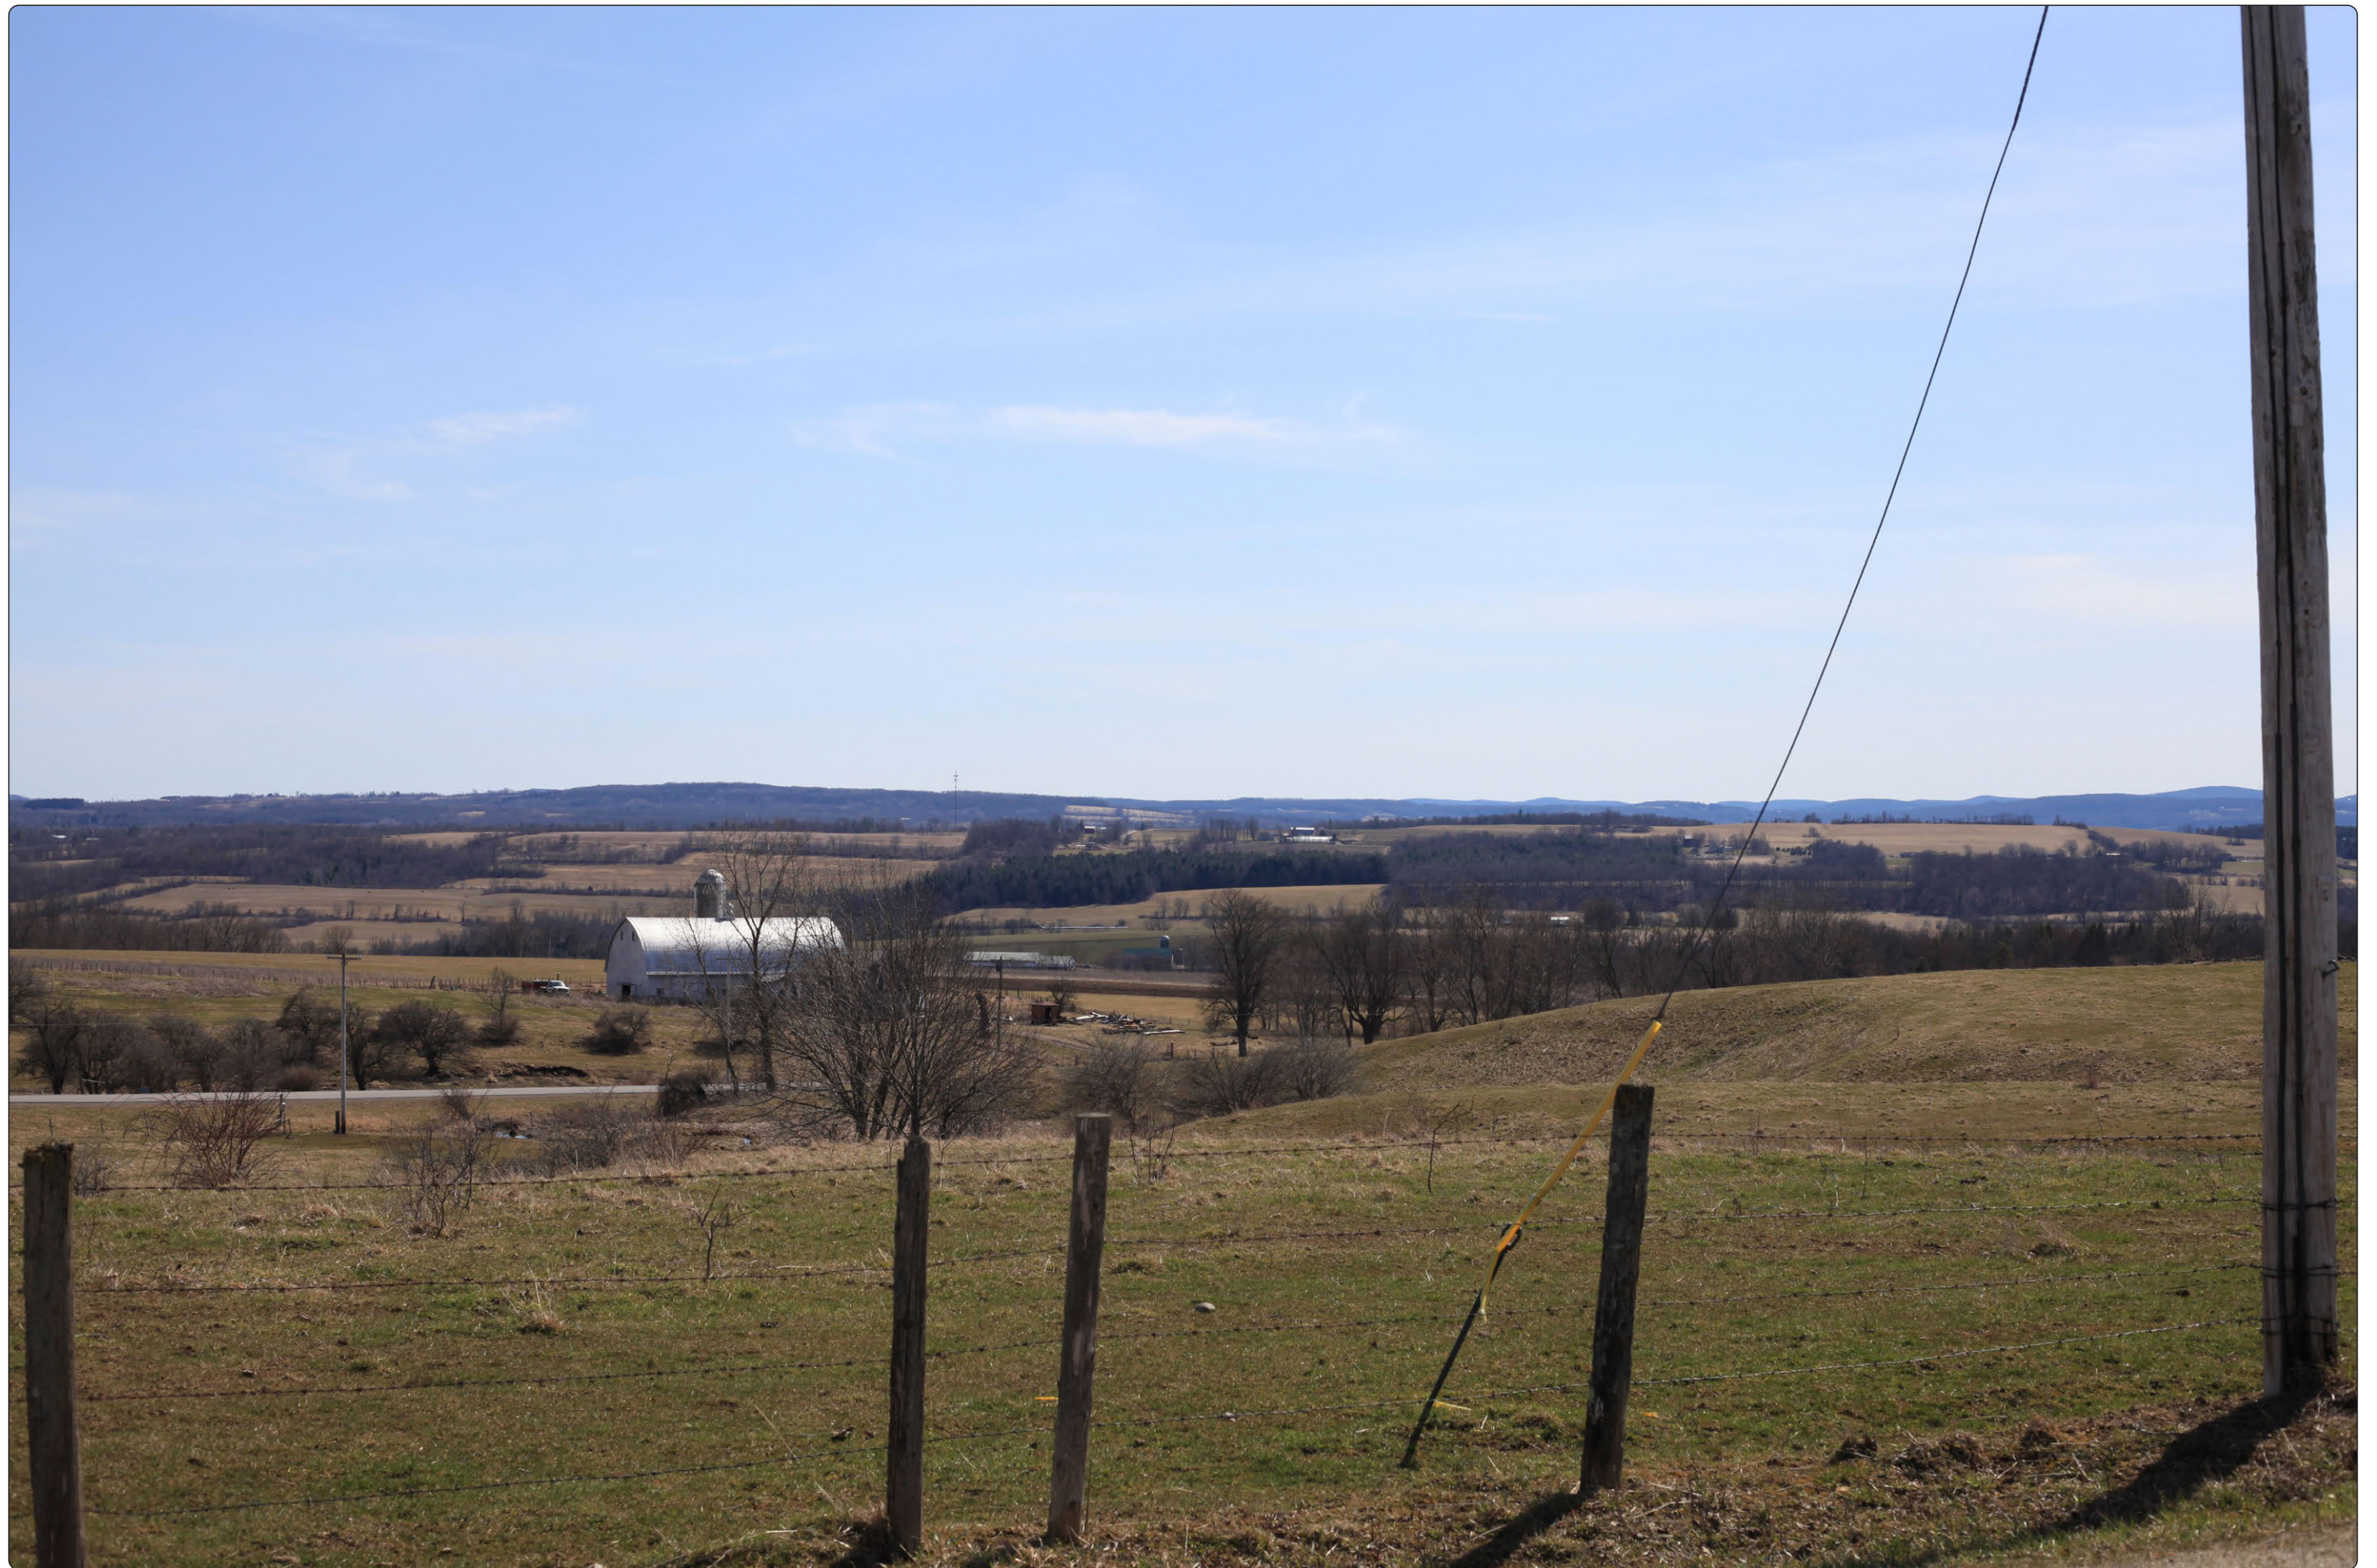
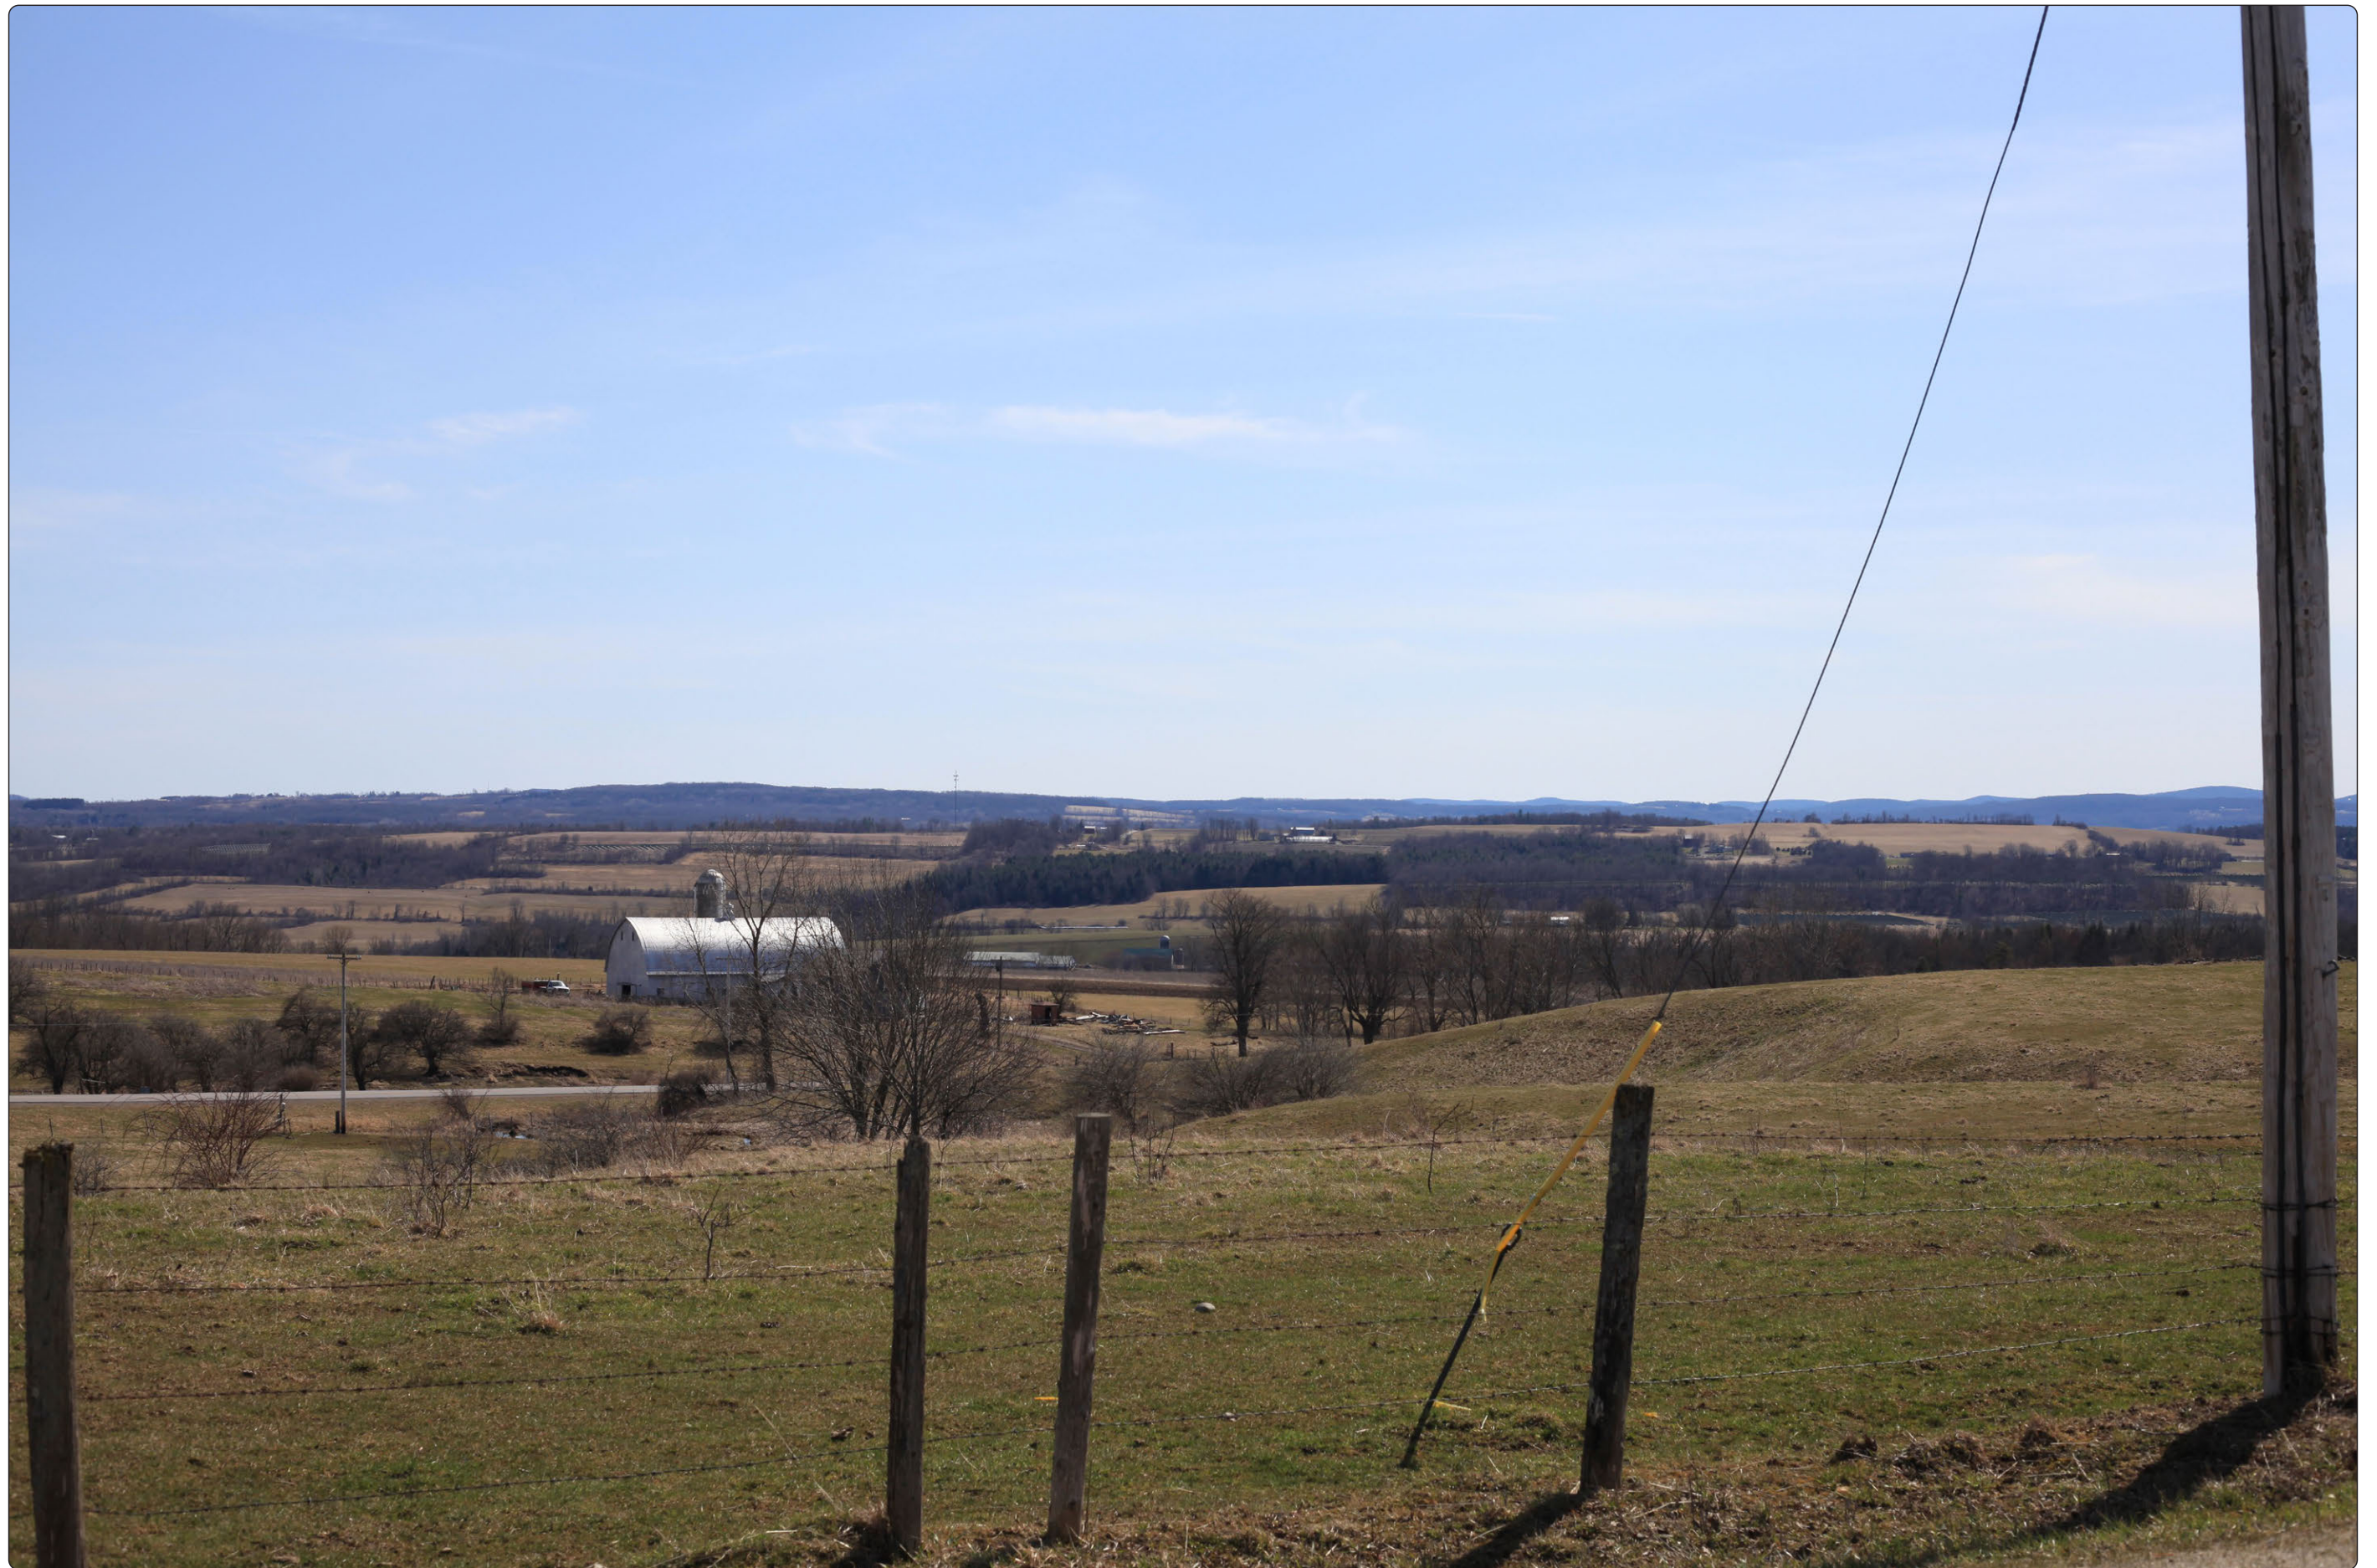
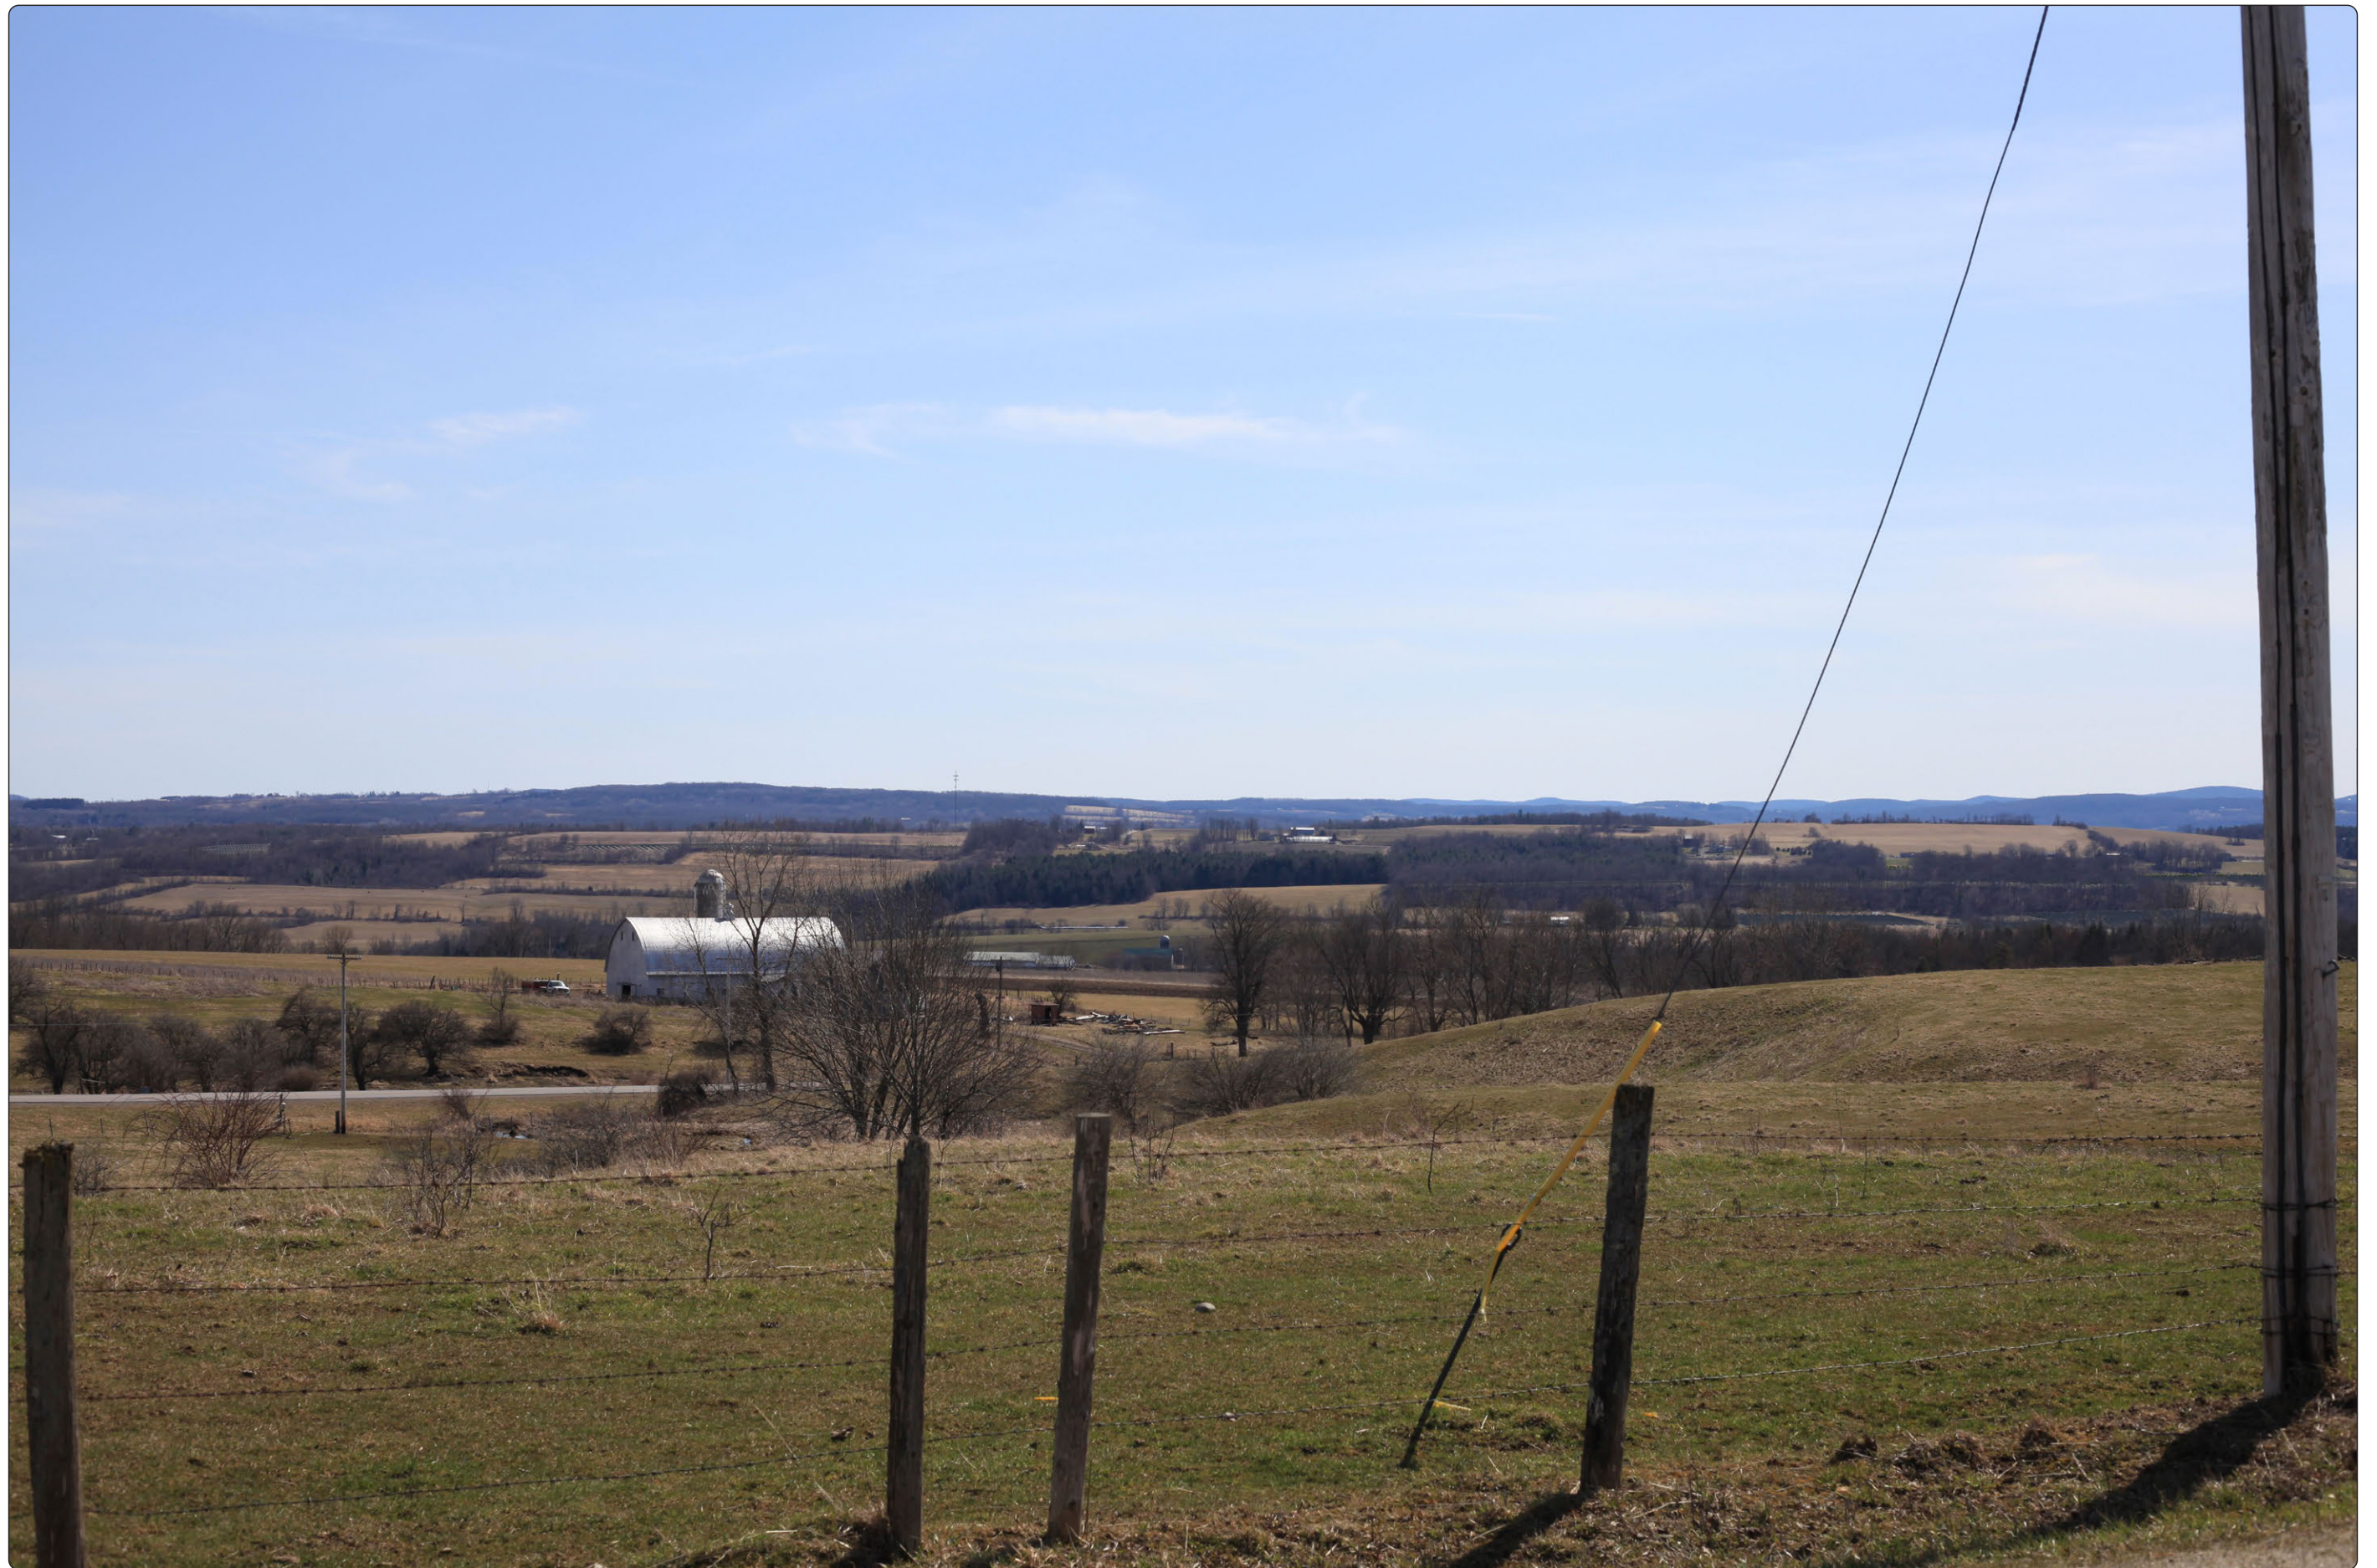
VP83 - Canajoharie Senior High School Athletic Fields

Existing Conditions

Viewpoint Coordinates	42.89532, -74.55792
Town	Canajoharie
Landscape Similarity Zone	3,4
Distance to Project	570 Feet
Direction of View	Southeast
Lens Focal Length	32 mm Equivalent
Date/Time of Photo	4/9/2024, 10:23 AM
Comments	Representative vantage point from Canajoharie Senior High School Athletic Fields, intermittent high-use area. Location was recommended by ORES and Town of Canajoharie during stakeholder outreach and a meeting with the Town of Canajoharie and Applicant.

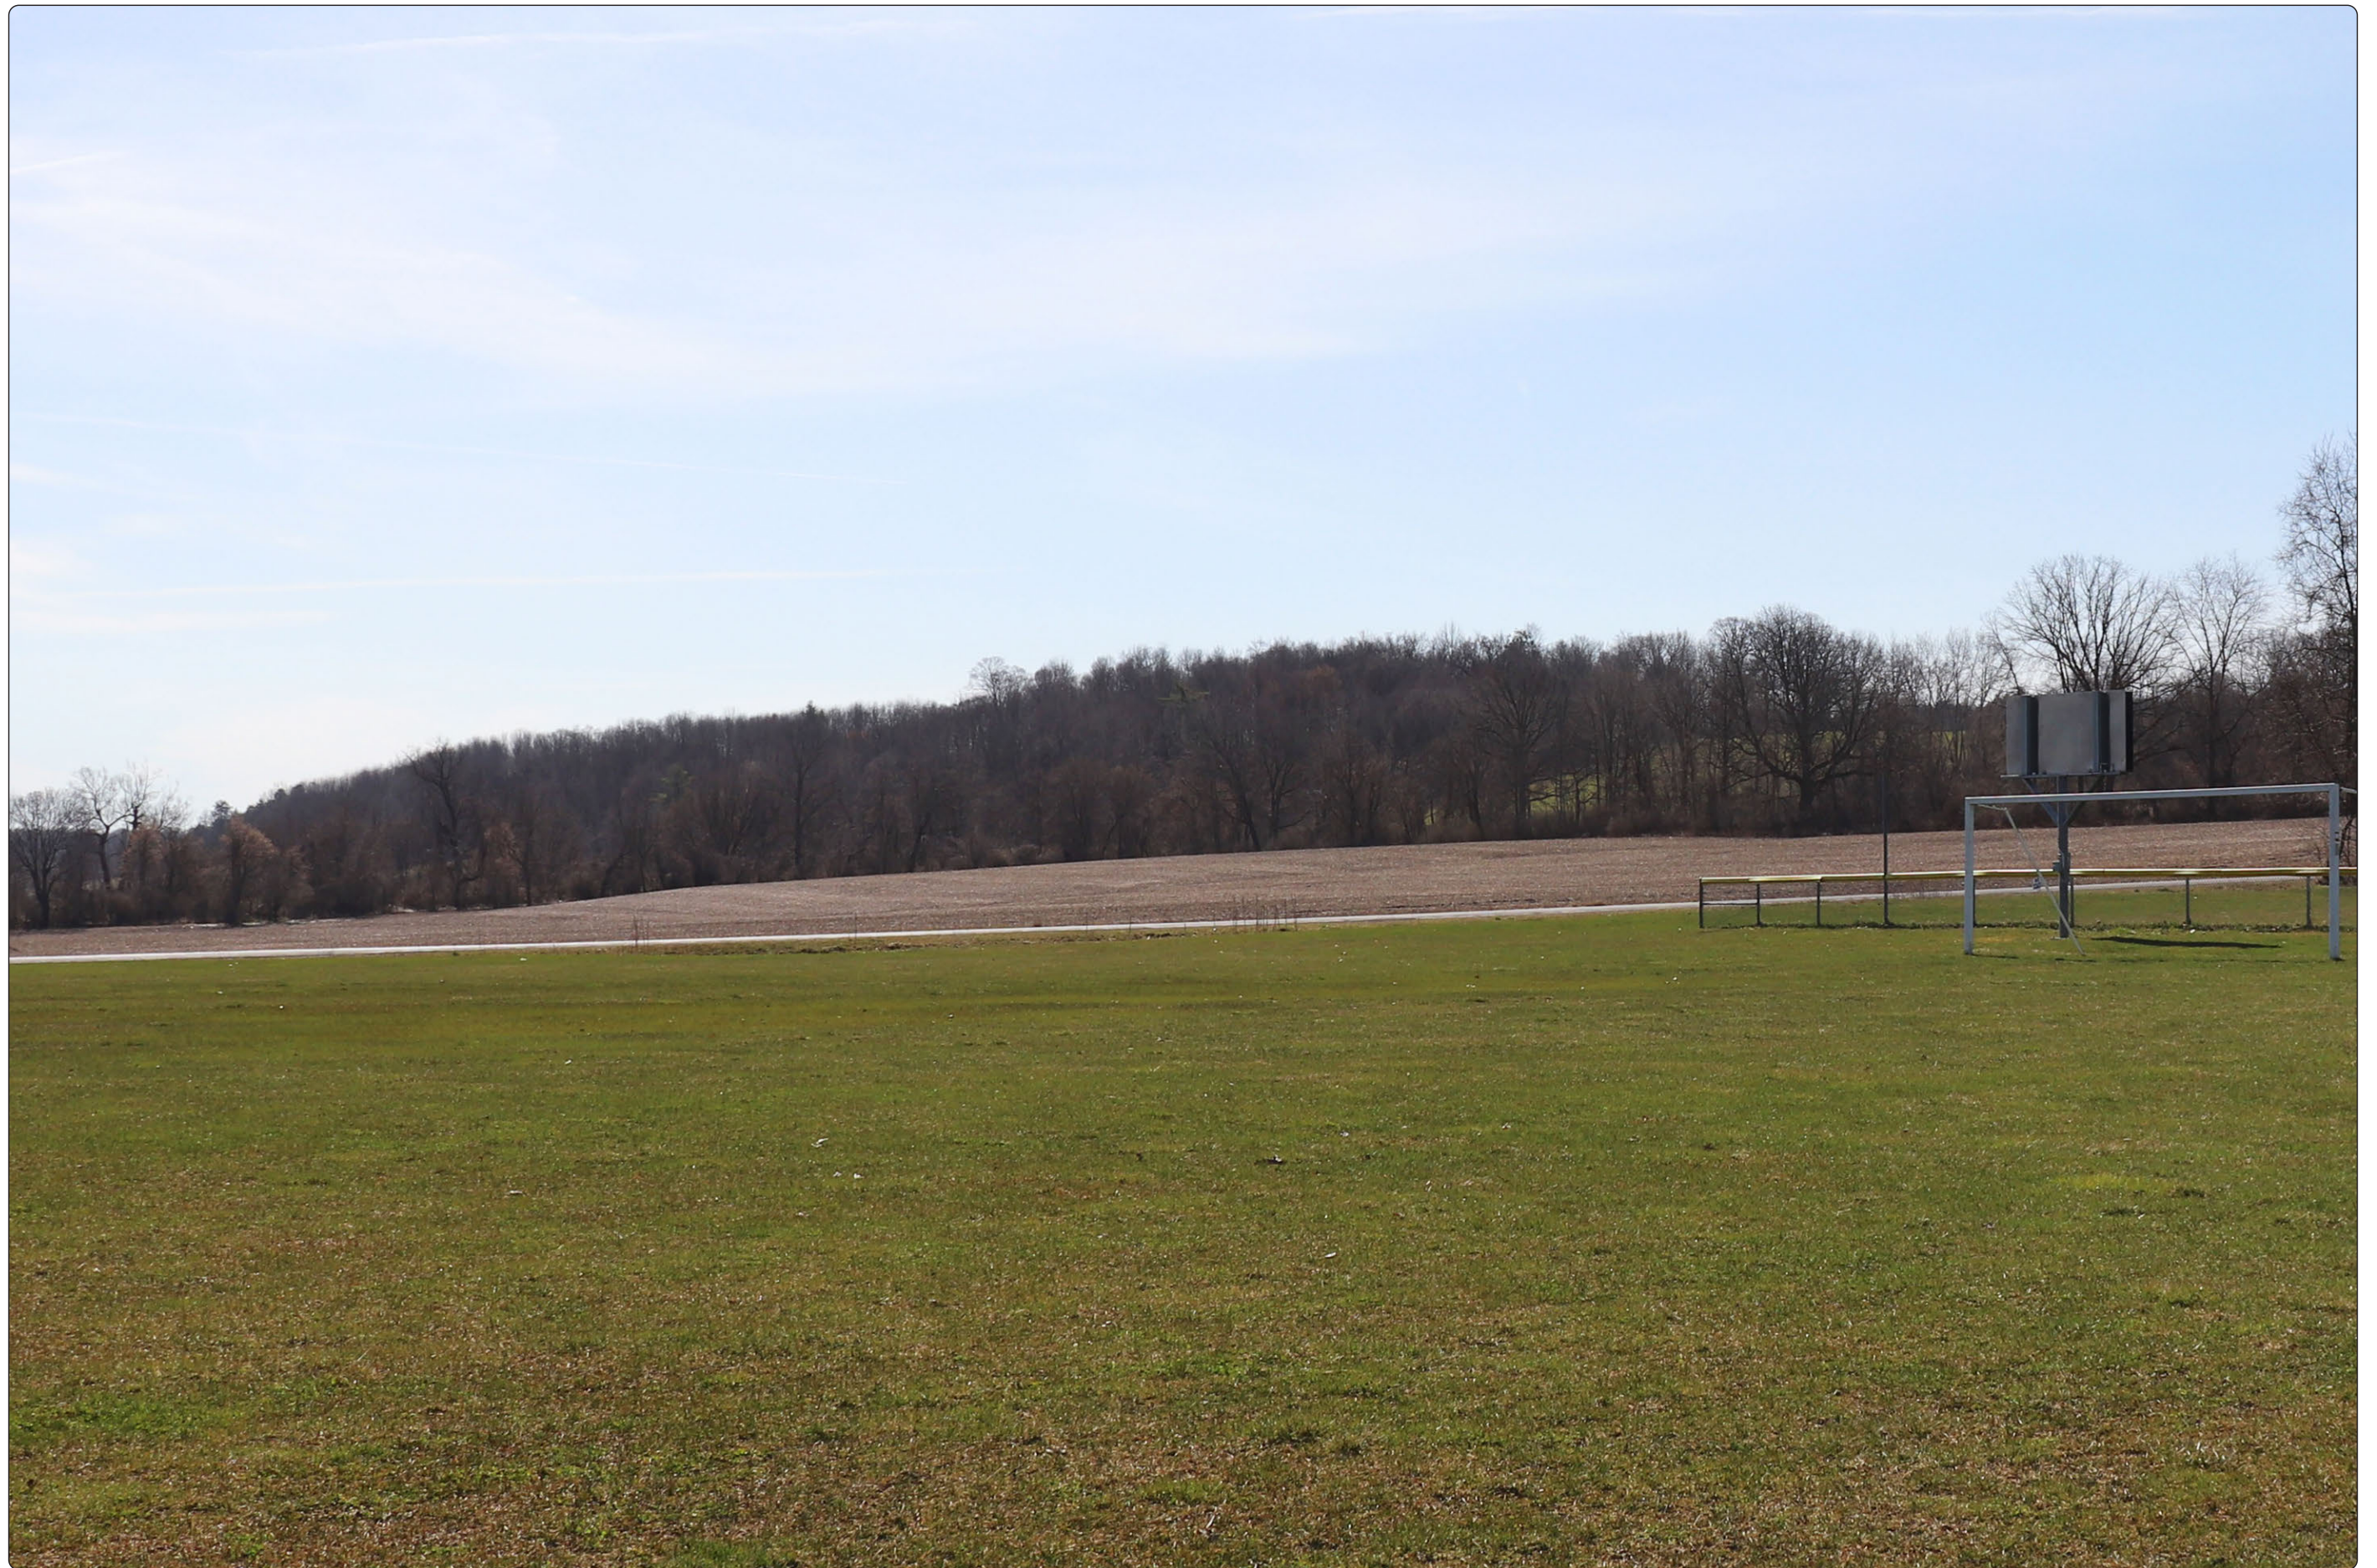
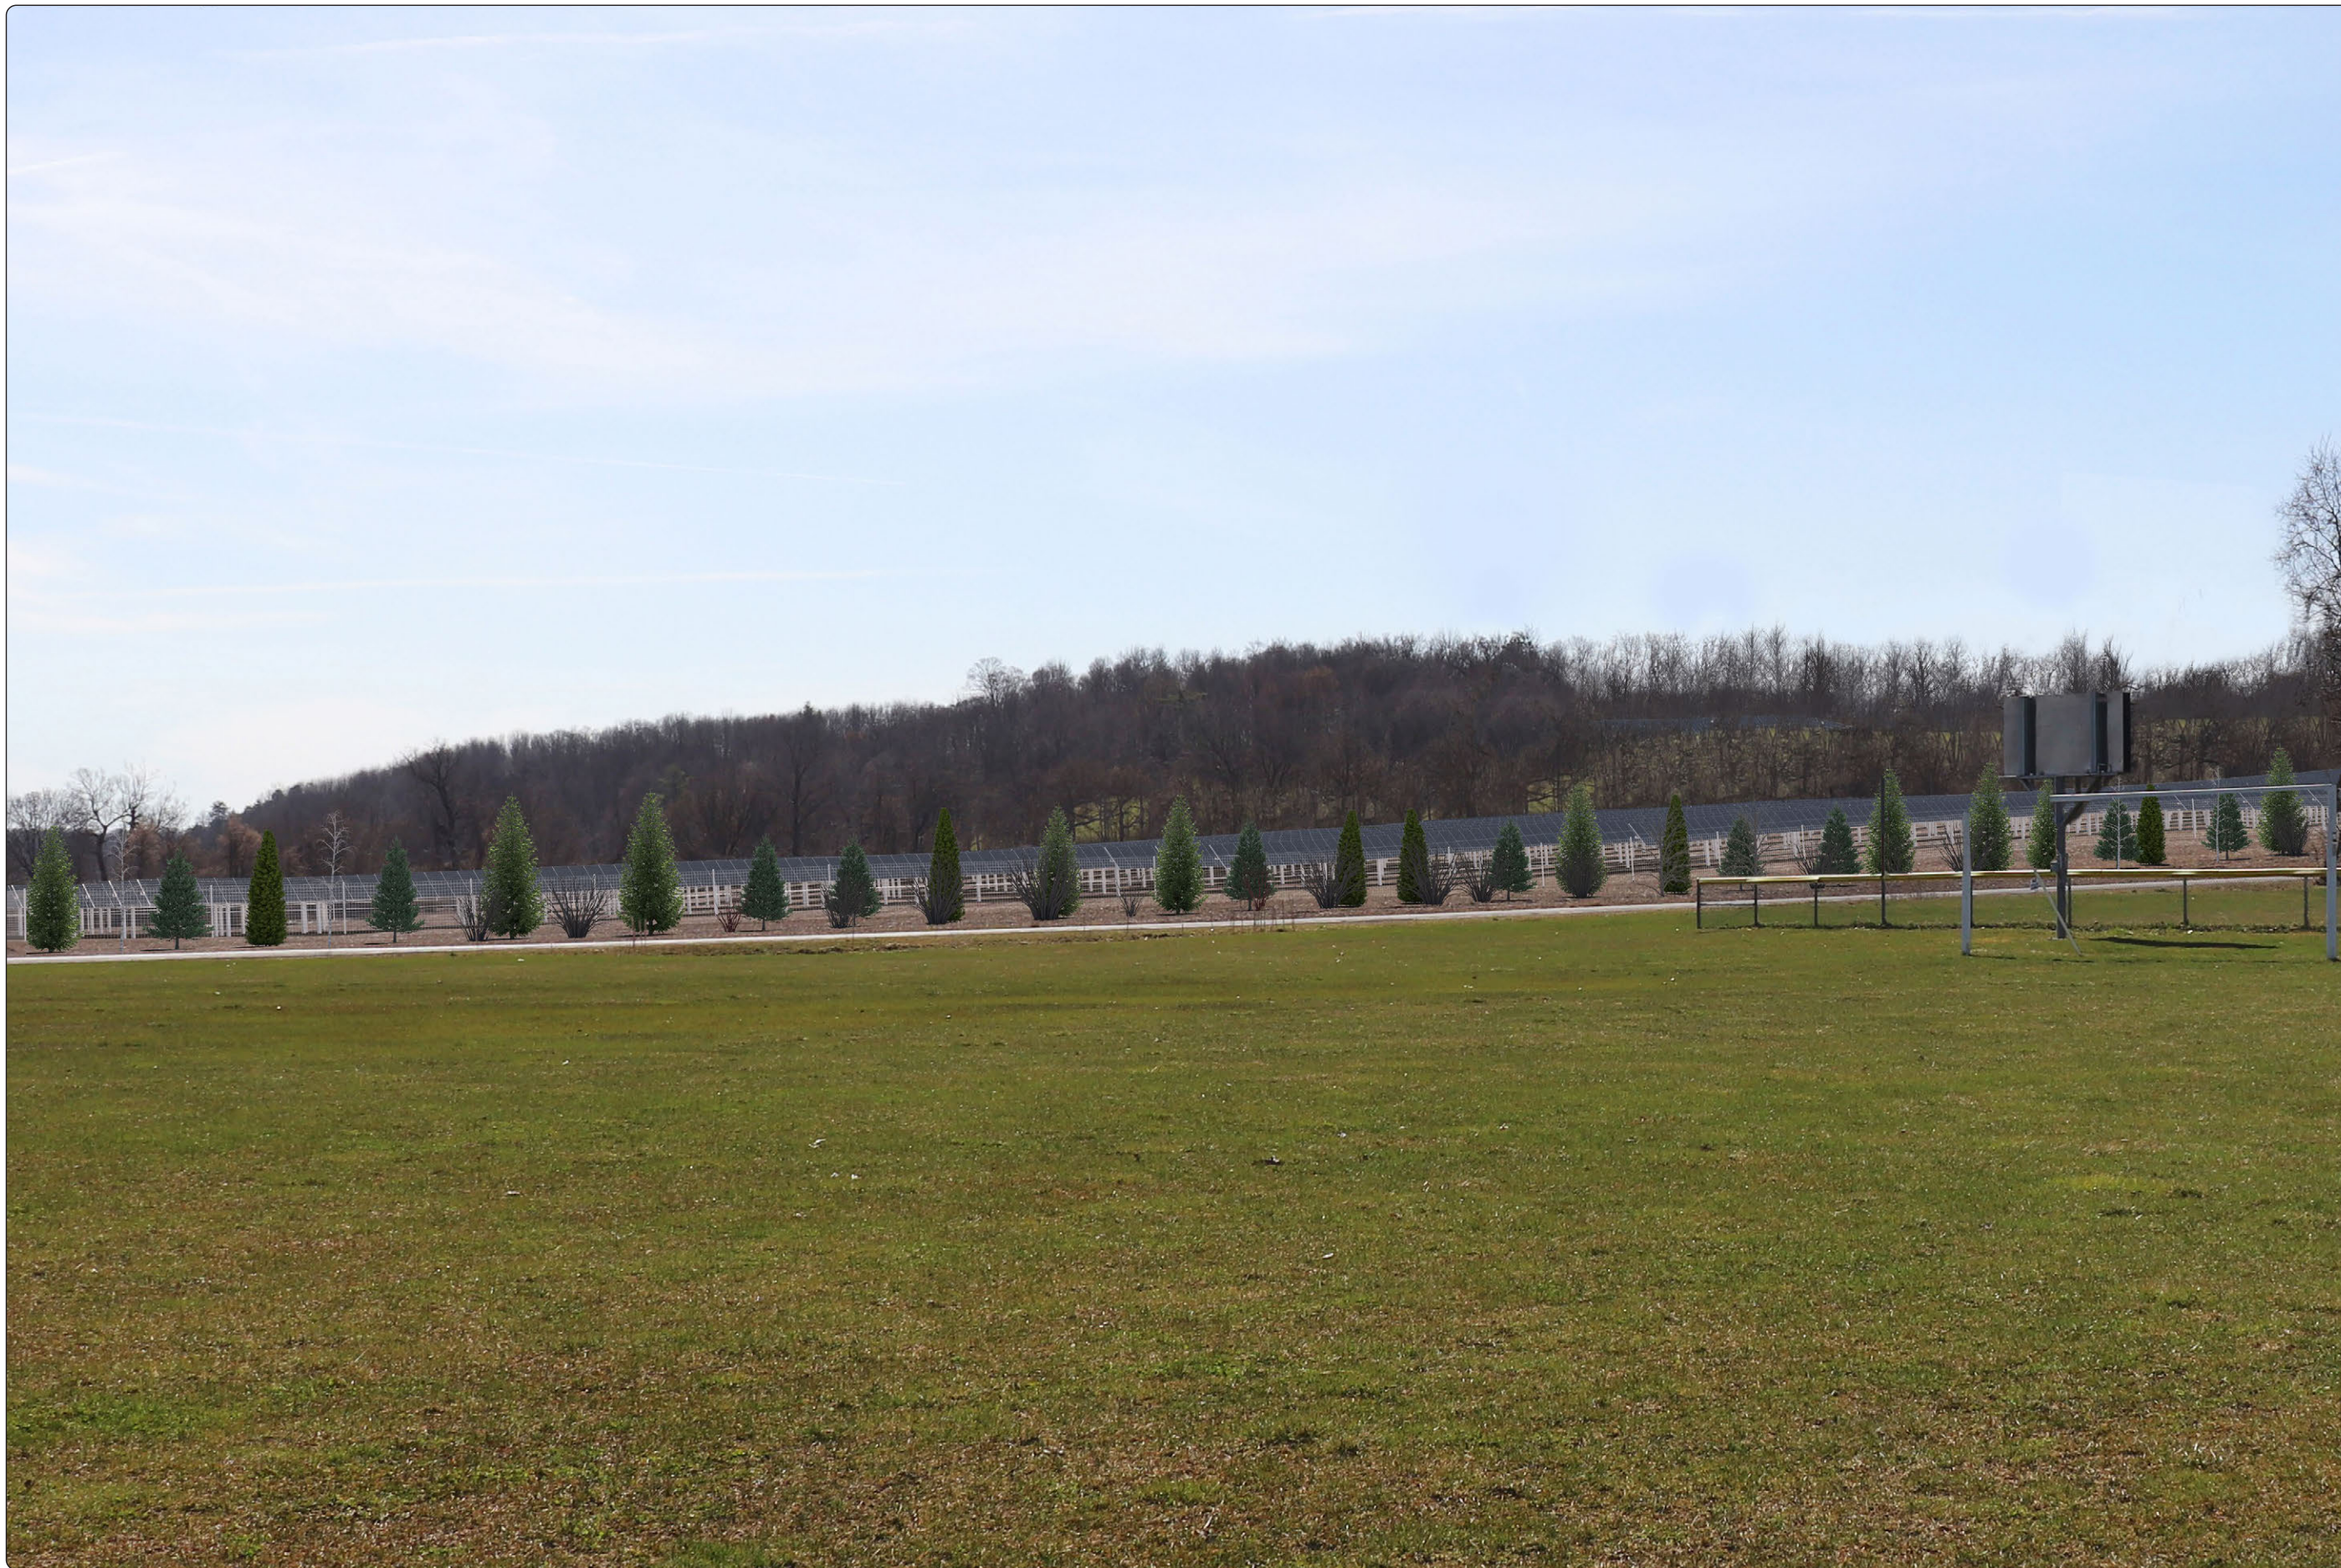
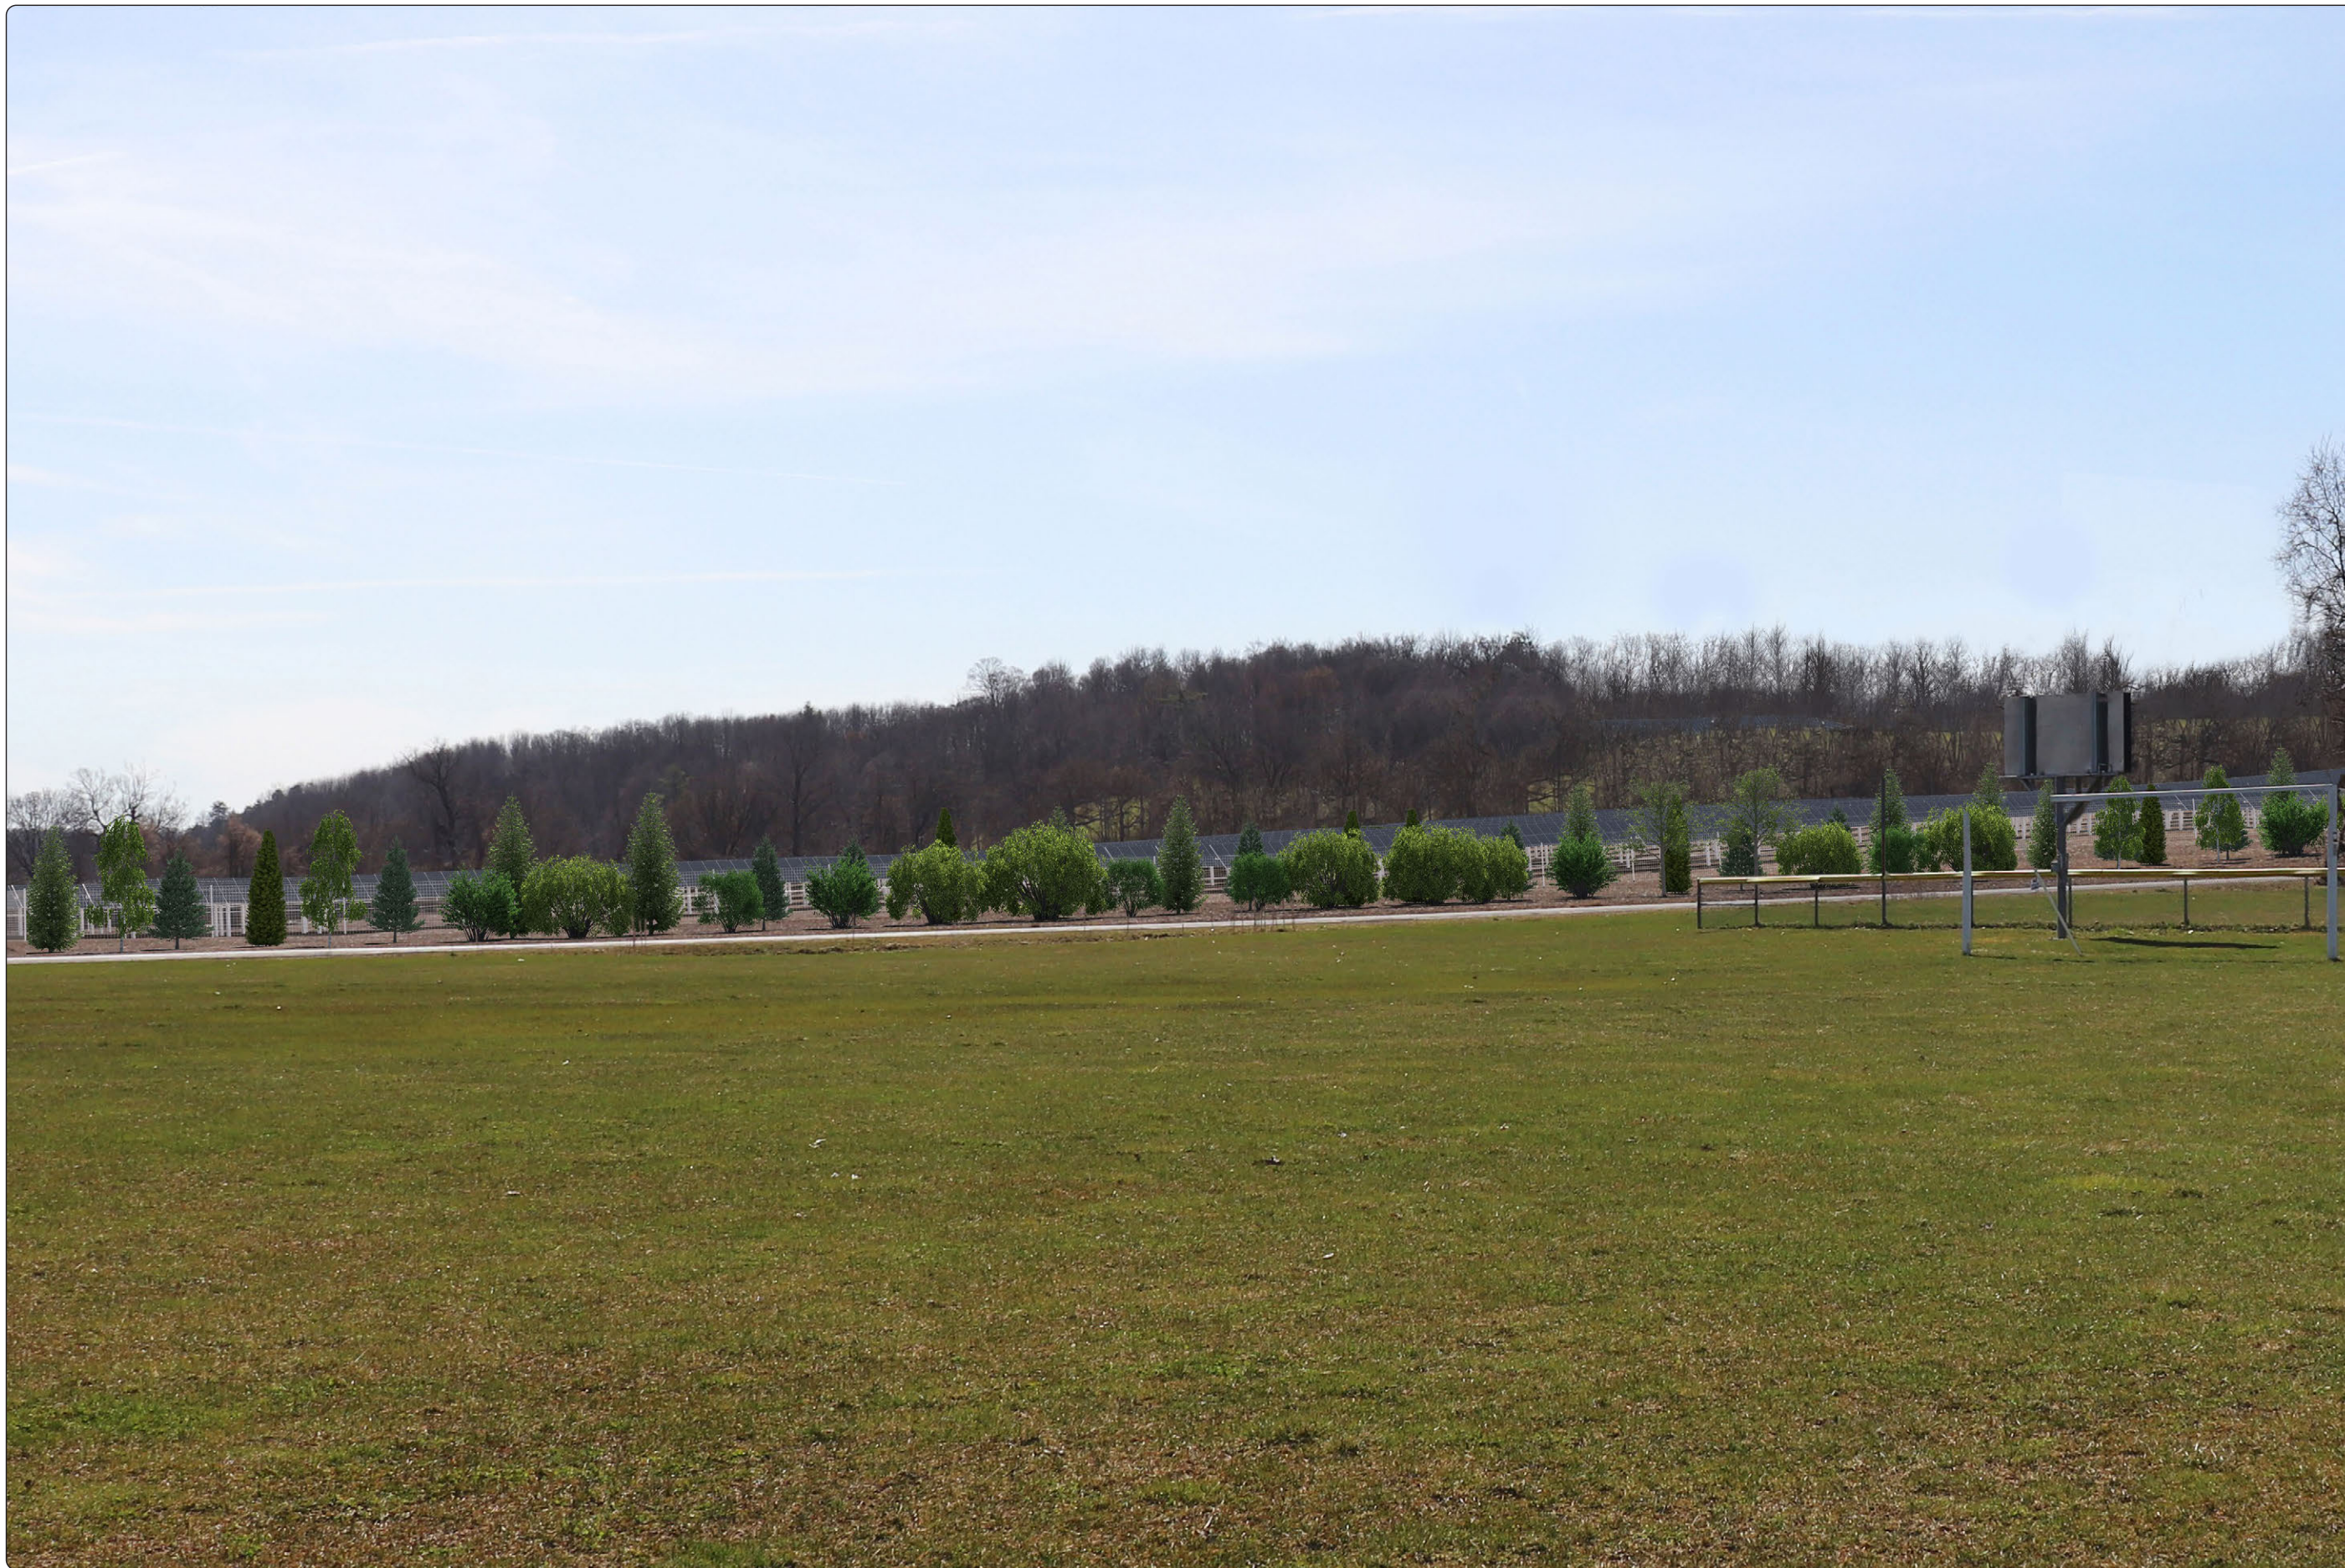
VP85 - Canajoharie Senior High School Athletic Fields

Existing Conditions

Viewpoint Coordinates	42.895746, -74.561037
Town	Canajoharie
Landscape Similarity Zone	3,4
Distance to Project	.26 Miles
Direction of View	Northeast
Lens Focal Length	32 mm Equivalent
Date/Time of Photo	4/9/2024, 10:38 AM
Comments	Representative vantage point from Canajoharie Senior High School Athletic Fields, intermittent high-use area. Location was recommended by Town of Canajoharie during a meeting with the Applicant.
