Flat Creek Solar

94-C Exhibit 8

**Visual Impacts Minimization and  
Mitigation Plan (VIMMP)**

**PLAN 7A - LANDSCAPE PLAN**

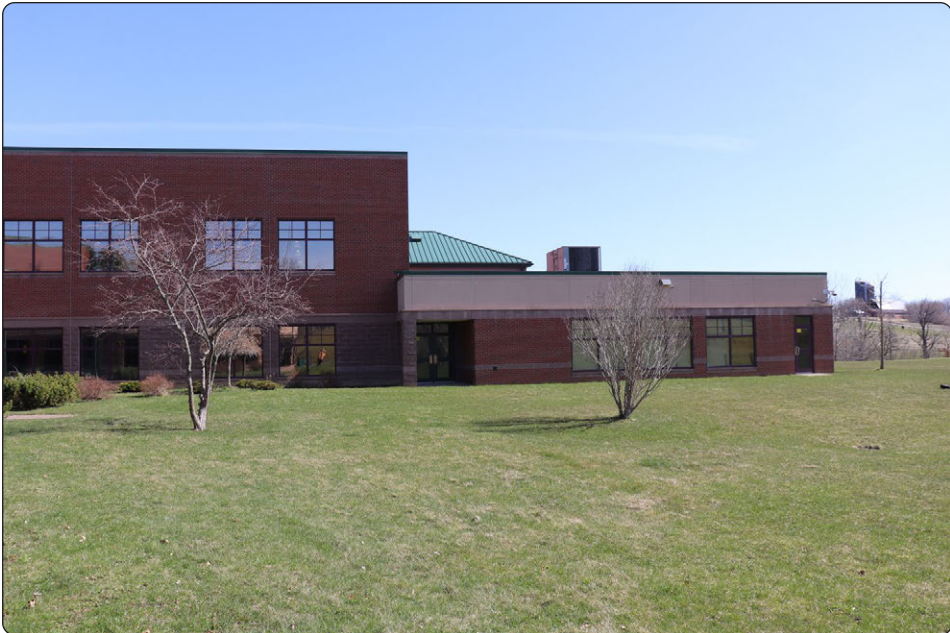
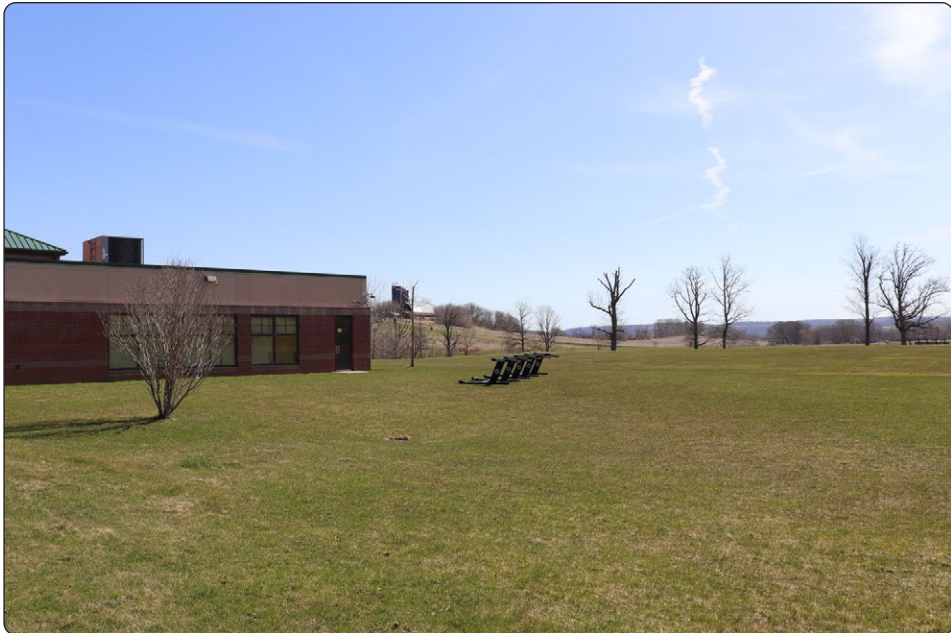
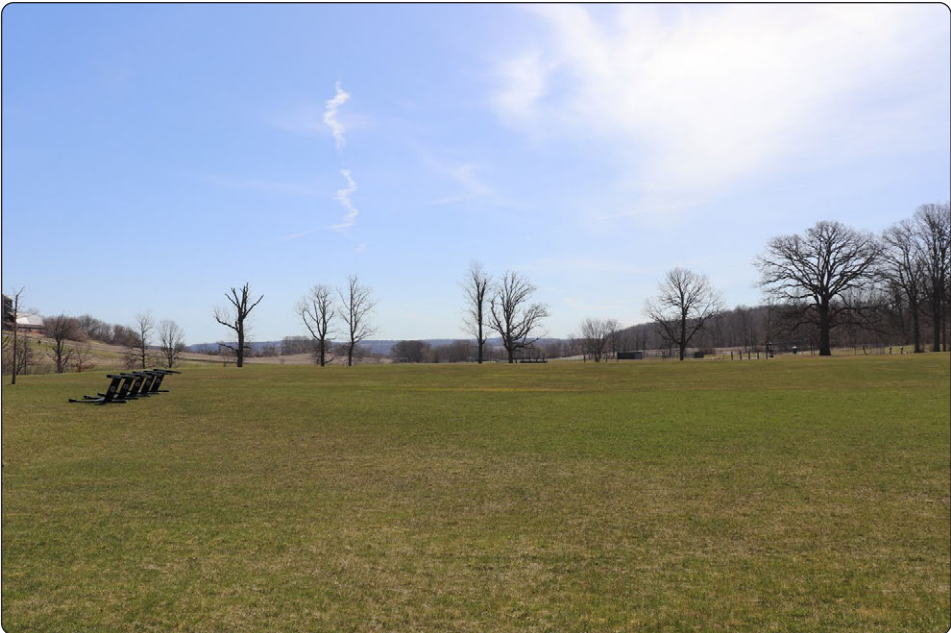
VP85 - Canajoharie Senior High School Athletic Fields

Existing Conditions

Viewpoint Coordinates	42.895746, -74.561037
Town	Canajoharie
Landscape Similarity Zone	3,4
Distance to Project	.26 Miles
Direction of View	Northeast
Lens Focal Length	32 mm Equivalent
Date/Time of Photo	4/9/2024, 10:38 AM
Comments	Representative vantage point from Canajoharie Senior High School Athletic Fields, intermittent high-use area. Location was recommended by Town of Canajoharie during a meeting with the Applicant.

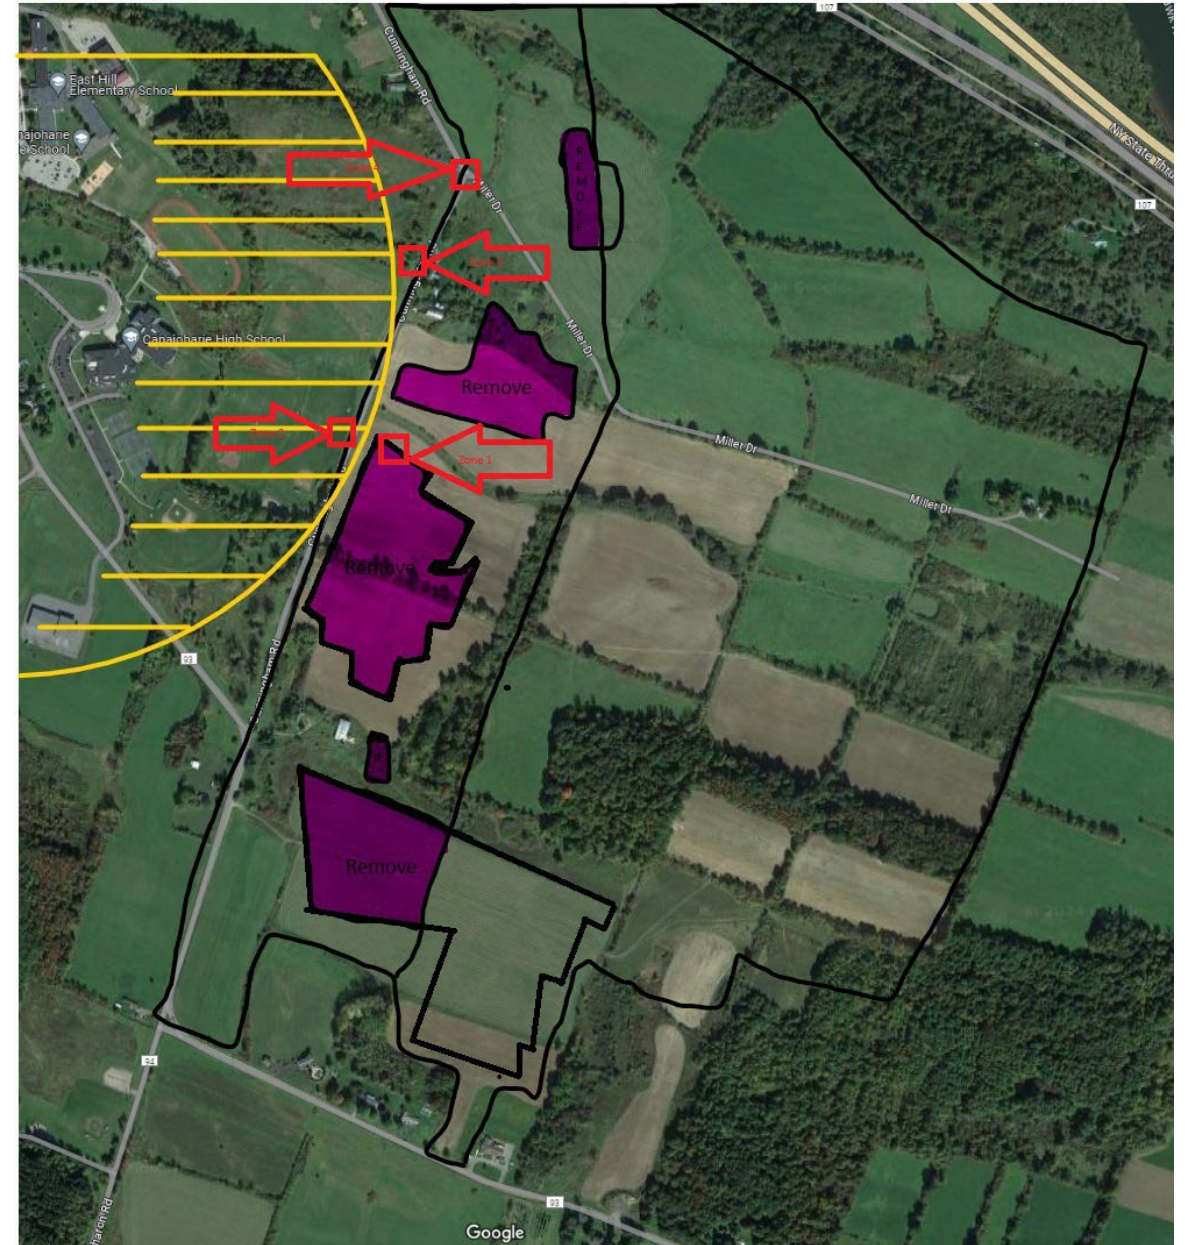
- Upon review of Visual Assessment, it has been found that only 1 potential development location will have a major visual impact. Location of concern is on Cunningham Road and Carlisle Road (Zones 1, 2, 3 and 4).
- Impact is severe to the east from the Canajoharie School athletic fields; panel location will be within 300 feet of field and panels will be facing westward during athletic events.
- Impact is severe northward from Carlisle Road/Old Sharon as proposed developed area is open and on down slope from roads and homes
- Zone 4 Impact is Severe across from Miller Road, but not as critical as 1, 2, 3
- There are significant potential noise and construction impacts based on the design shown on the plans.

Proposed Development areas 1, 2, 3, 4 and 5 are areas of concern, shown in image in this slide highlighted with fuchsia, they have been noted with "Remove". Images have been taken from area 1, 2, 3 and 4 showing impact.

Zone 3 – Image set taken from documented location that Cordelio/Suneast noted as to where they took their images, they will fall in line with impacted view in Zones 1 and 2

Zone 4 – Image set taken from documented location that Cordelio/Suneast noted as to where they took their images. Impact will be from North and West visually. Traffic will be high during construction.

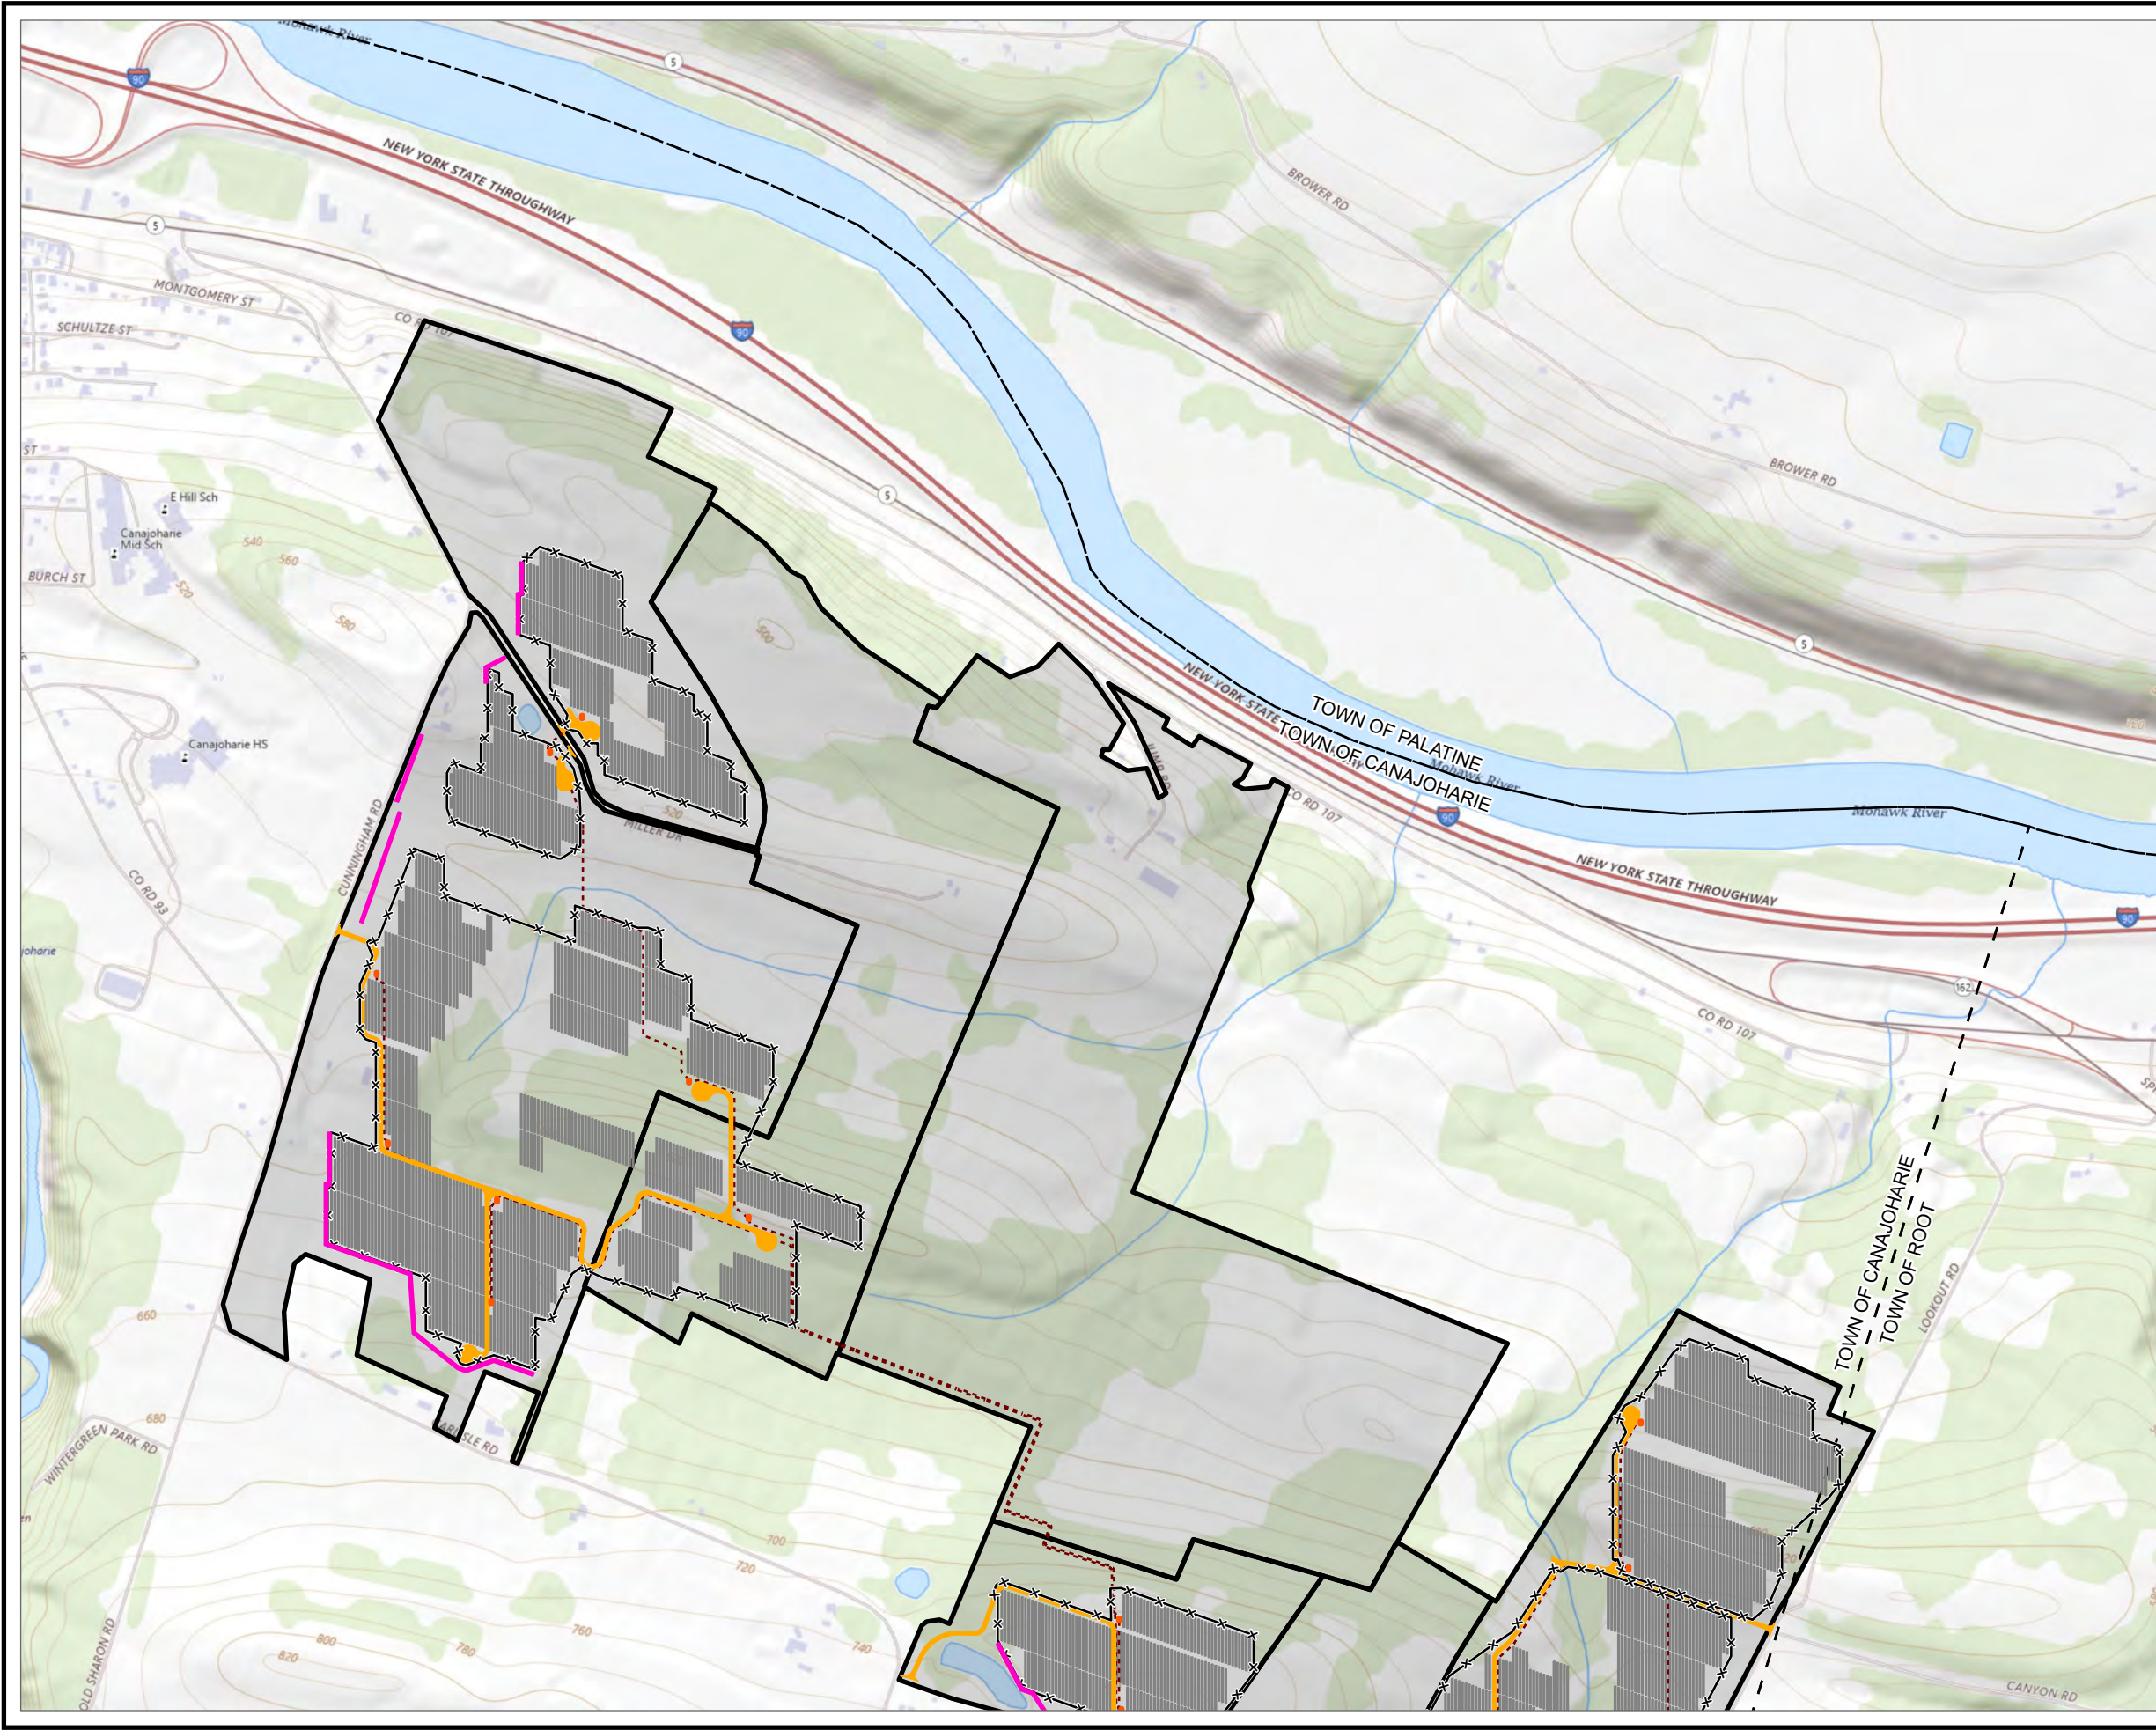
PROJECT:		FLAT CREEK SOLAR TOWNS OF CANAJOHARIE AND ROOT MONTGOMERY COUNTY, NY	
TITLE:		MAP OF THE PROPOSED LANDSCAPE PLAN	
DRAWN BY:	R. BARBER	PROJ. NO.:	427281.2022.0000
CHECKED BY:	G. CORYELL	SHEET 1 OF 5	
APPROVED BY:	S. KRANES		
DATE:	AUGUST 2024
