Project/Site: Flat Creek Solar Pro	oject	City/County: Spra	kers, Montgomery County	/	Sampling Date: 202	21-Sept-08
Applicant/Owner: SunEast			State: NY		Sampling Point: W-JM	IP-14_PUB-1
Investigator(s): Jerry Peake, Ca	rson Rowe, Abi Lig	ght	Section, Township,	, Range: NA	Α	
Landform (hillslope, terrace, etc.)): Depression		 Local relief (concave, conv	vex, none):	None	Slope (%): 1 to 3
Subregion (LRR or MLRA):L	.RR L	·	Lat: 42.854913057	73 Long:	-74.5112568359	Datum: WGS84
Soil Map Unit Name: Fonda m	ucky silty clay loar	n, Fo	_		NWI classification	n: None
Are climatic/hydrologic condition	s on the site typica	al for this time of yea	ar? Yes No)(If no	o, explain in Remarks.)	
Are Vegetation, Soil,	or Hydrology ₋	significantly dis	turbed? Are "Norm	al Circumst	tances" present?	Yes No
Are Vegetation, Soil,	or Hydrology ₋	naturally proble	ematic? (If needed,	, explain an	y answers in Remarks.	.)
SUMMARY OF FINDINGS – A	Attach site map	showing samplin	ng point locations, tra	nsects, im	portant features, e	etc.

Project/Site: Flat Creek Solar Pr	oject		City/County: Spra	kers, Montgomery County	Sampling Date:	2021-Sept-08
Applicant/Owner: SunEast				State: NY	Sampling Point:	W-JMP-14_UP

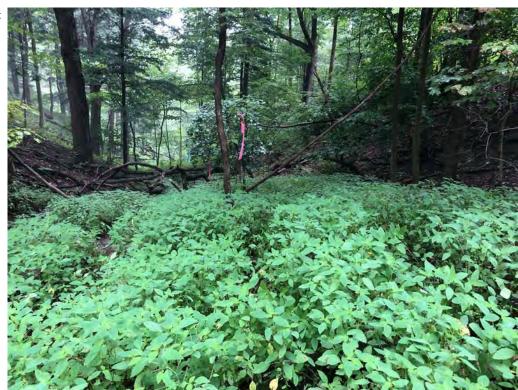
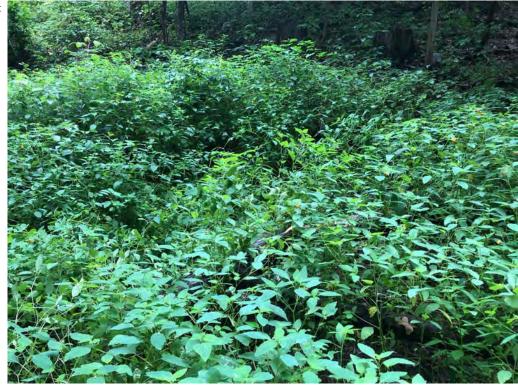
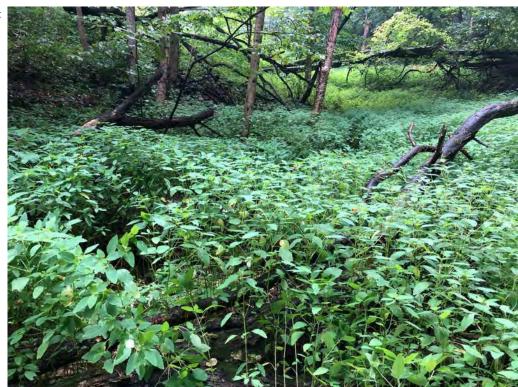
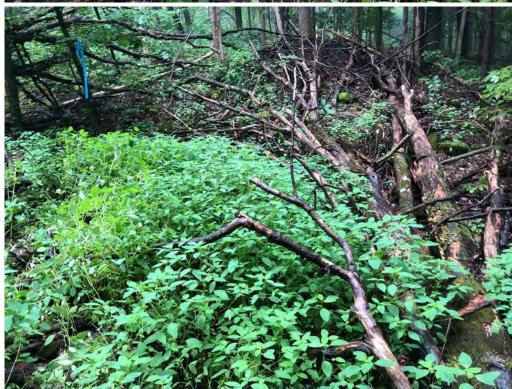
Photo of Sample Plot North

Photo of Sample Plot East

Photo of Sample Plot South

Photo of Sample Plot West

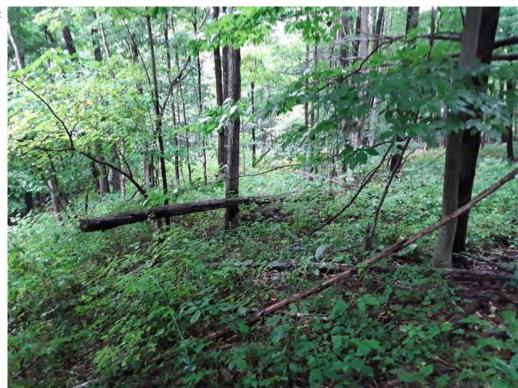
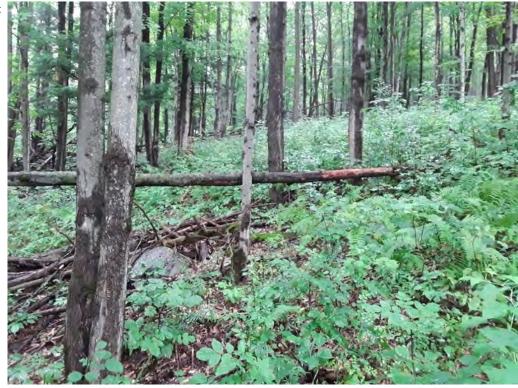
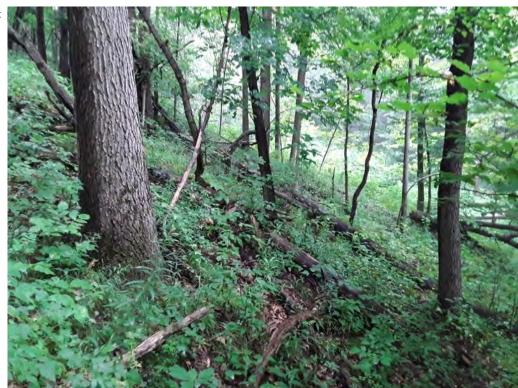
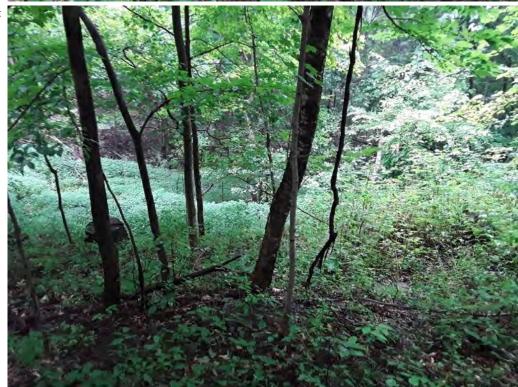
-	Redox (S5)							•	(TA6) (MLRA 144A, 145, 149B)
-	ed Matrix (S6)							Red Parent M	
	urface (S7) (LRR R, N	ΛΙ DΔ 1./	QR)					•	Dark Surface (TF12)
Daik 3	urrace (37) (EKK K, K	ILIXA 14	3 6)					Other (Explai	n in Remarks)
3Indicators	of hydrophytic veg	etation	and wetland hydro	ology	/ must b	e preser	t, unless disturbe	ed or problematic.	
Restrictive	Layer (if observed):								
	Type:		None			Hydric	Soil Present?		Yes No/_
	Depth (inches):		_						
Remarks:									
No positive	e indication of hydri	ic soils v	vas observed. The	crite	rion for	hydric s	oil is not met. Ref	usal due to coarse	fragments.

Photo of Sample Plot North

Photo of Sample Plot East

Photo of Sample Plot South

Photo of Sample Plot West

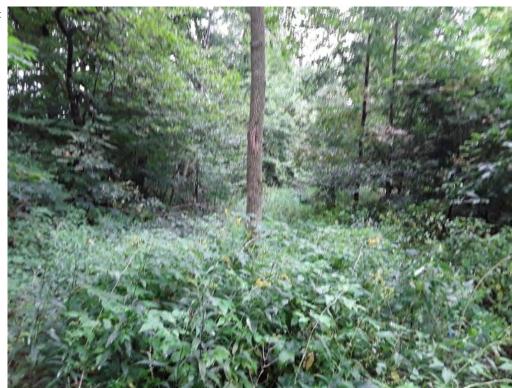
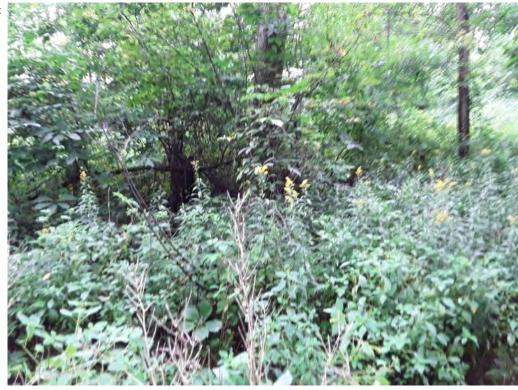
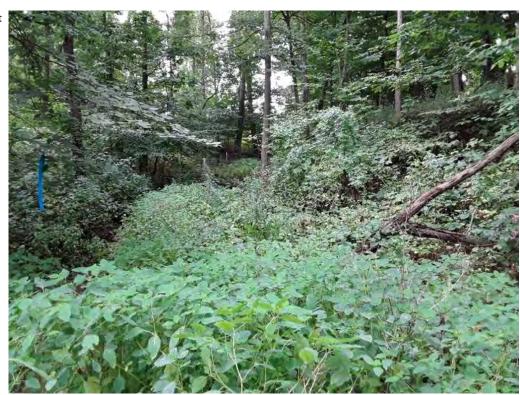
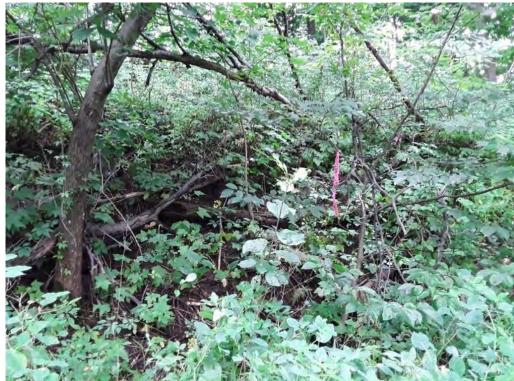
ce (S7) (LRR R, M	LRA 14	9B)						Dark Surface (TF12)
	(-·) (····) ···		,					Other (Explain	i in Remarks)
3Indicators of	nydrophytic vege	etation	and wetland hyd	rolog	y must b	e presen	t, unless disturbe	ed or problematic.	
Restrictive Lay	er (if observed):								
Ту	pe:		None	_		Hydric	Soil Present?		Yes No
De	pth (inches):								
Remarks:									
A positive indi	cation of hydric s	soil was	s observed. The c	riterio	on for hy	dric soil	is met. Refusal du	ue to coarse fragmer	nts.

Photo of Sample Plot North

Photo of Sample Plot East

Photo of Sample Plot South

Photo of Sample Plot West

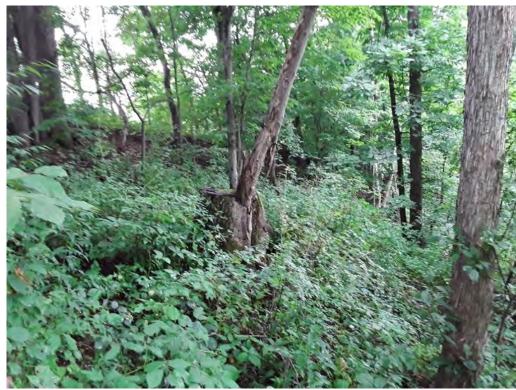
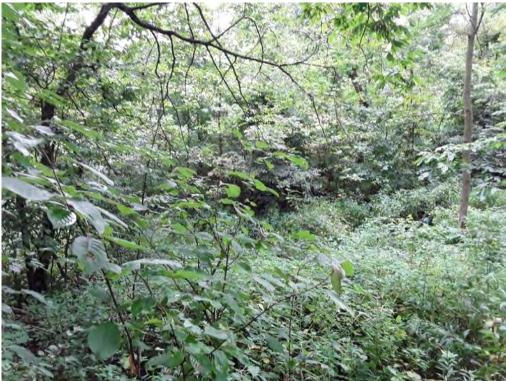
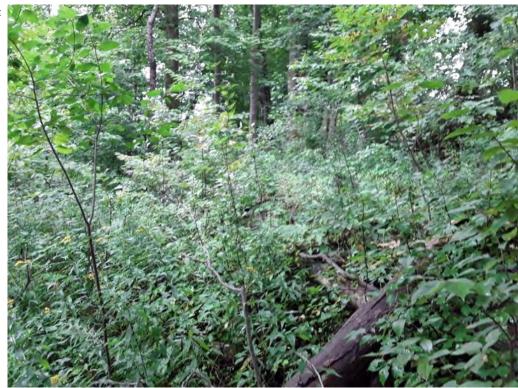
-	Deptil (iliches).	_							
Remarks:	indication of hydri	c soils w	as observed. The	crite	erion for	hvdric s	nil is not met. Ref	usal due to coarse	fragments
ino positive	indication of riguri	C 30113 W	as observed. The	CITC	.11011101	riyuric s	on is not met. Ken	asai ade to coarse	riaginents.
L

Photo of Sample Plot North

Photo of Sample Plot East

Photo of Sample Plot South

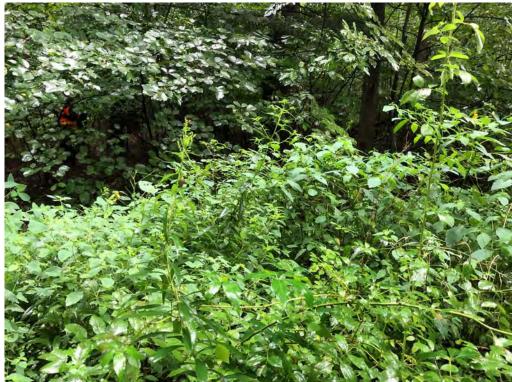
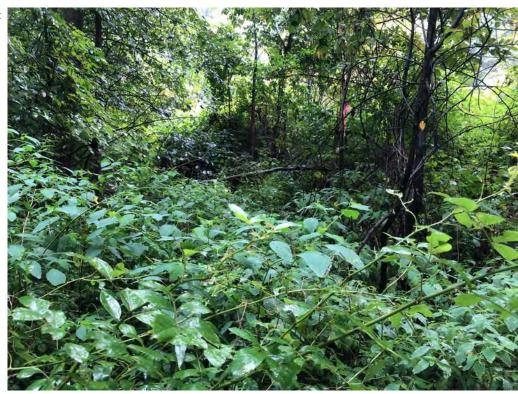
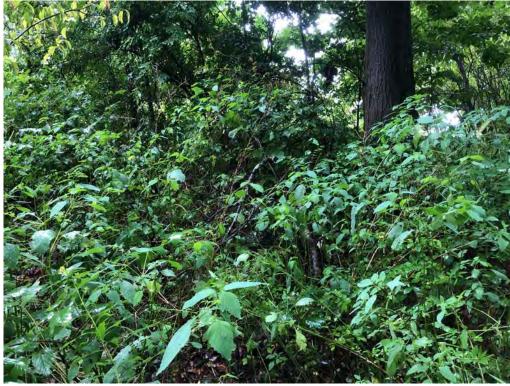
Restrictive Layer (if observed): Type: Depth (inches): Remarks: Hydric Soil Present? Yes No No No No No No No No No No	³ Indicators	of hydrophytic veg	getation	and wetland hyd	rolog	y must be	e presen	nt, unless disturbe	•	
Type: None Hydric Soil Present? Yes ✓ No Depth (inches): Remarks:			_	<u>, , , , , , , , , , , , , , , , , , , </u>		,				
Depth (inches): Remarks:		•	,	None			Hydric	Soil Present?		Yes / No
Remarks:		• •		TVOTIC			liyanc	John Tesene.		165 <u>v</u> 140
	Damandra	Deptil (iliches).								
		indication of hydric	c soil wa	is observed. The c	riterio	on for hy	dric soil	is met.

Photo of Sample Plot East

Photo of Sample Plot South

Photo of Sample Plot West

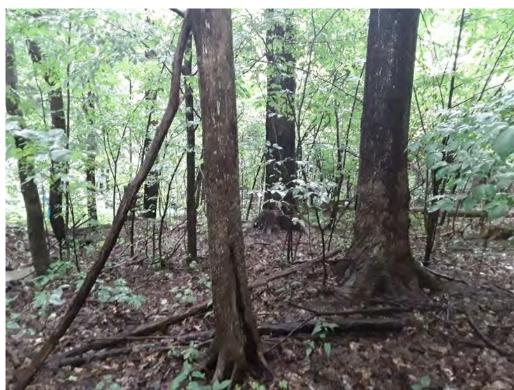
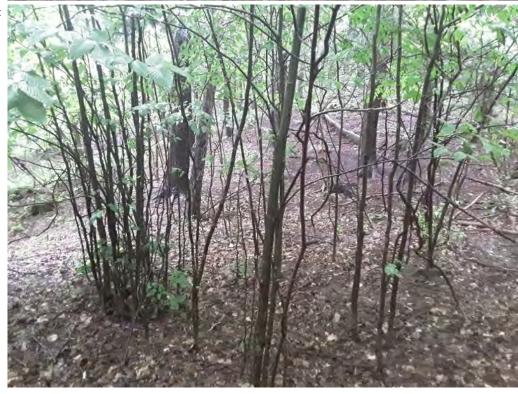
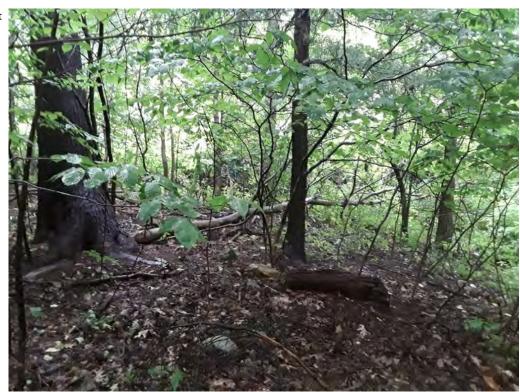
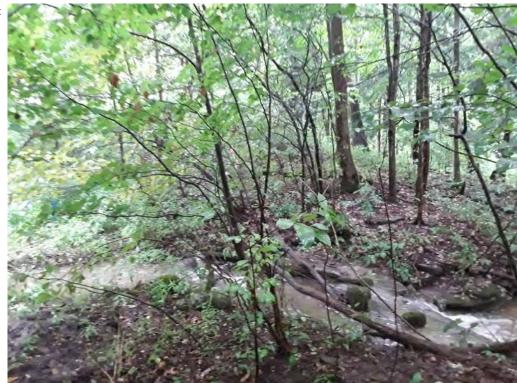
-	ledox (S5)							Mesic Spodic (TA6) (
-								Red Parent Material	l (F21)
	d Matrix (S6)							Very Shallow Dark S	Surface (TF12)
Dark Su	rface (S7) (LRR R, N	/ILRA 149	9B)					Other (Explain in Re	emarks)
3Indicators	of hydrophytic veg	etation a	and wetland hydr	ology	y must be	e presen	t, unless disturb	ed or problematic.	
Restrictive I	_ayer (if observed):	;							
	Type:		None			Hydric	Soil Present?		Yes No _✓
	Depth (inches):								
Remarks:	<u> Берен (шенез).</u>								
	indication of budge	ic coile w	us observed The	crito	rian far l	budric ca	ail is not mot		
No positive	indication of hydri	ic soils w	as observed. The	crite	erion ior i	nyaric so	on is not met.

Photo of Sample Plot North

Photo of Sample Plot East

Photo of Sample Plot South

Photo of Sample Plot West
