NextEra Energy Canada, ULC
Bluewater Wind Energy Centre

Final Water Assessment and Water Body Report

60155032

June, 2012

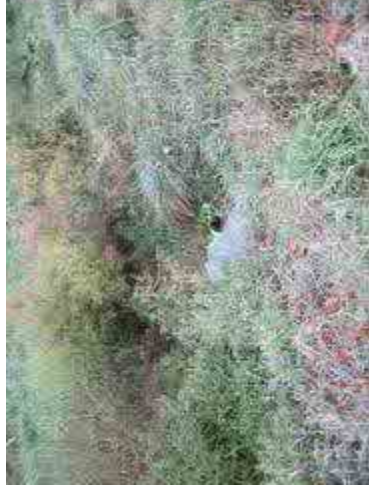
Photograph 2. Culvert on west side ↑

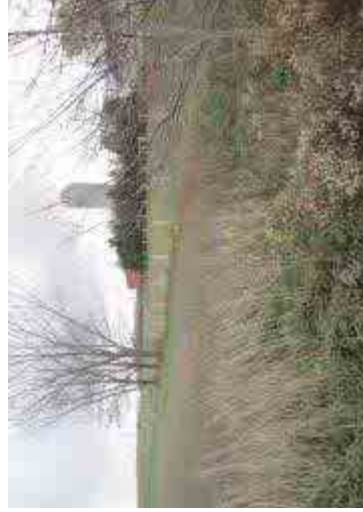
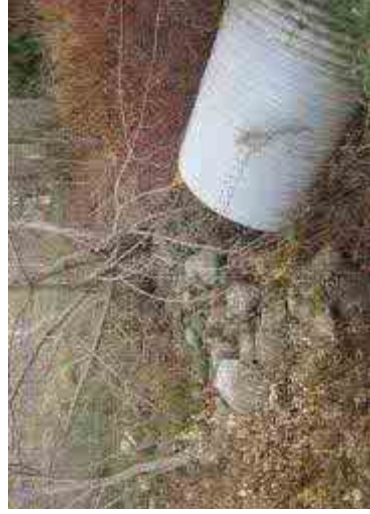
Photograph 1. Buried channel on east side ↑

Photograph 2. Buried channel on east side ↑

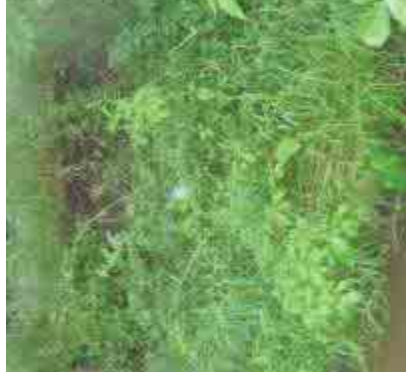
Photograph 3. Bank slumping on North side ↑

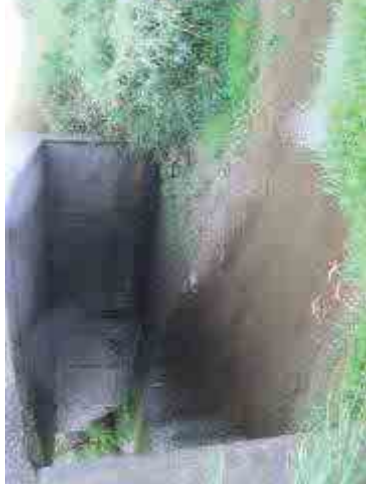
Photograph 3. Concrete box culvert ↑

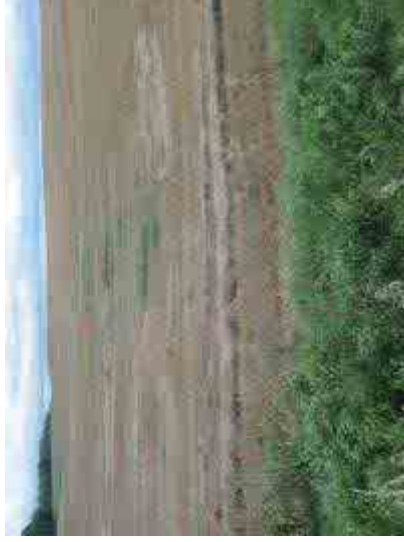
Photograph 1. South side overview ↗

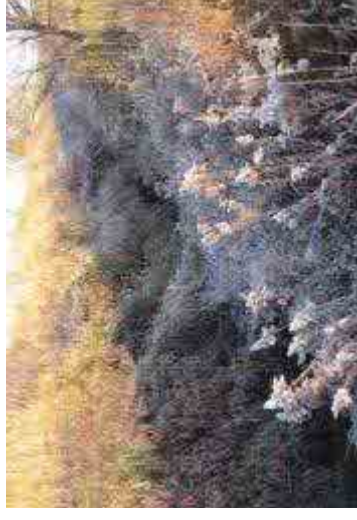
Photograph 3. Channel overview, downstream (north of Kippen Road) ↑
