Appendix E

Field Notes

Water Bodies Assessment Field Collection Form

Study Area: Jericho Goshen Bluewater Land Parcel# Bgr Site ID: R1.8#2

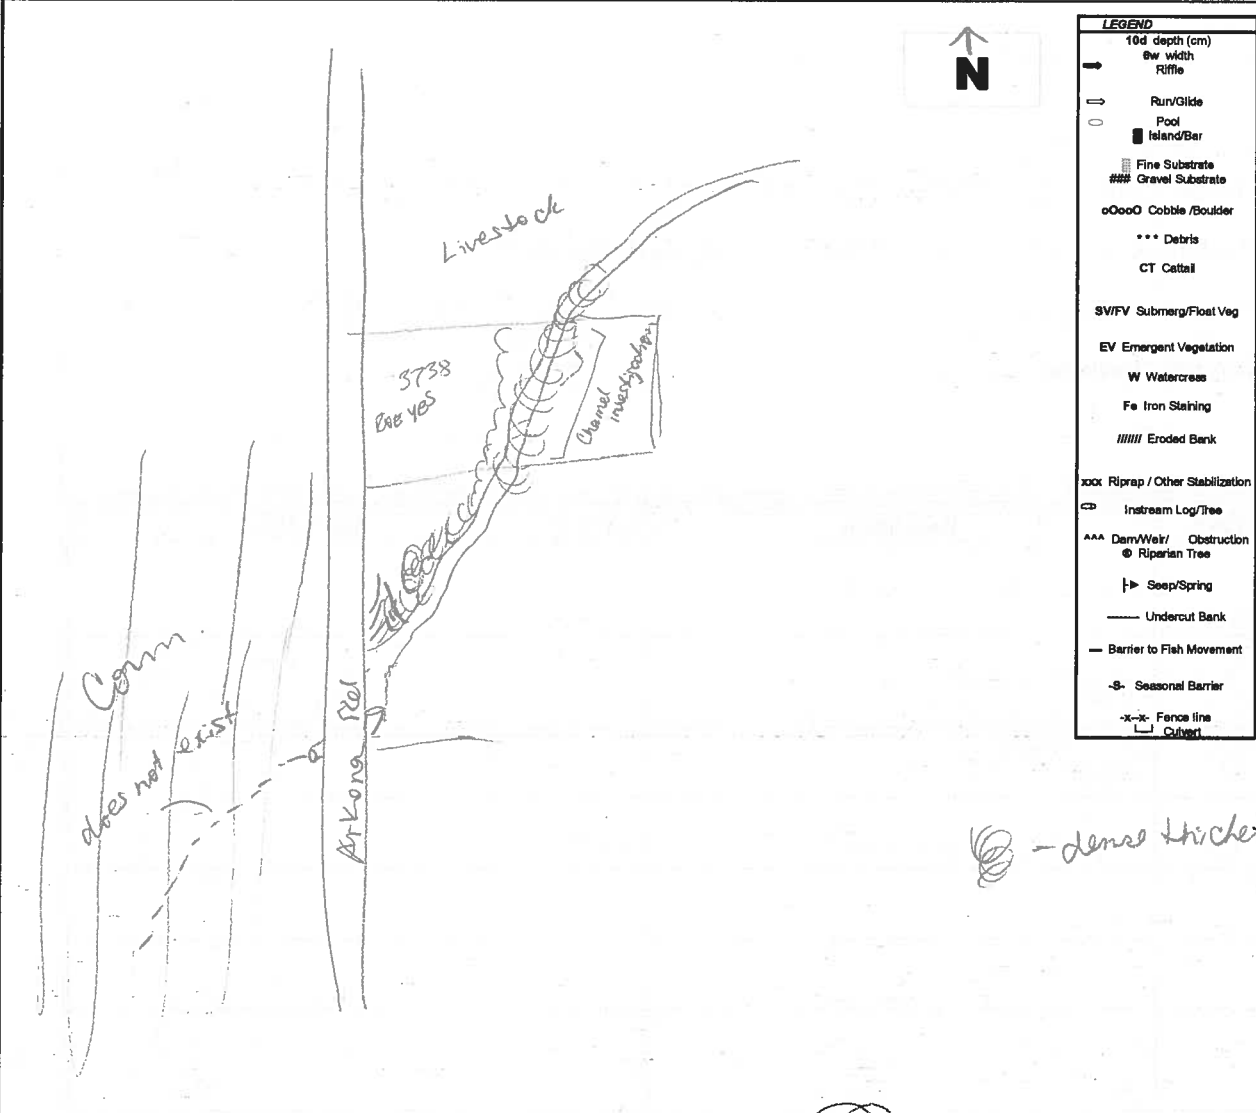
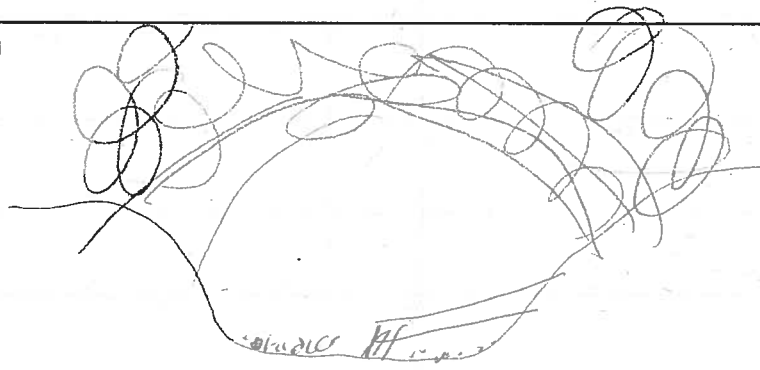
R. 2. 28

Stable	Slightly unstable	Moderately unstable	Unstable																
Left Bank	<input type="checkbox"/>	<input checked="" type="checkbox"/>	<input type="checkbox"/>	<input type="checkbox"/>																
Right Bank	<input type="checkbox"/>	<input checked="" type="checkbox"/>	<input type="checkbox"/>	<input type="checkbox"/>																
Mean Wetted Width (m): 0.8	Mean Wetted Depth (m): /	Description: erosion observed.																		
Mean Bankfull Width (m): 1	Mean Bankfull Depth (m): 0.4																			
Mean Top of Bank Width (m): 1.05	Mean Top of Bank Depth (m): 0.8																			
Flow Description: (high or low flow conditions, stagnant, etc)																				
no flow - channel dry except 1 pool (~4m long)																				
Habitat																				
Substrate (<=>)		Description		Morphological Structure (%)																
Bo - Boulder Co - Cobble Gr - Gravel Sa - Sand Si - Silt Cl - Clay MK - Muck DT - Detritus	clay > sa = si = gr > co		<table border="1" style="width:100%; border-collapse: collapse;"> <thead> <tr> <th colspan="4" style="text-align: center;">Morphological Structure (%)</th> </tr> <tr> <th style="width: 25%;">Pool</th> <th style="width: 25%;">Riffle</th> <th style="width: 25%;">Run</th> <th style="width: 25%;">Flat</th> </tr> </thead> <tbody> <tr> <td style="height: 20px;"></td> <td></td> <td></td> <td></td> </tr> </tbody> </table>		Morphological Structure (%)				Pool	Riffle	Run	Flat					Notes: slight meanders in forest

ash, dogwood, hawthorn																				
Riparian Vegetation																				
Width and Description of riparian vegetation:		LB - 10m - shrub + trees		RB - 10m - shrub + trees																
Overhanging Vegetation Present <input checked="" type="checkbox"/> N			% Overhanging Vegetation: 75																	
Description of Overhanging Vegetation:																				
dense thicket - dogwood, raspberry, grapevine,																				
Obstructions to Fish Passage																				
None Observed	<input type="checkbox"/>	Man-Made	<input type="checkbox"/>	Natural	<input type="checkbox"/>	Low Flow Barrier	<input checked="" type="checkbox"/>													
Description of Barrier:																				
almost entire channel dry																				
Height of Barrier (m)			GPS Coordinates:

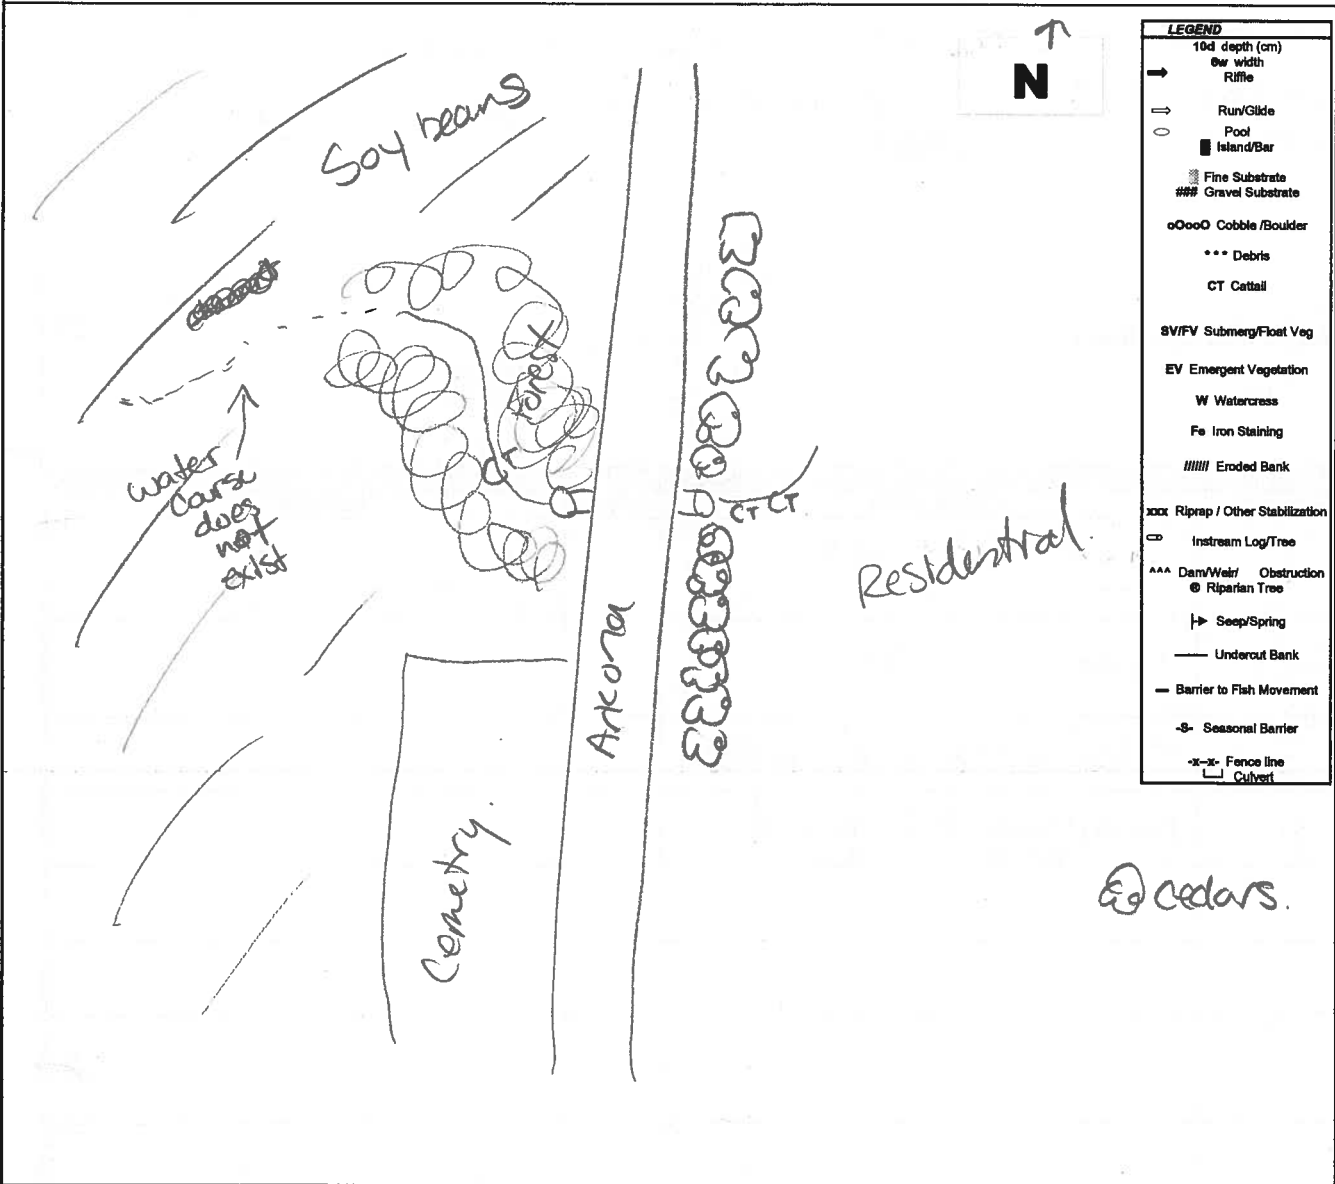
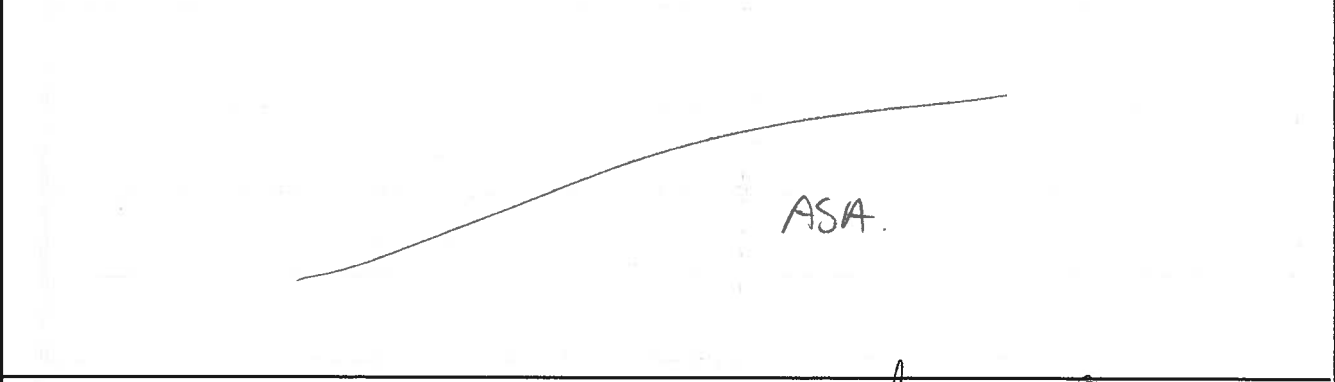
R2.34

Left Bank	<input checked="" type="checkbox"/>	<input type="checkbox"/>	<input type="checkbox"/>	<input type="checkbox"/>																					
Right Bank	<input checked="" type="checkbox"/>	<input type="checkbox"/>	<input type="checkbox"/>	<input type="checkbox"/>																					
Mean Bankfull Width (m): <u>n/a</u>	Mean Bankfull Depth (m): <u>n/a.</u>	Description: <u>well vegetated.</u>																							
Mean Top of Bank Width (m): <u>n/a</u>	Mean Top of Bank Depth (m): <u>n/a.</u>																								
Flow Description: (high or low flow conditions, stagnant, etc)																									
<u>N/a could not see ASA</u>																									
Habitat																									
Substrate (<=>)			Morphological Structure (%)																						
Description Bo - Boulder Co - Cobble Gr - Gravel Sa - Sand Si - Silt Cl - Clay MK - Muck DT - Detritus			<table border="1" style="width:100%; border-collapse: collapse;"> <tr> <th>Pool</th> <th>Riffle</th> <th>Run</th> <th>Flat</th> </tr> <tr> <td></td> <td></td> <td></td> <td></td> </tr> </table>			Pool	Riffle	Run	Flat
