Water Bodies Assessment Field Collection Form

502 1709 / 1724 / 1736
R9B

AECOM

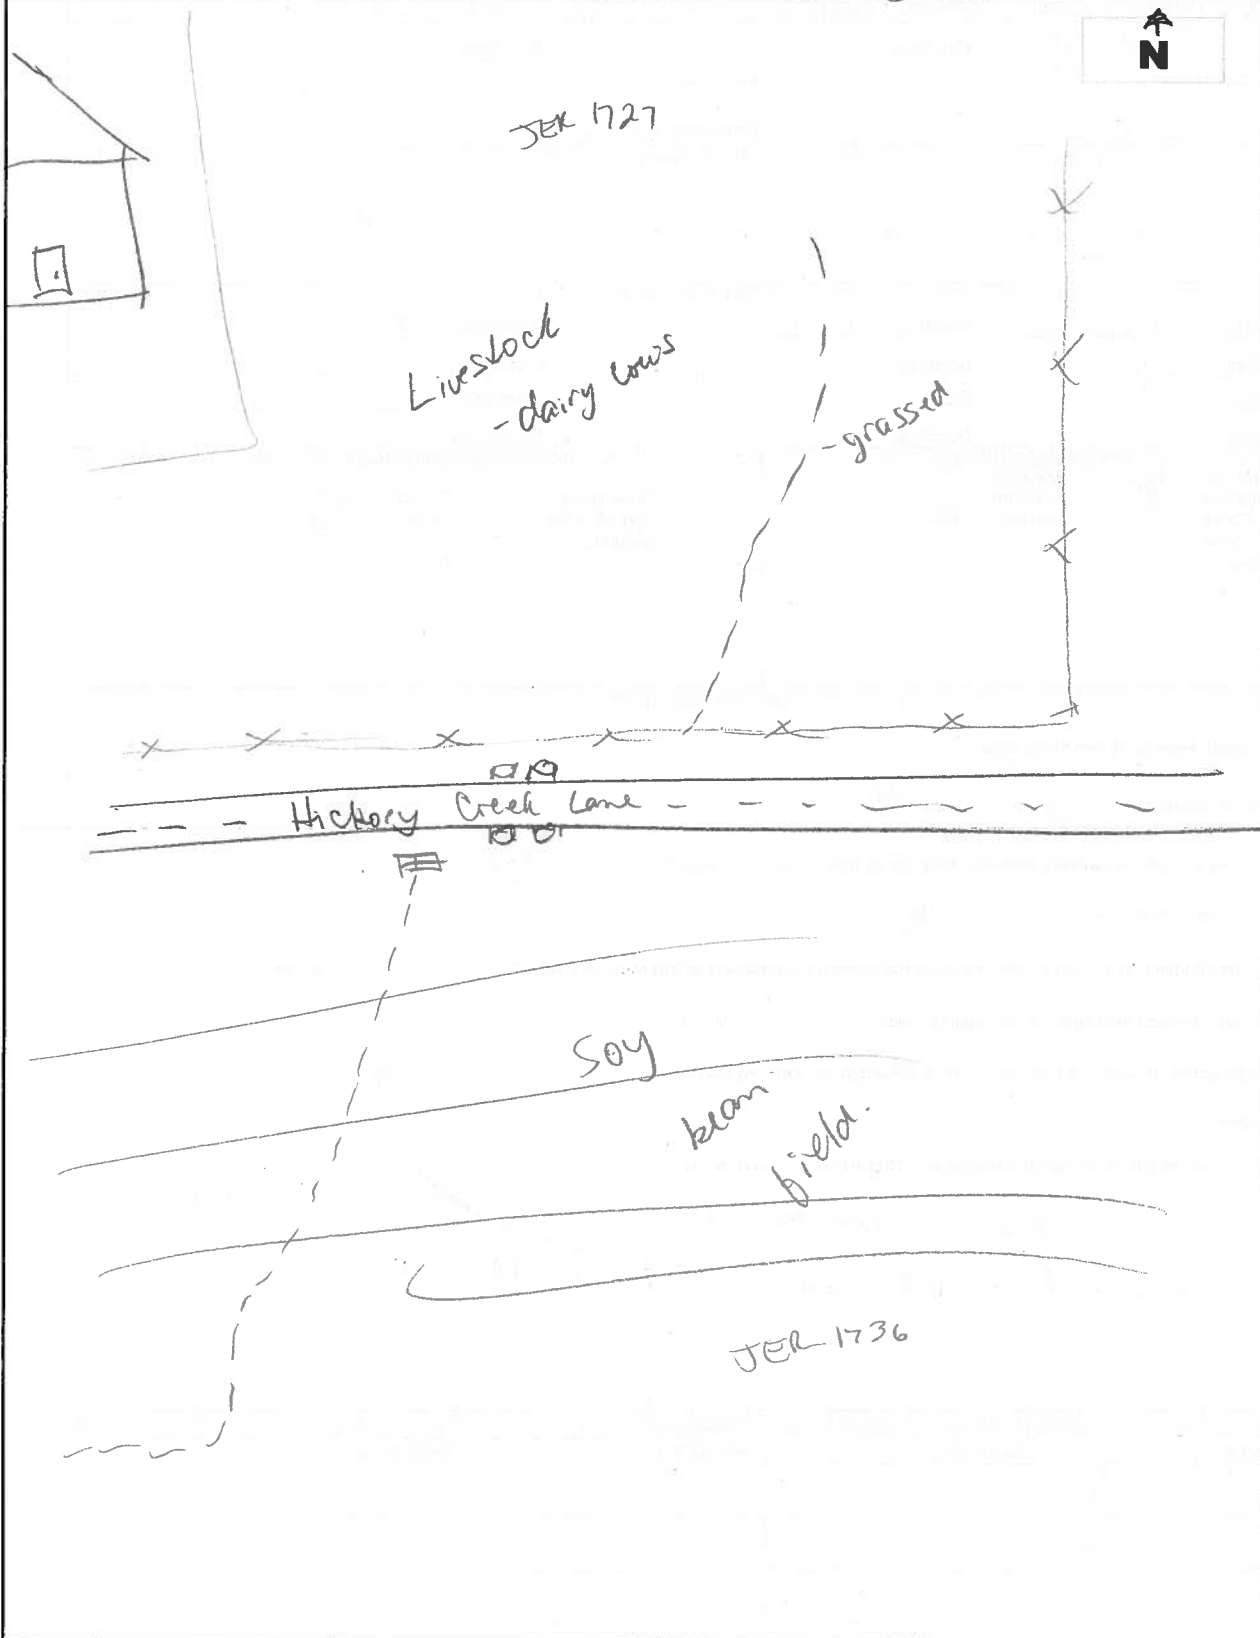
29.33C

- swale check adjacent to R9.33
↳ no water course present

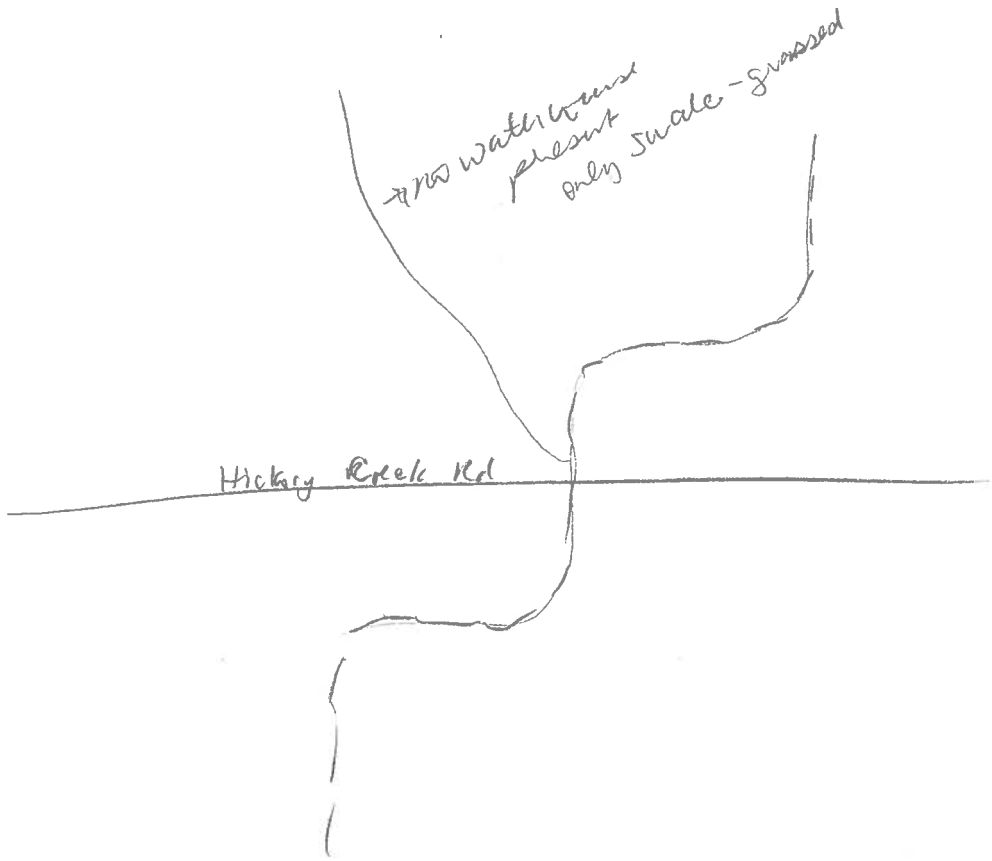
no waterways
present
only shale-grassed

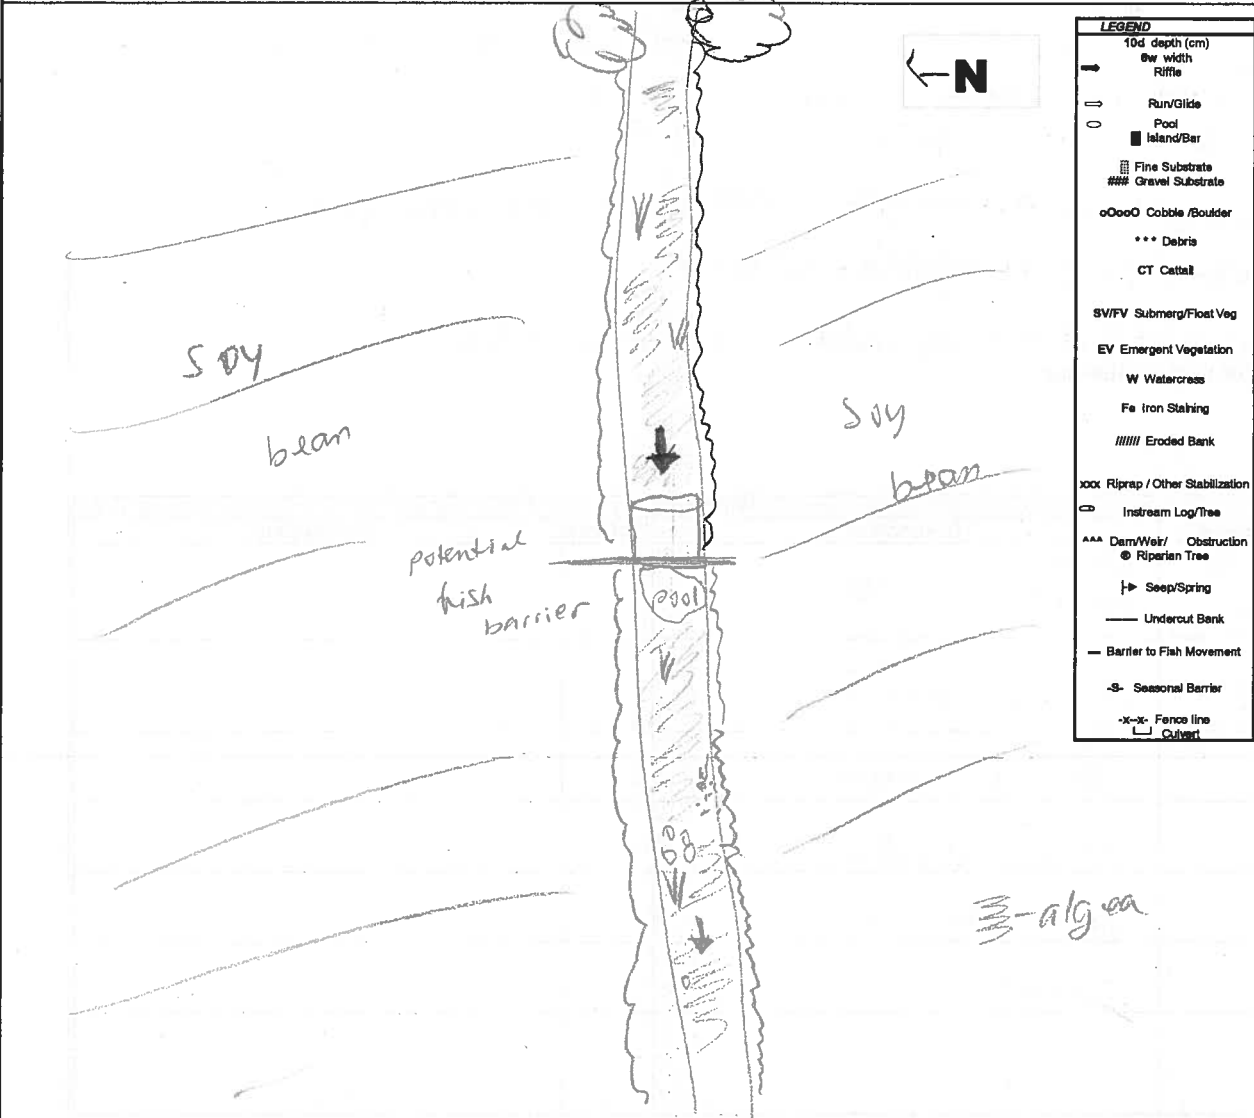
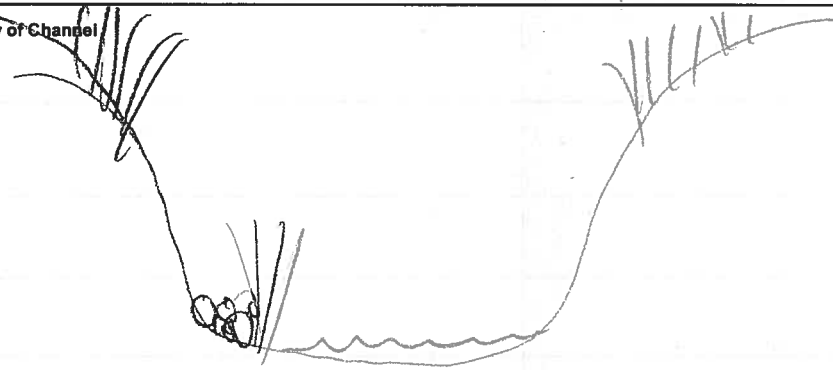
R9.29 F

- minnows observed (~10)
- leopard frog observed on bank

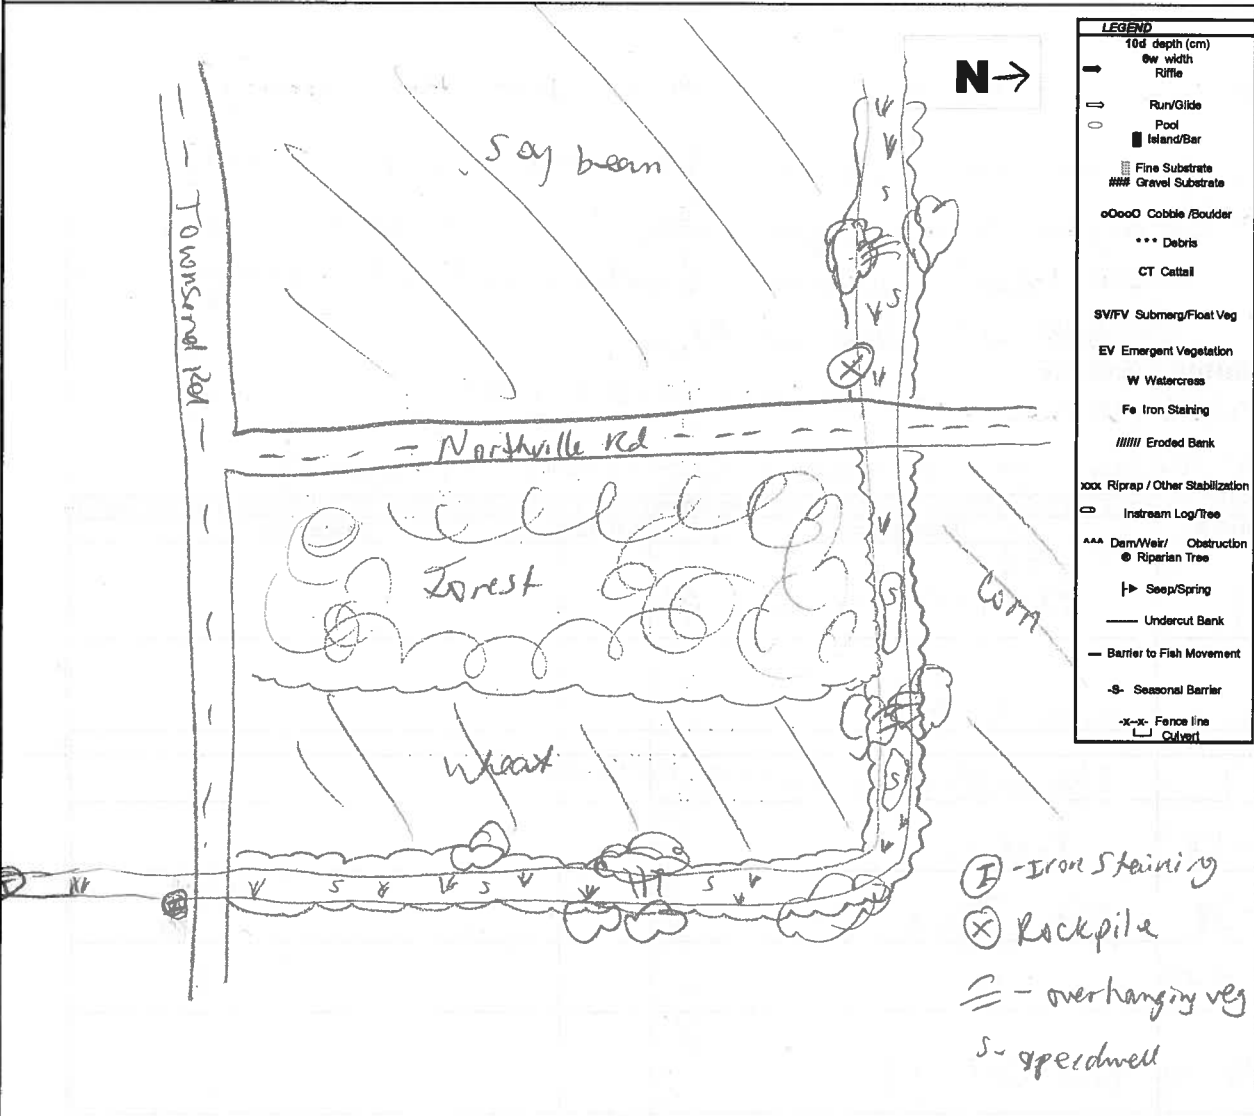
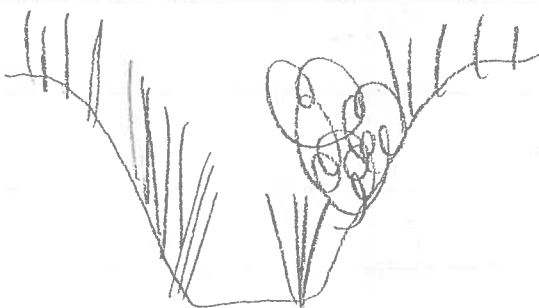
R9.29B

Details:
 - small clumps + mats of Speedwell ground throughout
 - iron staining found on S side of Townsend Rd @ Nauvoo

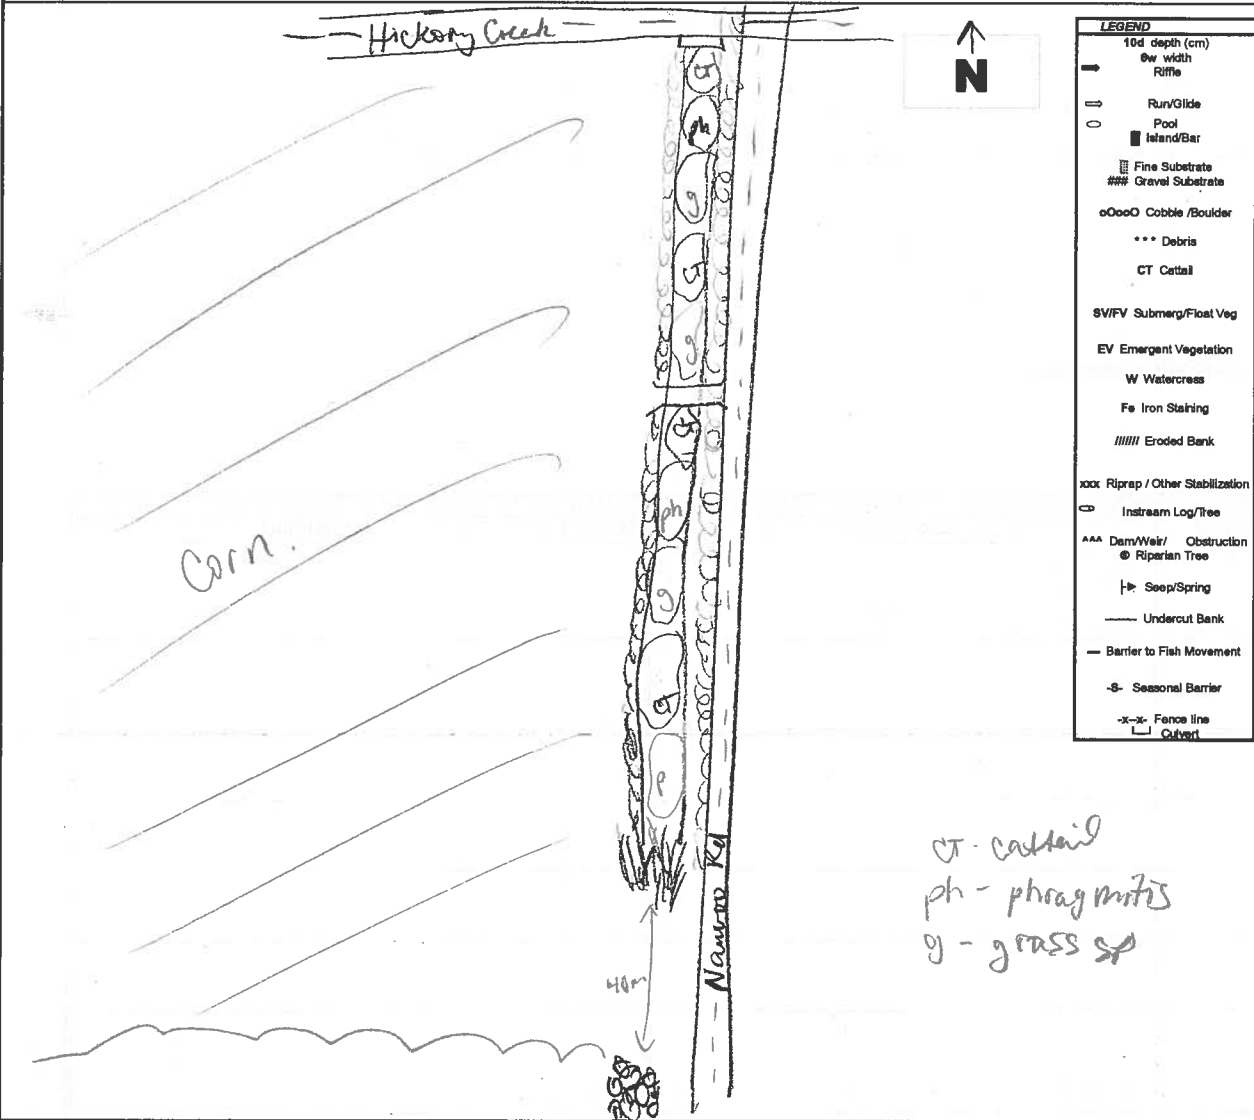
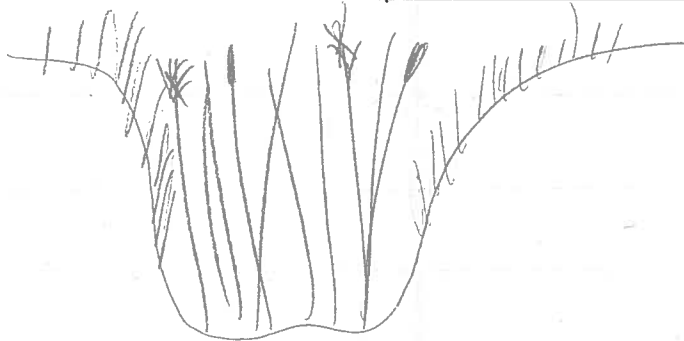
R 9. 29 A.

Flow Description: (high or low flow conditions, stagnant, etc)
stagnant pools + sections of dry channel

Obstructions to Fish Passage							
None Observed	<input type="checkbox"/>	Man-Made	<input type="checkbox"/>	Natural	<input type="checkbox"/>	Low Flow Barrier	<input checked="" type="checkbox"/>
Description of Barrier: <i>patches of dry dry channel throughout</i>							
Height of Barrier (m)				GPS Coordinates:

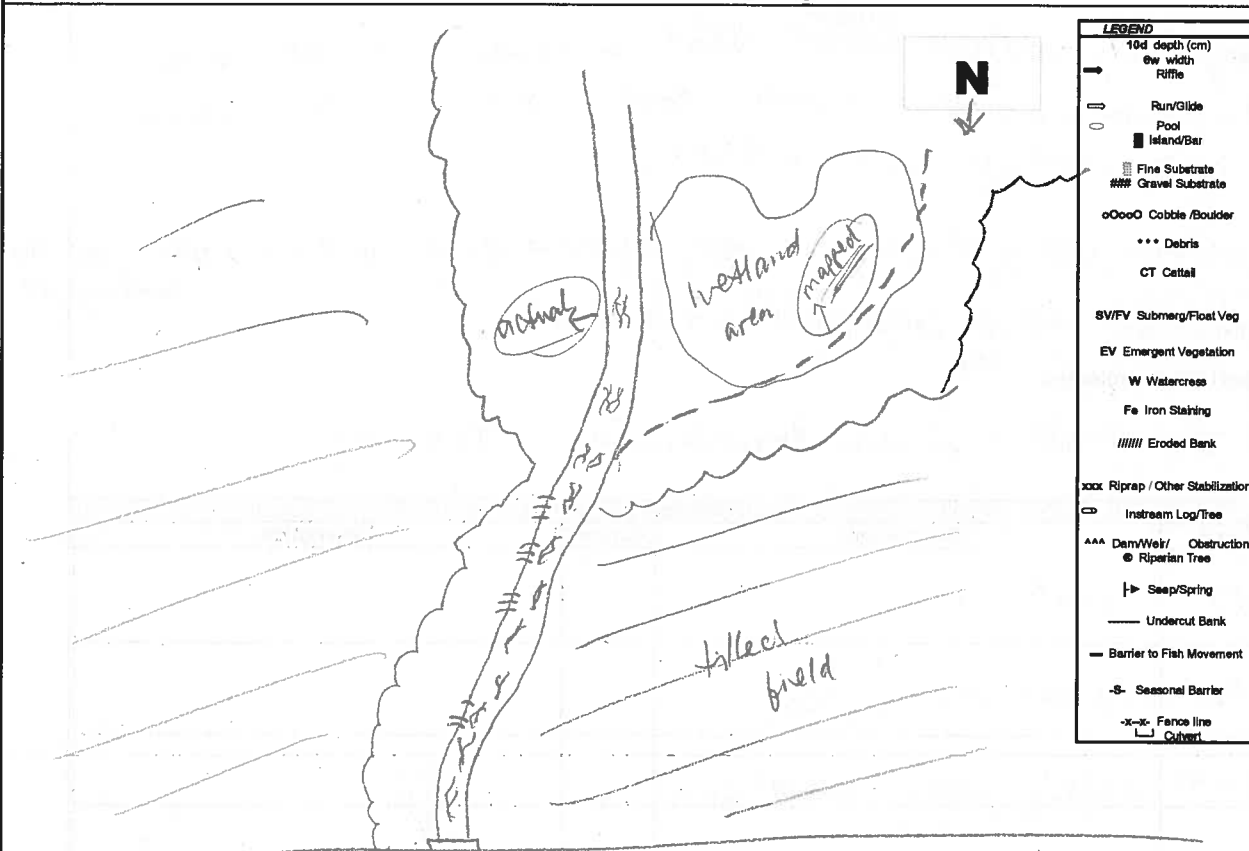
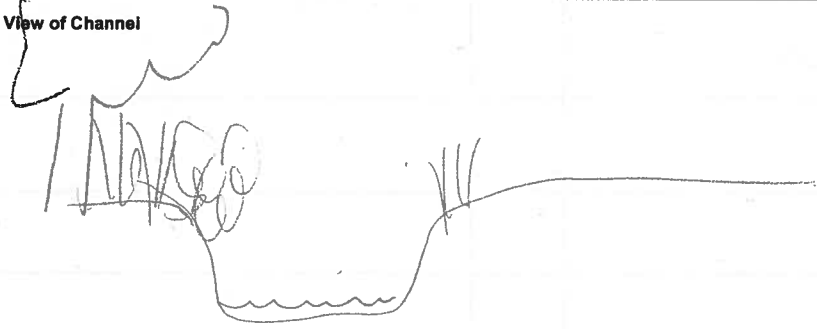
R/R 54 B

- Cyprinids observed (~5), 2 young mallard ducks observed, green frog heard calling in wetland area
* Channel not as mapped on JER 2797

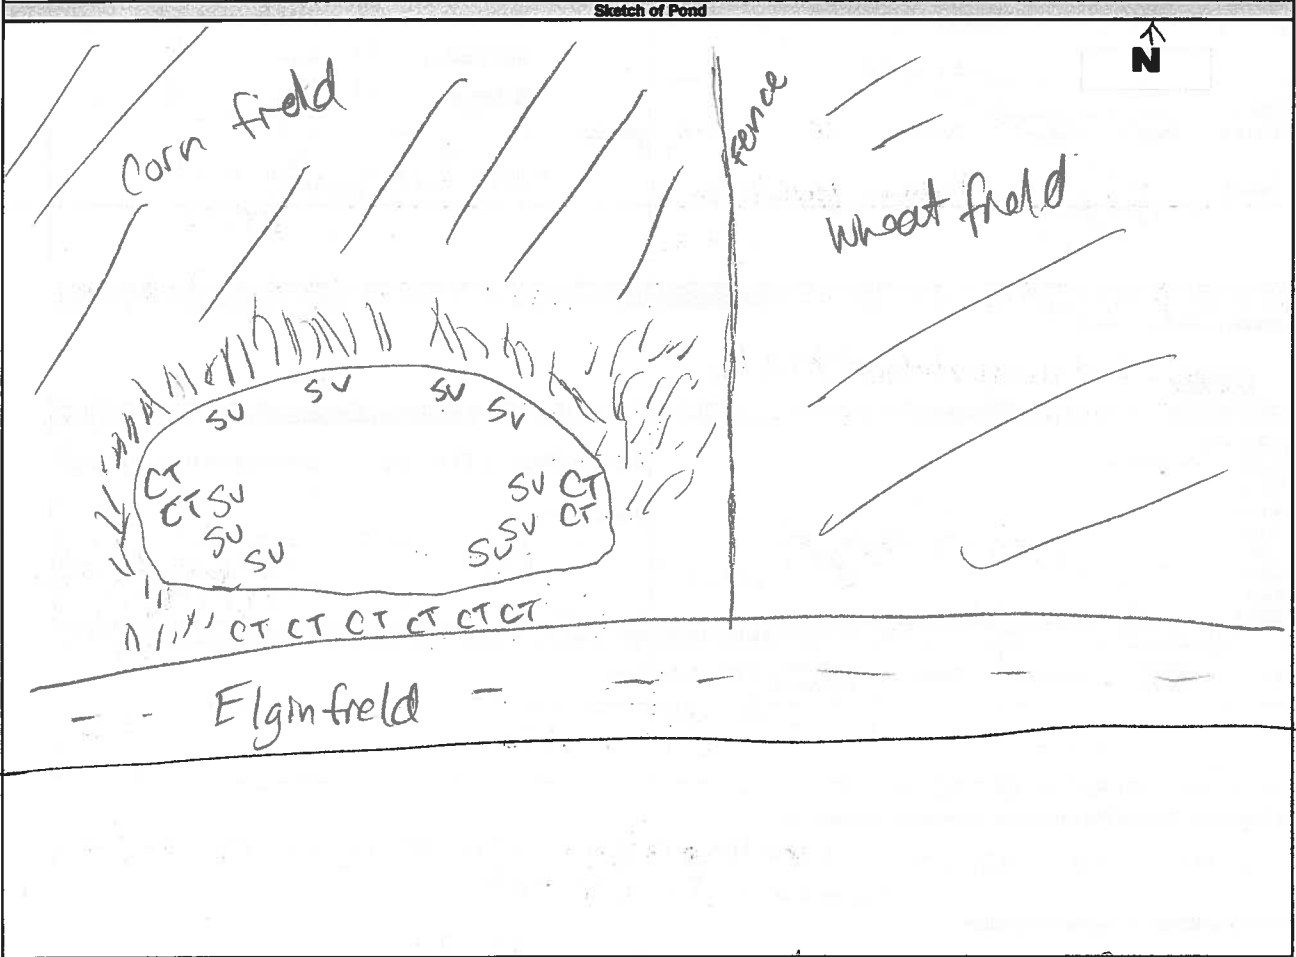
Other General Comments Regarding the Study Area:
 Dugout pond in low lying area right near the roadside (Elgin field). Some aquatic vegetation visible from Roadside

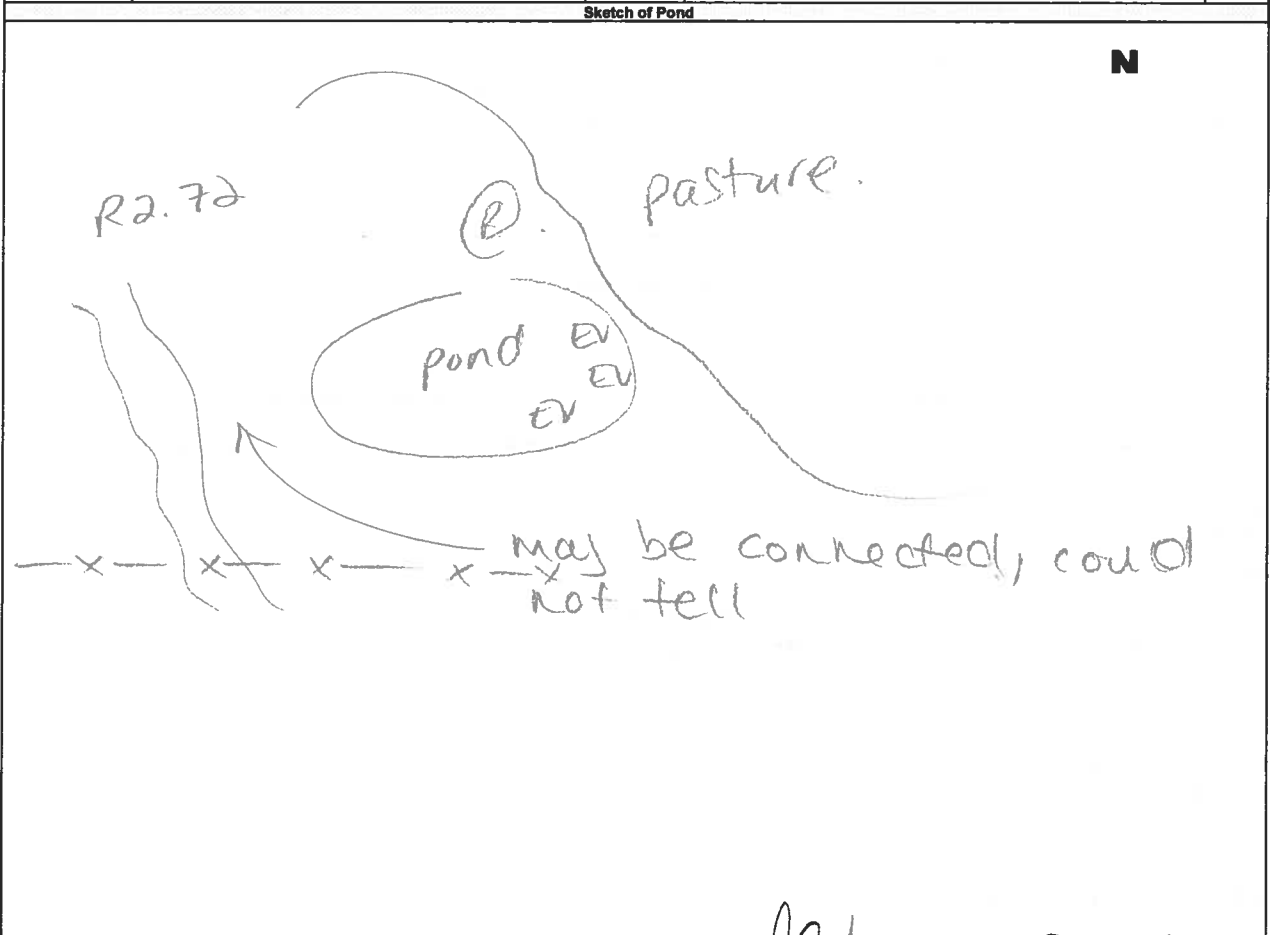
Other General Comments Regarding the Study Area:
 pond was naturalized and in an area w/ very hydrophilic soils + marshy vegetation type.

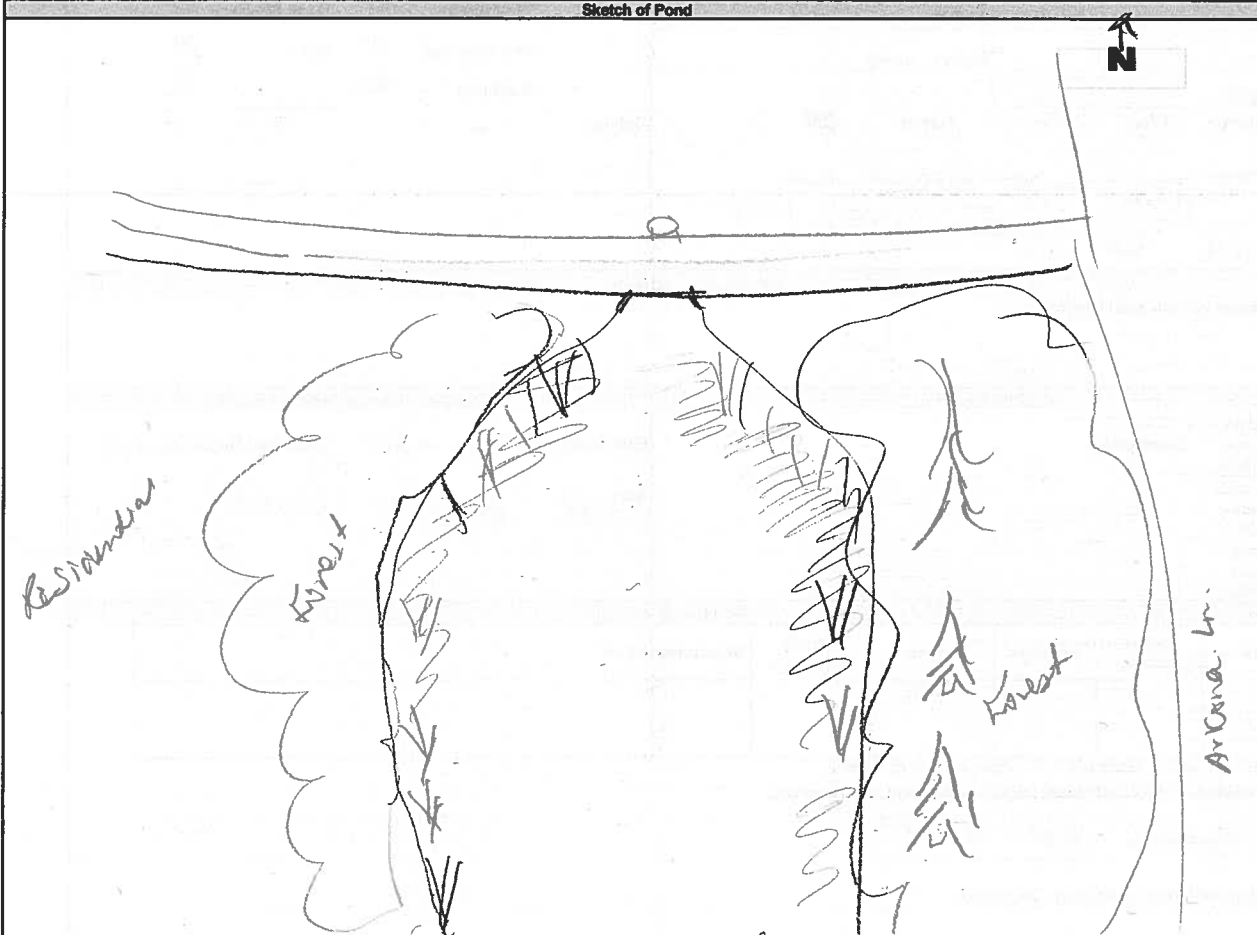
Other General Comments Regarding the Study Area:
algae + grasses line the perimeter of the pond.
