Water Bodies Assessment Field Collection Form

Study Area: Dericho Goshen Bluewater Land Parcel# JUL 9166 Site ID: R3 B
 Date: June 7/12 Start time: 14:00 3588 End Time: 15:10
 Weather Conditions: Sunny, 19°C Field Crew: C. Barros, S. Darciche
 Field Notes By: C. Barros

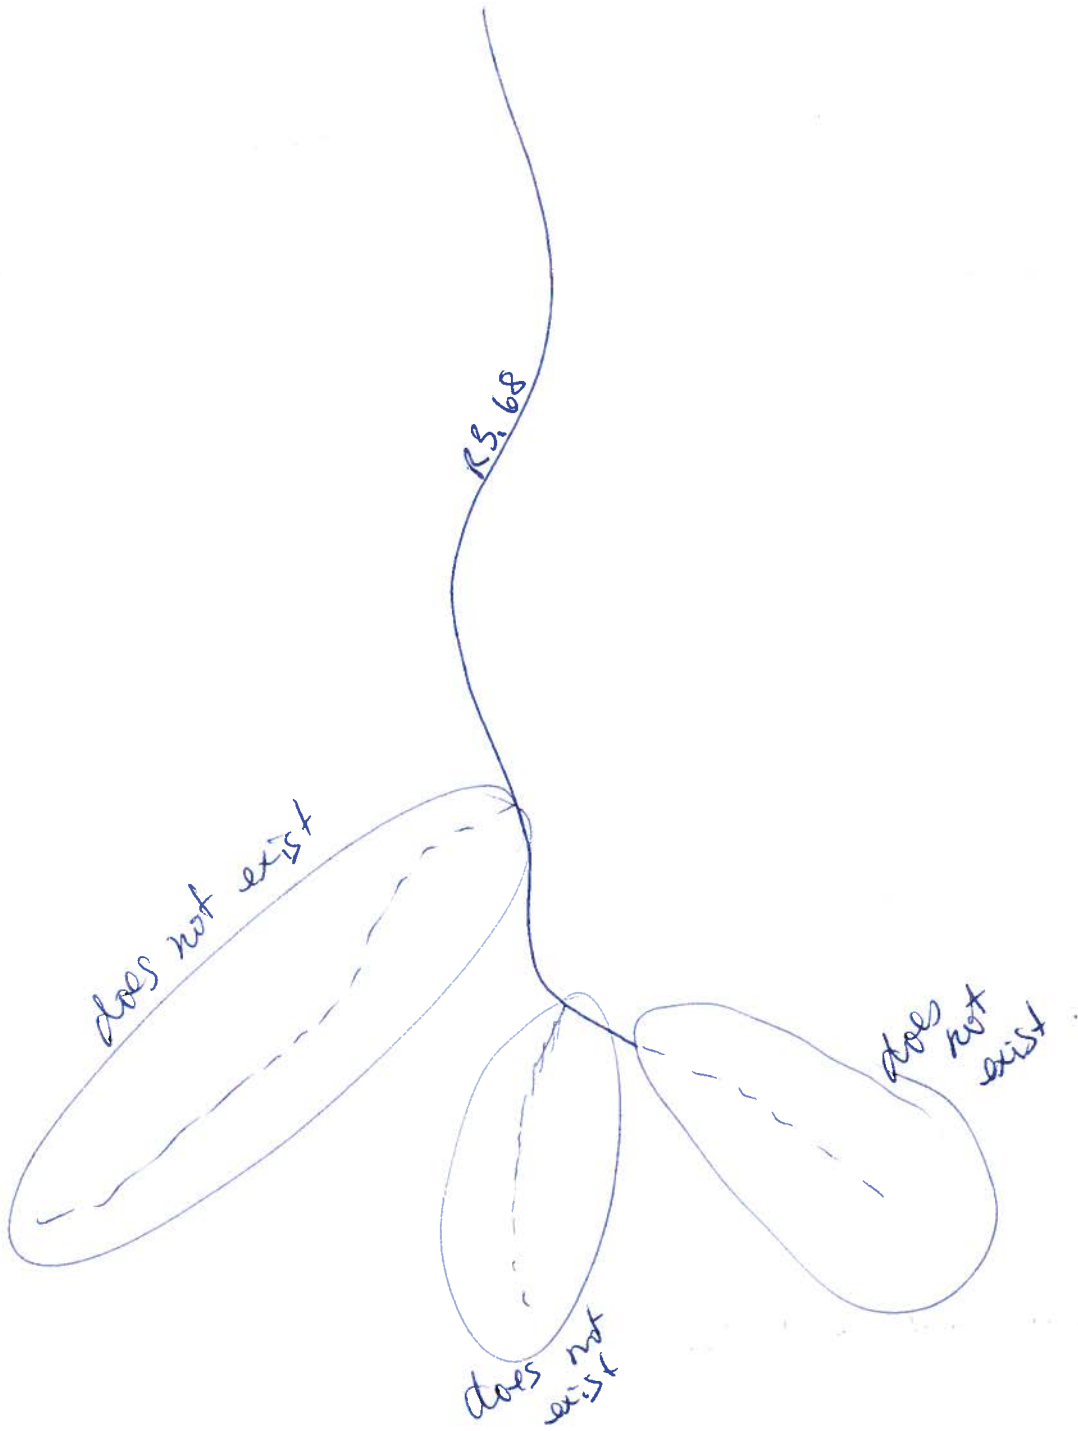
- walked the property and no swales
or waterbodies observed
↳ see map on back

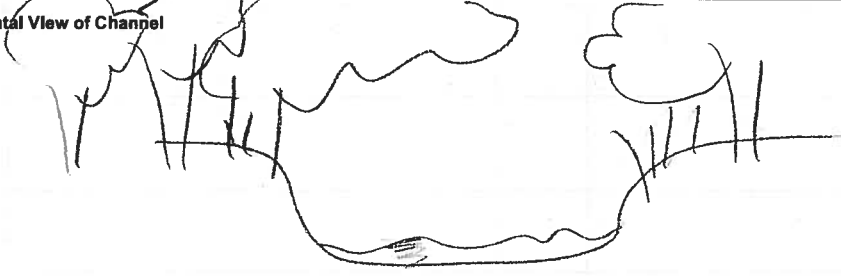
This is on unmapped watercourse found on JER 1008.
It is a channel that runs along the east side of
Feature 213. It is channelized and is most
likely used for overflow - It was ponded in the
corner but becomes dry 20m out to the east and
20m out to the south.
