Jericho Wind, Inc.

Revision to the Water Assessment and Water Body Report – Jericho Wind Energy Centre

AECOM

October, 2013

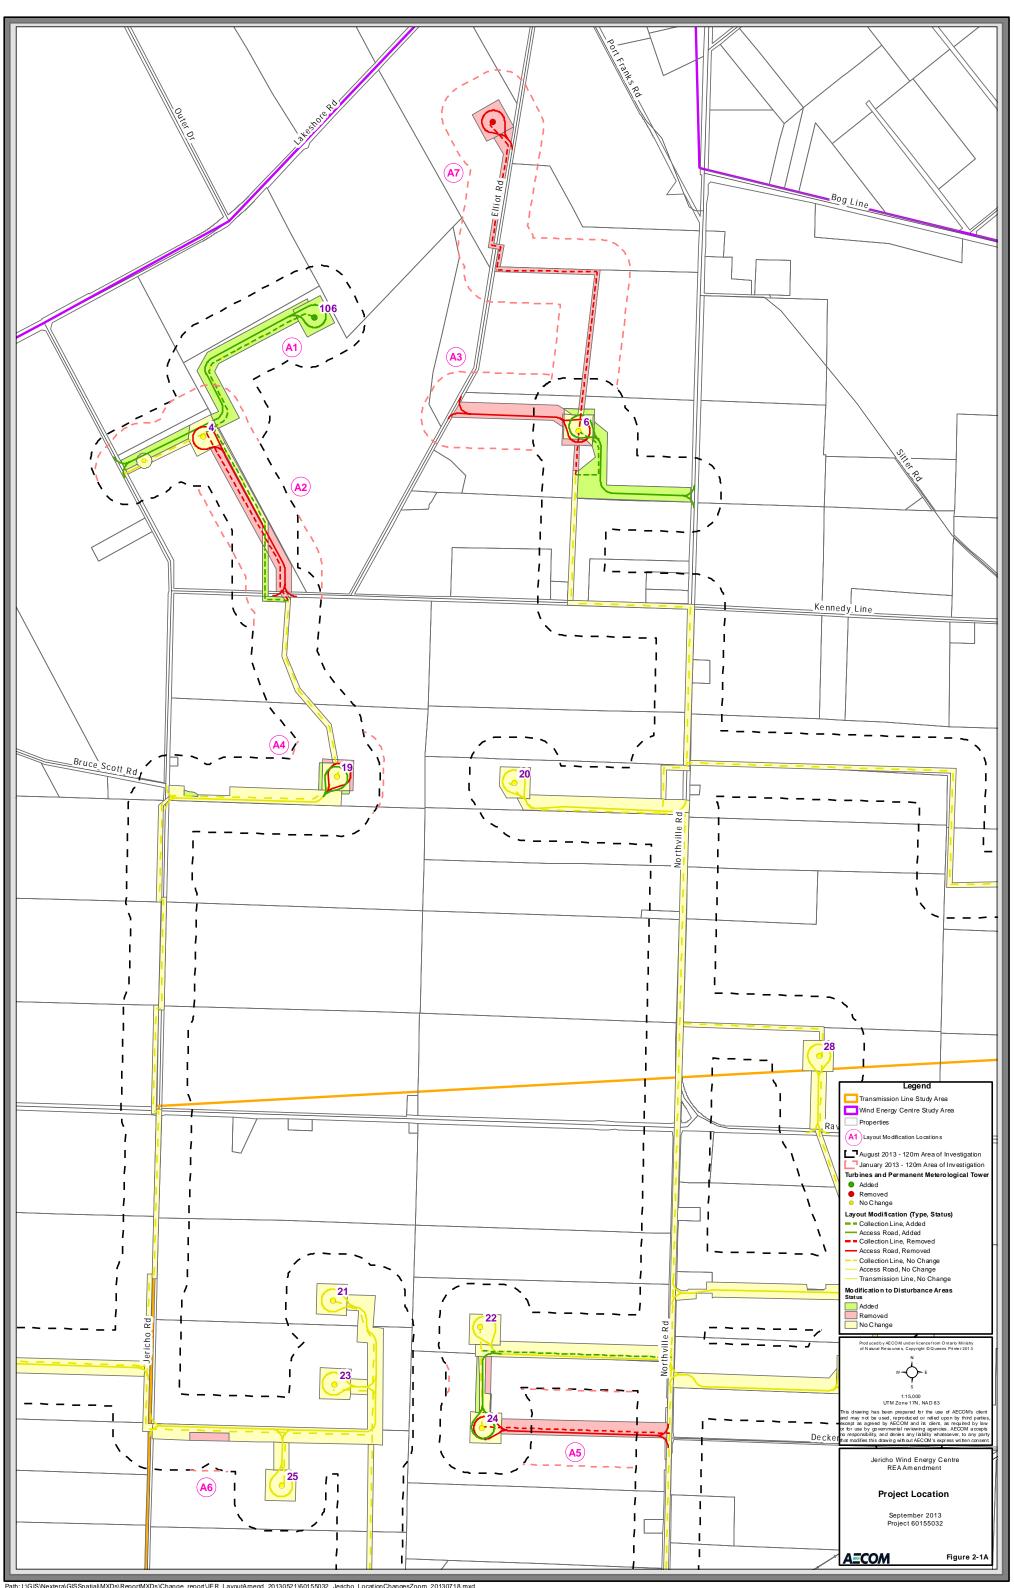
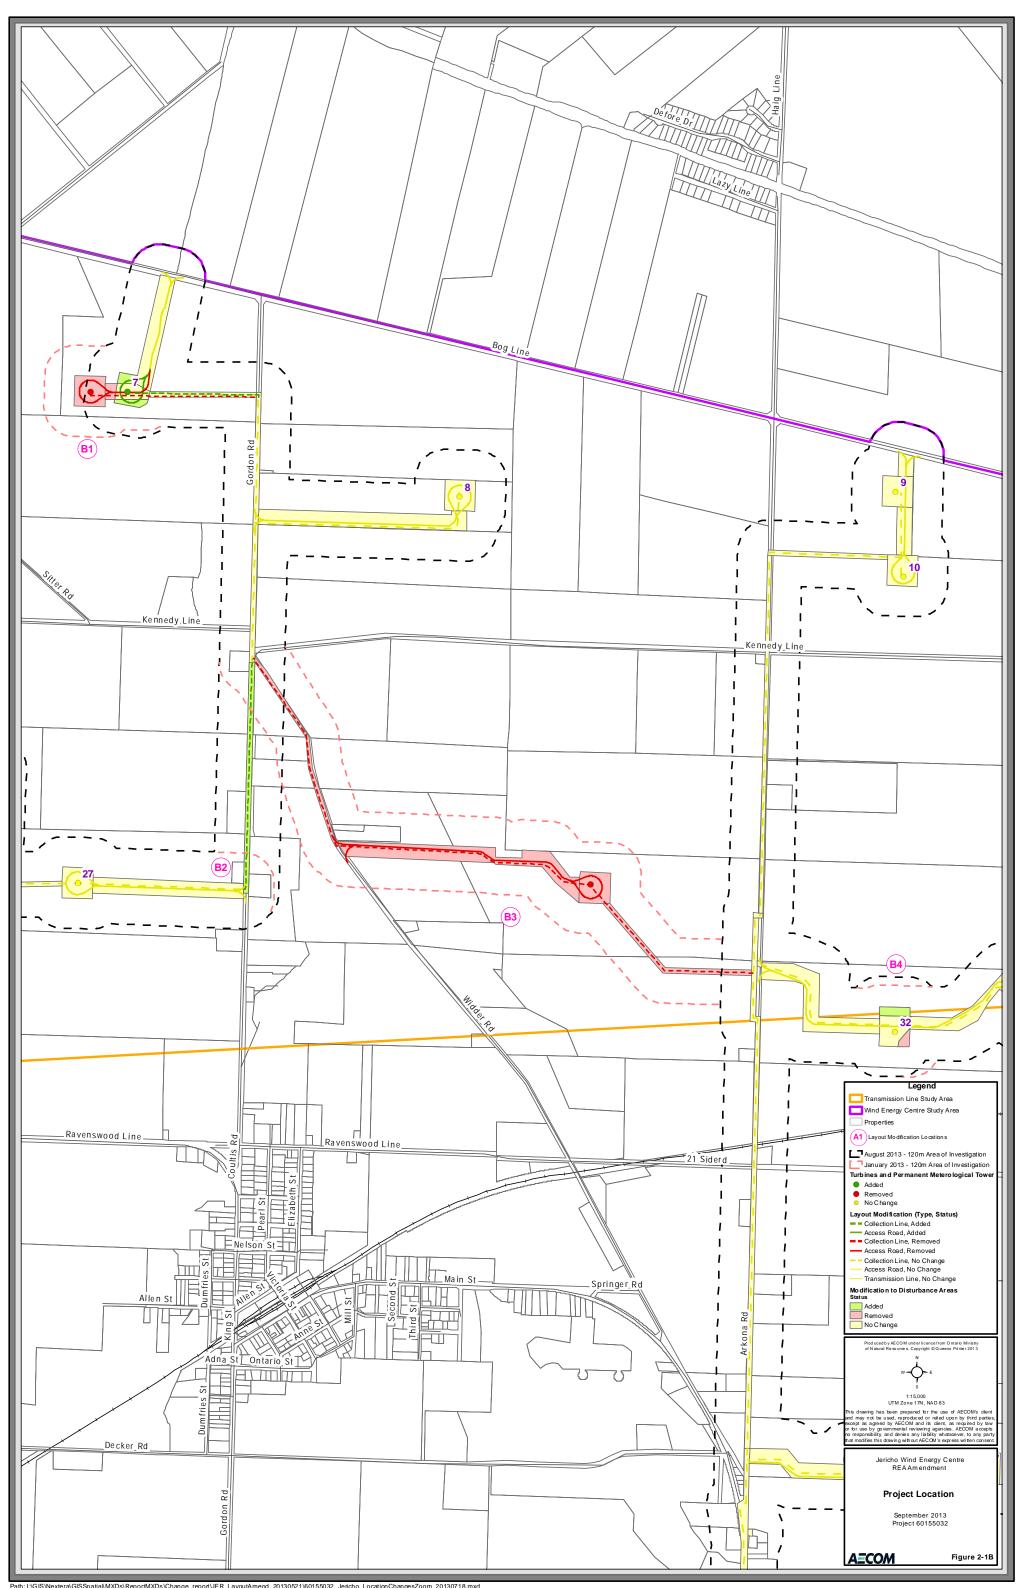
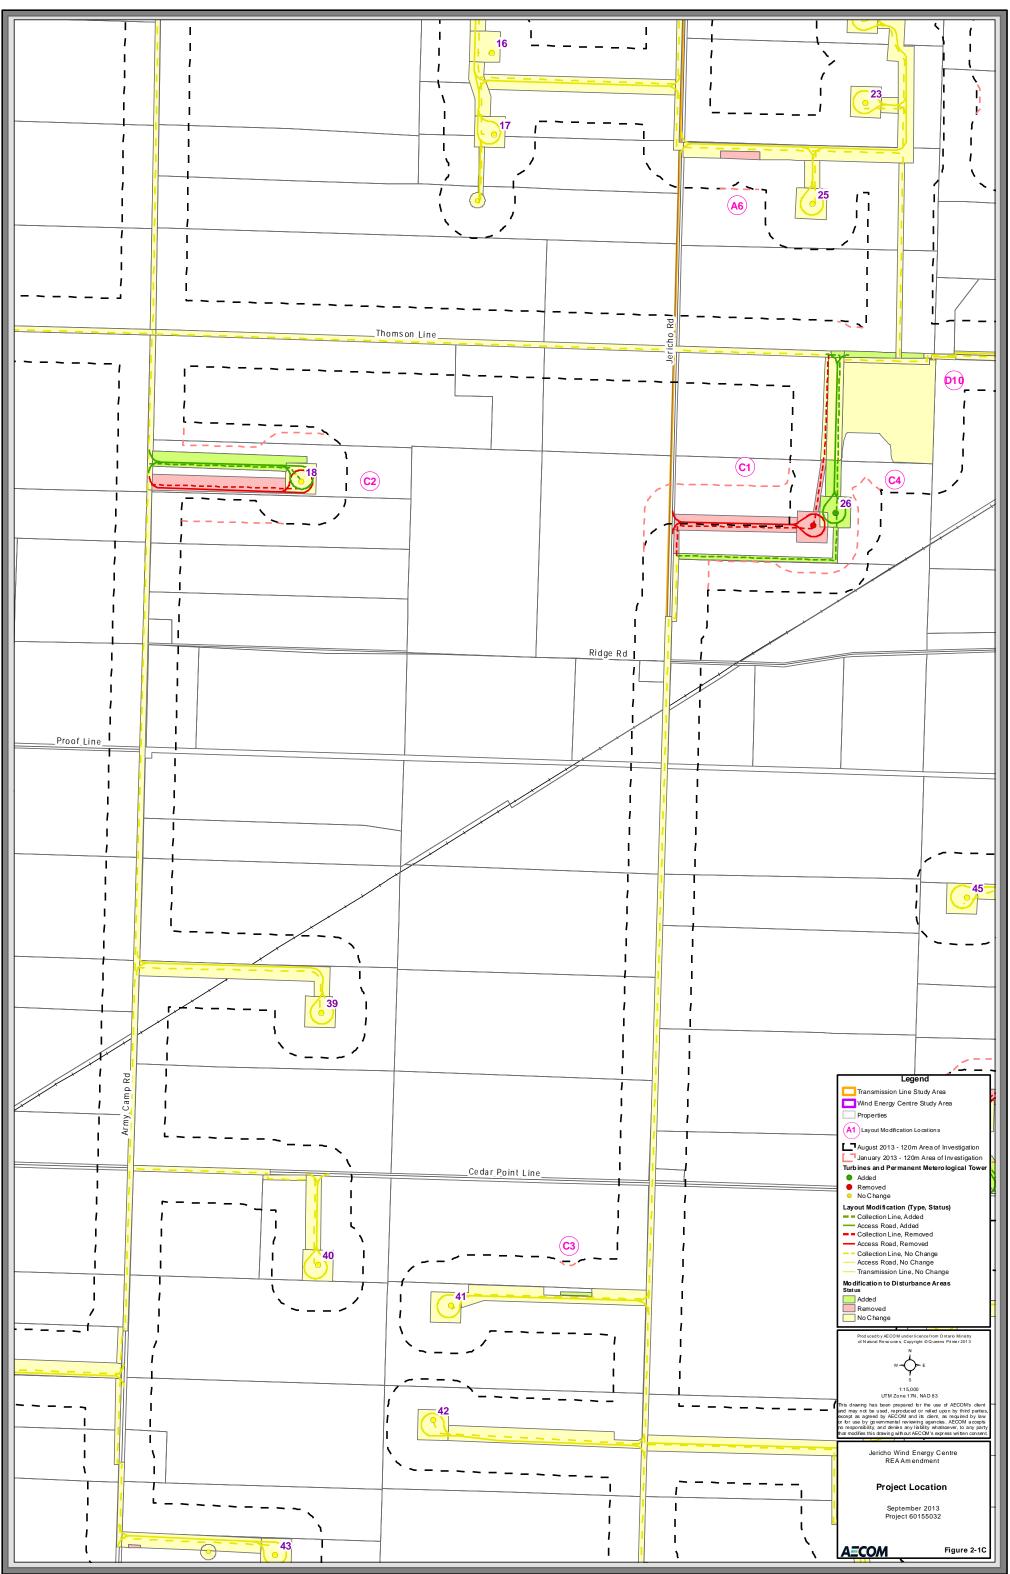
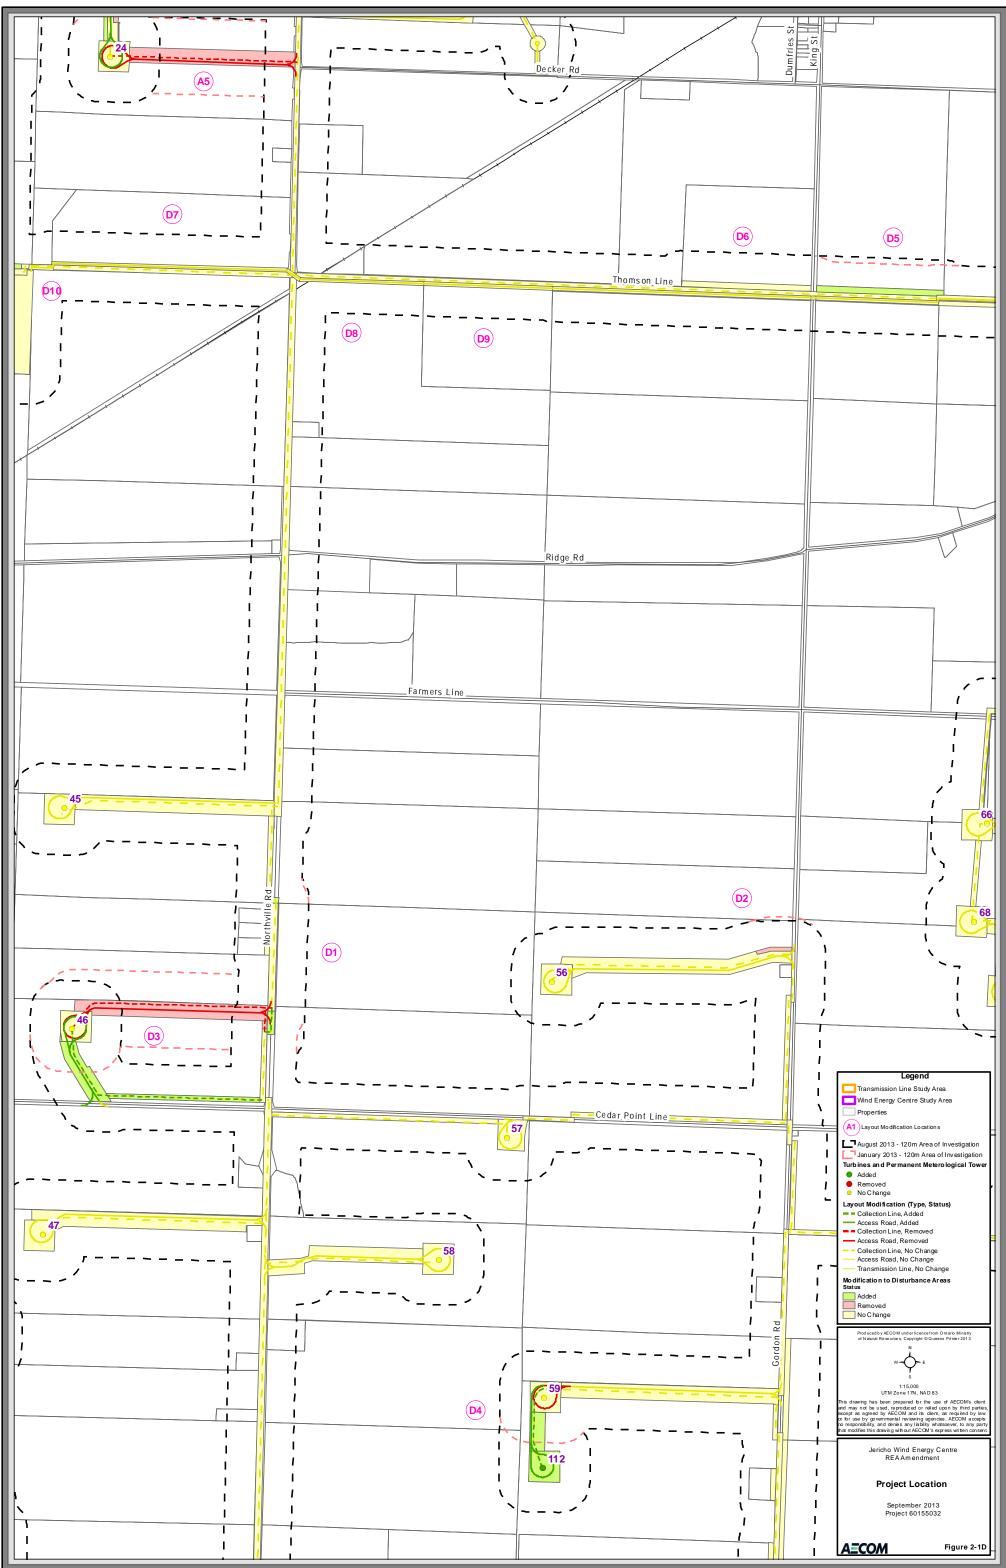
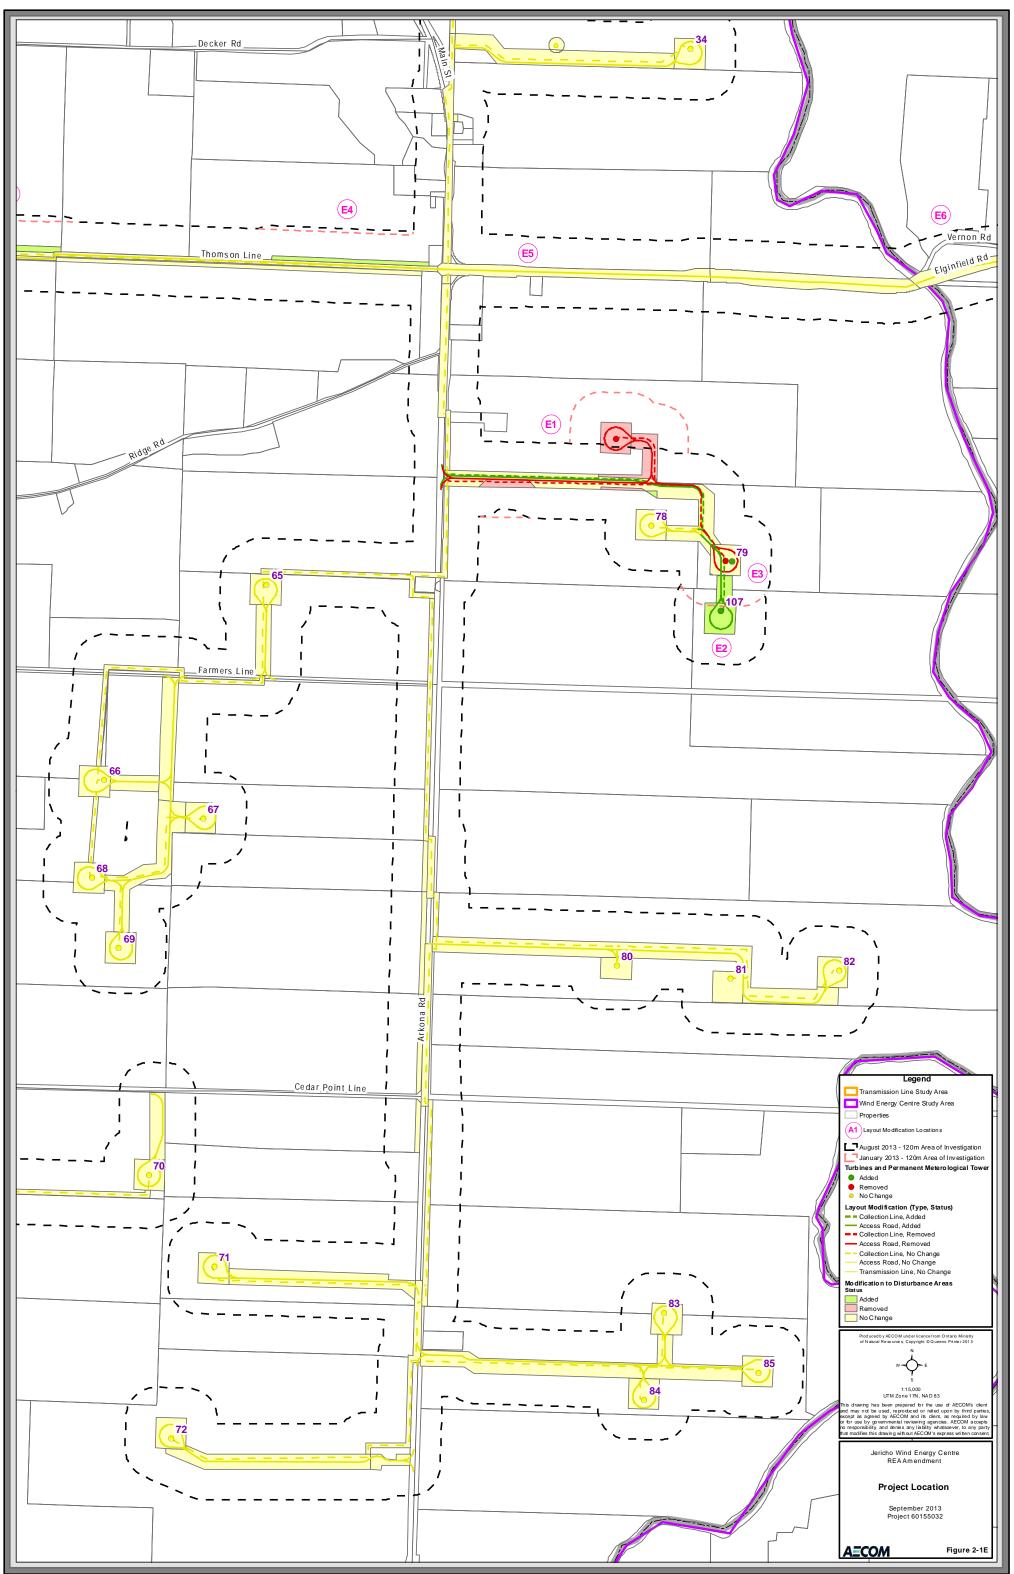
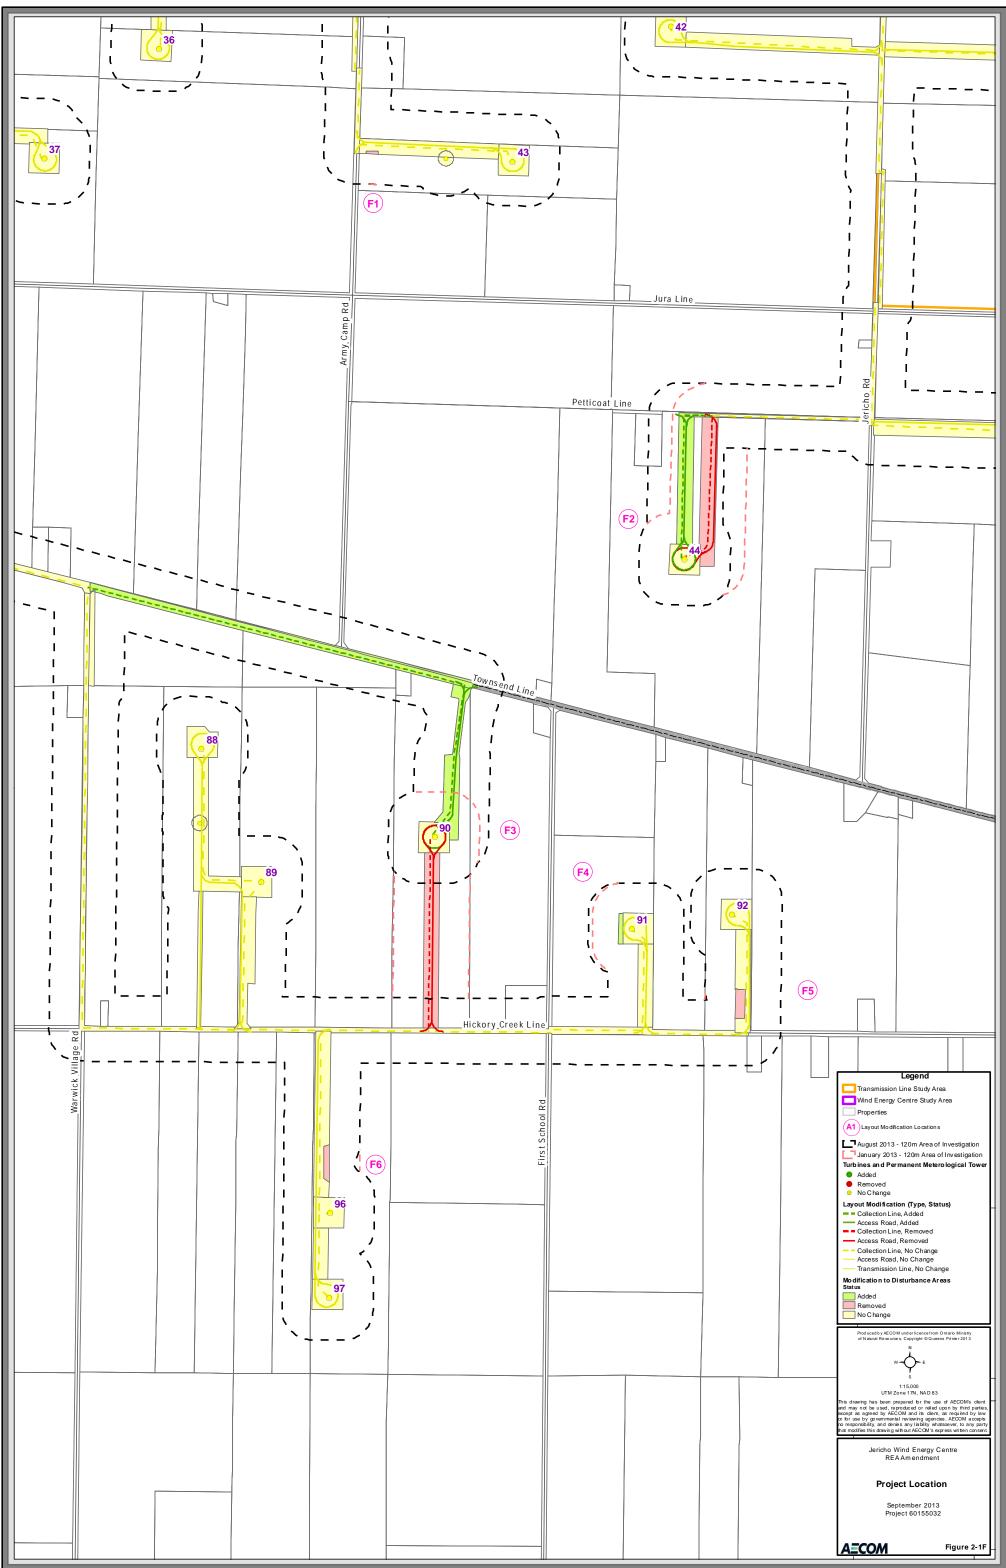
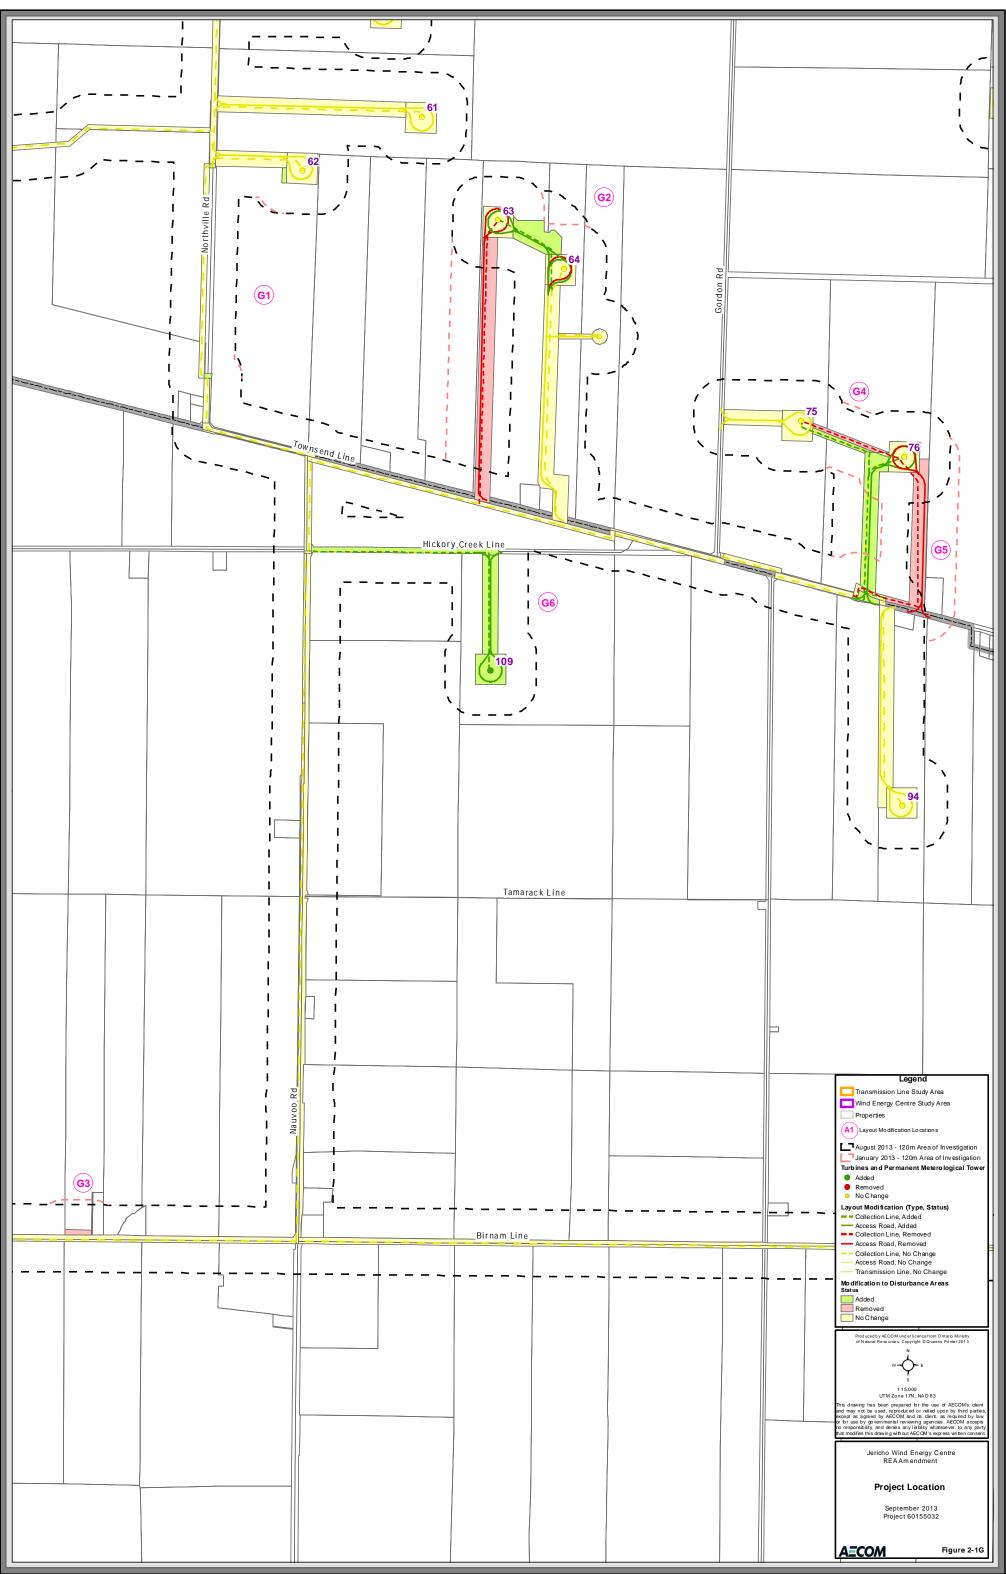
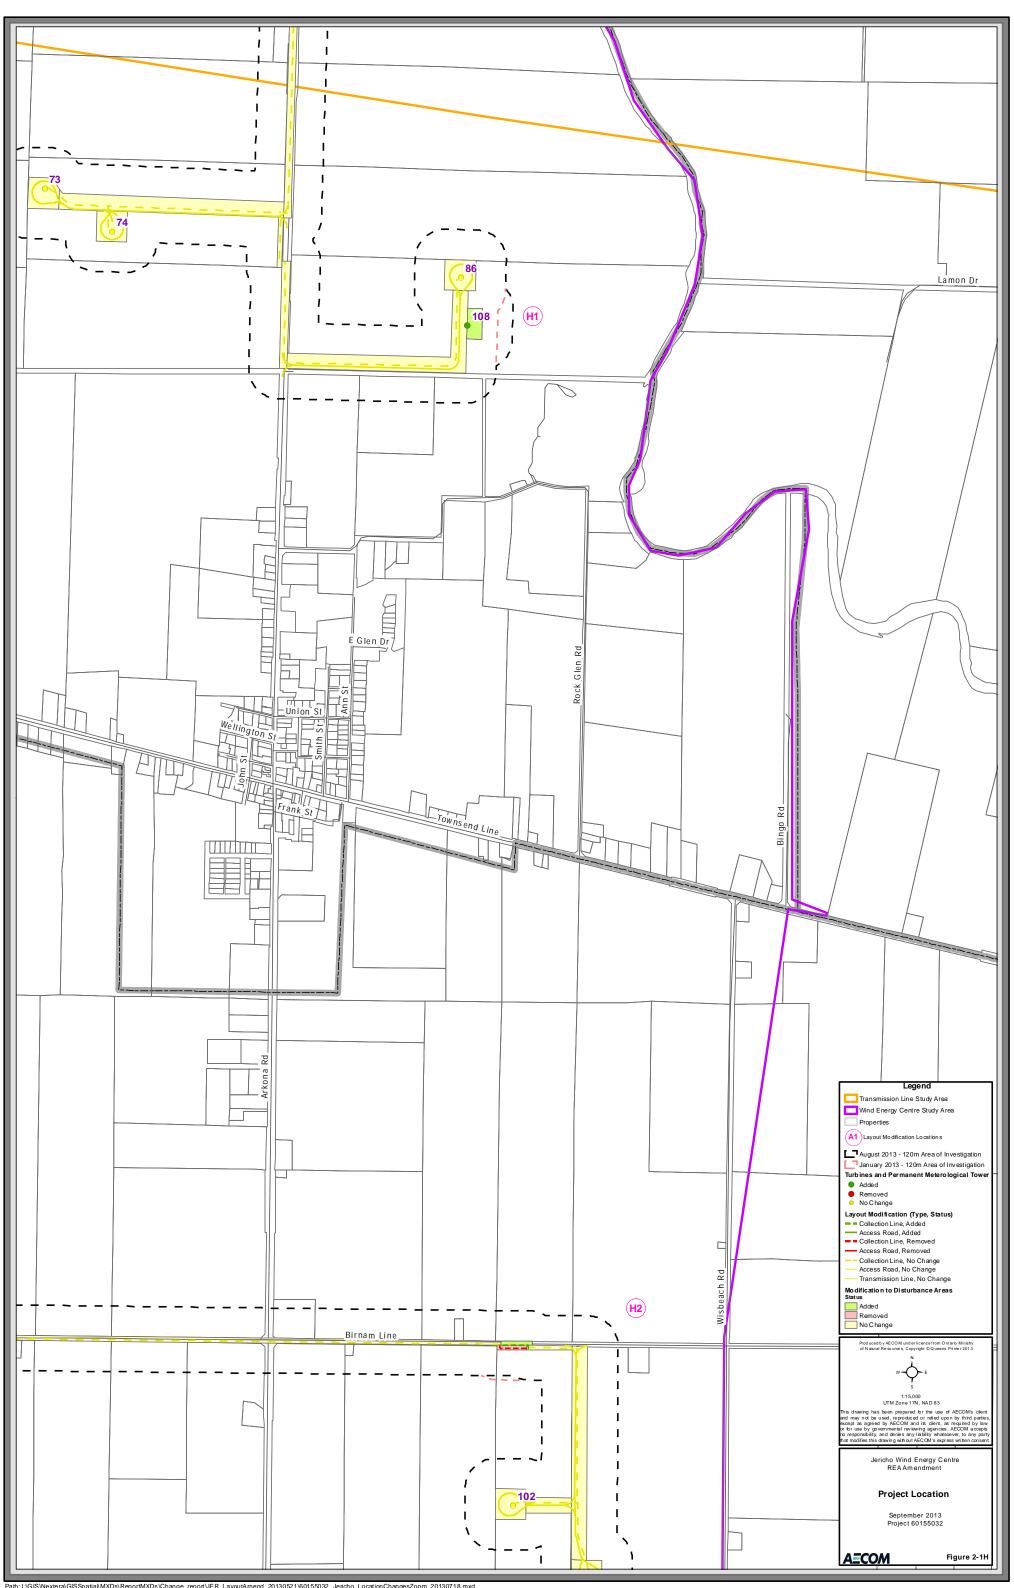
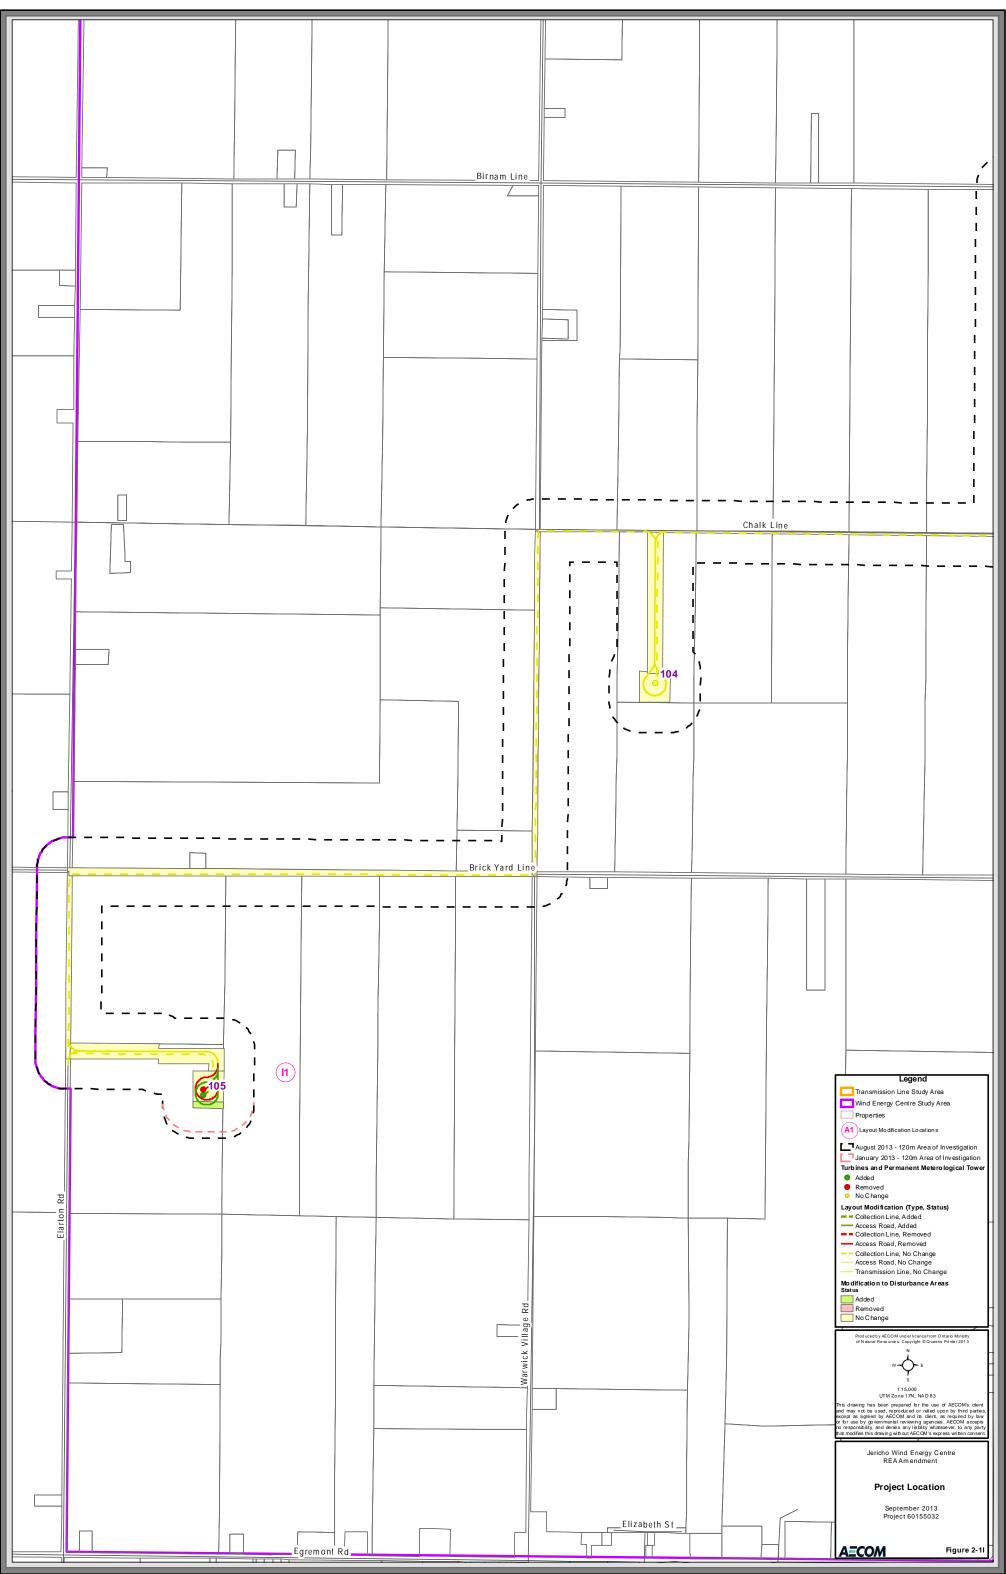
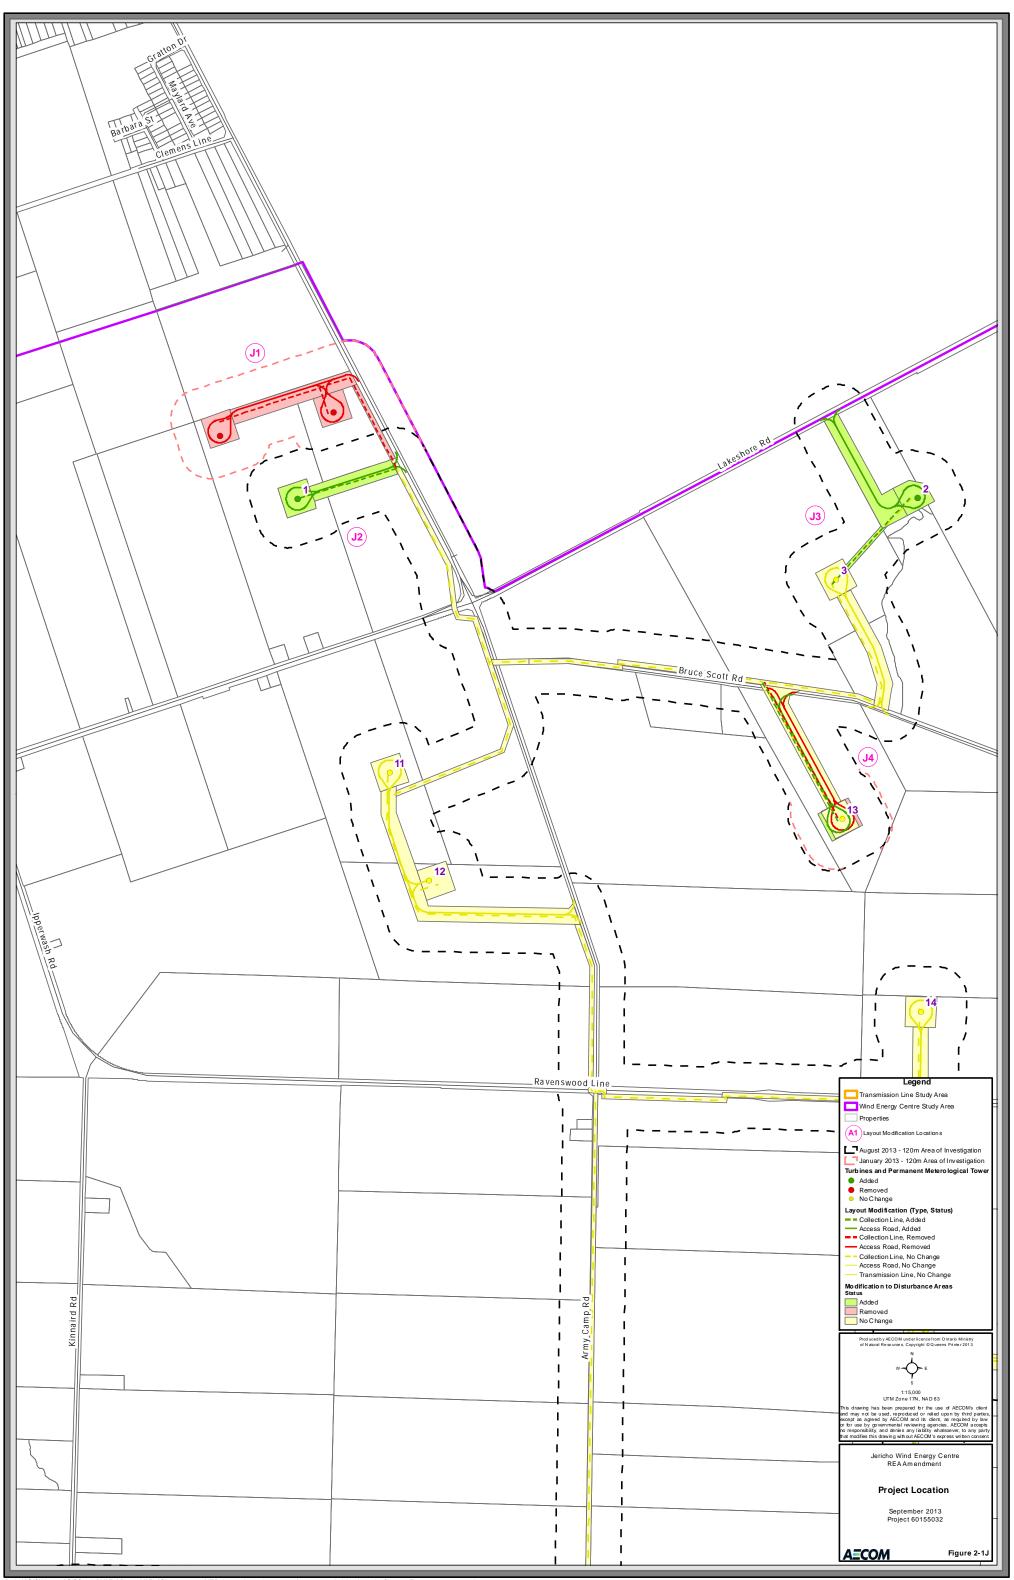
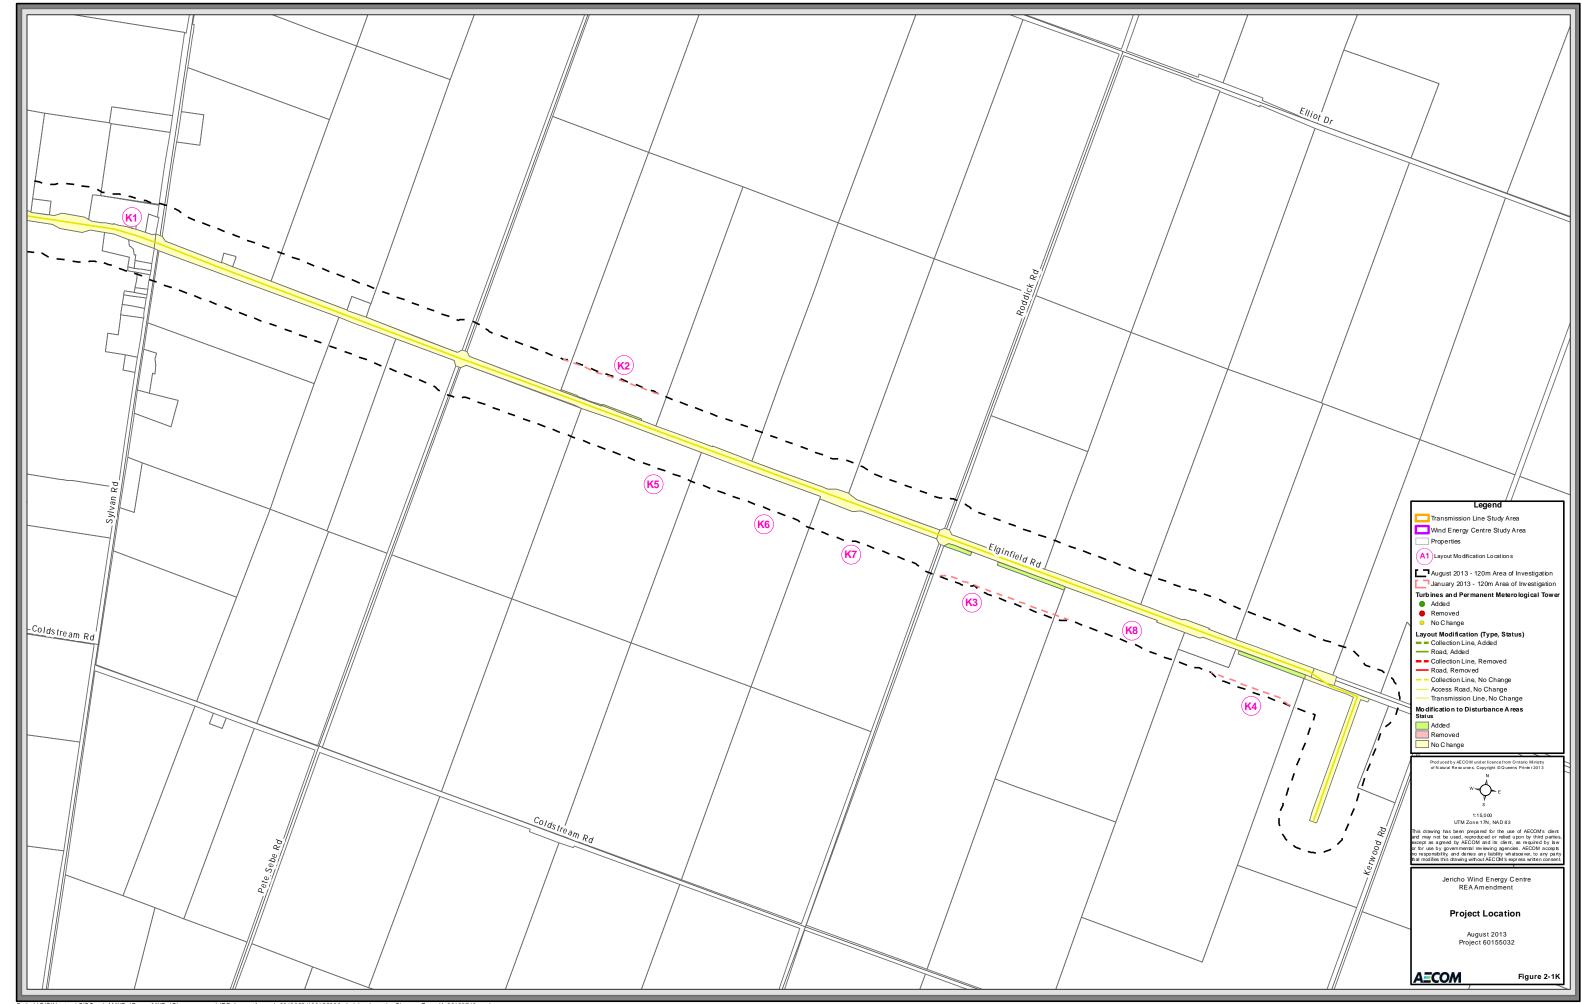
Project Modifications

Figure 2-1 illustrates the modified Project Location. **Appendix A** contains a series of figures showing the details for each of the modifications.
