Jericho Wind, Inc.

## **Final Water Assessment and Water Body Report – Jericho Wind Energy Centre**

60155032

February, 2013

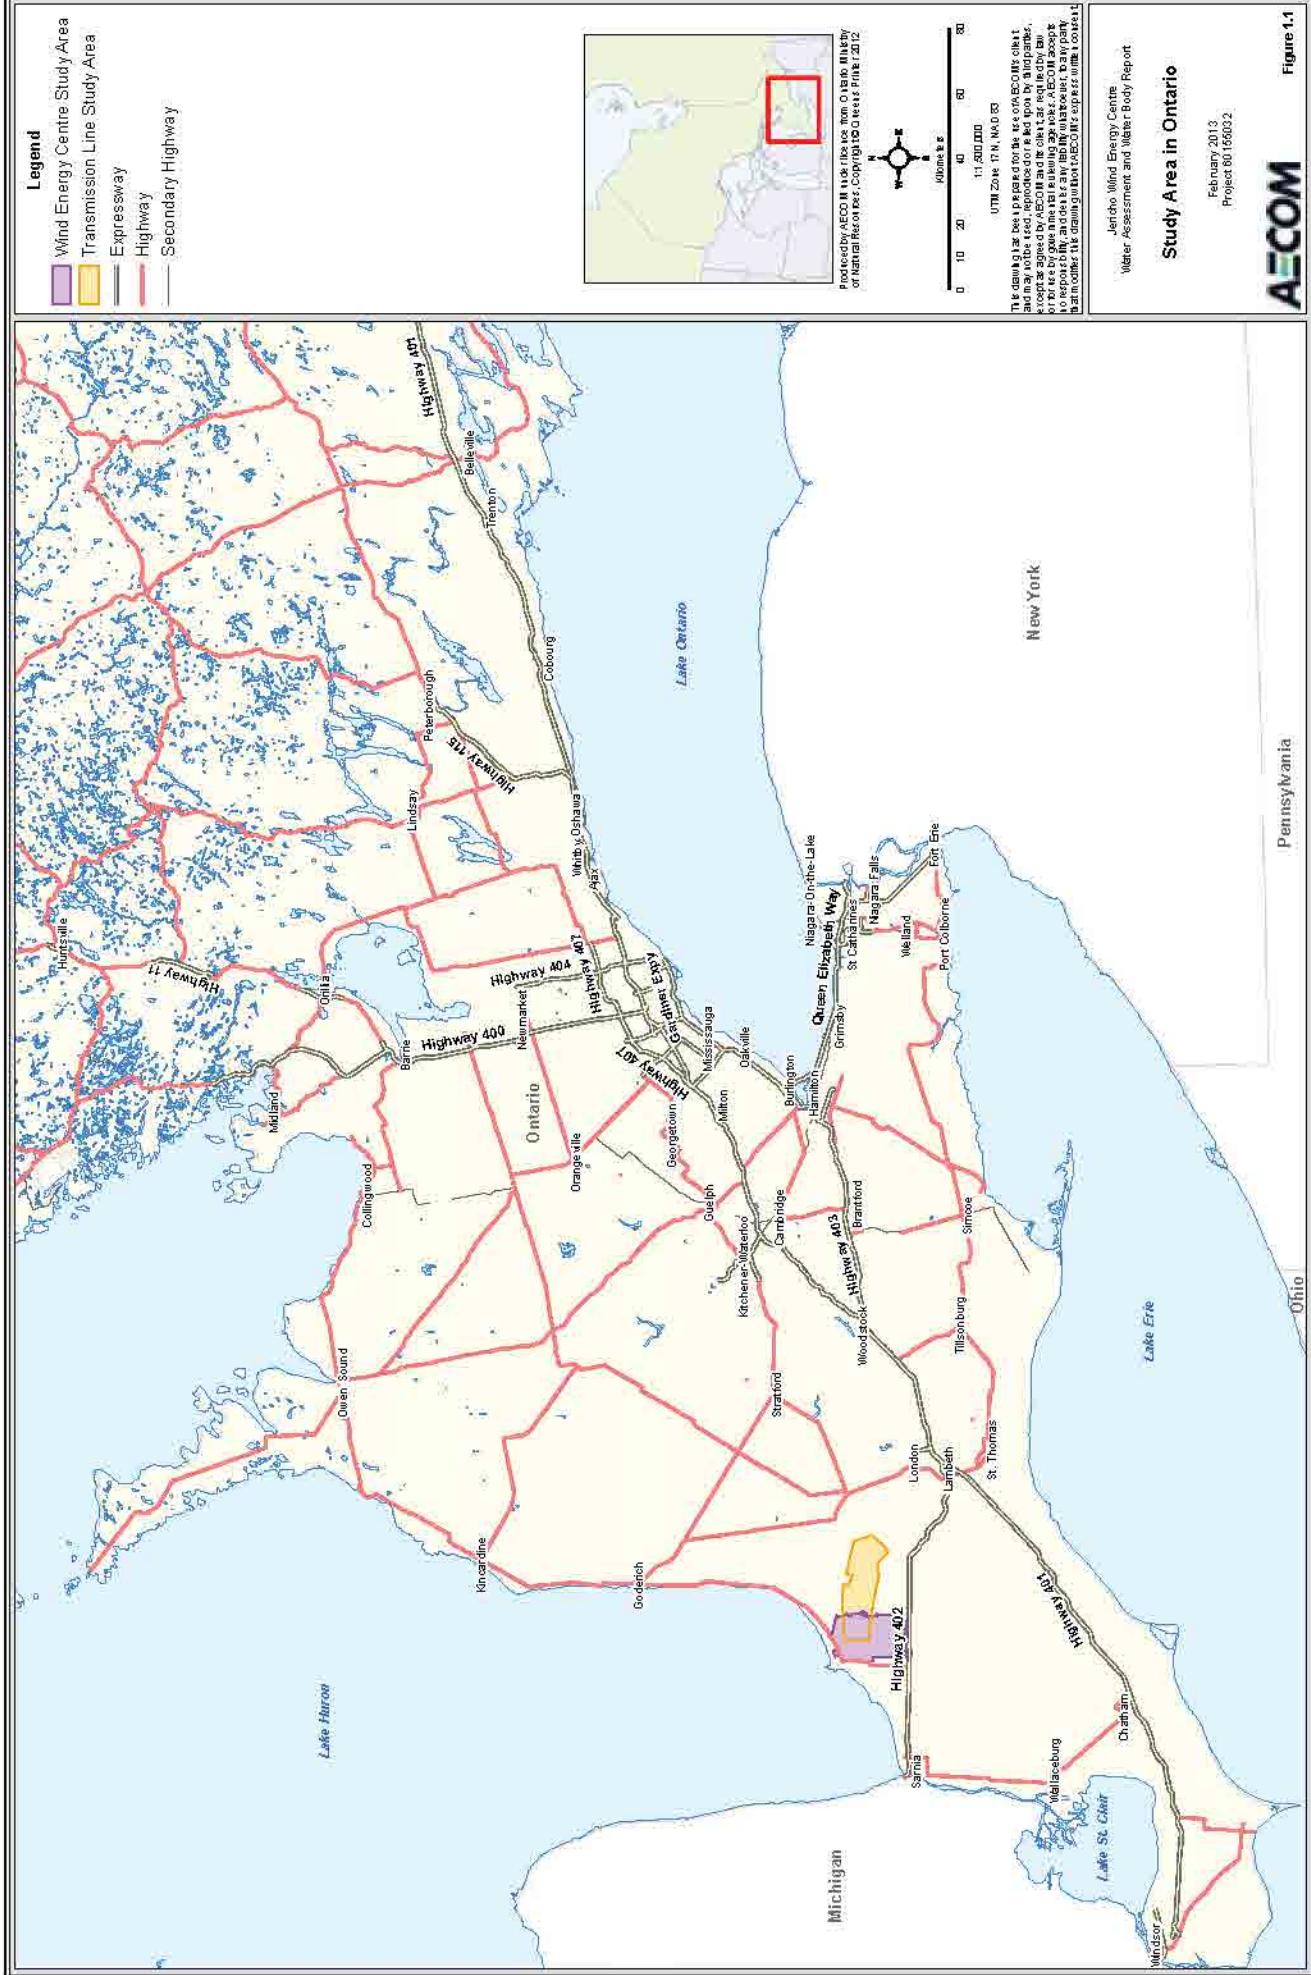
The proposed Project is located in the Municipality of Lambton Shores and the Township of Warwick, in Lambton County, Ontario and in the Municipality of North Middlesex, in Middlesex County, Ontario. The Project Study Area consists of the areas being studied for the wind energy component (Wind Energy Centre Study Area), as well as for the interconnection route (i.e., the area being studied for transmission lines to connect the Project to the electrical grid) (Transmission Line Study Area). The Wind Energy Centre Study Area is generally bounded by Lakeshore Road/Bog Line to the north, Egremont Road to the south, the Lambton Shores/North Middlesex municipal boundary to the east and Rawlings Road/Elarton Road to the west, in Lambton County. The Transmission Line Study Area is generally bounded by Kennedy Line, Parkhill Drive and Elginfield Road to the north, Jura Line, Elm Tree Drive and Poplar Hill Road to the south, Fernhill Drive to the east, and the Jericho Road to the west, in Lambton and Middlesex Counties.

The location of the Project Study Area was defined early in the planning process for the proposed wind energy facility, based on the availability of wind resources, approximate area required for the proposed project, and availability of existing infrastructure for connection to the electrical grid. The Project Study Area was used to facilitate information collection.

Figure 1-1	Jericho Wind Energy Centre Project Study Area .....	2
Figure 1-2	Project Location .....	4
Figure 2-1	Overall Methodology Employed for the Water Body Assessment .....	7
Figure 3-1	Records Review Mapping for the Jericho Project Study Area .....	10
Figure 4-1	Potential Water Bodies Identified through Records Review for Site Investigations .....	27
Figure 4-2	Identified REA and Non-REA Water Bodies and Distance to Project Locations .....	228

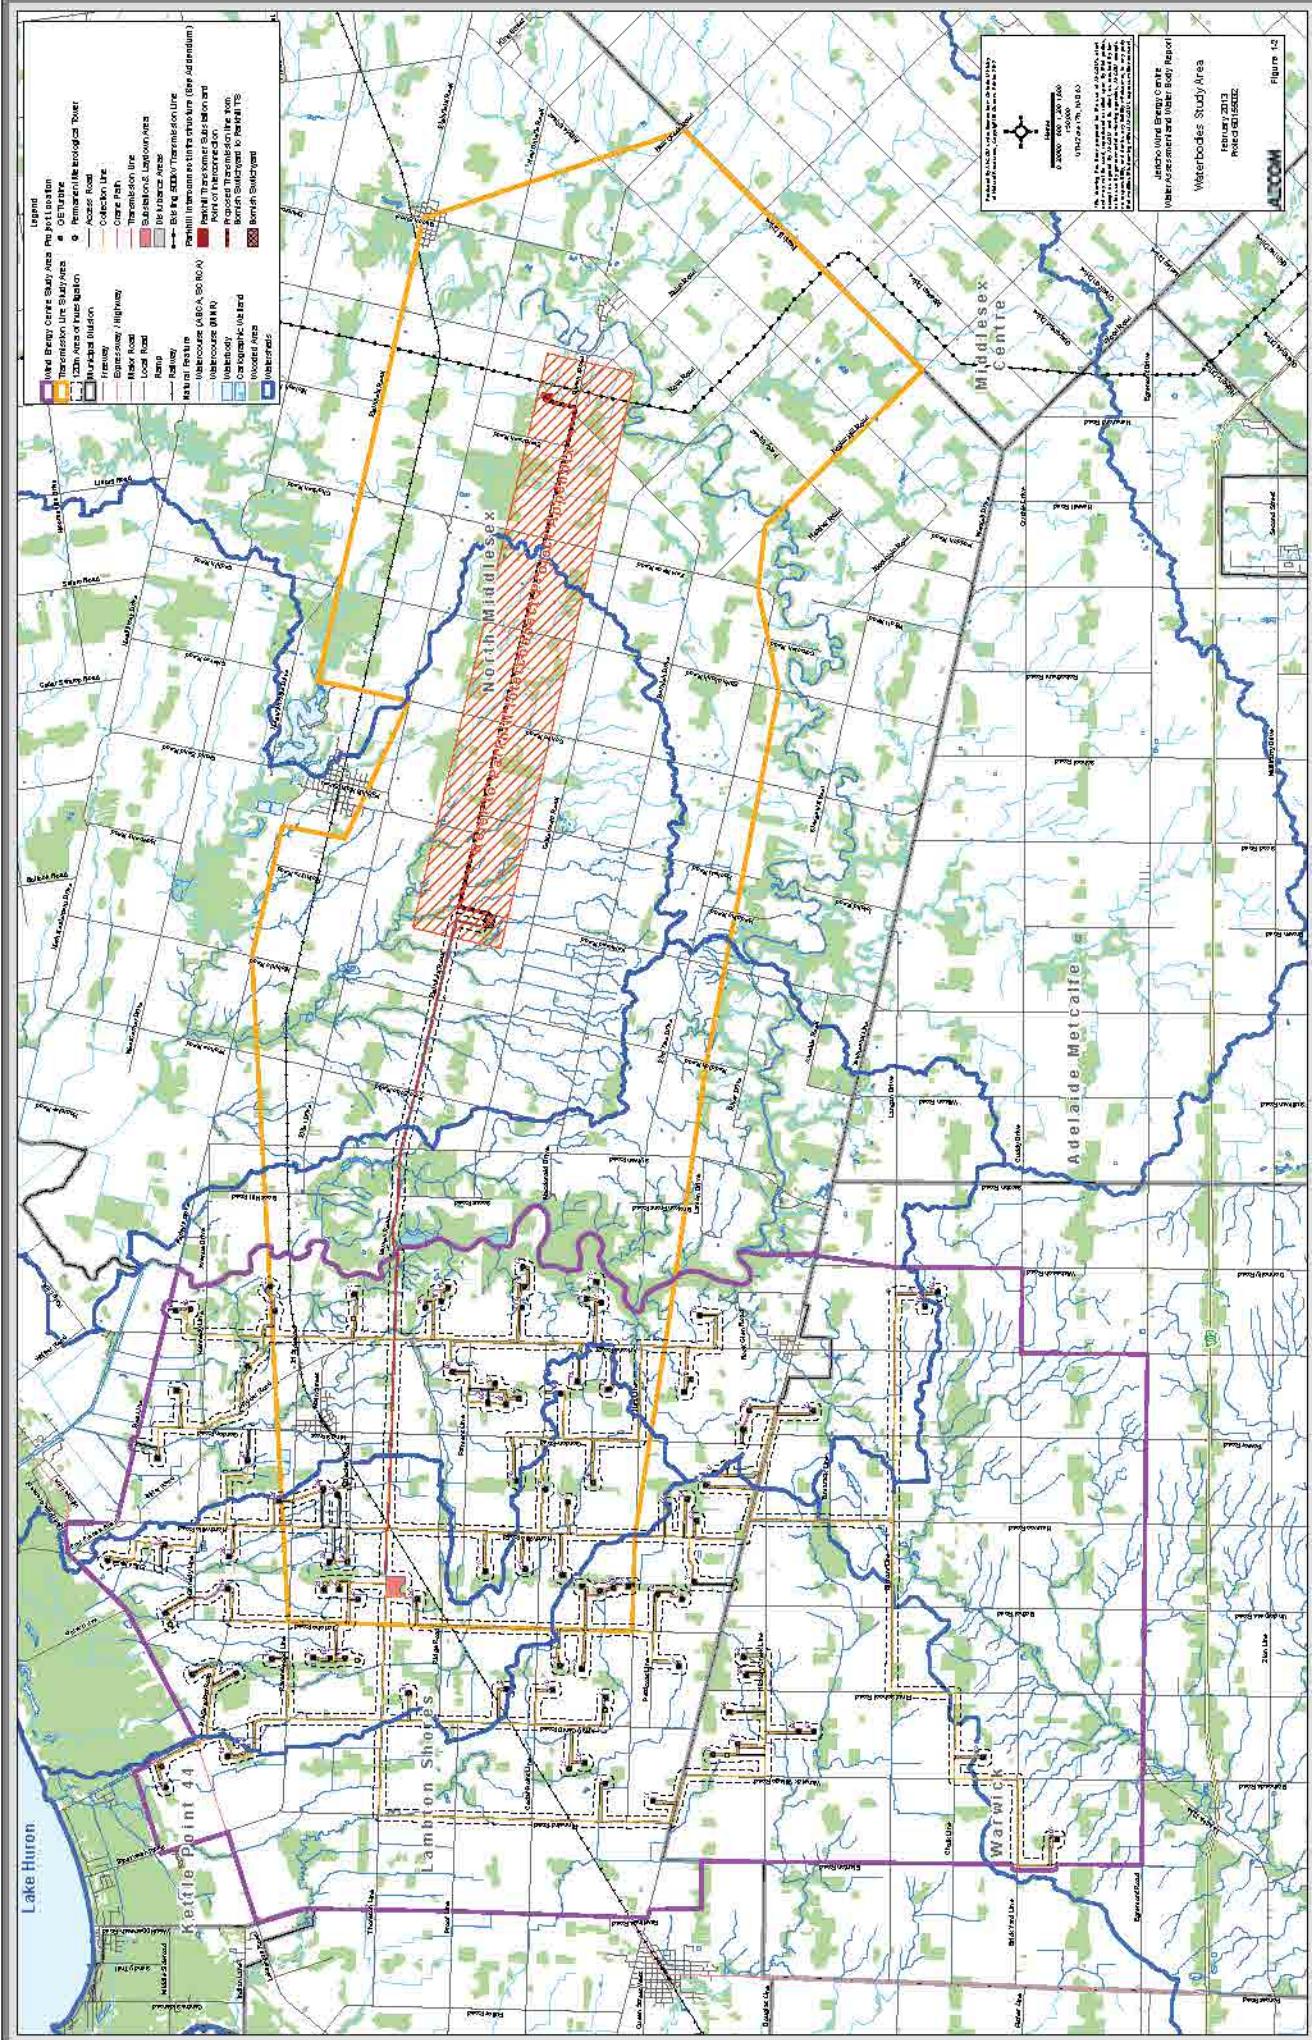
The Project Location is defined as per O. Reg. 359/09 as “*a part of land and all or part of any building or structure in, on or over which a person is engaging in or proposes to engage in the project and any air space in which a person is engaging in or proposes to engage in the project*”. As described therein, the Project Location boundary is the outer limit of where site preparation and construction activities will occur (i.e., Disturbance Areas described below) and where permanent infrastructure will be located, including the air space occupied by turbine blades. The proposed Project Location is shown on Figure 1-2, and includes the locations of the components of the Project listed below.

*Disturbance Areas* have been identified surrounding various Project components, and are depicted on Figure 1-2. These denote areas where temporary disturbance during the construction phase may occur as a result of: temporary project component laydown and storage areas, crane pad construction, turbine turnaround areas, and construction of access roads and electrical collection system. With the exception of the project components described above, no permanent infrastructure is proposed within these areas. Following construction activities, the land will be returned to pre-construction conditions.

The above mentioned Project components, with the exception of the common 115 kV transmission line from the Bornish switchyard to the PCC, are depicted in the Project Location figure below (please refer to **Appendix A** for the Water Assessment and Water Body Report for the Parkhill Interconnect Project).

For the purposes of completing the Water Bodies Assessment, a 120 m Area of Investigation was defined, based on the requirements of O. Reg. 359/09 and the *Technical Guide to Renewable Energy Approvals* (MOE, June 2011). The Area of Investigation encompasses the Project Location and an additional 120 m measured from the Project Location boundary as described above. As part of the REA process, features located within the 120 m Area of Investigation must be investigated and evaluated to determine whether they are significant or provincially significant, in order to ascertain whether development prohibitions apply as per O. Reg. 359/09. The location of the 120 m Area of Investigation for the Jericho Study Area is shown on Figure 1-2.

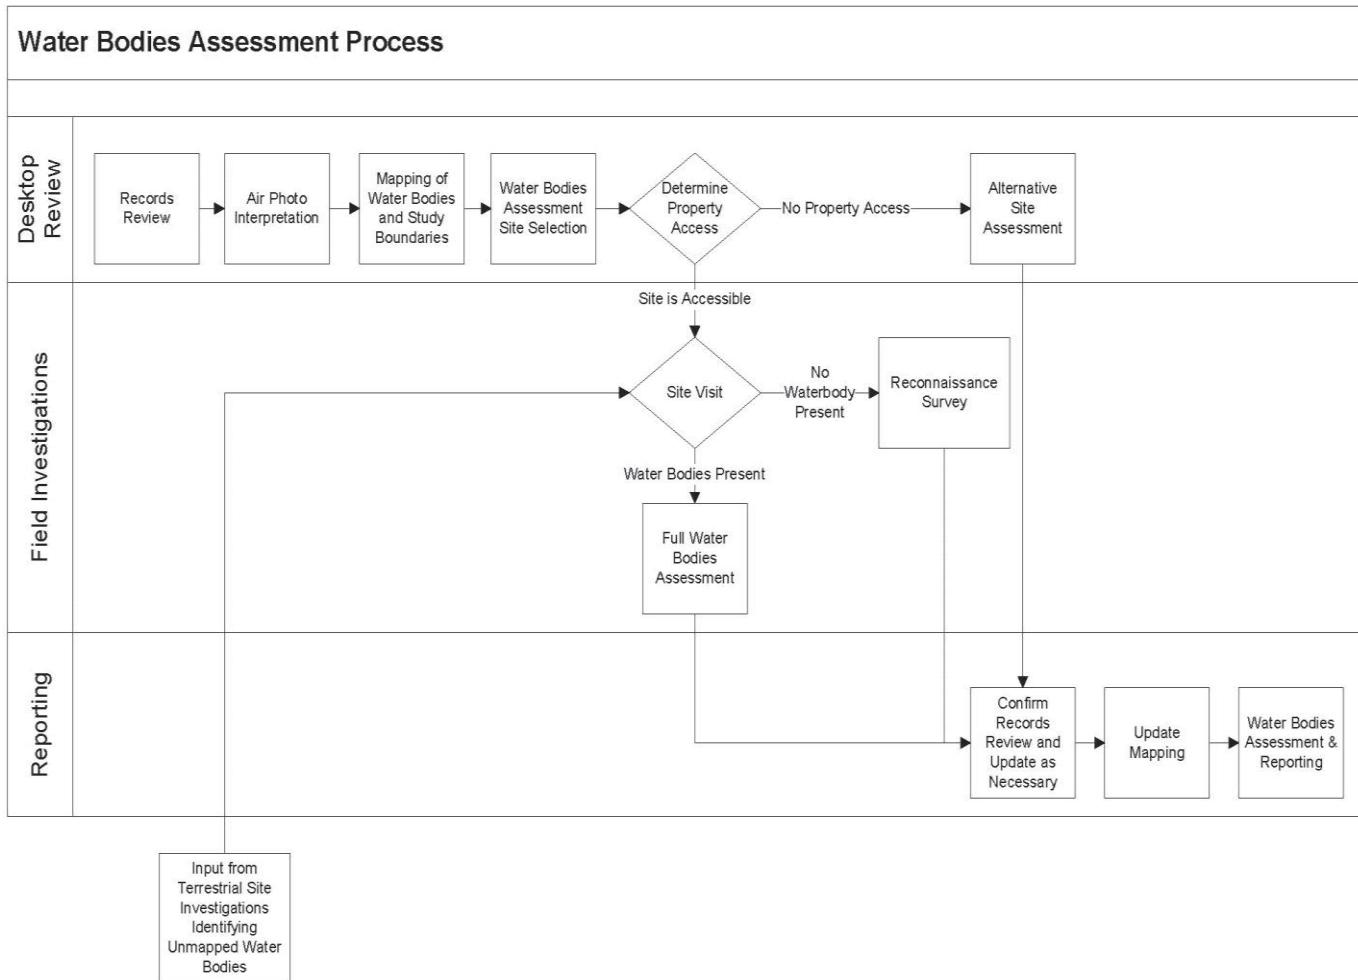
**Figure 2-1      Overall Methodology Employed for the Water Body Assessment**

**Figure 2-1** outlines the approach undertaken to identify, analyze, and evaluate all water bodies identified within the Project Location, in compliance with O. Reg. 359/09.

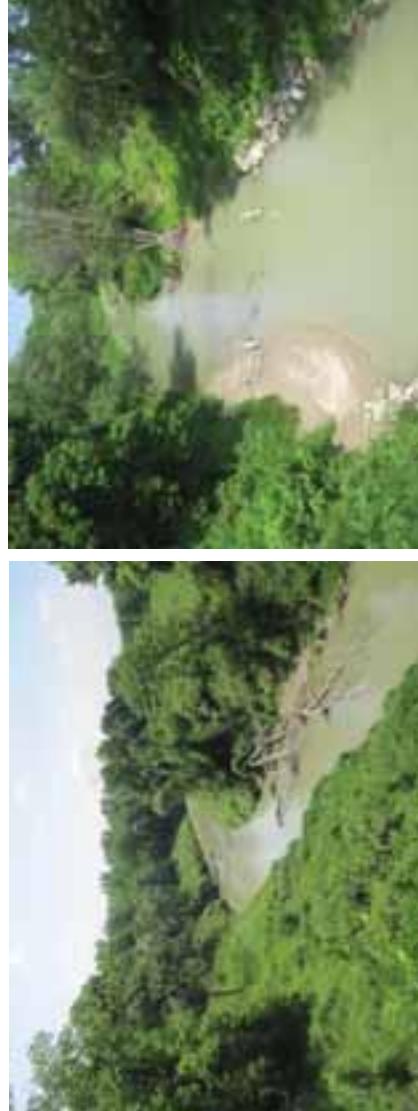
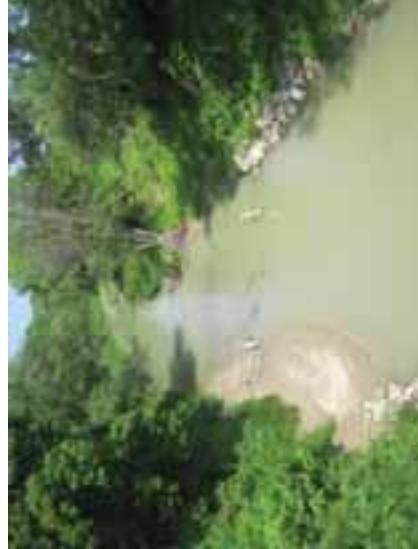
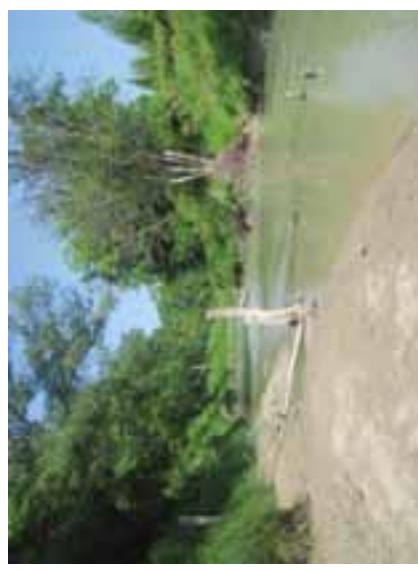
Watercourse Name	Ausable River	R2.2
DFO Drain Classification	E	MWW(m): 12 MBW(m): 14

**Photograph 1. Site overview ↑**

**Photograph 2. Channel overview ↑**

**Photograph 3. Channel view ↑**

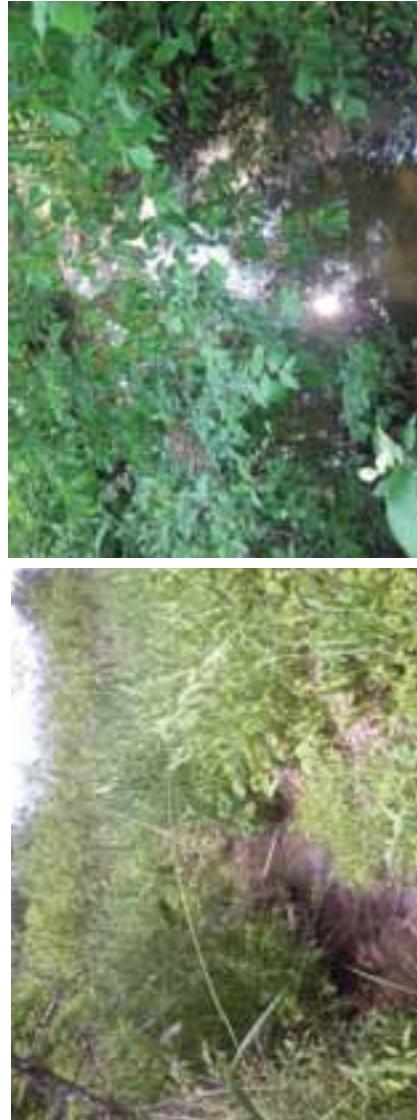
R2.14
MWD(m): 0.15
MBD(m): 0.42

**Photograph 1. Channel view in southern section ↑****Photograph 2. Channel view in forest ↑**

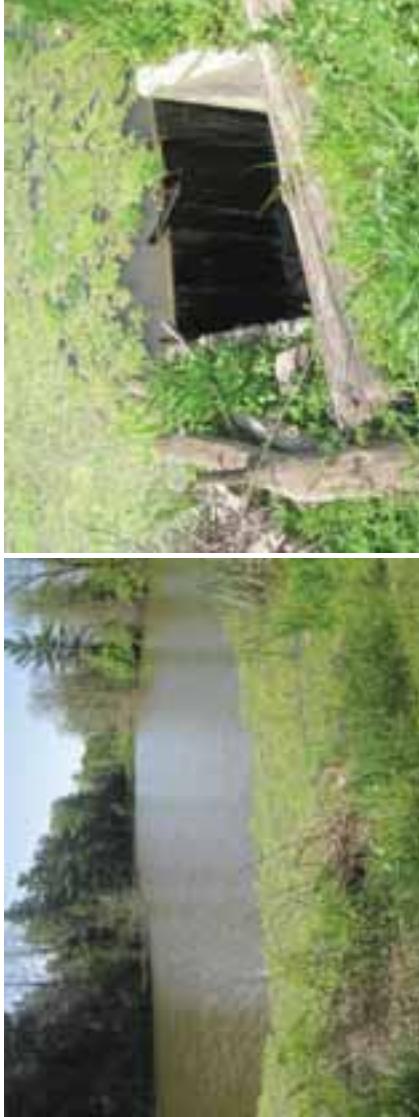
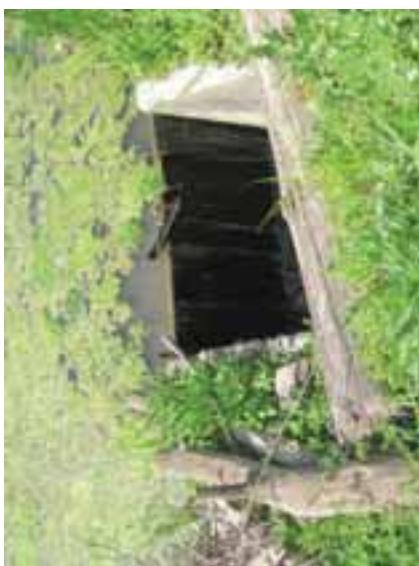
Feature ID	Project Component	Investigation Date	Description of Site	Feature Description	Feature Sensitivity
P2.136	• Collection Line Buffer	May 15, 2012	<ul style="list-style-type: none"> <li>The pond is located in a forested area beside a residence. The pond is 80 m by 30 m. The pond is online with a riparian buffer greater than 3 m of trees and grasses.</li> </ul>	<ul style="list-style-type: none"> <li>R2.14 is dammed by a manmade structure creating the pond. The water was turbid at time of investigation. <i>In-situ</i> cover contains algae and grasses around the perimeter of the pond.</li> </ul>	Moderate

**Photograph 1. Pond overview ↑**

**Photograph 2. Dam ↑**

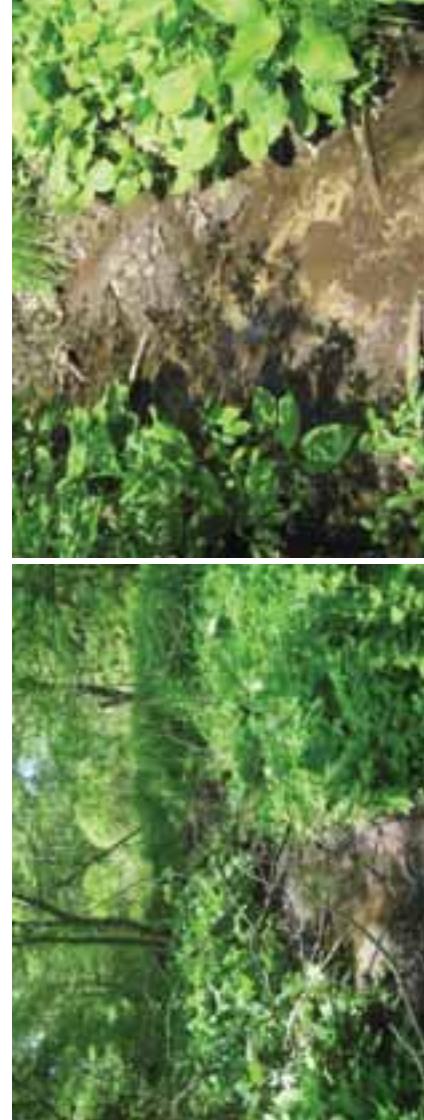
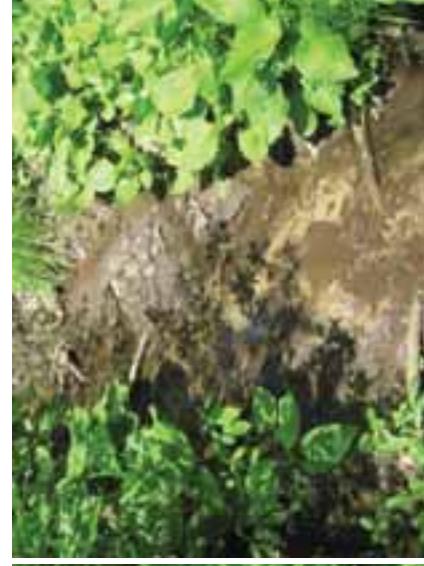
Watercourse Name		Wilcox Drain Branch	R2.18
DFO Drain Classification		U	MWW(m): 0.7
			MBW(m): 1.2
			MWD(m): 0.05
			MBD(m): 0.15

**Photograph 1. Site overview ↑**

**Photograph 2. Channel view ↑**

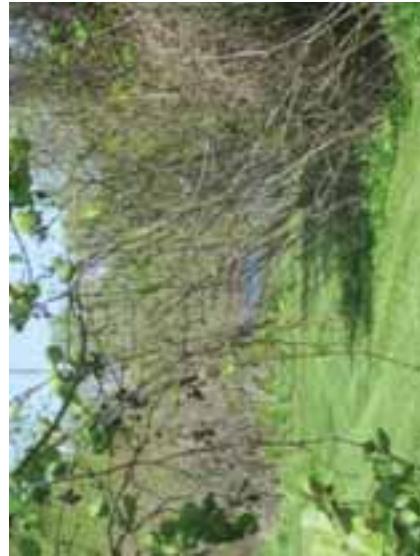
Feature ID	Project Component	Investigation Date	Description of Site	Feature Description	Feature Sensitivity
P2.18*	<ul style="list-style-type: none"> <li>• Collection Line Buffer</li> <li>• Road Buffer</li> </ul>	May 15, 2012	<ul style="list-style-type: none"> <li>• The pond is located in a deciduous forest (classified as FOD5-8, FOD6b, ELC Feature ID 250) surrounded by agricultural fields.</li> <li>• The pond could not be assessed because access was not granted. Pond appears to be connected to R2.18.</li> </ul>		High

**Photograph 1. Site overview ↗**

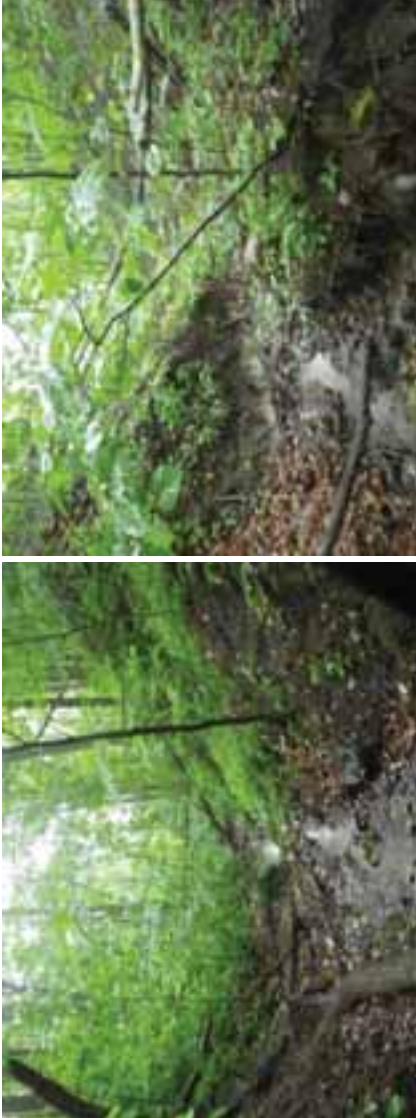
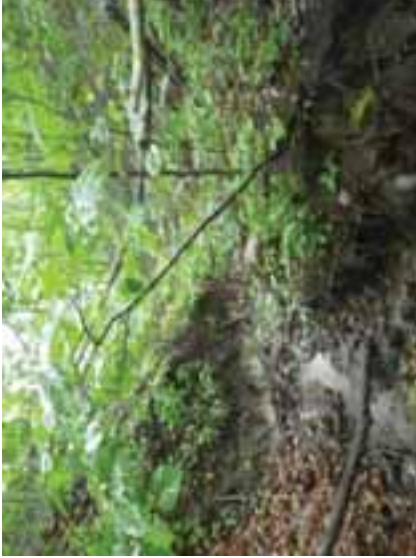
Watercourse Name		Ausable River Trib	R2.51
DFO Drain Classification		U	MWW(m): 0.2
			MWD(m): 0.02
			MBW(m): 2.0
			MBD(m): 0.6

Photograph 1. Site overview ↑

Photograph 2. Channel overview ↑

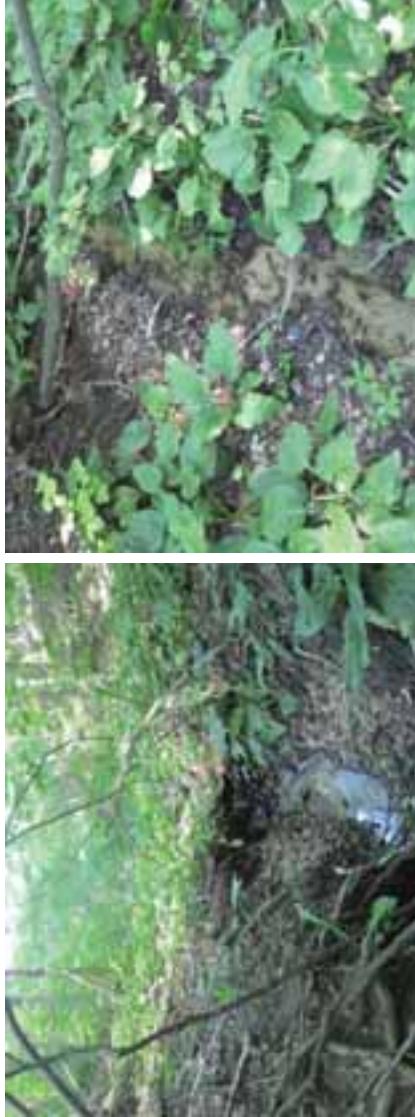
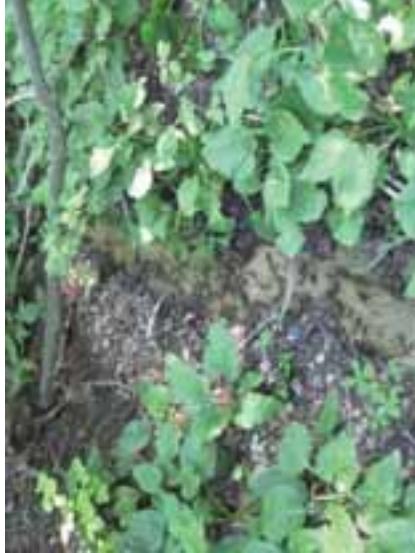
Feature ID	Project Component	Investigation Date	Description of Site	Feature Description	Feature Sensitivity
R2.70	• Transmission Line Buffer	June 12, 2012	<ul style="list-style-type: none"> <li>The watercourse begins as groundwater seeps and flows through deciduous forest, shallow marsh and cultural plantation (classified as CUP3-2, MAS2-1, FOD6a, ELC Feature ID 90). No tile drain inputs were noted at time of investigation. Surrounding topography is a valley sloped towards the watercourse. Riparian buffer is greater than 6 m.</li> </ul>	<ul style="list-style-type: none"> <li>The watercourse is a defined natural channel. The watercourse was all run. The water was clear and had moderate flow at time of investigation. It is classified as unknown by ABCA. Banks are stable and well vegetated. Substrate is dominated by sand followed by silt, clay and organics. Canopy cover is high and is dominated by trees. Instream habitat cover is low and consists of only woody debris. The headwaters begin as a seep which is a groundwater indicator. The water level was very low creating a potential low flow barrier to fish passage.</li> </ul>	High

R2.70	
MWW(m):	0.35
MBW(m):	0.45

**Photograph 1. Site overview** ↑

**Photograph 2. Channel view** ↑

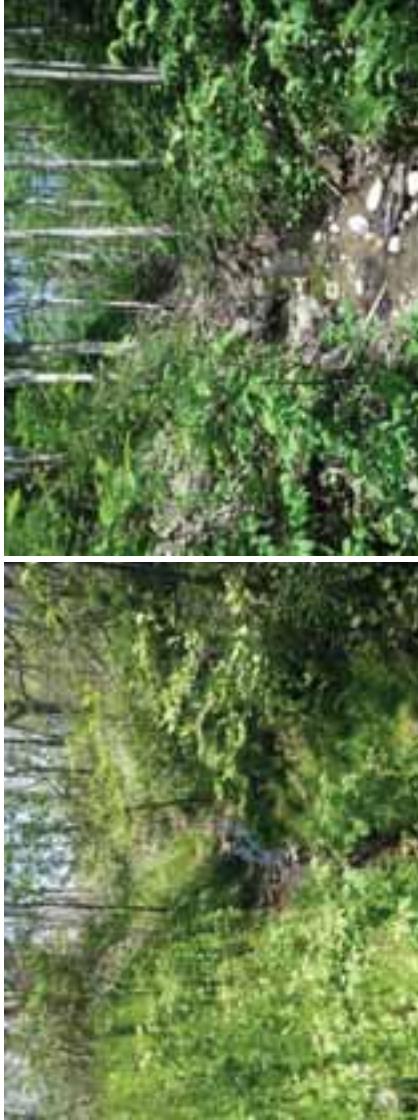
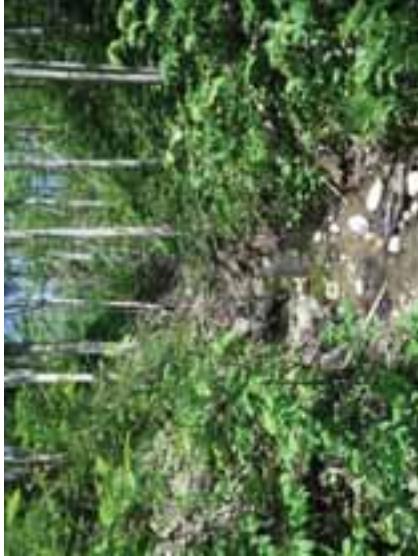
Watercourse Name	Ausable River Trib
DFO Drain Classification	U
MWW(m):	R2.73
MWD(m):	0.9
MBW(m):	0.05
MBD(m):	3.0

**Photograph 1. Site overview ↑**

**Photograph 2. Channel overview ↑**

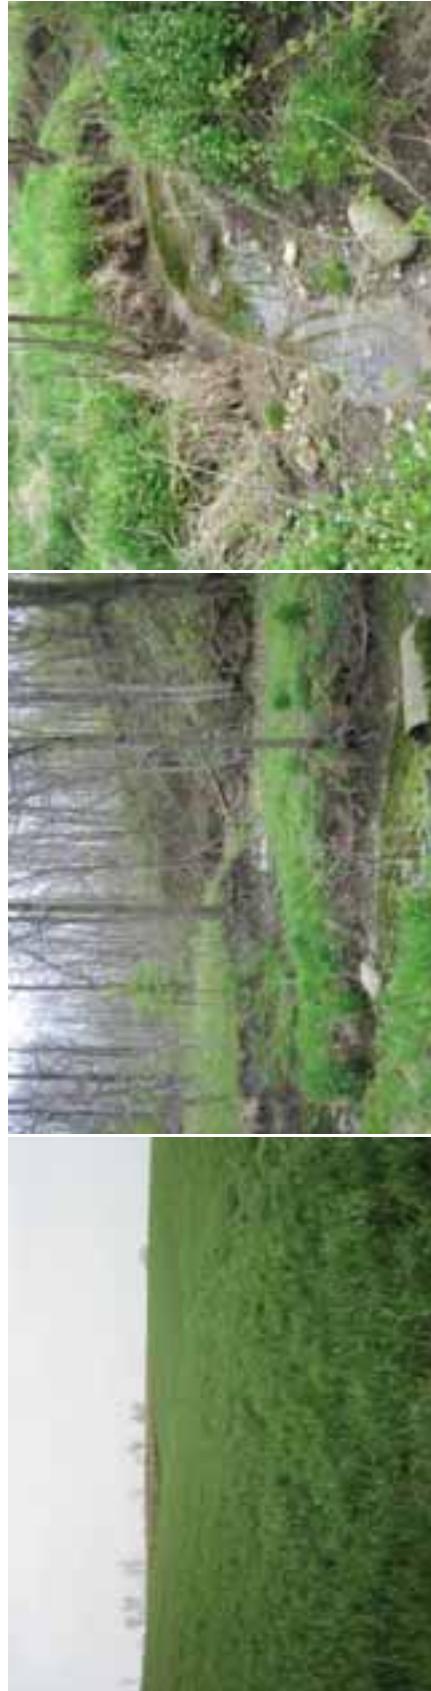
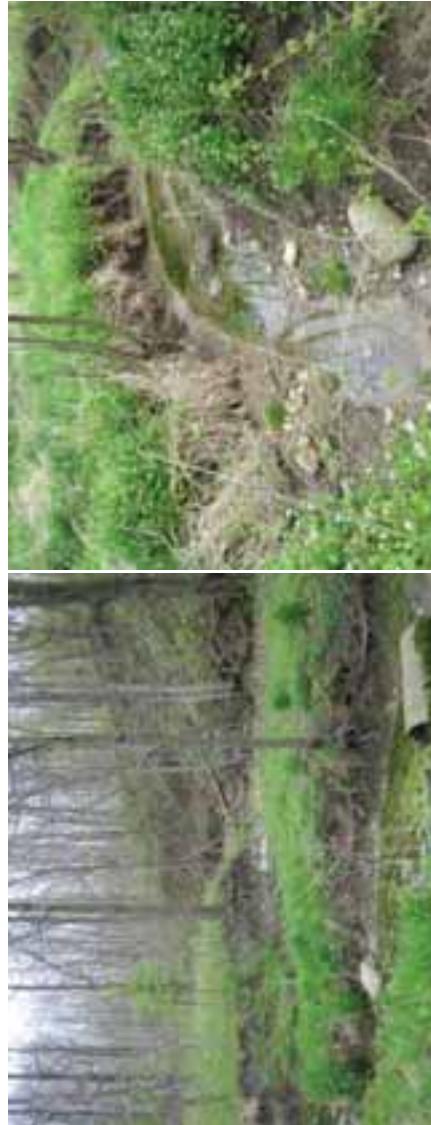
R2.101	
<b>MWD(m):</b>	0.09
<b>MBD(m):</b>	0.4

Photograph 1. Site overview in agricultural fields ↑

Photograph 2. Site overview in forest ↑

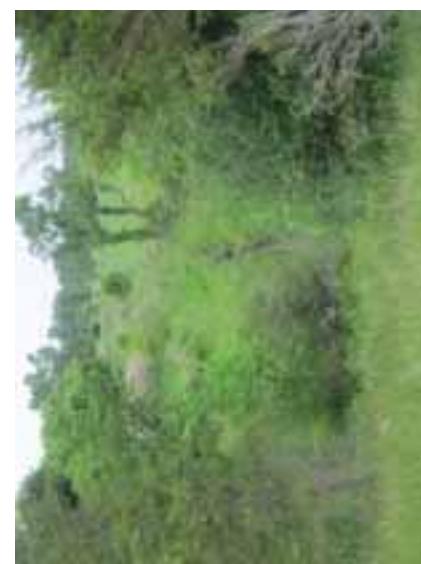
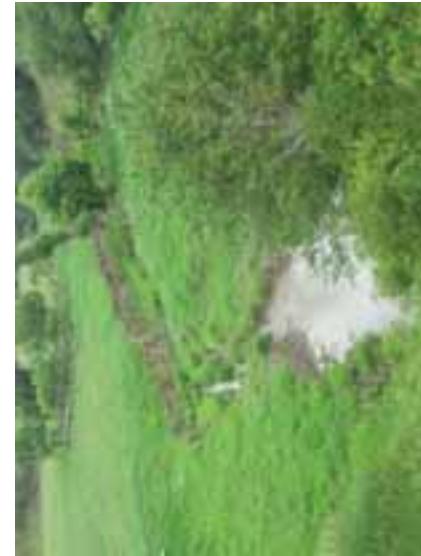
R1.2
MWW(m): 0.5
MBW(m): 1.5

Photograph 1. Site overview south of Elginfield Road↑

Photograph 2. Site overview north of Elginfield Road↑

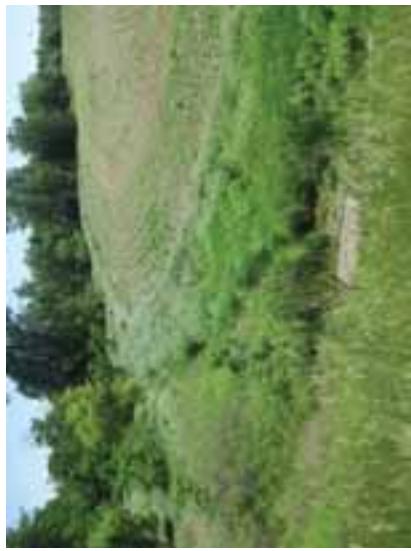
R1.49	
MWD(m):	n/a
MBD(m):	0.5

**Photograph 1. Site overview ↑**

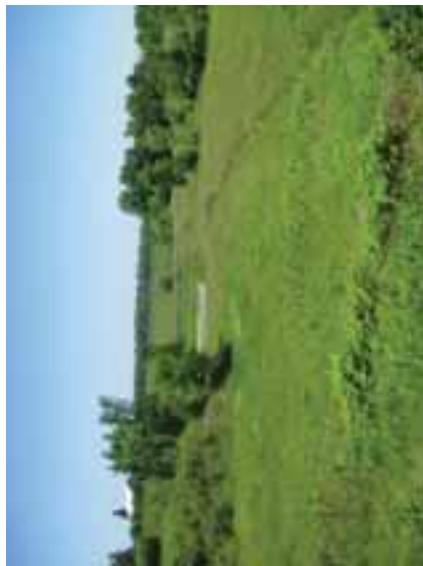
Feature ID	Project Component	Investigation Date	Description of Site	Feature Description	Feature Sensitivity
P1.35*	• Transmission Line Buffer	June 12, 2012	• The pond is located in livestock pasture and in a valley. • The pond is 10 m by 7 m. • Riparian buffer consists of grasses.	• The pond is a natural online feature and connected to R1.49. • The water was turbid at time of investigation. Duckweed was observed in the pond.	Moderate

**Photograph 1. Pond overview** ↑

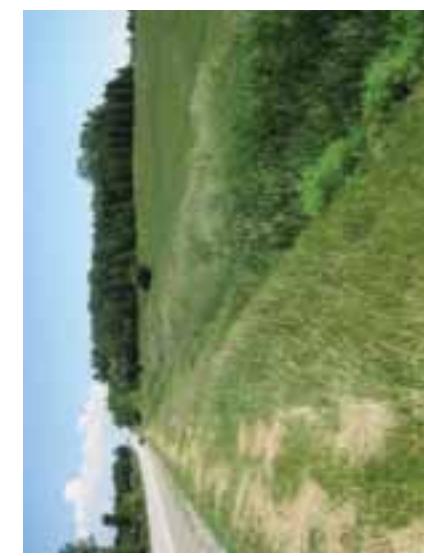
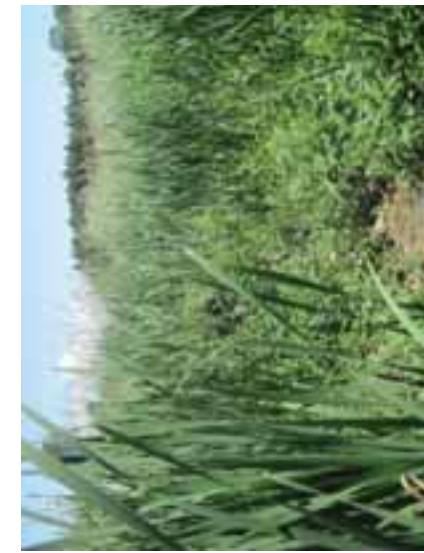
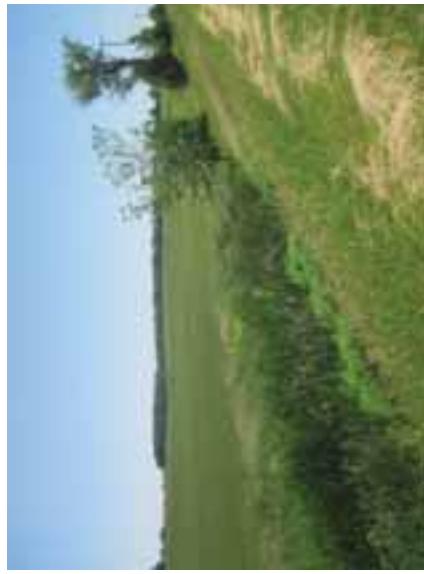
<b>R1.60</b>	<b>MWW(m):</b> <b>MBW(m):</b>	<b>R1.60</b>	<b>MWD(m):</b> <b>MBD(m):</b>
	0.8 2.0		0.12 0.45

**Photograph 1. Site overview ↑**

**Photograph 2. Channel view ↑**

**Photograph 3. Site overview in agricultural field ↑**

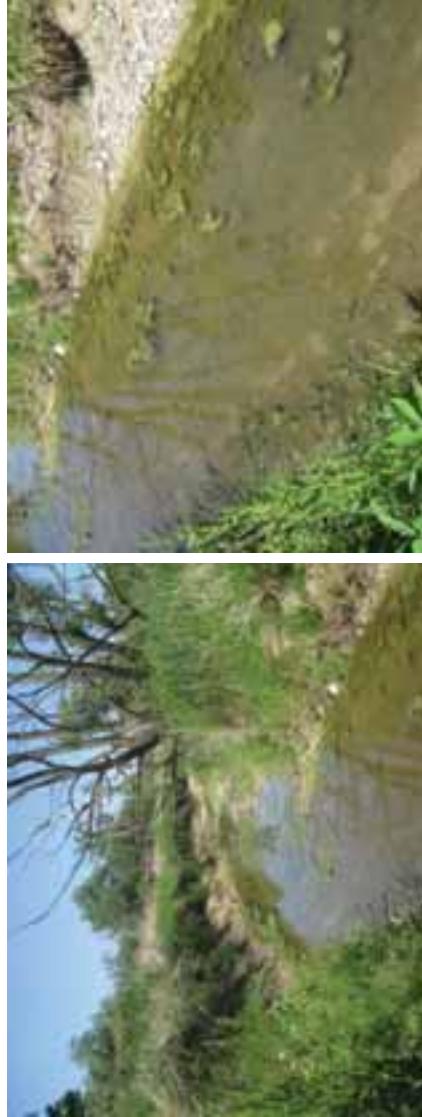
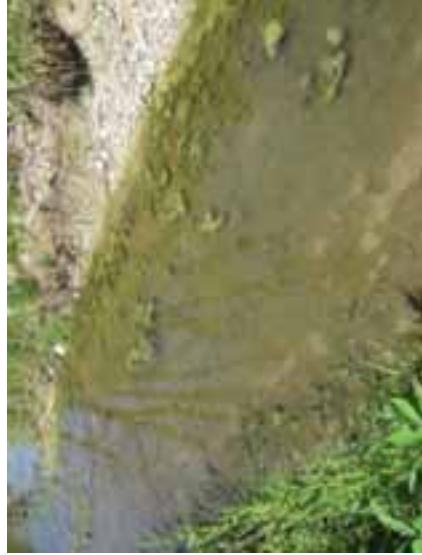
R1.82	
MWD(m):	0.14
MBD(m):	0.4

**Photograph 1. Site overview ↑**

**Photograph 2. Channel view ↑**

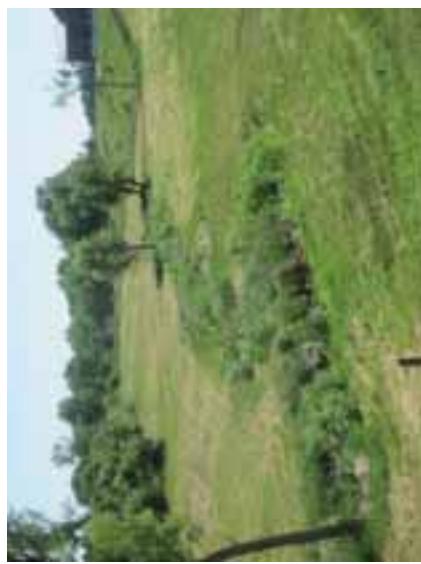
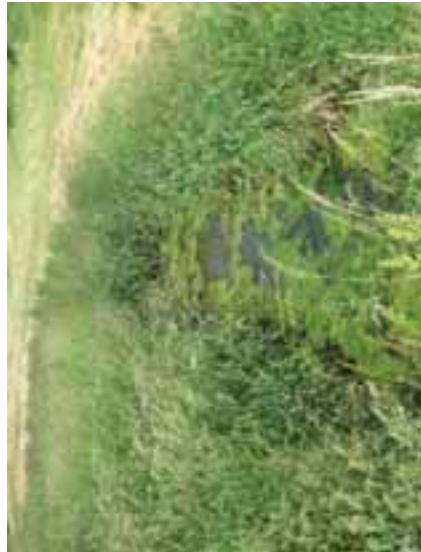
Watercourse Name	Ptsebe Trib WW C	R1.84								
DFO Drain Classification	C	<table border="1"> <thead> <tr> <th>MWW(m)</th> <td>2.0</td> <th>MWD(m):</th> <td>0.2</td> </tr> </thead> <tbody> <tr> <th>MBW(m):</th> <td>3.0</td> <th>MBD(m):</th> <td>0.5</td> </tr> </tbody> </table>	MWW(m)	2.0	MWD(m):	0.2	MBW(m):	3.0	MBD(m):	0.5
MWW(m)	2.0	MWD(m):	0.2							
MBW(m):	3.0	MBD(m):	0.5

Photograph 1. Site overview ↑

Photograph 2. Channel view ↑

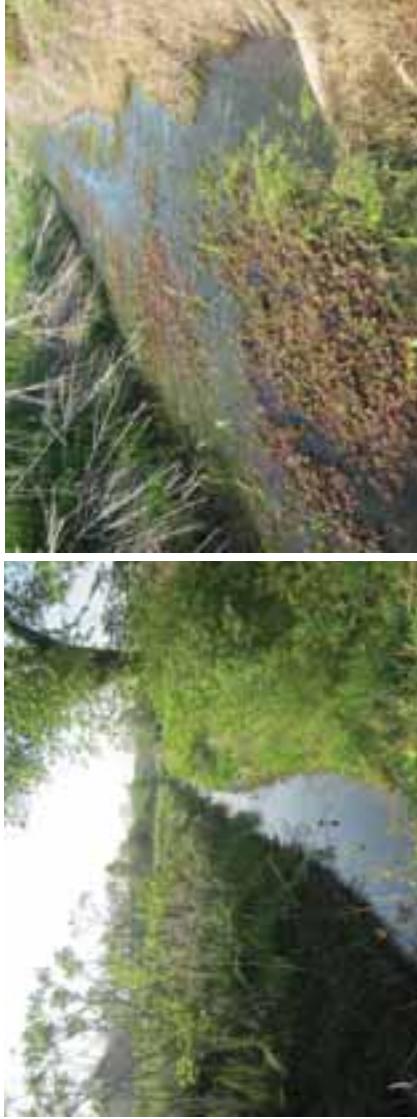
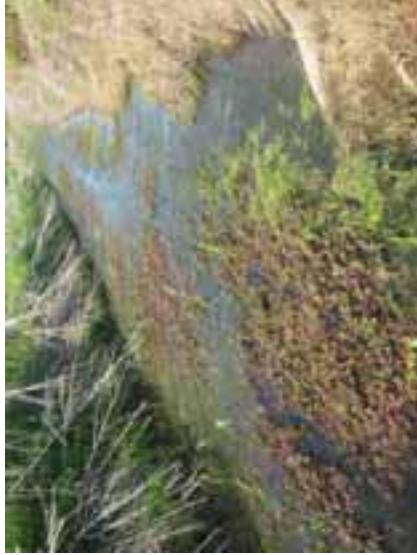
Watercourse Name	Borthwick Drain	R2.10-B
DFO Drain Classification	U	MWW(m): MWD(m): MBW(m):
		2.3 0.2 4.5 0.8

Photograph 1. Site overview ↗

Photograph 2. Channel view ↗

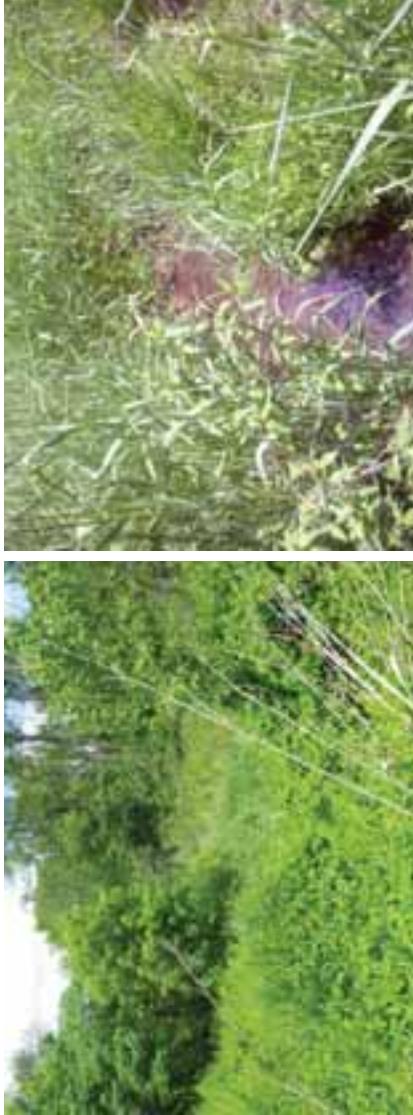
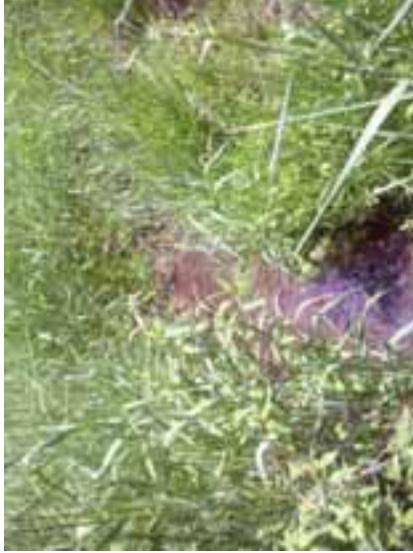
Watercourse Name	Wilcox Drain Branch	R2.27
DFO Drain Classification	U	MWW(m): 0.35
		MWD(m): 0.05
		MBW(m): 0.65

Photograph 1. Site overview ↑

Photograph 2. Channel view ↑

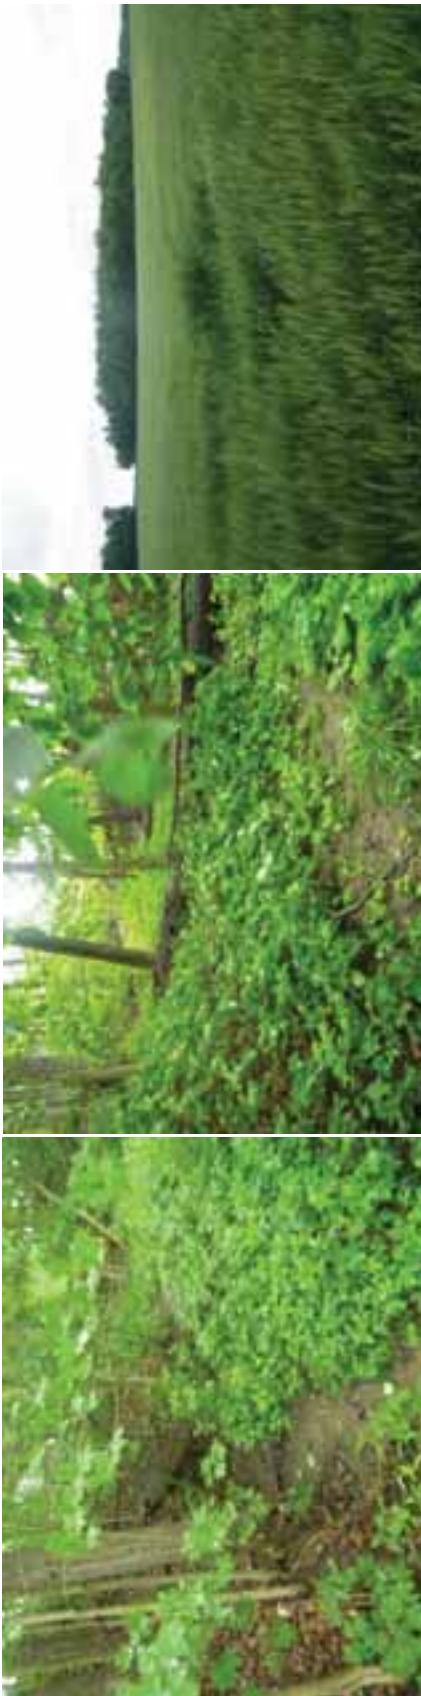
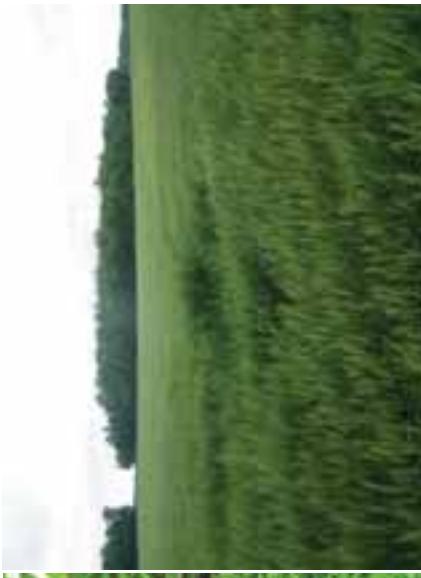
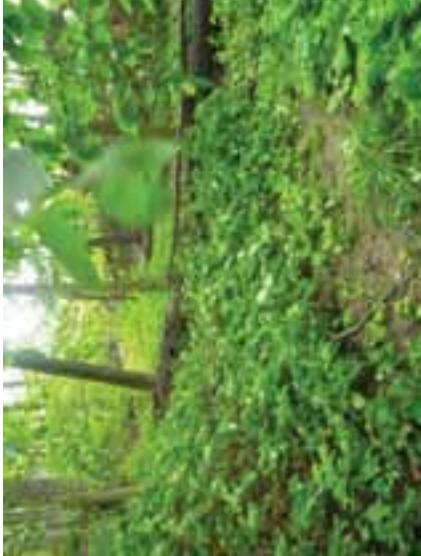
Watercourse Name	Ausable River Trib	R2.30
DFO Drain Classification	U	MWW(m): n/a
		MWD(m): n/a
		MBD(m): 0.3

**Photograph 1. Site overview ↑**

**Photograph 2. Channel overview ↑**

**Photograph 3. Tiled portion in agricultural field ↑**

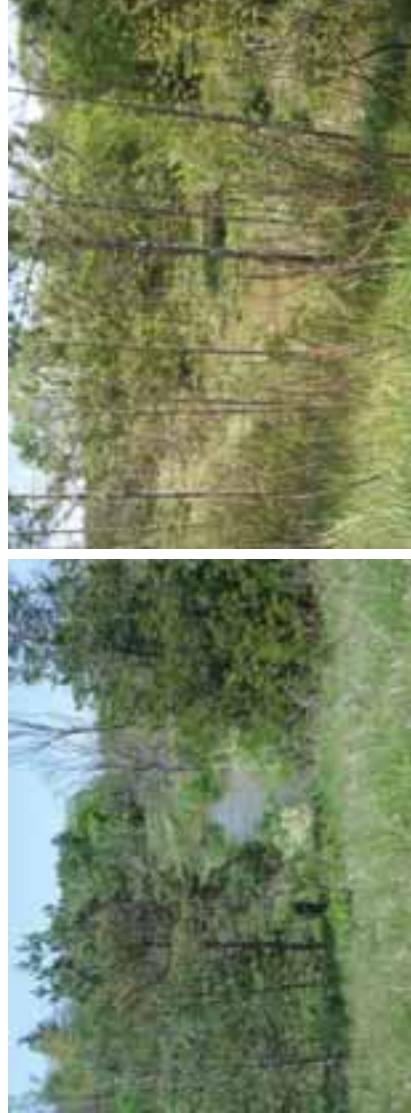
Feature ID	Project Component	Investigation Date	Description of Site	Feature Description	Feature Sensitivity
R2.40*	• Transmission Line Crossing	May 16, 2012	<ul style="list-style-type: none"> <li>The watercourse is located in a mix of meadow marsh, swamp thicket and deciduous forest (classified as MAM2-2, SWT2-9, FOD5-1, FOD7-4, ELC Feature ID 90 and 339) crossing Elginfield Road. No tile drain inputs were noted at time of investigation. Surrounding topography is a forested ravine with a wide floodplain. Riparian buffer is greater than 30 m.</li> </ul>	<ul style="list-style-type: none"> <li>The watercourse is a defined natural feature. The watercourse is all flat. The water was turbid and had low flow at time of investigation. It is classified as a permanent warmwater system by ABCA. Banks are stable and well vegetated. Canopy cover is low and consists of trees, shrubs and grasses. No groundwater indicators were observed. Approximately 2 km downstream, fish species consists of baitfish community (ABCA, 1999).</li> </ul>	Moderate

Watercourse Name		Boothill Creek	R2.40
DFO Drain Classification		E	MWW(m): 4.5 MWD(m): n/a MBW(m): 5.25 MBD(m): n/a

Photograph 1. Site overview north ↑

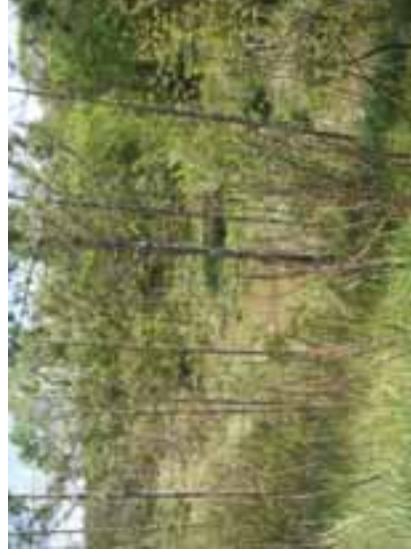
Photograph 2. Site overview south ↑
