Jericho Wind, Inc.

## **Final Water Assessment and Water Body Report – Jericho Wind Energy Centre**

60155032

February, 2013

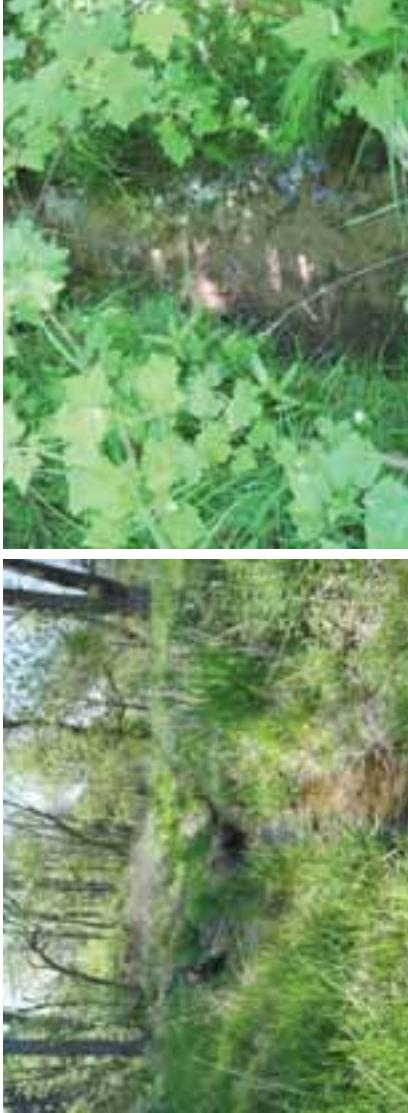
Feature ID	Project Component	Investigation Date	Description of Site	Feature Description	Feature Sensitivity
R2.72*	• Transmission Line Crossing	May 16, 2012 May 30, 2012	• The watercourse flows through a deciduous forest where it is buried for approximately 60 m before emerging in another deciduous forest (classified as FOD5-1, FOD, ELC Feature ID 90 and 339). No tiled drain inputs were noted at time of investigations. Surrounding topography is rolling hills. Riparian buffer is approximately 30 m south of Elginfield Road and less than 5 m north of Elginfield Road.	• The watercourse was all run and flat. The water was clear and had moderate flow at time of investigations. It is classified as tiled by ABCA. Banks are stable and well vegetated. Substrate is dominated by silt and sand followed by clay and gravel. Canopy cover is moderate and is dominated by trees. Instream habitat cover is moderate and consists of aquatic vegetation followed by undercut banks. Groundwater indicator watercress was observed at time of first investigation. The watercourse is dammed south of Elginfield road. Approximately 2 km downstream, fish species consists of baitfish community (ABCA, 1999).	Moderate

Watercourse Name	Boothill Creek Trib G	R2.72
DFO Drain Classification	T	MWD(m): 0.08
		MBD(m): 0.2
		MWW(m): 0.5
		MBW(m): 0.06

**Photograph 1. Site overview north of Elginfield Road**

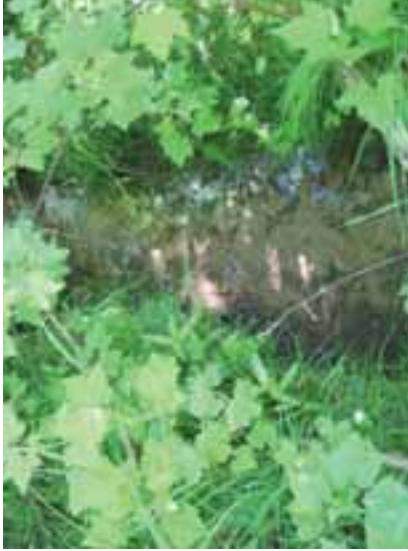
**Photograph 2. Channel south of Elginfield Road**

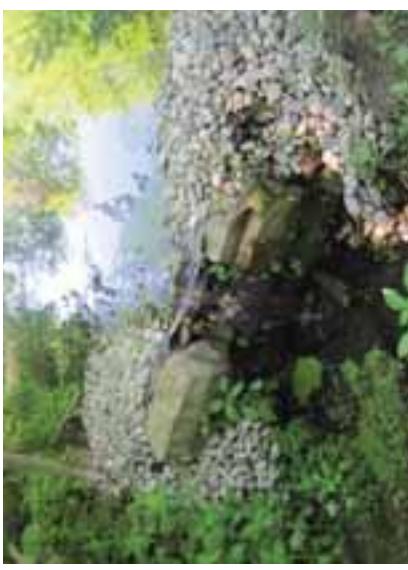
**Photograph 3. Dammed area**

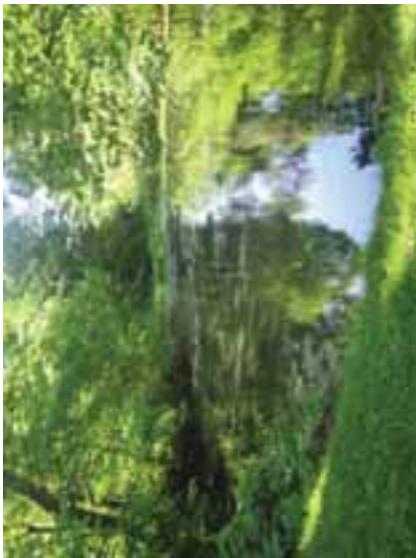
Feature ID	Project Component	Investigation Date	Description of Site	Feature Description	Feature Sensitivity
P2.138	• Transmission Line Buffer	May 30, 2012	<ul style="list-style-type: none"> <li>The pond is located surrounded by deciduous forest (classified as FOD5-1, ELC Feature ID 339). The pond is 12 by 25 m and approximately 0.15 m deep. Riparian buffer ranges from 1 to 8 m of grasses and forest.</li> </ul>	<ul style="list-style-type: none"> <li>The pond is a dammed portion of R2.72. The water was turbid at time of investigation. Substrate consists of muck. <i>In-situ</i> cover consists of emergent grasses. No groundwater indicators were observed.</li> </ul>	Moderate

**Photograph 1. Pond overview ↑**

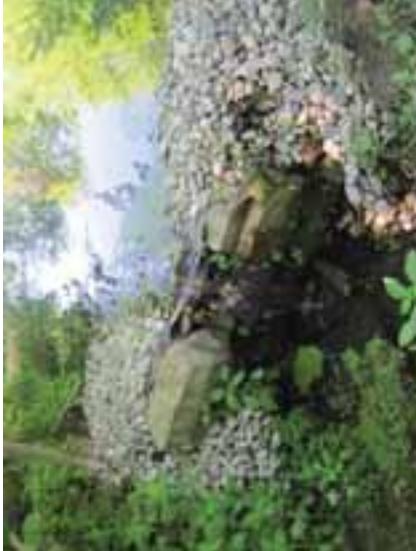
**Photograph 2. Dam ↑**

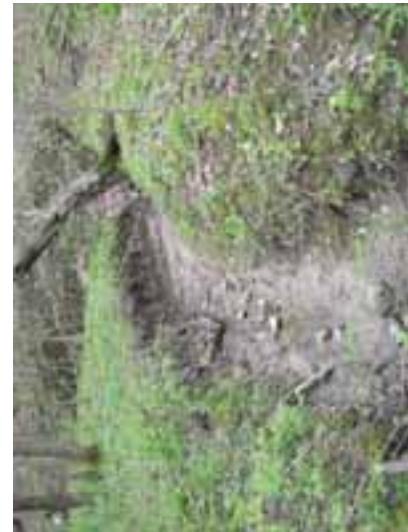
Watercourse Name	Glen Drift A	R2.102
DFO Drain Classification	T, U	MWW(m):
		0.6
		MBW(m):
		1.0
		MWD(m):
		0.1
		MBD(m):
		0.5

**Photograph 2. Channel overview ↑**

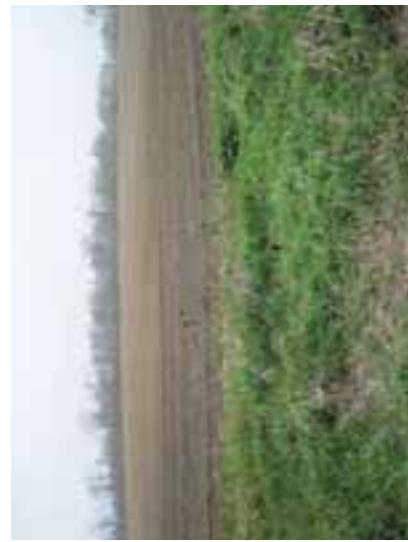
**Photograph 3. Tiled portion ↑**

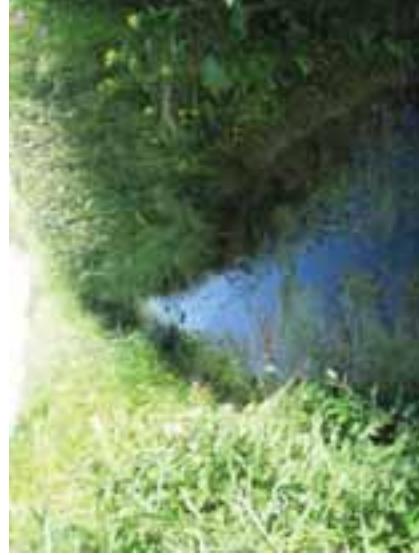
Watercourse Name	Roder Outlet Drain	R2.179
DFO Drain Classification	F	MBD(m):
		2.3

**Photograph 2. Channel view ↑**

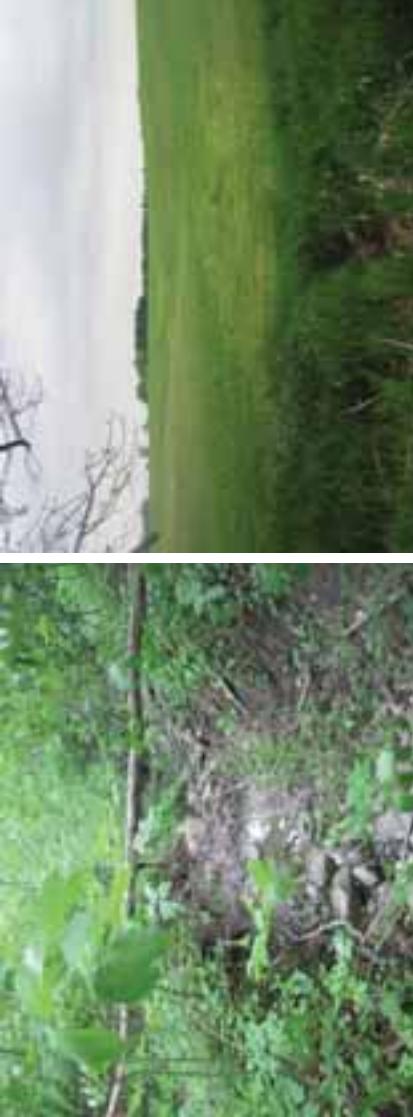
Feature ID	Project Component	Investigation Date	Description of Site	Feature Description	Feature Sensitivity
R2.186	• Collection Line and Buffer	May 29, 2012	<ul style="list-style-type: none"> <li>The watercourse is buried south of Jura Line. North of the Jura Line the watercourse flows through a deciduous forest (FOD5-8, FOD7-4, ELC Feature ID 149). Tile drain inputs that were not flowing were noted at time of investigation. Surrounding topography is slightly hilly. Riparian buffer is greater than 15 m.</li> </ul>	<ul style="list-style-type: none"> <li>The watercourse is a defined natural feature. The watercourse is mostly flat with some riffles and pools. The water was clear and had no flow, only pooled areas during time of investigation. It is classified as tiled and unknown by ABCA. Banks are slightly unstable with evidence of erosion. Substrate is dominated by silt, clay and sand followed by cobble. Canopy cover is high and is dominated by trees. Instream habitat cover is moderate and consists of cobble and woody debris followed by aquatic vegetation. No groundwater indicators were noted. Fish are present approximately 700 m downstream in the Ausable River.</li> </ul>	Moderate

Watercourse Name	Sercombe Drain Branches	R2.186
DFO Drain Classification	T, U	MWW(m): MBW(m):
		n/a 1.0
		n/a 0.5

**Photograph 1. Channel overview ↑**

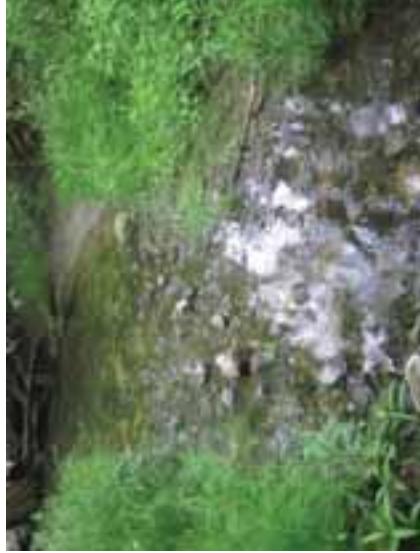
Feature ID	Project Component	Investigation Date	Description of Site	Feature Description	Feature Sensitivity
R2.192*	• Collection Line Crossing	May 29, 2012	<ul style="list-style-type: none"> <li>The watercourse is buried to the south of Jura Line and opens up in the north flowing adjacent to a residential property, deciduous forest (classified as FOD7-4, ELC Feature ID 149) and agricultural fields. Tile drains that were not flowing were noted at time of investigation. Surrounding topography is flat. Riparian buffer is 1 to 15 m.</li> </ul>	<ul style="list-style-type: none"> <li>The watercourse is a defined channelized feature. The watercourse consists of flats. It is classified as tiled and intermittent by ABCA. Banks are stable and well vegetated. Substrate consists of silt, clay and sand. Canopy cover is high and consists of trees and shrubs. Instream habitat cover is moderate and consists of aquatic vegetation and woody debris, followed by cobble. No groundwater indicators were noted. Fish are present approximately 1.2 km downstream in the Ausable River.</li> </ul>	Moderate

Watercourse Name	From Sercombe Drain Trib	R2.192
		MWD(m): n/a
		MBW(m): 0.5

**Photograph 2. Channel view**

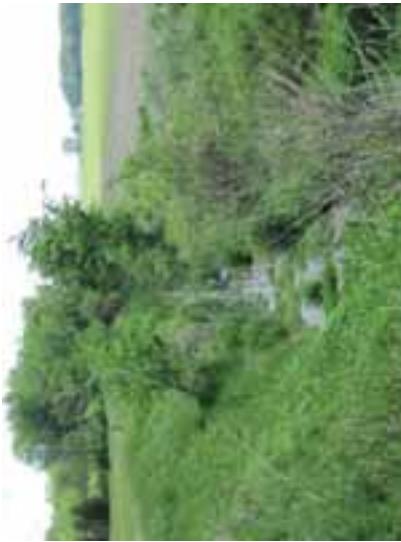
Feature ID	Project Component	Investigation Date	Description of Site	Feature Description	Feature Sensitivity
R3-A*	• Collection Line and Buffer	May 23, 2012	<ul style="list-style-type: none"> <li>The watercourse runs through crop agricultural fields, crosses Northville Road running parallel to the road and through a corn field and residential property. No tile drain inputs were observed at time of investigation. Surrounding land topography is flat. Riparian vegetation is 1.5 m through the agricultural fields and 6 m through the residential property.</li> </ul>	<ul style="list-style-type: none"> <li>The watercourse is a defined channelized feature. The watercourse has a straight flat channel. The water was clear and had very low flow at time of investigation. It is classified as a permanent warmwater system by ABCA. The banks were stable and well vegetated. Substrate consists of sand, silt, clay and gravel. Canopy cover is low consisting of shrubs, trees and grasses. Instream habitat cover is moderate and consists of aquatic vegetation. Small mats of groundwater indicator water speedwell were noted along the roadside. Approximately 4.5 km downstream, fish species consist of baitfish community (ABCA, 2003).</li> </ul>	Moderate

Watercourse Name	Trick Drain	R3-A
DFO Drain Classification	C	MWW(m): 1.0 MBW(m): 1.4

Photograph 3. Channel overview looking east ↑

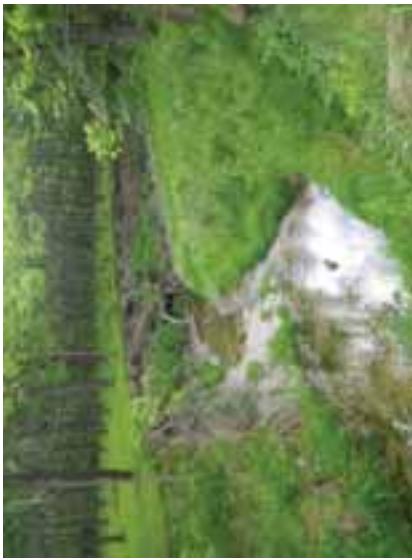
Feature ID	Project Component	Investigation Date	Description of Site	Feature Description	Feature Sensitivity
R3-C*	• Road Buffer	June 6, 2012	<ul style="list-style-type: none"> <li>The watercourse is located in a deciduous forest (classified as FOD7-4, ELC Feature ID 243). No tile drain inputs were observed at time of investigation. Surrounding topography is rolling hills. Riparian buffer is greater than 15 m.</li> </ul>	<ul style="list-style-type: none"> <li>The watercourse is a defined natural feature. It follows a riffle/run/pool sequence with flat areas. The water was clear and had moderate flow during time of investigation. It is classified as a warmwater system by ABCA. Banks are slightly unstable with some erosion occurring. Substrate is dominated by silt and clay, followed by muck, cobble and boulder. Canopy cover is high and is dominated by trees. Instream habitat cover is low and consists of cobble followed by woody debris and boulders. No groundwater indicators were observed. Approximately 500 m downstream, fish species consist of baitfish community, Largemouth Bass and Green Sunfish (ABCA, 2001).</li> </ul>	Moderate

Watercourse Name	Decker Creek	R3-C
DFO Drain Classification	E	MWW(m): 3.5 MWD(m): 0.3 MBW(m): 6.0 MBD(m): 1.3

**Photograph 1. Site overview ↗**

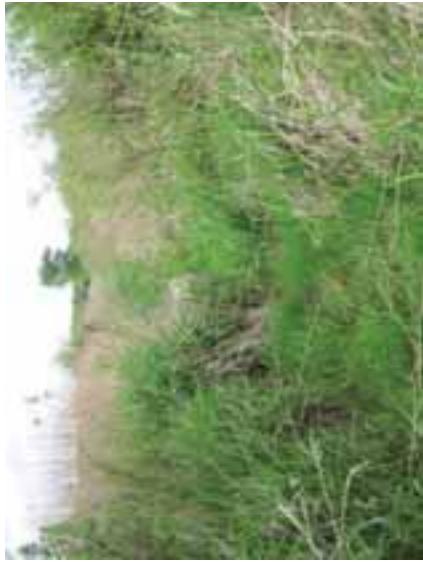
Feature ID	Project Component	Investigation Date	Description of Site	Feature Description	Feature Sensitivity
R3-D*	• Collection Line • Crossing • Road Buffer	May 23, 2012	<ul style="list-style-type: none"> <li>The watercourse begins north of Bog Line between agricultural fields, then flows through fallow meadows into more agricultural fields. A pond (P3.29) is located to the west of the watercourse in an excavation area. Tile drain inputs were observed throughout the site with some flowing at time of investigation. Surrounding land topography is flat. Riparian buffer is 1.25 m of meadow.</li> </ul>	<ul style="list-style-type: none"> <li>The watercourse is a defined channelized feature. The watercourse has a straight flat channel. The water was clear and had no visible flow at time of investigation. It is classified as a permanent warmwater system by ABCA. The banks were stable to slightly unstable with well vegetated sandy banks causing some slumping. Substrate is dominated by sand followed by gravel, silt and clay. Canopy cover is low with shrubs dominating. Instream habitat cover is high and consists of aquatic vegetation. Groundwater indicators water speedwell and watercress were observed. Dense mats of pondweed and watercress were present just south of Bog Line. Some areas of the channel were dry creating a low flow fish barrier. Approximately 1 km upstream, fish species consist of baitfish community, Largemouth Bass and Green Sunfish (ABCA, 2001).</li> </ul>	Moderate

Photograph 3. Dry channel ↑

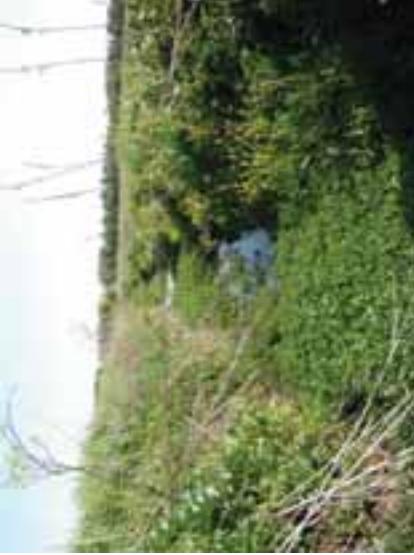
Feature ID	Project Component	Investigation Date	Description of Site	Feature Description	Feature Sensitivity
R3.22*	<ul style="list-style-type: none"> <li>Collection Line Crossing</li> <li>Road Crossing</li> </ul>	May 16, 2012	<ul style="list-style-type: none"> <li>The watercourse flows through crop agricultural fields. A tile drain input was observed. Surrounding topography is flat. Riparian buffer is 5 m of grasses.</li> </ul>	<ul style="list-style-type: none"> <li>The watercourse is a defined channelized feature. The watercourse has a straight flat uniform channel. The water was clear and had low flow during the time of investigation. The system is classified as intermittent by ABCA. The banks are stable and well vegetated. Substrate consists of silt and muck. There is no canopy cover. Instream habitat cover is high contains only aquatic vegetation. Large mats of groundwater indicator watercress were observed throughout the watercourse.</li> </ul>	Moderate

Watercourse Name	Elliot Drain	R3.22
DFO Drain Classification	F	MWW(m): 1.5 MBW(m): 2.0

Photograph 2. Channel overview ↑

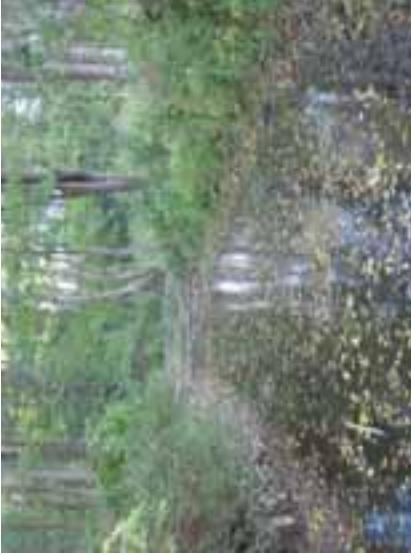
Feature ID	Project Component	Investigation Date	Description of Site	Feature Description	Feature Sensitivity
R3.74	• Collection Buffer	Line September 28, 2012	<ul style="list-style-type: none"> <li>The watercourse is located in a small ravine surrounded by meadow and then deciduous forest (classified as FOD7-4, ELC Feature 243). Tile drain inputs were observed at time of investigation. Surrounding topography is hilly. Riparian buffer is greater than 10 m.</li> </ul>	<ul style="list-style-type: none"> <li>The watercourse may be a natural feature that has previously been dug out. The majority of the channel was dry with one stagnant pool at time of investigation. It is unclassified by ABCA. Banks are stable. Substrate is detritus, clay, silt and sand. Canopy cover is high and is dominated by trees. Instream habitat cover is high and consists of vegetation followed by woody debris. Small patches of groundwater indicator watercress were observed.</li> </ul>	Moderate

Photograph 2. Stagnant pool ↑

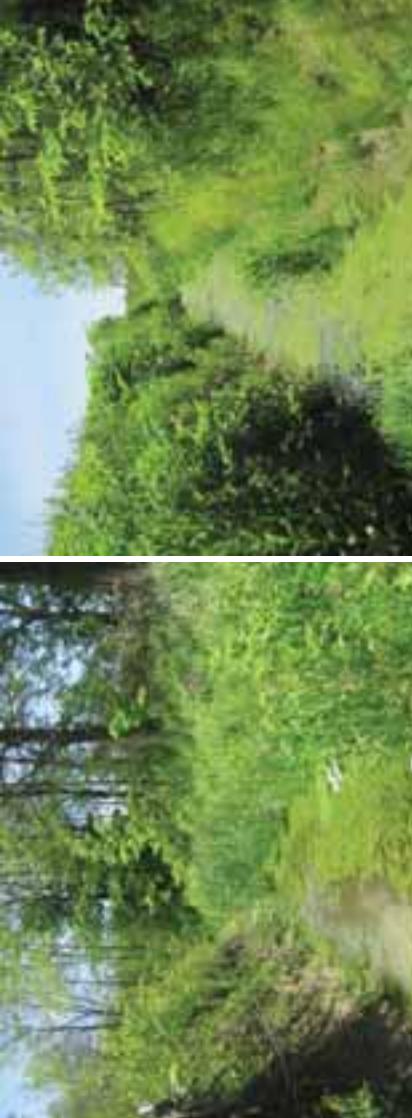
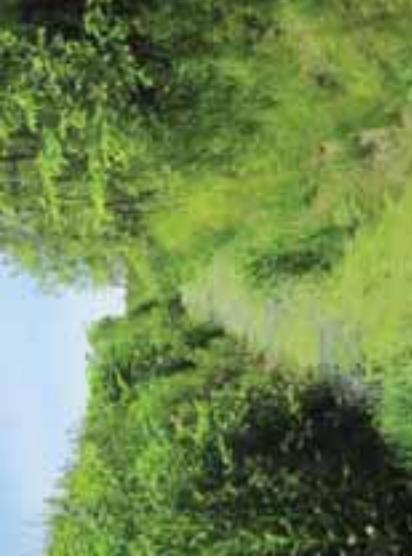
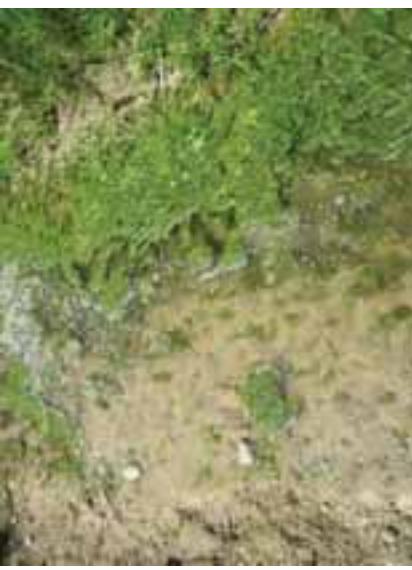
**Photograph 1. Channel view ↑**

**Photograph 2. Channel view ↑**

**Photograph 3. Substrate ↑**

Feature ID	Project Component	Investigation Date	Description of Site	Feature Description	Feature Sensitivity
R4-B*	• Road Buffer • Turbine 71	May 23, 2012	<ul style="list-style-type: none"> <li>The watercourse flows through crop agricultural fields into a mix of cultural thicket and deciduous swamp (classified as CUT1-4, SWD3-3, ELC Feature ID 148) with agricultural field to the northeast and southwest. Flowing tile drains were observed at time of investigation. Surrounding land topography is flat. Riparian buffer is 5 m.</li> </ul>	<ul style="list-style-type: none"> <li>The watercourse is a defined channelized feature. The watercourse is a straight flat uniform channel. The water was clear and had very low flow at time of investigation. It is classified as a permanent warmwater system by ABCA. Banks are stable and well vegetated. Substrate is dominated by silt, clay and muck followed by gravel, sand and cobble. Canopy cover is low with a mix of trees, shrubs and grasses. Instream habitat cover is high and consists of aquatic vegetation followed by cobble. The channel is choked with algae. No groundwater indicators were noted. Approximately 7 km downstream, fish species consist of baitfish community, Black Bullhead and Pumpkinseed (ABCA, 2001).</li> </ul>	Moderate

Watercourse Name	Upper Mud Creek	R4-B
DFO Drain Classification	Drain No 5	<b>MWW(m):</b> 1.4 <b>MBW(m):</b> 2.0

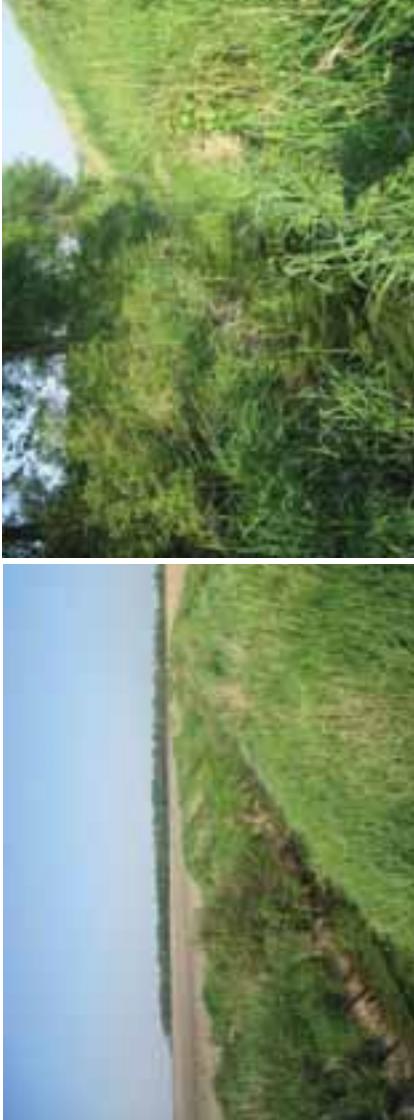
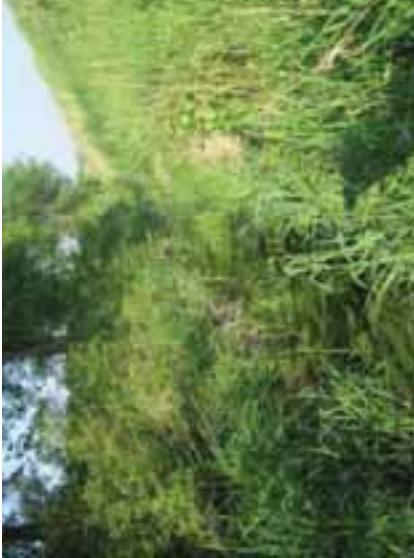
Photograph 1. Site overview ↑

Photograph 2. Channel overview ↑

Feature ID	Project Component	Investigation Date	Description of Site	Feature Description	Feature Sensitivity
R4-C*	<ul style="list-style-type: none"> <li>Collection Line Crossing and Buffer</li> <li>Road Buffer</li> </ul>	May 24, 2012	<ul style="list-style-type: none"> <li>The watercourse flows through agricultural row crops, crosses Gordon Road and flows through more agricultural row crops. Flowing tile drain inputs were noted at time of investigation. Surrounding land topography is flat. Riparian buffer is 1.25 m of grasses.</li> </ul>	<ul style="list-style-type: none"> <li>The watercourse is a defined channelized feature. The watercourse is flat with some pools present. The water was clear and had low flow at time of investigation. It is classified as a permanent warmwater system by ABCA. Banks are stable and well vegetated. Substrate consists of silt, clay and muck. Canopy cover is low with grasses followed by shrubs and trees. Instream habitat cover is high and consists of aquatic vegetation. The watercourse is algae choked. No groundwater indicators were observed. Approximately 6 km downstream, fish species consist of baitfish community, Black Bullhead and Pumpkinseed (ABCA, 2001).</li> </ul>	Moderate

Watercourse Name	Upper Mud Creek	R4-C
DFO Drain Classification	Drain No 3	MWD(m): 0.15
	C	MBD(m): 0.4

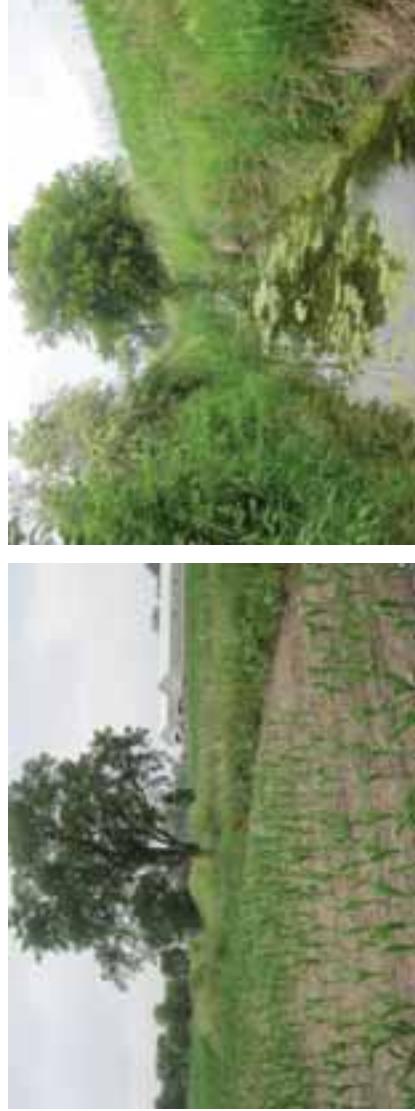
**Photograph 1. Site overview ↑****Photograph 2. Channel overview ↑**

Feature ID	Project Component	Investigation Date	Description of Site	Feature Description	Feature Sensitivity
R4-D*	<ul style="list-style-type: none"> <li>Collection Line Crossing</li> <li>Road Crossing</li> </ul>	<ul style="list-style-type: none"> <li>June 12, 2012</li> <li>September 17, 2012</li> </ul>	<ul style="list-style-type: none"> <li>The watercourse is surrounded by wheat field and three residential properties and crosses Northville Road. Flowing tile drain inputs were observed at time of investigation. Surrounding topography is flat. Riparian buffer is 6 m consisting of meadow.</li> </ul>	<ul style="list-style-type: none"> <li>The watercourse is a defined channelized feature. The watercourse is straight flat channel with a few pools. The water was clear and had slow flow during the time of first site visit and no flow during the second site visit. It is classified as a permanent warmwater system by ABCA. Banks are stable to slightly unstable with evidence of erosion. Substrate is dominated by muck, silt and clay followed by sand and cobble. Canopy cover is low and is dominated by trees. Instream habitat cover is high and is dominated by aquatic vegetation, followed by cobble, woody debris and undercut banks. The channel is algae choked. No groundwater indicators were observed. A few Cyprinids and a school of YOYs were observed at time of first site investigation. Approximately 4 km downstream, fish species consist of batfish community, Black Bullhead and Pumpkinseed (ABCA, 2001).</li> </ul>	Moderate

Watercourse Name	Upper Mud Creek Drain No 2	C	R4-D
DFO Drain Classification			MWW(m): 1.5
			MWD(m): 0.1
			MBD(m): 3.0

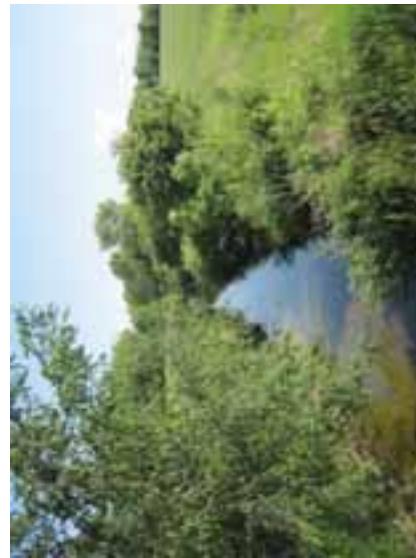
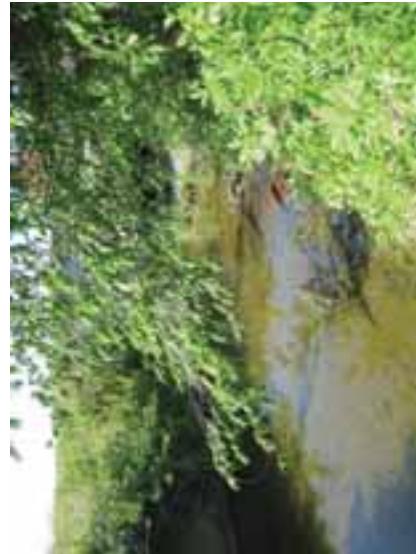
Photograph 1. Site overview ↑

Photograph 2. Channel view ↑

Feature ID	Project Component	Investigation Date	Description of Site	Feature Description	Feature Sensitivity
R4-G*	• Collection Line Crossing	June 6, 2012	<ul style="list-style-type: none"> <li>The watercourse crosses Thomson Line and flows through corn and wheat fields. Tile drain inputs with some flowing were noted at time of investigation. Surrounding topography is flat. Riparian buffer is 6 m of meadow.</li> </ul>	<ul style="list-style-type: none"> <li>The watercourse is a defined natural feature. The watercourse is mostly flat with some riffles present. The water was clear and had slow flow at time of investigation. It is classified as a permanent warmwater feature. Banks are stable and well vegetated. Substrate is dominated by sand, silt, clay and gravel followed by cobble. Canopy cover is low and is dominated by shrubs. Instream habitat cover is moderate and consists of aquatic vegetation followed by small woody debris and cobble. No groundwater indicators were observed. Cyprinids were observed at time of investigation. Fish species at Thomson Line consist of baitfish community, Black Bullhead and Pumpkinseed (ABCA, 2001).</li> </ul>	Moderate

Watercourse Name	Upper Mud Creek Drain No 1/Jericho Creek	R4-G								
DFO Drain Classification	C	<table border="1"> <thead> <tr> <th>MWW(m):</th> <td>4.0</td> <th>MWD(m):</th> <td>0.2</td> </tr> </thead> <tbody> <tr> <th>MBW(m):</th> <td>6.0</td> <th>MBD(m):</th> <td>0.8</td> </tr> </tbody> </table>	MWW(m):	4.0	MWD(m):	0.2	MBW(m):	6.0	MBD(m):	0.8
MWW(m):	4.0	MWD(m):	0.2							
MBW(m):	6.0	MBD(m):	0.8

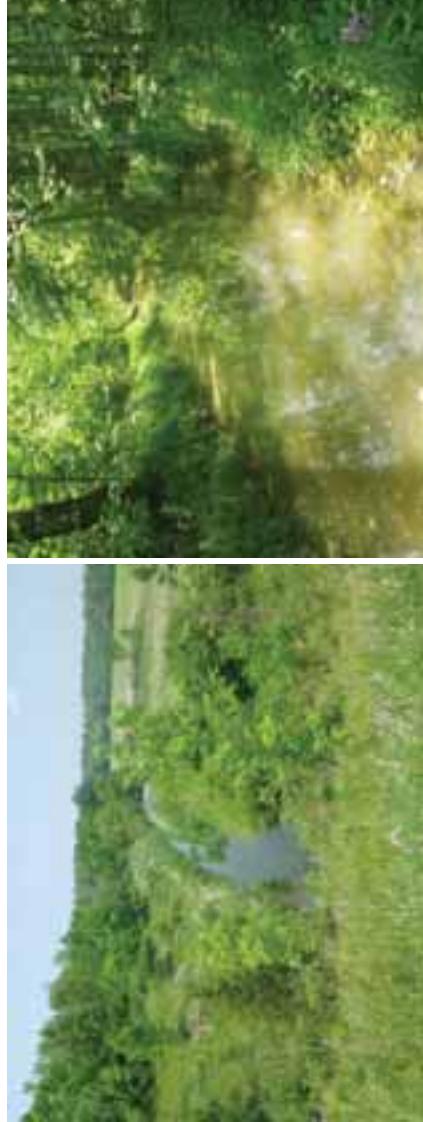
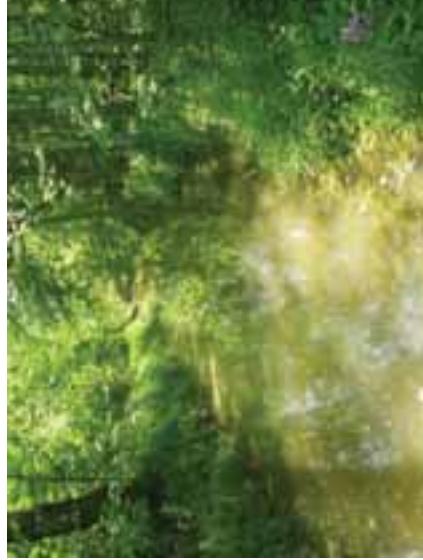
**Photograph 1. Site overview ↑**

**Photograph 2. Channel view ↑**

Feature ID	Project Component	Investigation Date	Description of Site	Feature Description	Feature Sensitivity
R4-H*	• Collection Line Crossing	May 28, 2012	<ul style="list-style-type: none"> <li>The watercourse is surrounded by a mix of cultural woodland and deciduous forest (classified as CUW1g, FOD7-2, ELC Feature ID 213 and 214). No tile drain inputs were noted at time of investigation. Surrounding land topography is sloped towards the watercourse. Riparian buffer is greater than 30 m.</li> </ul>	<p>• The watercourse is a defined natural feature. The watercourse follows a riffle/run/pool sequence. The water was turbid and had low flow at time of investigation. It is classified as a permanent warmwater system by ABCA. Banks are stable and vegetated. Substrate is dominated by silt and gravel followed by cobble. Canopy cover is moderate consisting mainly of trees. Instream habitat cover is low and consists of undercut banks, woody debris, boulders and cobble. No groundwater indicators were observed. Cyprinids were observed at time of investigation, as well as one dead adult White Sucker. Several old beaver dams and one new beaver dam are creating potential fish barriers with a height of 0.5 m. Approximately 2 km upstream, fish species consist of baitfish community, Black Bullhead and Pumpkinseed (ABCA, 2001).</p>	Moderate

Watercourse Name	Jericho Creek	R4-H
DFO Drain Classification	C	MWD(m): 0.76
		MBD(m): 1.2

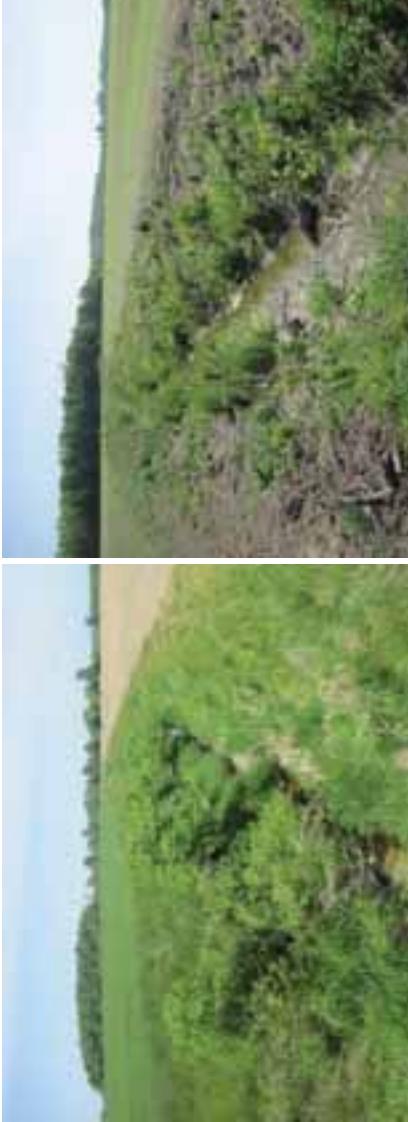
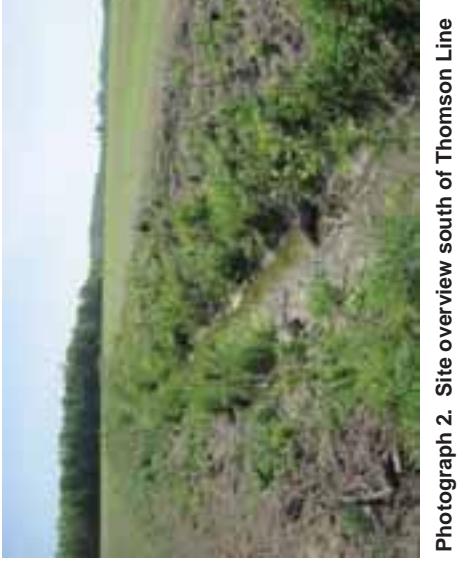
Photograph 1. Site overview north of Thomson Line      Photograph 2. Site overview south of Thomson Line

Feature ID	Project Component	Investigation Date	Description of Site	Feature Sensitivity
R4.8-A	• Collection Line Crossing • Transmission Line Crossing	May 23, 2012	<ul style="list-style-type: none"> <li>Watercourse is surrounded by crop agricultural fields and crosses Thomson Line. Flowing tile drain inputs were noted at time of investigation. Surrounding land topography is flat. Riparian buffer is 5 m of grasses and meadow.</li> <li>The watercourse is a defined channelized feature. The watercourse is a straight flat uniform channel. The water was clear and had low flow at time of investigation. It is classified as a permanent warmwater system by ABCA. Banks are stable and well vegetated. Substrate consists of silt, clay and muck. Canopy cover is low and consists of shrubs and grasses. Instream habitat cover is high and consists of aquatic vegetation followed by woody debris. No groundwater indicators were observed. Fish were observed at time of investigation. Fish species at Thomson Line consist of baitfish community (ABCA, 2001).</li> </ul>	Moderate

Watercourse Name	Golden Creek Drain Branch East	R4.8-A
DFO Drain Classification	C	MWW(m): MBW(m):
		0.5 1.0
		MWD(m): MBD(m):
		0.1 0.3

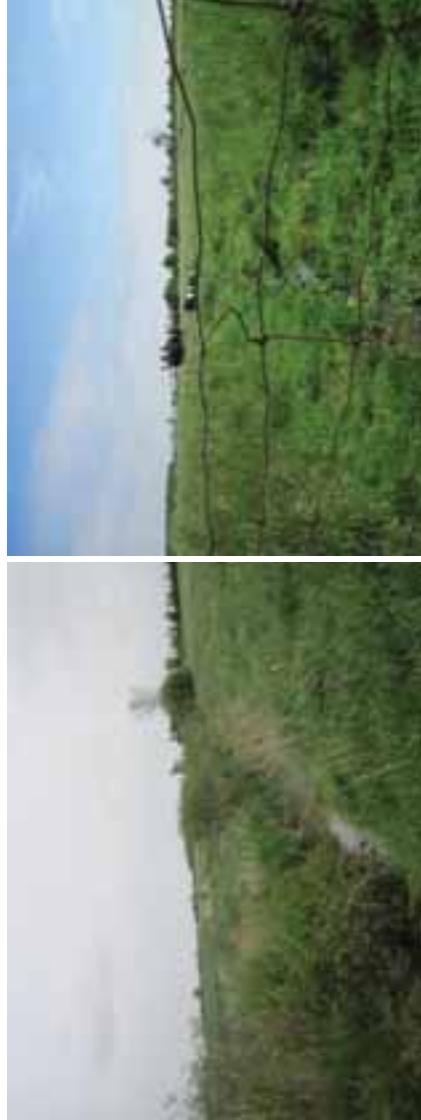
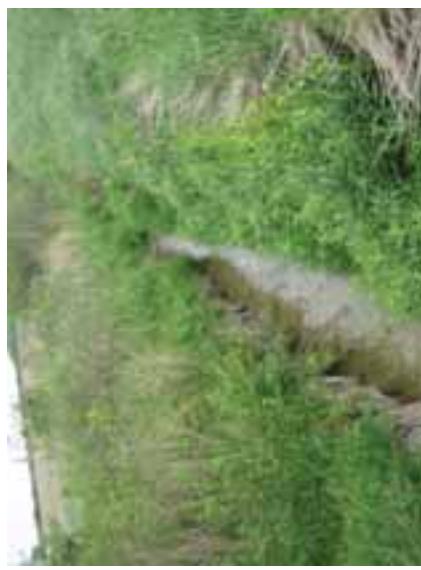
**Photograph 1. Site overview in agricultural fields** ↑

**Photograph 2. Site overview in cattle pasture** ↑**Photograph 3. Channel view** ↑

Feature ID	Project Component	Investigation Date	Description of Site	Feature Description	Feature Sensitivity
R4.8-B*	<ul style="list-style-type: none"> <li>• Collection Line</li> <li>• Buffer</li> <li>• Road Crossing and Buffer</li> <li>• Turbines 29 and 30</li> <li>• Met Tower</li> <li>• Buffer</li> </ul>	May 22, 2012 July 30, 2012	<ul style="list-style-type: none"> <li>The watercourse is surrounded by crop agricultural fields and passes through active cattle pasture crossing Thomson Line into soybean and wheat fields. Tile drain inputs and channels for overland flow were noted. Surrounding land topography is flat. Riparian buffer is approximately 6 m in the agricultural fields.</li> </ul>	<ul style="list-style-type: none"> <li>The watercourse is a defined channelized feature. The watercourse is flat with a few riffle/pool sequences. The water was clear and had slow flow at time of first site investigation. The water was slightly turbid and had no visible flow at time of second site investigation. It is classified as a permanent warmwater system by ABCA. Banks are slightly unstable with some erosion and slumping evident. Substrate is dominated by clay, silt, muck and sand followed by gravel and cobble. Canopy cover is moderate to low with trees and shrubs in the agricultural fields and some areas of overhanging vegetation. Canopy cover in the cattle pasture is low and consists of grasses. Instream habitat cover is high north of Thomson Line and low to the south. Instream habitat cover consists of aquatic vegetation followed by woody debris and cobble. Groundwater indicators watercress and water speedwell were present throughout the site. Cyprinids were observed at time of both investigations. Approximately 500 m upstream, fish species consist of batfish community (ABCA, 2001).</li> </ul>	Moderate

R4.8-B	
MWD(m):	0.17
MBD(m):	0.33

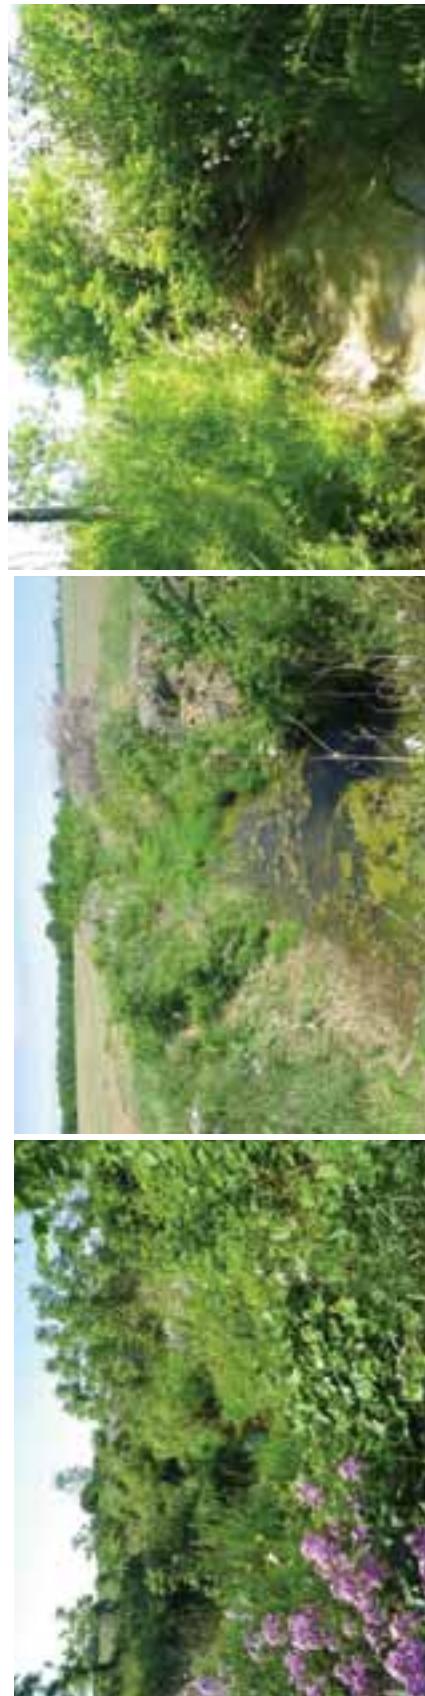
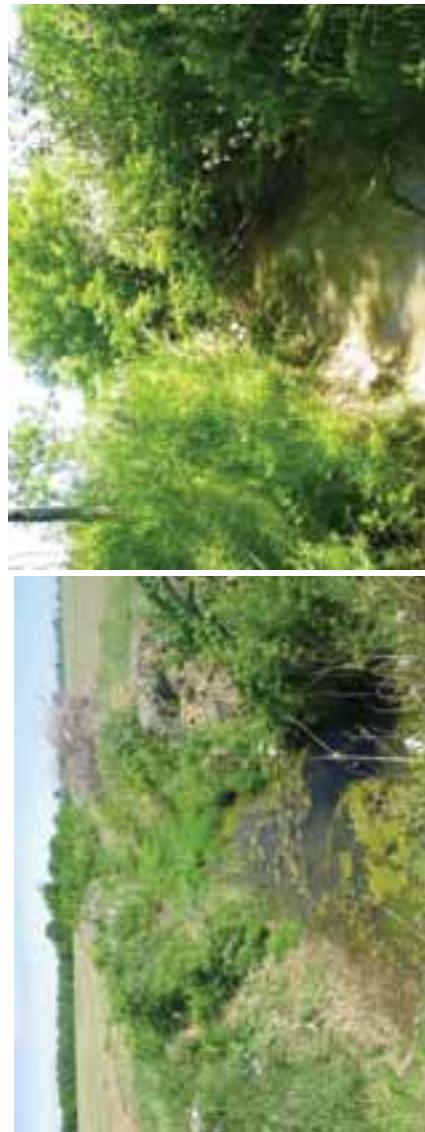
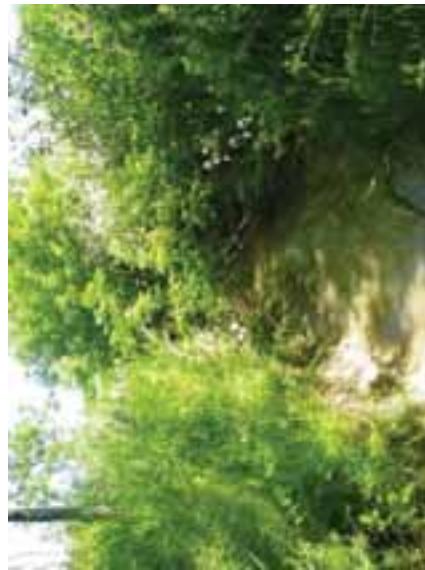
Photograph 1. Site overview ↑

Photograph 2. Site overview in agricultural fields ↑

Photograph 3. Channel view ↑

Feature ID	Project Component	Investigation Date	Description of Site	Feature Description	Feature Sensitivity
R4.8-D*	<ul style="list-style-type: none"> <li>• Collection Line Crossing</li> <li>• Road Crossing</li> <li>• Turbine 20</li> </ul>	May 30, 2012	<ul style="list-style-type: none"> <li>• The watercourse flows through agricultural fields with a small section of cultural thicket and woodland (classified as CUW1m, CUT1-4, ELC Feature ID 219). No tile drain inputs were noted. Surrounding land topography is sloping towards the watercourse. Riparian buffer is 25 m.</li> </ul>	<ul style="list-style-type: none"> <li>• The watercourse is a defined natural feature to the north and becomes a channelized feature in the agricultural fields. The watercourse is mostly flat runs with a few pools and riffle present. The water was clear and had low flow at time of investigation. It is classified as a permanent warmwater system by ABCA. Banks are slightly to moderately unstable with undercutting and signs of erosion. Substrate is dominated by silt and clay followed by gravel and cobble. Canopy cover is moderate and consists of trees and shrubs. Instream habitat cover is low and consists of aquatic vegetation and woody debris followed by cobble. Groundwater indicator bittercress was observed. Approximately 3.7 km upstream, fish species consist of baitfish community (ABCA, 2001).</li> </ul>	Moderate

Watercourse Name	Golden Creek Drain Branch East	R4.8-D
DFO Drain Classification	C	MWW(m): 1.25 MBW(m): 3.0

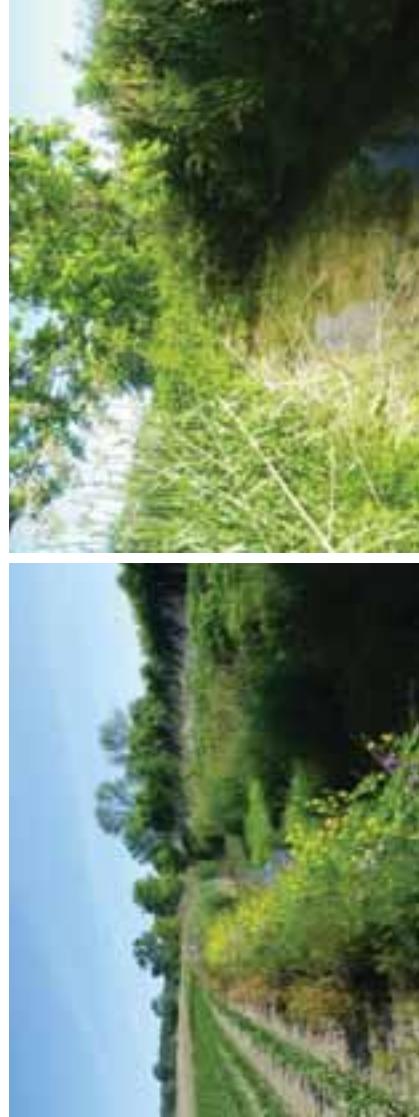
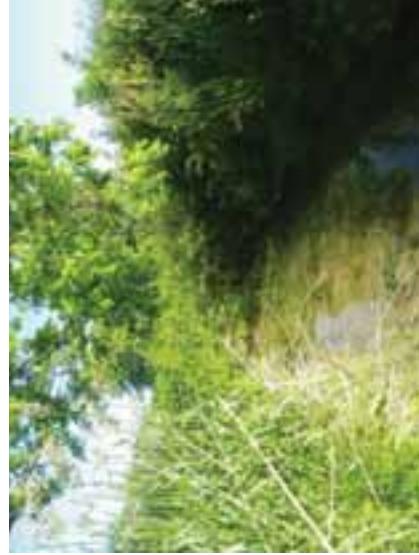
**Photograph 1. Site overview †**

**Photograph 2. Channel view ↑**

Feature ID	Project Component	Investigation Date	Description of Site	Feature Sensitivity
R4.8-E*	• Collection Line • Buffer • Road Buffer	June 8, 2012	<ul style="list-style-type: none"> <li>The watercourse flows through agricultural fields and livestock pasture, crossing Elliot Road. Tile drain inputs that were not flowing were noted at time of investigation. Surrounding topography is slightly hilly. Riparian buffer is 7 m of cultural meadow along the pasture and 1 m along the agricultural fields.</li> <li>The watercourse is a natural feature to the south of Elliot Road and channelized to the north. The watercourse is mostly flat with some riffle/run/pool sequences. The water was slightly turbid and had slow flow at time of investigation. It is classified as a permanent warmwater system by ABCA. Banks are slightly unstable with evidence of erosion and slumping. Substrate is dominated by gravel followed by sand, silt, clay and cobble. Canopy cover is moderate and is dominated by trees. Instream habitat cover is moderate and consists of aquatic vegetation and woody debris, followed by cobble and undercut banks. Groundwater indicator water speedwell was found sporadically along the reach. Adult and YOY Cyprinids were observed at time of investigation. Approximately 5 km upstream, fish species consist of baitfish community (ABCA, 2001).</li> </ul>	Moderate

Watercourse Name	Golden Creek Drain	R4.8-E
DFO Drain Classification	C	MWW(m): MBW(m):
	2.2 5.5	MWD(m): MBD(m):

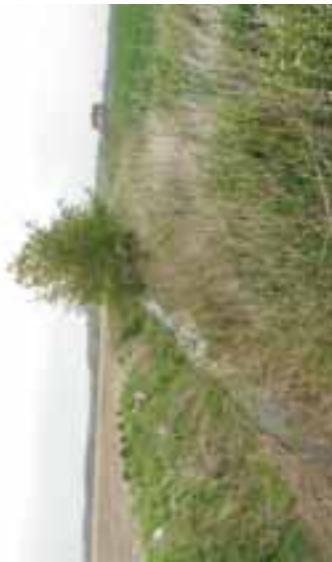
**Photograph 1. Site overview** ↗

Feature ID	Project Component	Investigation Date	Description of Site	Feature Description	Feature Sensitivity
R4.11-B*	<ul style="list-style-type: none"> <li>• Collection Line Crossing</li> <li>• Road Buffer</li> <li>• Turbine 4 Tower</li> <li>• MET Buffer</li> </ul>	May 9, 2012	<ul style="list-style-type: none"> <li>• The watercourse flows through a crop agricultural field into a mix of cultural thicket and woodland (classified as CUW1h, CUT1-4, ELC Feature ID 290). Tile drain inputs were observed at time of investigation. The surrounding topography is flat. Riparian buffer of 5 m on the left bank.</li> </ul>	<ul style="list-style-type: none"> <li>• The watercourse is a defined channelized feature. The watercourse follows a riffle/run sequence. The water was clear and had moderate flow at time of investigation. It is classified as a permanent warmwater feature by ABCA. Banks are stable to slightly unstable with some signs of erosion. Substrate is dominated by sand and gravel followed by boulder and cobble. Canopy cover is moderate and dominated by shrubs. Instream habitat cover is high and consists of aquatic vegetation followed by cobble. Isolated patches of groundwater indicator watercress were observed.</li> </ul>	Moderate

R4.11-B	
<b>MWD(m):</b>	0.3
<b>MBD(m):</b>	0.7

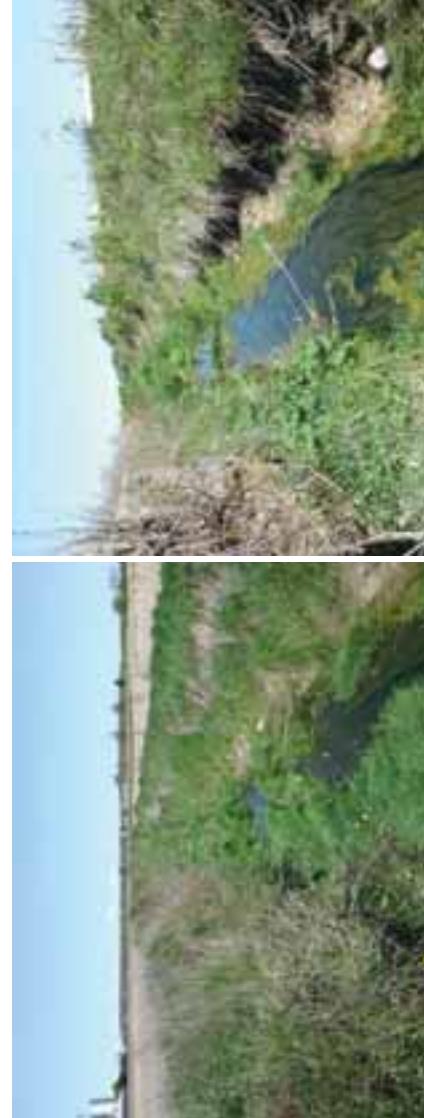
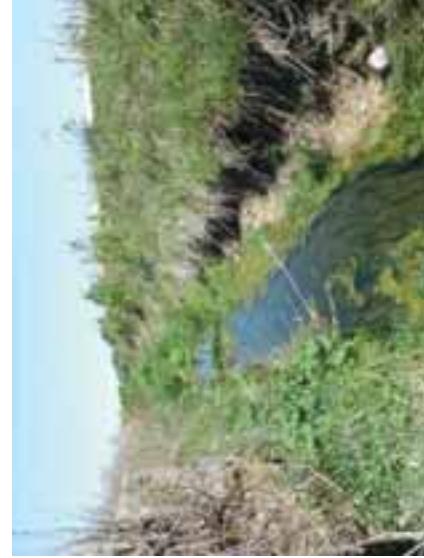
**Photograph 1. Site overview**

**Photograph 2. Channel overview in forest**

Feature ID	Project Component	Investigation Date	Description of Site	Feature Description	Feature Sensitivity
R4.16-B	<ul style="list-style-type: none"> <li>• Collection Line</li> <li>• Crossing and Buffer</li> <li>• Road Crossing and Buffer</li> <li>• Turbine 25</li> </ul>	<ul style="list-style-type: none"> <li>May 10, 2012</li> <li>May 15, 2012</li> </ul>	<ul style="list-style-type: none"> <li>• The watercourse flows through horse pasture into crop agricultural fields. Tile drain inputs were observed throughout the watercourse. The surrounding topography is flat with some sloping towards the watercourse. Riparian buffer is 5 m of grasses.</li> </ul>	<ul style="list-style-type: none"> <li>• The watercourse is a defined channelized feature. The watercourse has a straight uniform channel with some riffles present. The water was clear and had low flow at time of investigation. It is classified as intermittent by ABCA. Banks are stable and well vegetated. Substrate is dominated by silt and sand followed by gravel. Canopy cover is low and consists of trees and shrubs. Instream habitat cover is high and consists of aquatic vegetation followed by woody debris and cobble. The channel was choked with algae. Isolated mats of groundwater indicator watercress were observed in the southern portion of the watercourse. A perched culvert was present at a laneway crossing, creating a 0.05 m high barrier to fish passage.</li> </ul>	Moderate

R4.16-B	
MWD(m):	0.18
MBD(m):	0.85

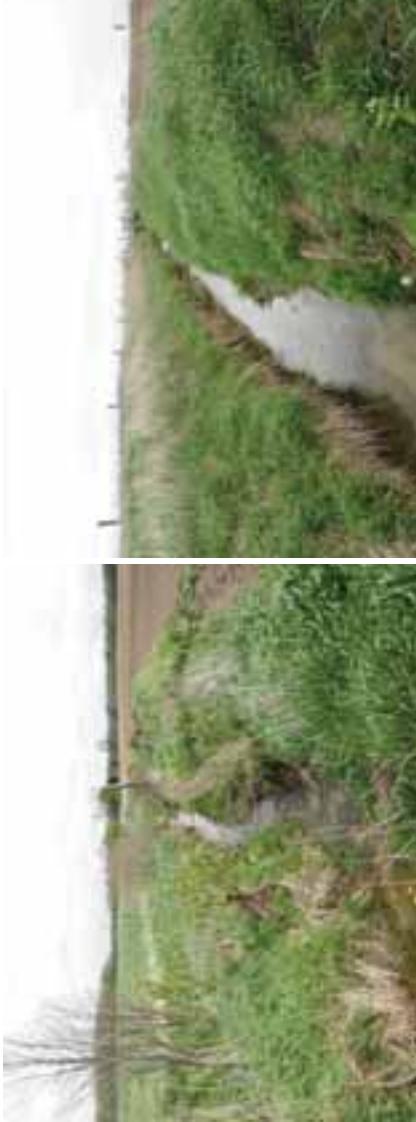
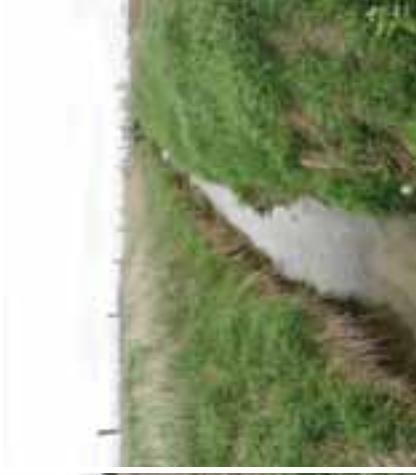
**Photograph 1. Site overview ↑**

**Photograph 2. Channel overview ↑**

Feature ID	Project Component	Investigation Date	Description of Site	Feature Description	Feature Sensitivity
R4.16-C*	<ul style="list-style-type: none"> <li>• Collection Line Buffer</li> <li>• Road Buffer</li> <li>• Turbine 19</li> </ul>	May 9, 2012	<ul style="list-style-type: none"> <li>• The watercourse is located in crop agricultural fields and crosses Kennedy Line. Tile drain inputs were observed throughout the watercourse. The surrounding land topography is gently sloped towards the watercourse. Riparian buffer is 5 m of grasses.</li> </ul>	<ul style="list-style-type: none"> <li>• The watercourse is a defined channelized feature. The watercourse follows a riffle/run/pool sequence. The water was clear and moderately flowing at the time of investigation. It is classified as a permanent warmwater feature by ABCA. Banks are stable and well vegetated. Substrate is dominated by sand and clay followed by cobble, gravel and boulders. Canopy cover is low and consists of trees and shrubs. Instream habitat cover is moderate and consists of aquatic vegetation, followed by boulders and bedrock shale. Groundwater indicator watercress was observed as well as bank seepage and iron staining.</li> </ul>	Moderate

Watercourse Name	Elliot McBryan Drain	R4.16-C
DFO Drain Classification	C	MWW(m): 1.0 MWD(m): 0.25 MBW(m): 2.6 MBD(m): 0.7

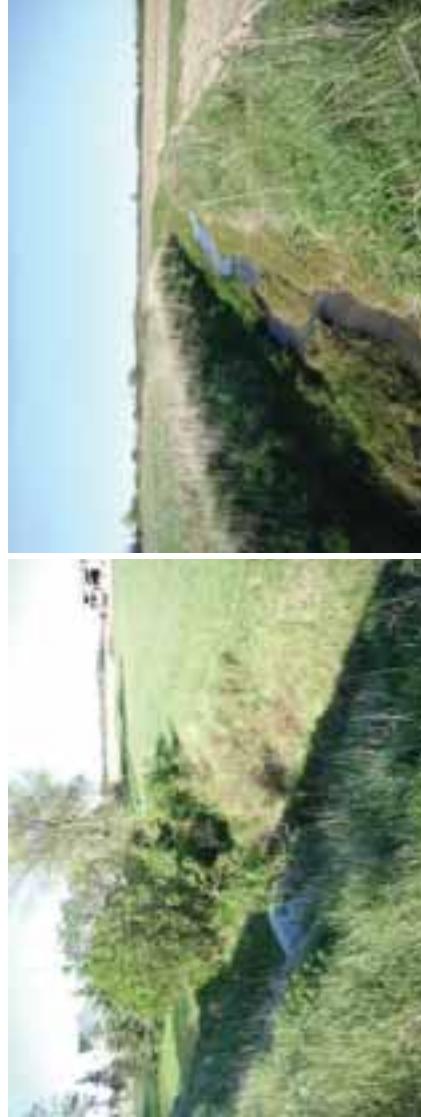
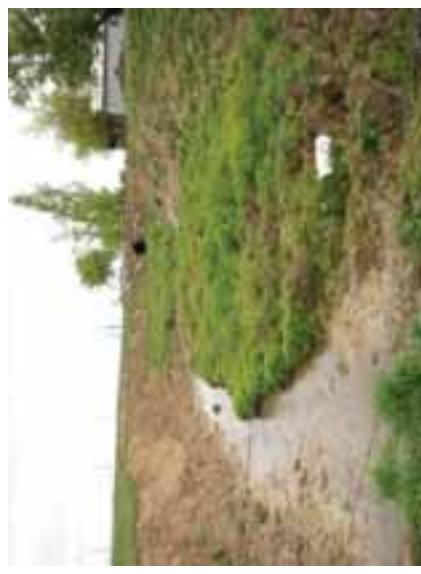
Photograph 1. Site overview in residential property ↑

Photograph 2. Site overview in agricultural fields ↑

Feature ID	Project Component	Investigation Date	Description of Site	Feature Sensitivity
R4.25-A	<ul style="list-style-type: none"> <li>• Collection Line Crossing and Buffer</li> <li>• Road Buffer</li> <li>• Transmission Line Crossing</li> </ul>	<ul style="list-style-type: none"> <li>May 10, 2012</li> <li>May 16, 2012</li> <li>July 25, 2012</li> </ul>	<ul style="list-style-type: none"> <li>• The watercourse flows through cattle pasture and residential properties and into crop agricultural fields. Roadside drainage inputs were observed at Northville Road, as well as tile drain inputs throughout the site. The surrounding land topography was gently sloped towards the watercourse. Riparian buffer is approximately 5 m of grasses.</li> <li>• The watercourse is a defined channelized feature. The watercourse has a straight run uniform channel. The water was turbid and had low flow during the first site investigation. The water was clear and had moderate flow at time of second investigation. The water was clear and there was no visible flow at time of third site investigation. It is classified as a permanent warmwater system by ABCA. Banks are stable to slightly unstable with signs of erosion and some exposed roots, in the cattle pasture banks are moderately unstable. Substrate is dominated by clay and silt followed by sand and gravel. Canopy cover is low and consists of trees and shrubs. Instream habitat cover is low and consists of aquatic vegetation followed by cobble and undercut banks. Large mats of groundwater indicator watercress and water speedwell were observed. Brook Sticklebacks were observed at time of first investigation.</li> </ul>	Moderate

R.25-A	R.25-A
MWD(m):	0.14
MBD(m):	0.3
