Jericho Wind, Inc.

## **Final Water Assessment and Water Body Report – Jericho Wind Energy Centre**

60155032

February, 2013

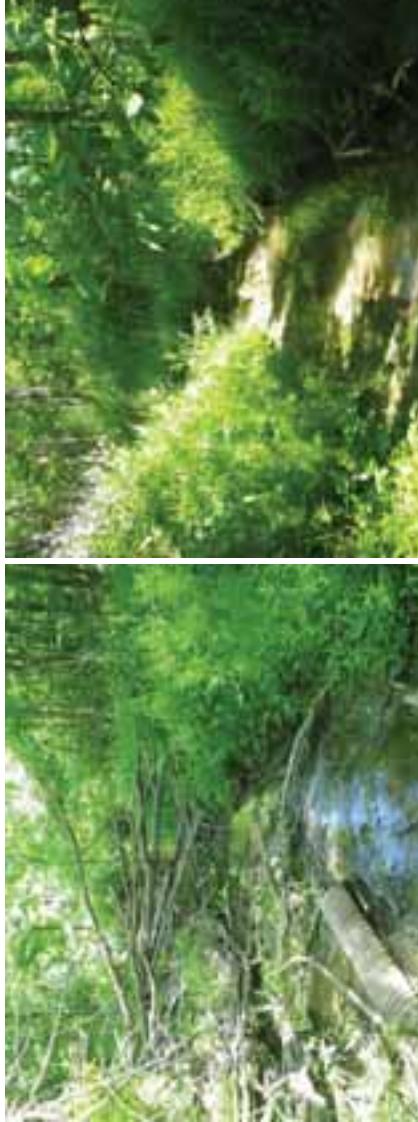
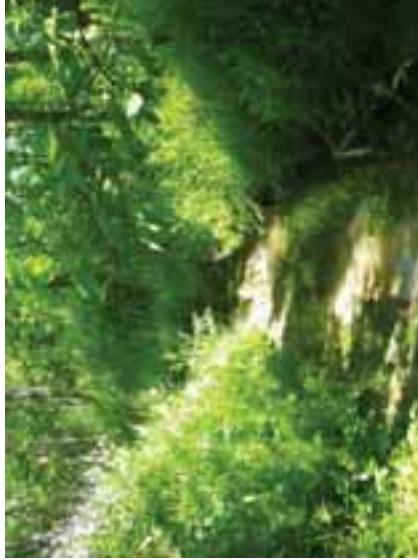
**Photograph 1. Site overview ↑**

**Photograph 2. Channel view ↑**

Feature ID	Project Component	Investigation Date	Description of Site	Feature Description	Feature Sensitivity
R4.25-C*	<ul style="list-style-type: none"> <li>Collection Line Buffer</li> <li>Road Buffer</li> <li>Turbine 20</li> </ul>	May 30, 2012	<ul style="list-style-type: none"> <li>The watercourse is located in a mix of deciduous forest and cultural meadow (classified as FOD7-2, FOC5-2, CUM1-1, ELC Feature ID 217). Tile drain inputs were observed at time of investigation. The surrounding land topography is rolling hills. Riparian buffer is 50 m.</li> </ul>	<ul style="list-style-type: none"> <li>The watercourse follows a riffle/run/pool sequence. The water was clear and had moderate flow at the time of investigation. It is classified as a permanent warmwater system by ABCA. Banks are slightly unstable with some erosion and undercutting. Substrate is dominated by silt followed by gravel, cobble and boulders. Canopy cover is moderate and consists of trees and shrubs. Instream habitat cover is low and consists of woody debris, boulders, cobble and undercut banks. No groundwater indicators were observed.</li> </ul>	Moderate

Watercourse Name		Golden Creek Drain		R4.25-C	
DFO Drain Classification		C		R4.25-C	
<b>MWW(m):</b>		<b>MWD(m):</b>	0.15	<b>MWW(m):</b>	1.5
<b>MBW(m):</b>	2.5	<b>MBD(m):</b>	0.45	<b>MBW(m):</b>	2.5

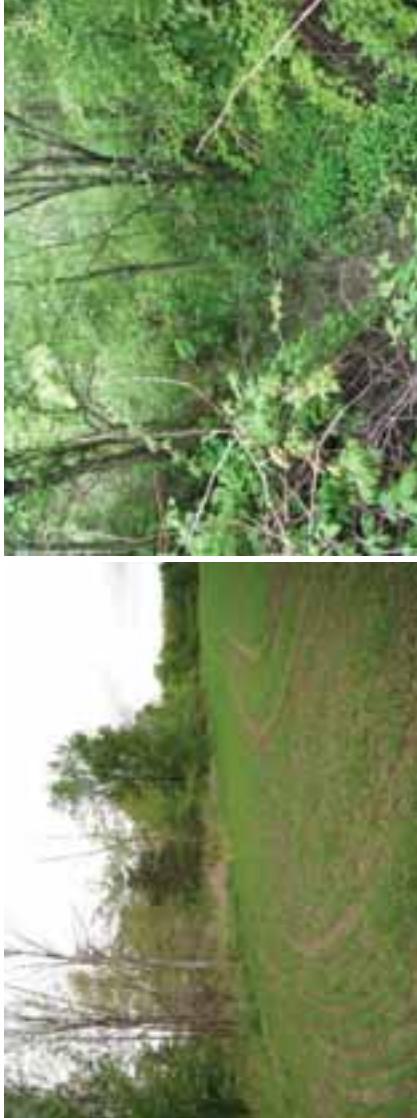
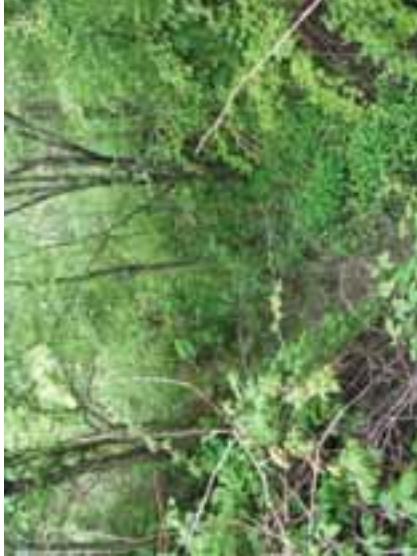
**Photograph 1. Site overview ↑**

**Photograph 2. Channel overview ↑**

Watercourse Name		R4.33-A	
DFO Drain Classification		R4.33-A	
Thompson Drain	T	MWW(m): MWD(m): MBW(m):	2.0 0.1 2.2
		MBD(m):	0.15

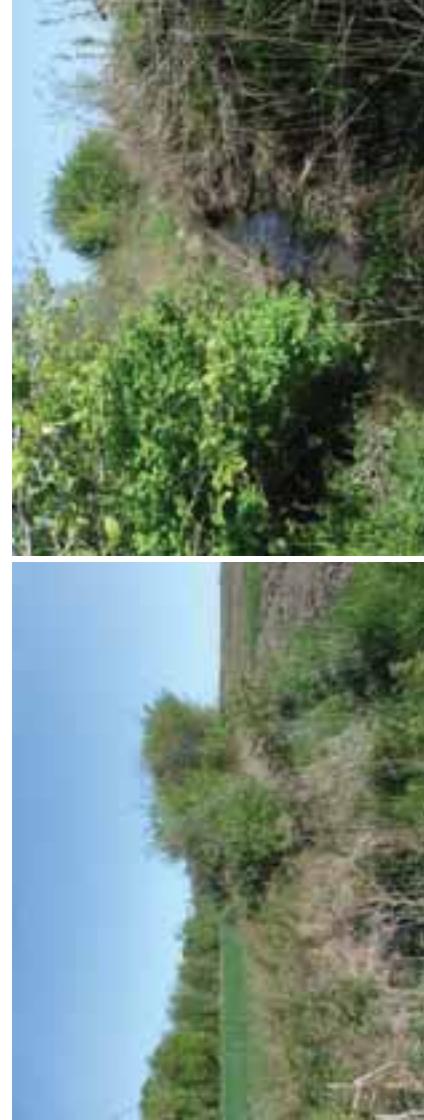
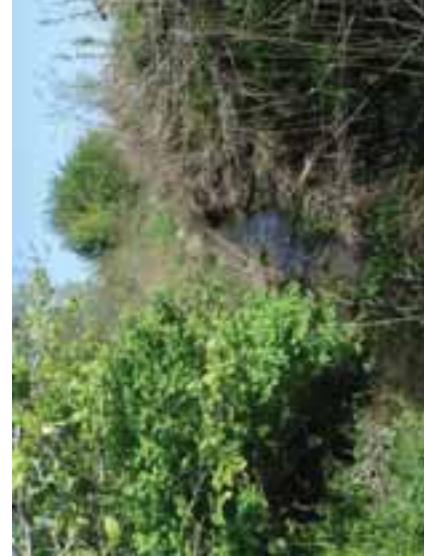
**Photograph 1. Site overview ↑**

**Photograph 2. Channel view ↑**

Watercourse Name	Thompson Drain	R4.33-B
DFO Drain Classification	C	MWD(m): 0.07 MBD(m): 0.3

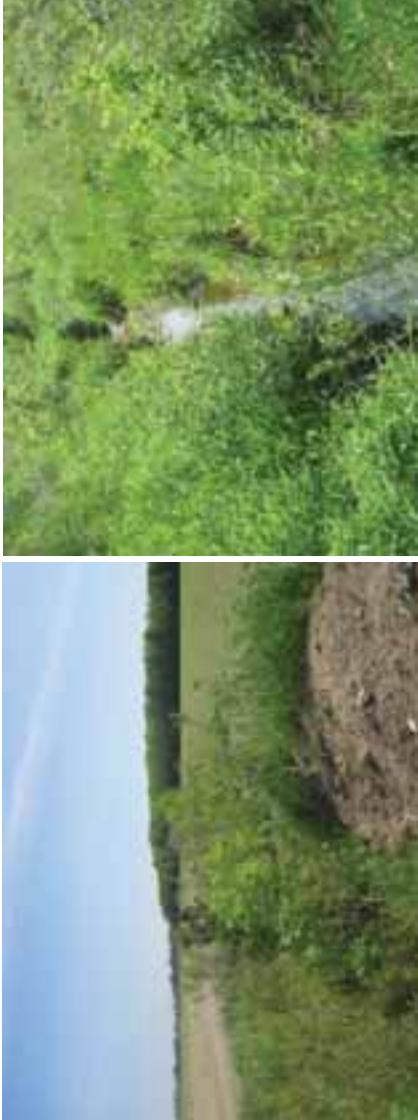
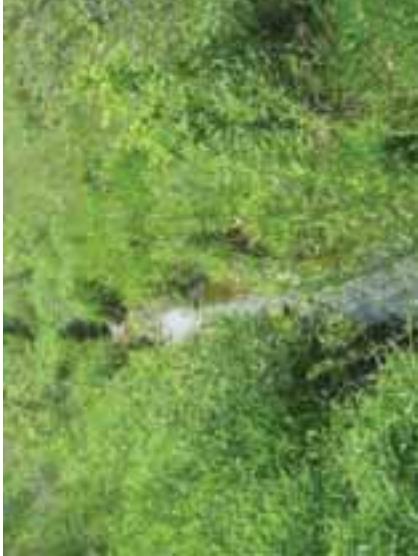
Watercourse Name	Hilborn Drain Branch West	R4.50								
DFO Drain Classification	C	<table border="1"> <tr> <td>MWW(m):</td> <td>0.5</td> </tr> <tr> <td>MBW(m):</td> <td>1.0</td> </tr> </table> <table border="1"> <tr> <td>MWD(m):</td> <td>0.1</td> </tr> <tr> <td>MBD(m):</td> <td>0.3</td> </tr> </table>	MWW(m):	0.5	MBW(m):	1.0	MWD(m):	0.1	MBD(m):	0.3
MWW(m):	0.5									
MBW(m):	1.0									
MWD(m):	0.1									
MBD(m):	0.3

Photograph 1. Site overview, dry channel ↑

Photograph 2. Channel overview ↑

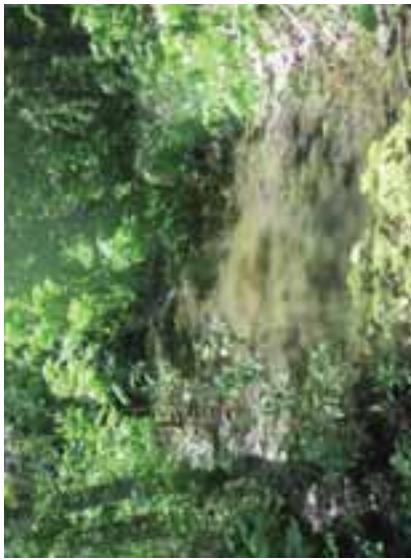
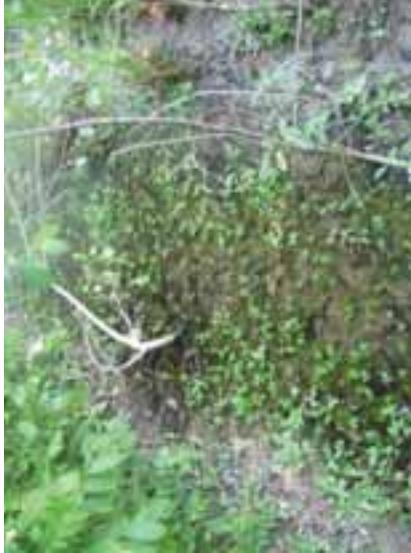
Feature ID	Project Component	Investigation Date	Description of Site	Feature Description	Feature Sensitivity
R4.59	• Road Buffer • Turbine 15	May 24, 2012	<ul style="list-style-type: none"> <li>The watercourse runs adjacent to deciduous swamp (classified as SWD2-2, ELC Feature 213) and corn fields. No tile drain inputs were noted at time of investigation. Surrounding topography is flat. Riparian buffer is 1.5 along the corn fields and greater than 30 m along the deciduous swamp.</li> </ul>	<ul style="list-style-type: none"> <li>The watercourse is a defined channelized feature. The watercourse is all flat. There was very little water and no visible flow at time of investigation. The watercourse is not classified by ABCA. Banks are stable with no signs of erosion. Substrate consists of muck, clay and silt. Canopy cover is high and is dominated by trees. Instream habitat cover is moderate and consists of aquatic vegetation followed by small woody debris. Small mats of groundwater indicator watercress were observed.</li> </ul>	Moderate

MWW(m):	1.5	R4.59
MBW(m):	2.0

**Photograph 1. Channel overview ↑****Photograph 2. Channel view ↑**

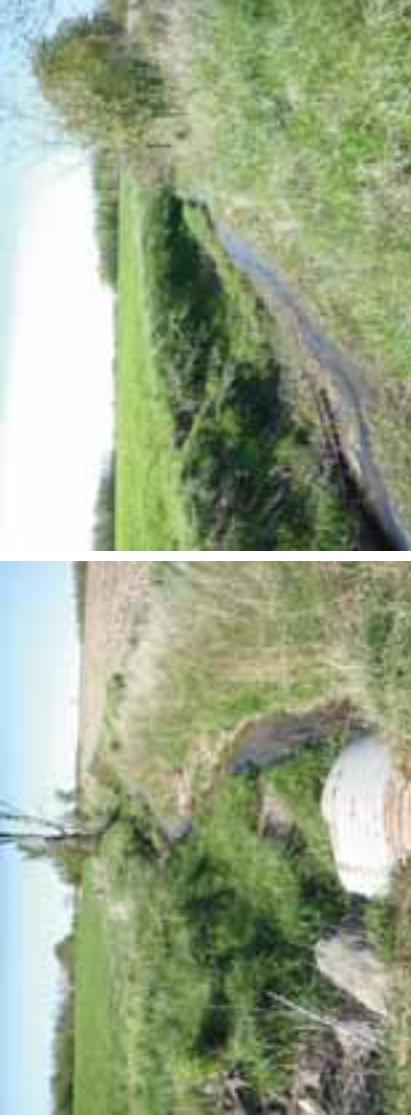
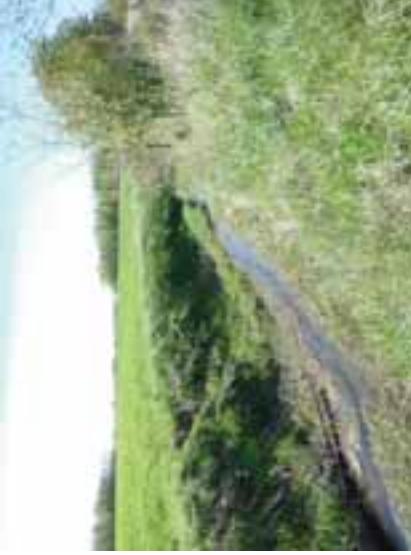
Feature ID	Project Component	Investigation Date	Description of Site	Feature Description	Feature Sensitivity
R4.61-B	• Collection Line Crossing • Road Crossing	May 10, 2012	<ul style="list-style-type: none"> <li>The watercourse is located in crop agricultural fields.</li> <li>Flowing tile drain inputs were noted at time of investigation.</li> <li>Surrounding topography is gently sloped towards the watercourse. Riparian buffer is less than 1 m of grasses.</li> </ul>	<ul style="list-style-type: none"> <li>The watercourse is a defined channelized feature that is starting to naturalize. The watercourse is all run. The water was slightly turbid and had low flow at time of investigation. It is classified as a permanent warmwater system by SCRCA.</li> <li>Banks are stable and well vegetated. Substrate consists of sand and silt. Canopy cover is low and is provided by shrubs.</li> <li>Instream habitat cover is high and consists of only aquatic vegetation. Some large mats of groundwater indicator watercress were observed.</li> </ul>	Moderate

Watercourse Name		R4.61-B	R4.61-B
DFO Drain Classification	C	MWW(m): MBW(m):	0.2 0.45
		MWD(m): MBD(m):	2.0 2.5

Photograph 1. Site overview ↑

Photograph 2. Channel overview ↑

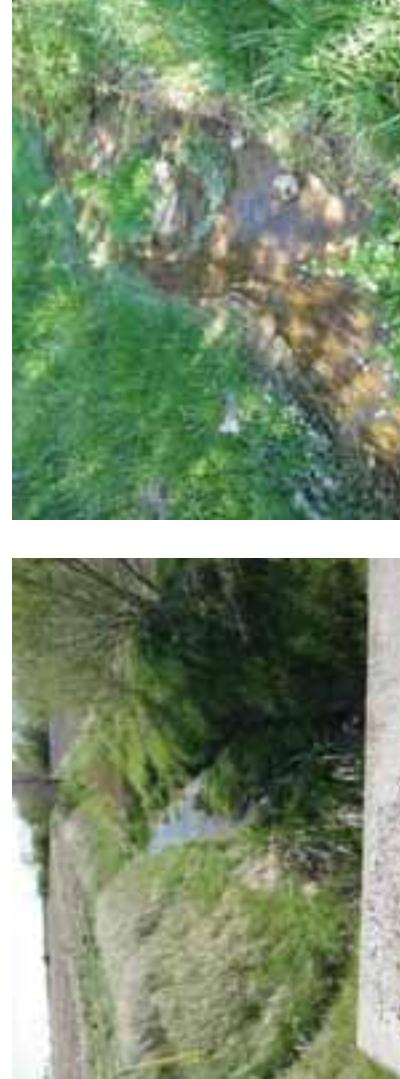
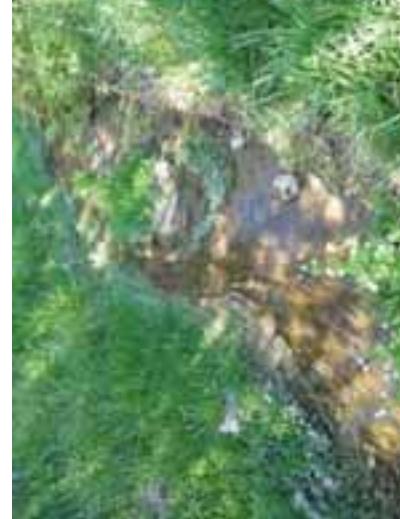
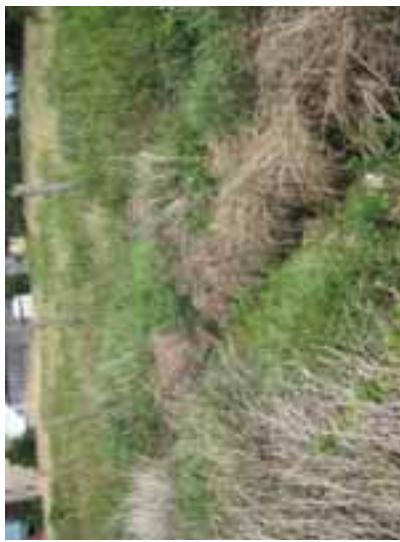
Feature ID	Project Component	Investigation Date	Description of Site	Feature Description	Feature Sensitivity
R4.61-C*	• Collection Crossing Buffer	May 10, 2012 July 30, 2012	<ul style="list-style-type: none"> <li>The watercourse is located in crop agricultural fields and passes by a small section of deciduous forest (classified as FOD5-6, ELC Feature ID 382) before crossing Army Camp Road into corn fields. The watercourse crosses Bruce Scott Road and flows through more agricultural fields and farm yards. Tile drain inputs and roadside ditches were observed. Surrounding topography is gently sloped towards the watercourse. Riparian is 5 m of grasses except at the forest area where it is 300 m.</li> </ul>	<ul style="list-style-type: none"> <li>The watercourse is a defined channelized feature with some section starting to naturalize. The watercourse has a straight run uniform channel. The water was slightly turbid and had moderate flow during the first site investigation and no flow during the second site investigation. It is classified as a permanent warmwater system by ABCA. Banks are stable to slightly unstable with some undercutting and erosion present. Substrate is dominated by silt, clay, sand and gravel followed by boulders, muck and cobble. Canopy cover is low and consists of trees and shrubs. Instream habitat cover is high and consists of aquatic vegetation followed by cobble, boulders, woody debris and undercut banks. Groundwater indicator watercress was observed throughout the watercourse. Cyprinids were observed on the west side of the culvert at Army Camp Road.</li> </ul>	Moderate

R4.61-C	
<b>MWW(m):</b>	0.7
<b>MBW(m):</b>	1.85

Photograph 1. Site overview ↑

Photograph 2. Channel view west of Army Camp Road ↑

Photograph 3. Channel view north of Bruce Scott Road ↑

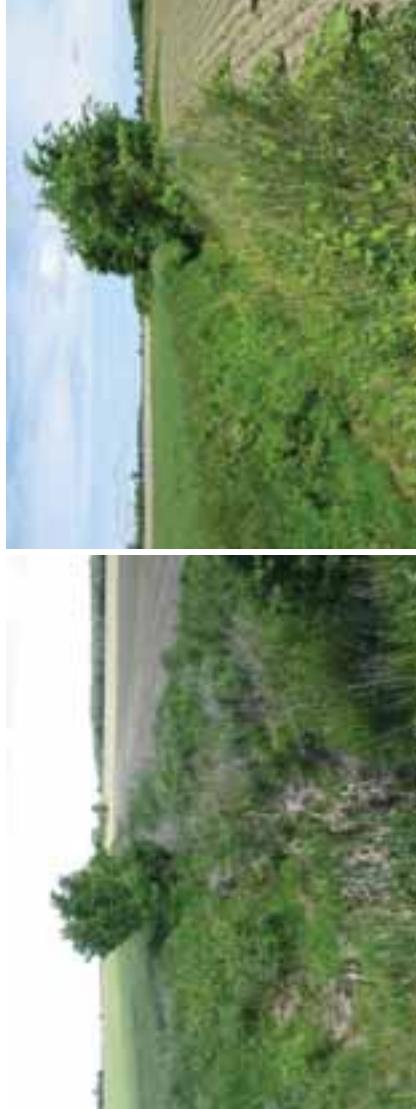
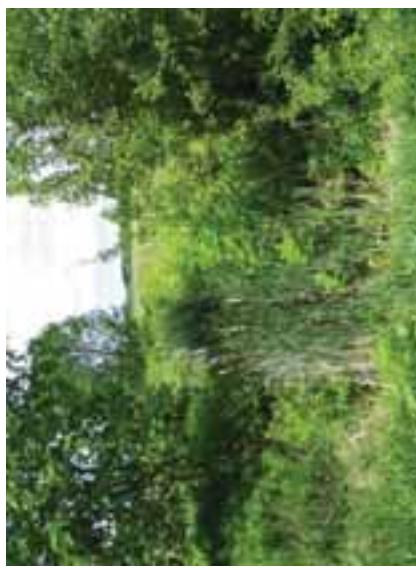
Watercourse Name		Lusby Drain		R5	
DFO Drain Classification		F		MWW(m):	MWD(m): 0.05
				MBW(m):	MBD(m): 0.45

Photograph 1. Site overview ↑

Photograph 2. Site overview ↑

Photograph 3. Cattail choked channel ↑

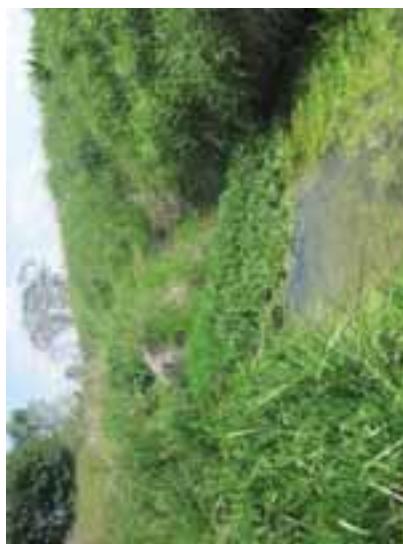
Feature ID	Project Component	Investigation Date	Description of Site	Feature Description	Feature Sensitivity
R5.8	<ul style="list-style-type: none"> <li>• Collection Line Crossing</li> <li>• Road Crossing and Buffer</li> <li>• Turbine 1</li> </ul>	May 24, 2012	<ul style="list-style-type: none"> <li>• The watercourse flows through crop agricultural fields into a shallow marsh and then deciduous forest (classified as FOD, MAS2-1, ELC Feature ID 298). No tile drain inputs were observed during time of investigation. Surrounding topography is flat in the agricultural fields and sloping towards the watercourse in the forest. Riparian buffer is 5 m on the right bank and 30 m on the left bank of a mix of cultural meadow and thicket (classified as CUM1-1 and CUT1-1, ELC Feature ID 298).</li> </ul>	<ul style="list-style-type: none"> <li>• The watercourse is a defined channelized feature. The watercourse is all flat with some pools present. The water was turbid and had low flow at time of investigation. It is classified as a permanent warmwater system by SCRCA. Banks are stable and vegetated. Substrate consists of silt. Canopy cover is low. Instream habitat cover is high and consists only of aquatic vegetation. The channel is cattail choked causing a potential low flow barrier. Groundwater indicator water speedwell was noted throughout the channel. Cyprinids were observed at time of investigation. Approximately 2 km downstream, fish species consist of batfish community (MNR, 1979), 0</li> </ul>	Moderate

Watercourse Name	Walden Drain	R5.8
DFO Drain Classification	C	MWW(m): 0.95
		MBD(m): 1.3

**Photograph 1. Channel overview ↑**

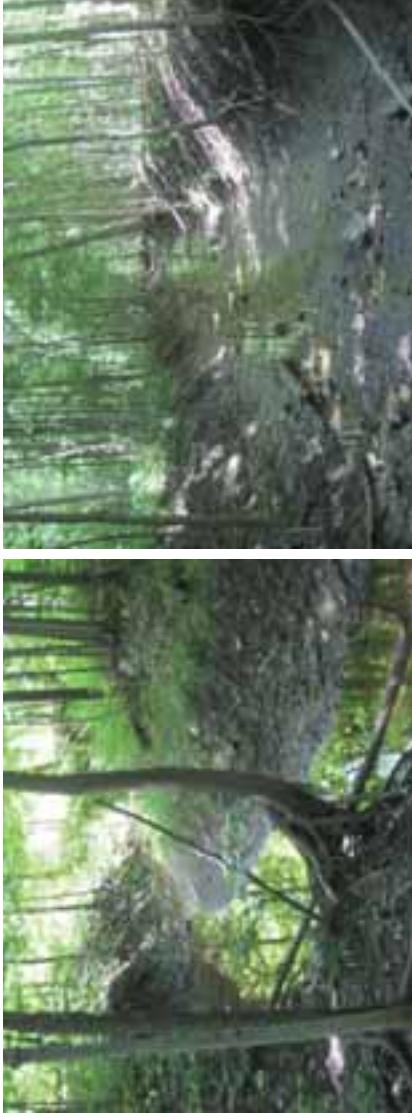
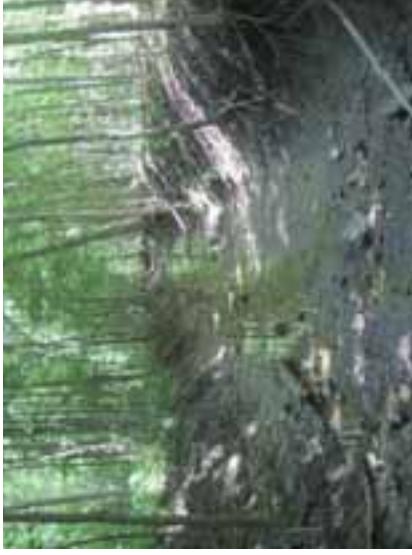
Feature ID	Project Component	Investigation Date	Description of Site	Feature Sensitivity
R6-B*	• Road Buffer • Turbine 35	July 31, 2012	<ul style="list-style-type: none"> <li>The watercourse is located in a deciduous forest (FODG-5, ELC Feature ID 132). No tile drain inputs were noted at time of investigation. Surrounding land topography is flat. Riparian buffer is greater than 15 m.</li> </ul> <p>• The watercourse is a defined channelized feature. The watercourse is mostly flat with some pools present. The water was clear and had no visible flow at time of investigation. It is classified as an intermittent system by SCRCA. Banks are stable with no signs of erosion. Substrate is dominated by sand and silt, followed by clay, gravel, cobble and boulders. Canopy cover is high and is dominated by trees. Instream habitat cover is moderate and consists of cobble, followed by woody debris and boulders. No groundwater indicators were observed. Approximately 5 km downstream fish species consists of baitfish community (MNR, 1976).</p>	Moderate

Watercourse Name	Russell Drain	R6-B
DFO Drain Classification	F	MWD(m): 0.12
		MBD(m): 0.55

Photograph 1. Site overview ↑

Photograph 2. Channel overview ↑

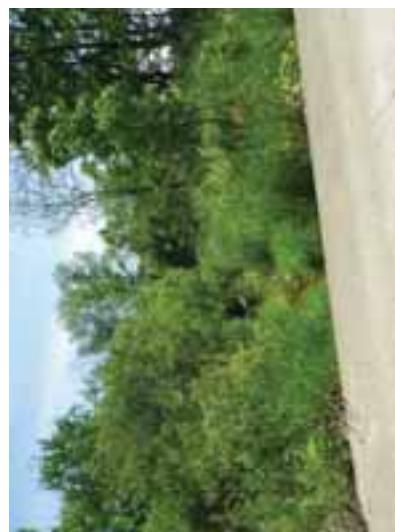
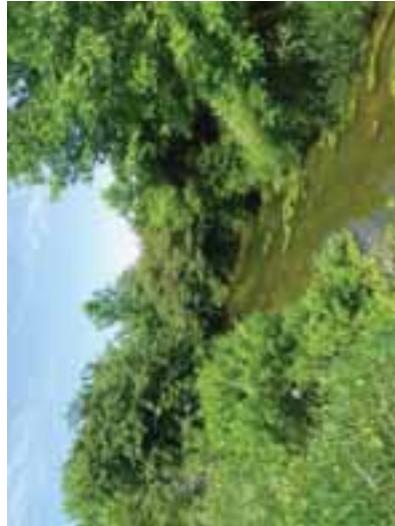
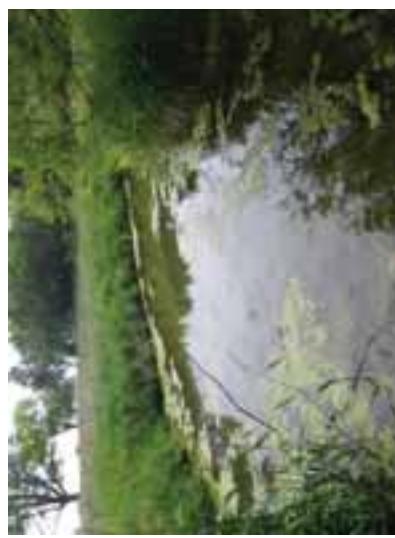
Feature ID	Project Component	Investigation Date	Description of Site	Feature Description	Feature Sensitivity
R6-C	• Collection Line Crossing and Buffer	May 31, 2012	<ul style="list-style-type: none"> <li>The watercourse flows through cultural meadow and woodland (classified as CUMI-1, CUWf, ELC Feature ID 191), adjacent to soy bean and corn fields and becomes dammed as it crosses Kinard Road and then Thomson Line into soy bean and winter wheat fields. Tile drain inputs were noted during time of investigation. Surrounding topography is sloping towards the watercourse. Riparian buffer is 5 m of along the agricultural fields and greater than 25 m in the meadow and woodland areas.</li> </ul>	<ul style="list-style-type: none"> <li>The watercourse is a defined natural feature. The watercourse follows a riffle/run sequence. The water was turbid and had low flow during the time of investigation. It is classified as a permanent warmwater system by SCRCA. Banks are stable and well vegetated. Substrate is dominated by silt followed by cobble and boulders. Canopy cover is low and consists of trees and shrubs. Instream habitat cover is low consisting of aquatic vegetation and boulders followed by cobble and undercut banks. No groundwater indicators were observed. Cyprinids were observed throughout the watercourse. A rock pile created to allow vehicle passage is causing a potential barrier to fish passage immediately upstream of the dammed area. Fish species at Thomson Line consist of baitfish community (MNR, 1976).</li> </ul>	Moderate

Watercourse Name	Shashawandah Creek	R6-C
DFO Drain Classification	C	MWW(m): 4.25
		MBW(m): 7.0
		MWD(m): 0.55
		MBD(m): 1.2

**Photograph 1. Site overview ↑**

**Photograph 2. Channel overview ↑**

**Photograph 3. Channel view ↑**

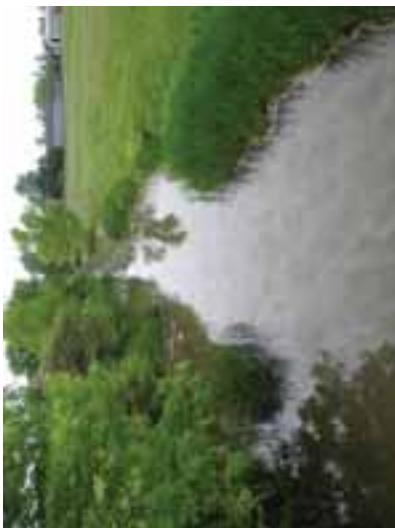
Feature ID	Project Component	Investigation Date	Description of Site	Feature Description	Feature Sensitivity
P6.3	• Collection Line and Buffer	May 31, 2012	<ul style="list-style-type: none"> <li>This is an on-line pond located in a livestock pasture and agricultural fields. The pond is 20 m wide and greater than 1 m deep. Riparian buffer of grasses and shrubs exist.</li> </ul>	<ul style="list-style-type: none"> <li>The pond is permanent on-line feature. The pond is part of R6-C which has been dammed. Substrate is dominated by silt followed by cobble and boulders. <i>In-situ</i> cover is low and consists of boulders and aquatic vegetation. No groundwater indicators were observed. Cyprinids were observed at time of investigation.</li> </ul>	Moderate

**Photograph 1. Pond overview ↑**

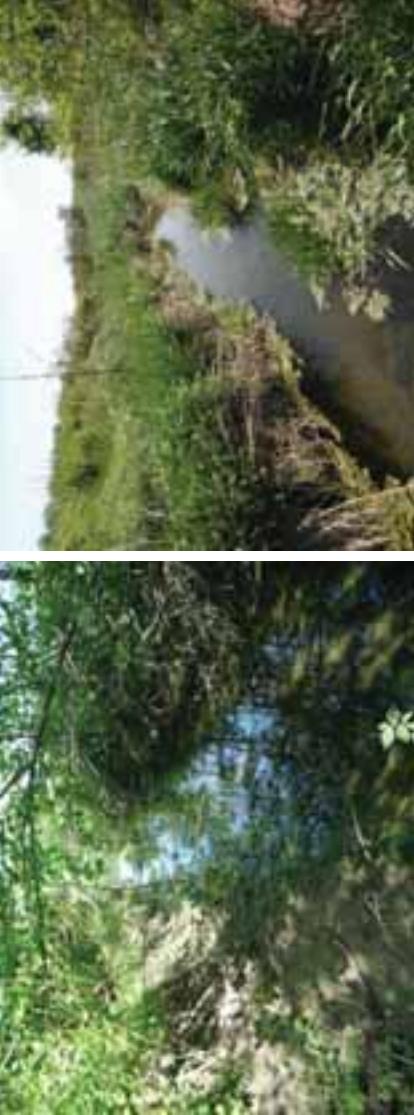
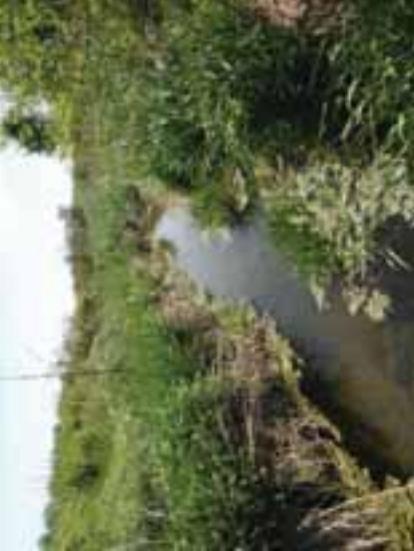
Feature ID	Project Component	Investigation Date	Description of Site	Feature Description	Feature Sensitivity
R6.18-B*	<ul style="list-style-type: none"> <li>Collection Line and Buffer</li> <li>Road Crossing and Buffer</li> <li>Turbines 49, 50 and 51</li> </ul>	May 17, 2012 May 30, 2012	<ul style="list-style-type: none"> <li>The watercourse runs in-between deciduous forest (classified as FOD7-1, ELC Feature ID 113) and agricultural fields and crosses Jura Line into more agricultural fields and cultural thicket (classified as CUT1-4, ELC Feature ID 144). Flowing tile drain inputs were observed at time of first site investigation. Surrounding topography is flat with some gentle sloping towards the watercourse. Riparian buffer was approximately 5 m and greater than 15 m along the forest area.</li> </ul>	<ul style="list-style-type: none"> <li>The watercourse is a defined channelized feature that is starting to naturalize to the north. The watercourse is mostly flat with some pools present. The water was clear and had moderate flow at time of investigations. It is classified as an intermittent system by SCRCA. Banks are stable with no signs of erosion. Substrate is muck, clay, sand and silt. Canopy cover is high and is dominated by trees. Instream habitat cover is moderate and consists of aquatic vegetation, small woody debris and vegetation debris. No groundwater indicators were observed. Approximately 5 km downstream, fish species consists of baitfish community (MNR, 1976).</li> </ul>	Moderate

R6.18-B	
MWW(m):	2.0
MBW(m):	3.0

**Photograph 1. Channel view in cultural thicket ↗**

**Photograph 2. Channel view in agricultural fields ↗**

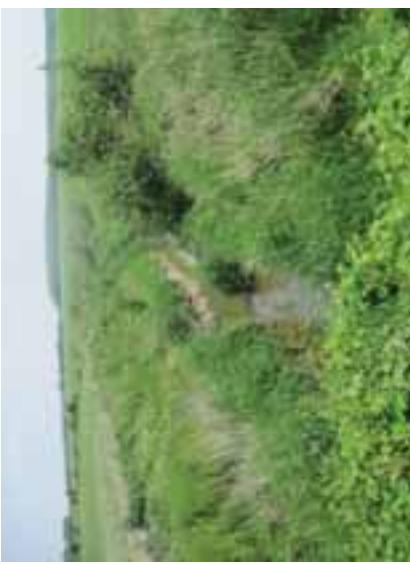
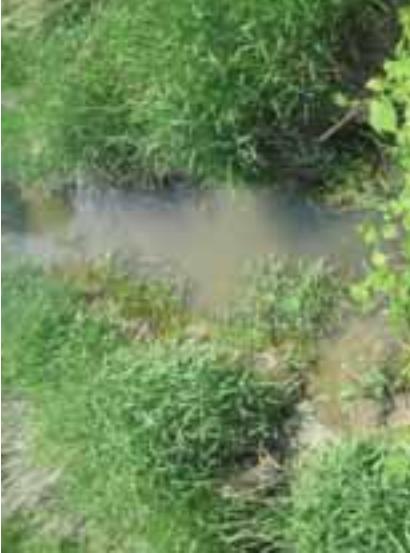
Feature ID	Project Component	Investigation Date	Description of Site	Feature Description	Feature Sensitivity
R6.18-C*	• Collection Line Crossing	May 28, 2012	<ul style="list-style-type: none"> <li>The watercourse flows through corn fields and crosses Jericho Road. Flowing tile drain inputs were observed at time of investigation. Surrounding land topography is flat. Riparian buffer is 10 m of meadow.</li> </ul>	<ul style="list-style-type: none"> <li>The watercourse is a defined channelized feature. The watercourse is mostly flat with some pools. The water was clear and had slow flow at time of investigation. It is classified as an intermittent system by SCRCA. Banks are stable and well vegetated. Substrate is dominated by muck, sand and silt, followed by clay. Canopy cover is moderate and is dominated by grasses. Instream habitat cover is moderate and consists of aquatic vegetation, corn debris and undercut banks. Small clumps of groundwater indicator watercress were observed throughout the channel. Approximately 5 km downstream, fish species consists of baitfish community (MNR, 1976).</li> </ul>	Moderate

Watercourse Name	Shawana Drain	R6.18-C
DFO Drain Classification	F	MWW(m): MBD(m):
		0.21 0.45
		MWD(m): MBD(m):

**Photograph 1. Site overview ↗**

**Photograph 2. Channel view ↗**

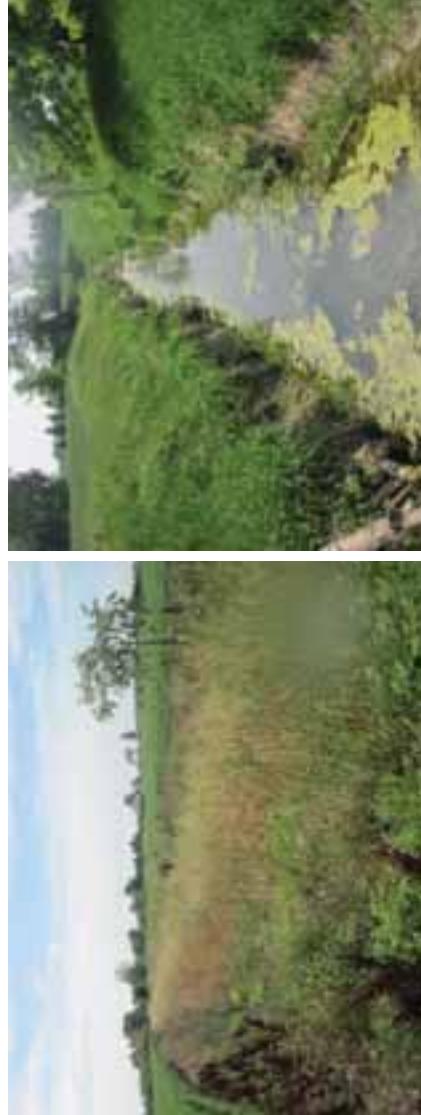
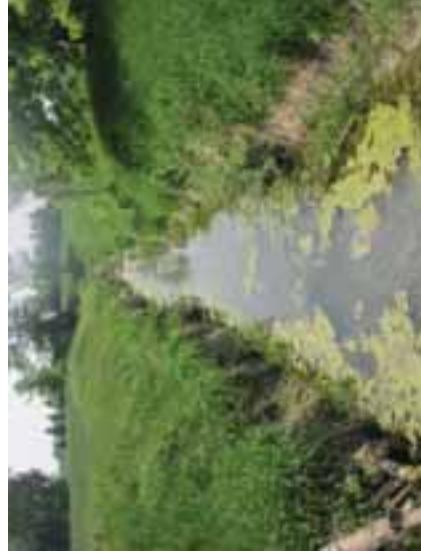
Feature ID	Project Component	Investigation Date	Description of Site	Feature Description	Feature Sensitivity
R6.18-D*	<ul style="list-style-type: none"> <li>Collection Line Crossing and Buffer</li> <li>Road Crossing and Buffer</li> </ul>	May 28, 2012 July 31, 2012	<ul style="list-style-type: none"> <li>The watercourse is surrounded by soybean and other crop fields. Tile drains were noted at time of investigation and some were flowing. Surrounding topography is flat. Riparian buffer varies from 5 m to 10 m of grasses and trees.</li> </ul>	<ul style="list-style-type: none"> <li>The watercourse is a defined channelized feature. The watercourse is straight and consisted of 100% flat. The water was slightly turbid and had slow flow at time of investigation. It is classified as a permanent warmwater system by SCRCA. Banks are stable to slightly unstable with some erosion and undercutting observed. Substrate is dominated by silt and clay, followed by sand, cobble and gravel. Canopy cover is moderate and is dominated by grasses. Instream habitat cover was high and was dominated by aquatic vegetation, followed by cobble, woody debris and undercut banks. The channel was choked in some sections with vegetation. Sporadic clumps of groundwater indicator watercress were observed. Fish were observed during the first site investigation. Approximately 6 km downstream, fish species consist of baitfish community (MNR, 1976),</li> </ul>	Moderate

R6.18-D	
<b>MWD(m):</b>	0.2
<b>MBD(m):</b>	0.7

**Photograph 1. Site overview ↑**

**Photograph 2. Channel view ↑**

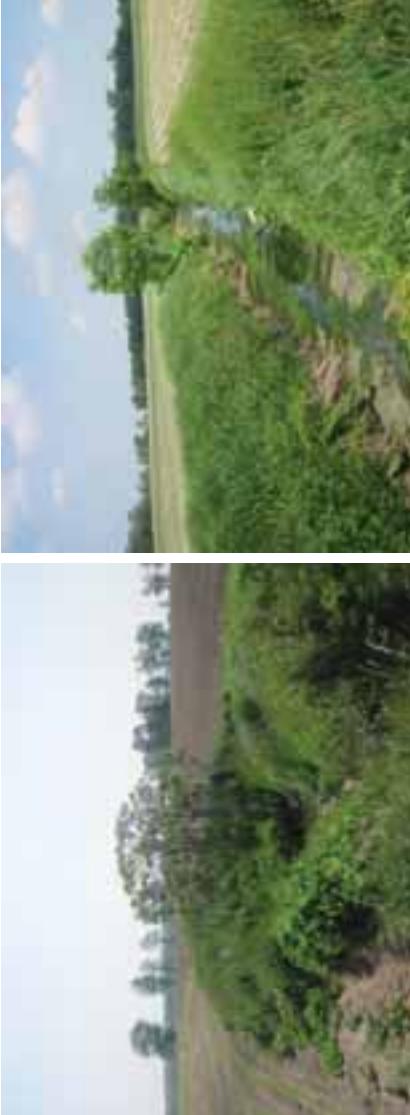
Feature ID	Project Component	Investigation Date	Description of Site	Feature Description	Feature Sensitivity
R6.20-A	• Collection Line • Buffer • Road Buffer	May 24, 2012	<ul style="list-style-type: none"> <li>The watercourse is located in a corn field. Flowing tile drain inputs were observed at time of investigation. Surrounding topography is flat. Riparian buffer is 5 m of meadow.</li> </ul>	<ul style="list-style-type: none"> <li>The watercourse is a defined channelized feature. The watercourse is mostly flat with some pools present. The water was clear and had very slow flow at time of investigation. It is classified as an intermittent system by SCRCA. Banks are stable and well vegetated. Substrate is dominated by muck, silt and clay, followed by sand and gravel. Canopy cover is moderate and is dominated by shrubs. Instream habitat cover is high and consists of aquatic vegetation followed by small woody debris. The channel is algae choked. No groundwater indicators were observed. Approximately 8 km downstream, fish species consists of baitfish community (MNR, 1976).</li> </ul>	Moderate

Watercourse Name		Sloan Russell Drain		R6.20-A	
DFO Drain Classification		F		MWW(m):	MWD(m):
				MBW(m):	MBD(m):

**Photograph 1. Site overview ↑****Photograph 2. Channel overview ↑**

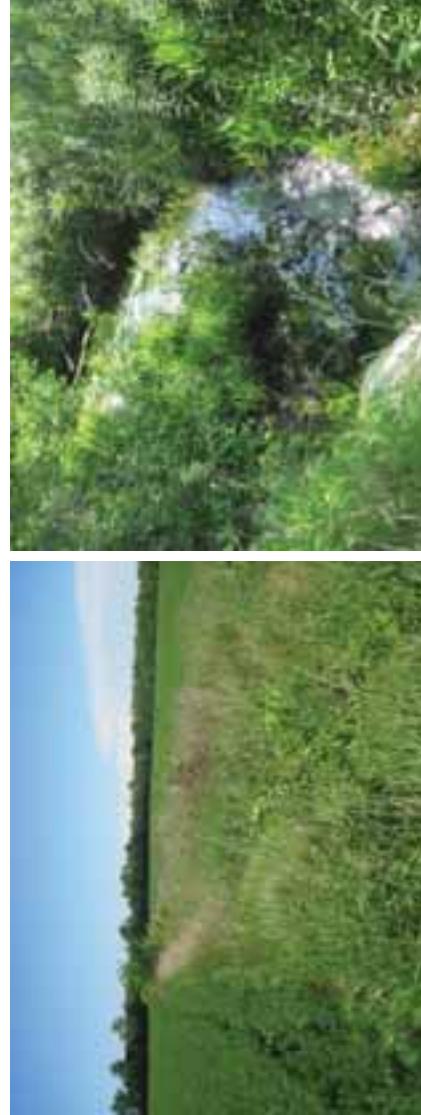
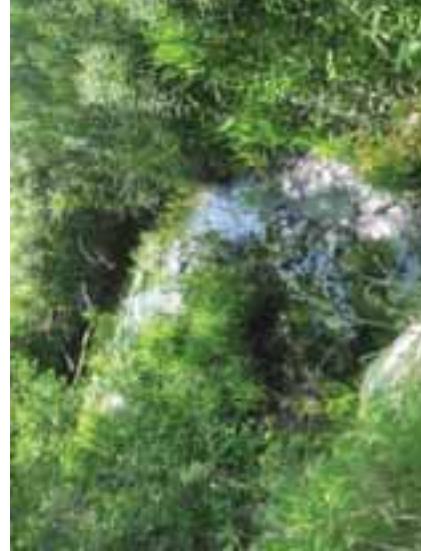
Feature ID	Project Component	Investigation Date	Description of Site	Feature Description	Feature Sensitivity
R6.20-B*	• Collection Line Crossing and Buffer	June 6, 2012 July 31, 2012	• The watercourse flows through clover, alfalfa and soybean fields. Tile drain inputs that were not flowing were observed at time of investigation. Surrounding topography is flat. Riparian buffer is 5 m of meadow.	• The watercourse is a defined channelized feature. The watercourse is mostly flat with some riffles. The water was clear and had very slow flow at time of first site investigation and no visible flow during the second site investigation. It is classified as an intermittent system by SCRCA. Banks are stable to slightly unstable with some erosion observed. Substrate is dominated by silt and clay, followed by sand and muck. Canopy cover is high and is dominated by grasses. Instream habitat cover is high and consists of aquatic vegetation, followed by small woody debris and undercut banks. The channel is choked with grasses. No groundwater indicators were observed. Approximately 5 km downstream, fish species consists of baitfish community (MNR, 1976).	Moderate

R6.20-B	
MWW(m):	0.55
MBW(m):	1.88

**Photograph 1. Site overview ↑**

**Photograph 2. Channel view ↑**

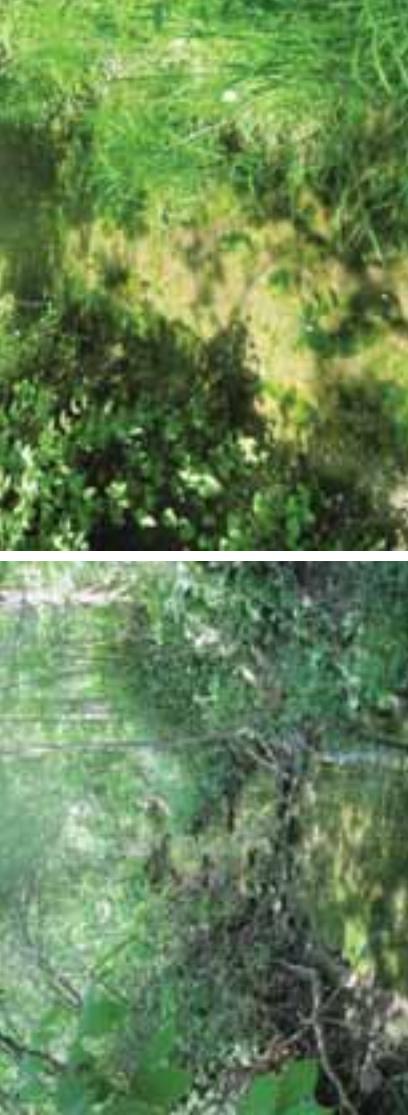
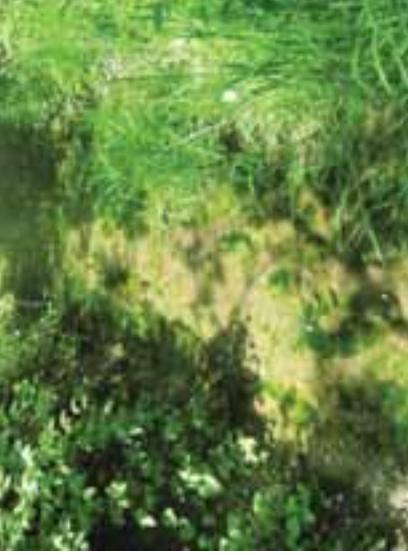
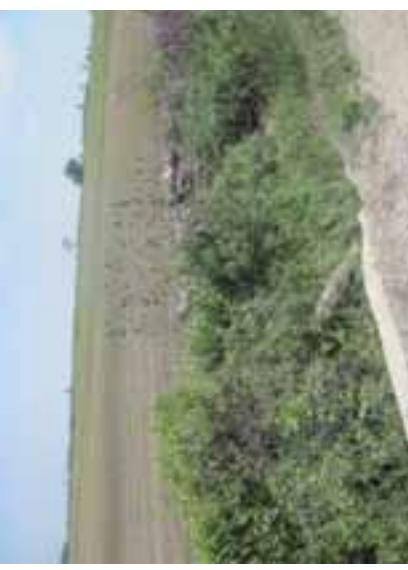
Watercourse Name	South Boundary Drain	R8.12
DFO Drain Classification	F	MWW(m): MBW(m):
		1.3 1.5
		0.15 0.25

Photograph 1. Site overview in forest ↑

Photograph 2. Channel view ↑

Photograph 3. Site overview east of Warwick Village Road ↑

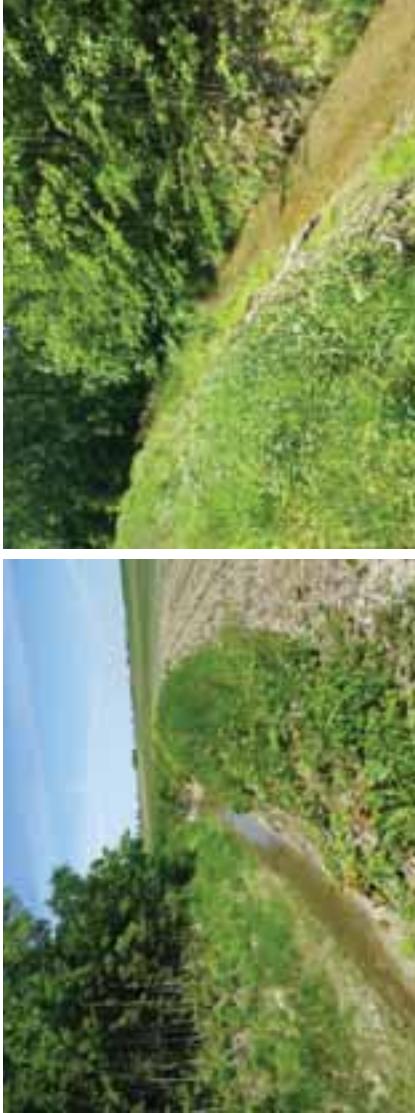
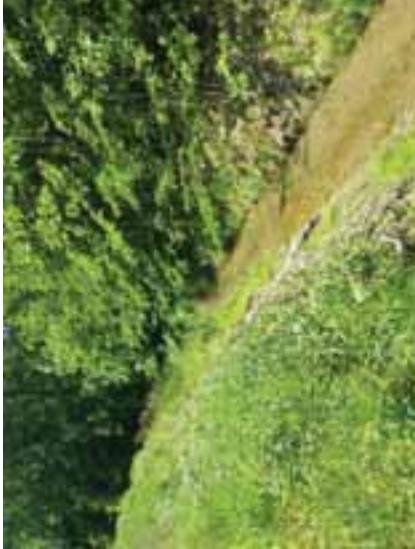
Feature ID	Project Component	Investigation Date	Description of Site	Feature Description	Feature Sensitivity
R9-B	• Road Buffer • Turbine 97	June 8, 2012	<ul style="list-style-type: none"> <li>The watercourse runs adjacent to a deciduous forest and a small patch of cultural thicket (classified as FOD6-5, CUT11-1, ELC Feature ID 63) and soybean fields. Flowing tile drain inputs were observed at time of investigation. Surrounding topography is flat. Riparian buffer is 5 m of grasses along the soybean fields and greater than 15 m along the forest.</li> </ul>	<ul style="list-style-type: none"> <li>The watercourse is a defined channelized feature. The watercourse is mostly flat with one riffle present. The water is clear and had slow flow at time of investigation. It is classified as an intermittent system by SCRCA. Banks are stable with no signs of erosion. Substrate consists of silt, sand and clay. Canopy cover is low and is dominated by trees. Instream habitat cover is low and consists of aquatic vegetation, followed by cobble. No groundwater indicators were observed. Sticklebacks were observed at time of investigation. Approximately 3 km downstream, fish species consist of baitfish community, Black Bullhead and Green Sunfish (SCRCA, 2000).</li> </ul>	Moderate

Watercourse Name	Graham Drain	R9-B
DFO Drain Classification	F	MWD(m): 0.15
MBW(m):		MBD(m): 0.7

**Photograph 1. Site overview ↑**

**Photograph 2. Channel overview ↑**

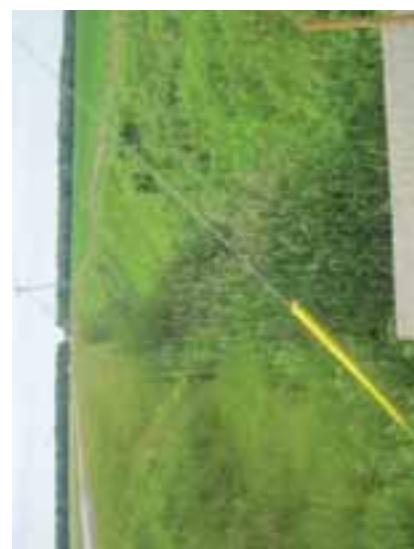
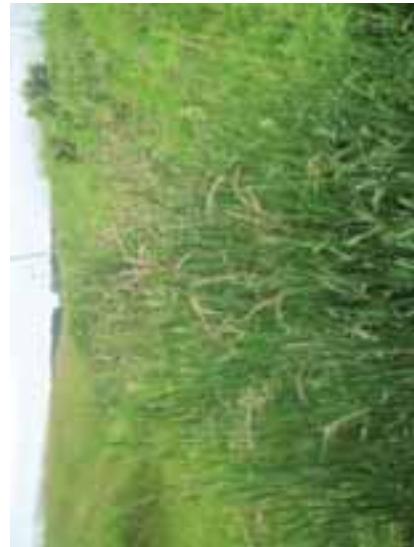
Feature ID	Project Component	Investigation Date	Description of Site	Feature Description	Feature Sensitivity
R9.29-A	• Collection Line Crossing and Buffer	June 18, 2012	<ul style="list-style-type: none"> <li>The watercourse is located in crop agricultural fields and runs along the roadside of Nauvo Road. Flowing tile drain inputs were noted during time of investigation. Surrounding topography is flat. Riparian buffer is 5 m of meadow.</li> </ul>	<ul style="list-style-type: none"> <li>The watercourse is a defined channelized feature. The watercourse is straight flat uniform channel. The water was clear and was stagnant with sections of dry channel during the time of investigation. It is classified as intermittent system by SCRCA. Banks are stable and well vegetated. Substrate consists of silt and clay. Canopy cover is high and dominated by grasses. Instream habitat cover is high and consists of only aquatic vegetation. The channel is grass choked. A few plants of groundwater indicator water speedwell were observed. Iron staining was present just south of Townsend Line. Fish were observed near a culvert at time of investigation. Approximately 8 km downstream, fish community consists of baitfish community, Black Bullhead and Green Sunfish (SCRCA, 2000).</li> </ul>	Moderate

<b>MWW(m):</b>	1.0	<b>MBW(m):</b>	2.5	<b>MWD(m):</b>	0.07	<b>MBD(m):</b>	0.6
<b>MWW(m):</b>	1.0									
<b>MBW(m):</b>	2.5									
<b>MWD(m):</b>	0.07									
<b>MBD(m):</b>	0.6

**Photograph 1. Site overview** ↑

**Photograph 2. Channel view** ↑

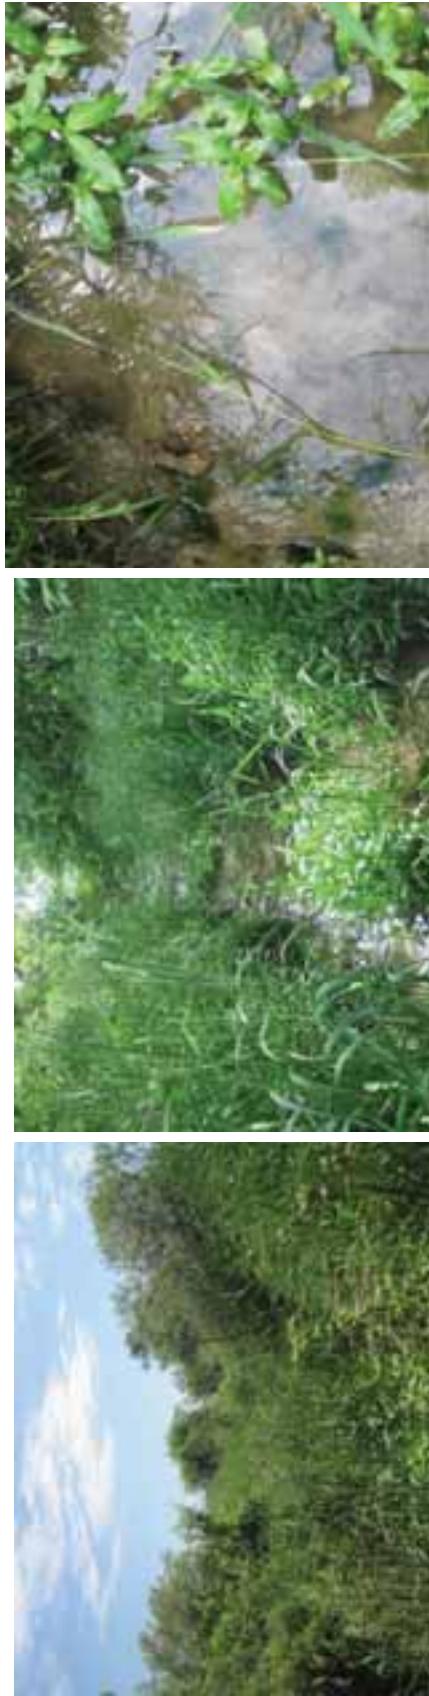
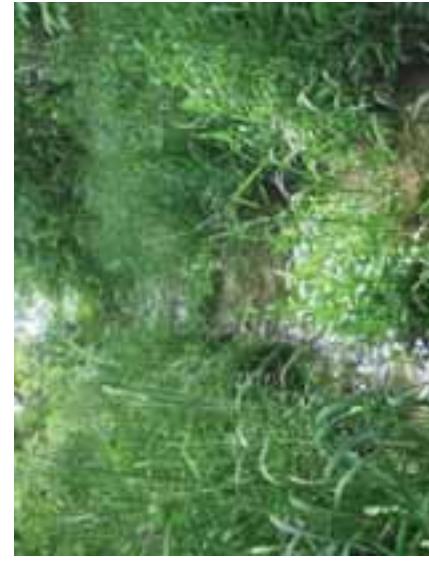
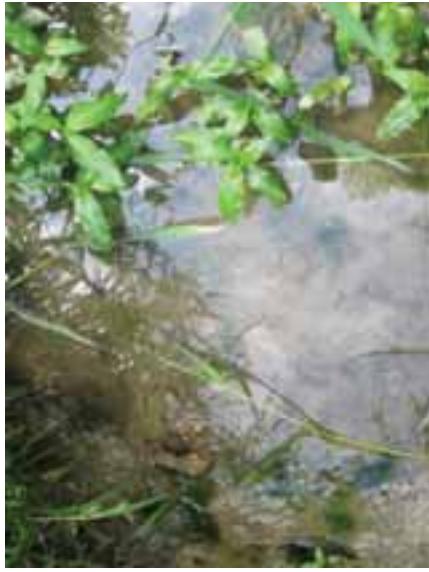
Feature ID	Project Component	Investigation Date	Description of Site	Feature Description	Feature Sensitivity
R9.29-B	• Collection Line Crossing	May 30, 2012	<ul style="list-style-type: none"> <li>The watercourse flows beside a deciduous forest (classified as FOD5-1, FOD6-5, ELC Feature ID 103), crossing Northville Road and into soybean and corn fields. Flowing tile drain inputs were noted at time of investigation. Surrounding topography is flat. Riparian buffer is 5 m of meadow in the agricultural fields and greater than 30 m on the south side along the forest.</li> </ul>	<ul style="list-style-type: none"> <li>The watercourse is a defined channelized feature. The watercourse is all straight flats. The water was clear and had slow flow at time of investigation. It is unclassified by SCRCA. Banks are stable to slightly unstable with some evidence of erosion. Substrate is dominated by silt, clay and muck followed by sand and cobble. Canopy cover is moderate and is a mix of shrubs, trees and grasses. Instream habitat cover is moderate and consists of aquatic vegetation followed by woody debris, undercut banks and cobble. Small clumps of groundwater indicator water speedwell were present throughout the reach. Young-of-the-year (YOY) and adults Cyprinids were observed at time of investigation. Approximately 7.5 km downstream, fish species consist of batfish community, Black Bullhead and Green Sunfish (SCRCA, 2000).</li> </ul>	Moderate

Watercourse Name	McPherson Drain 2005	R9.29-B
DFO Drain Classification	Unclassified	MWW(m): 1.5 MBW(m): 2.0

**Photograph 1. Site overview ↑**

**Photograph 2. Channel view ↑**

**Photograph 3. Substrate ↑**

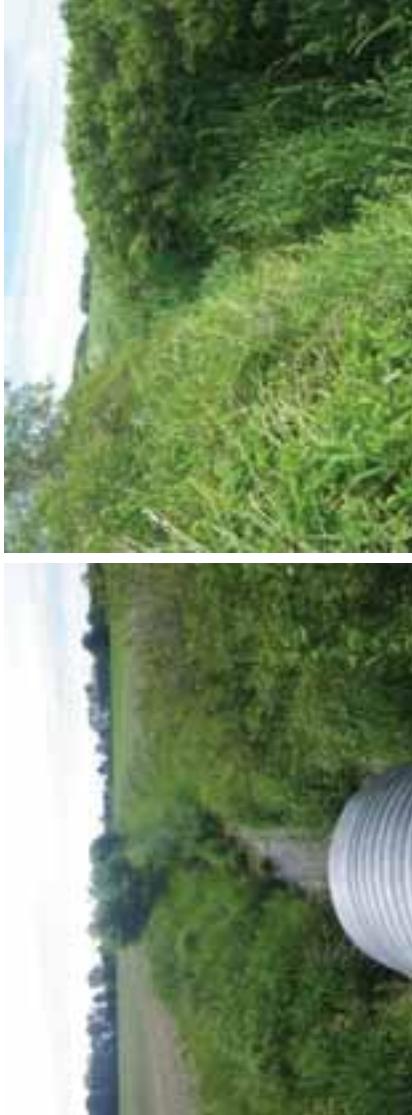
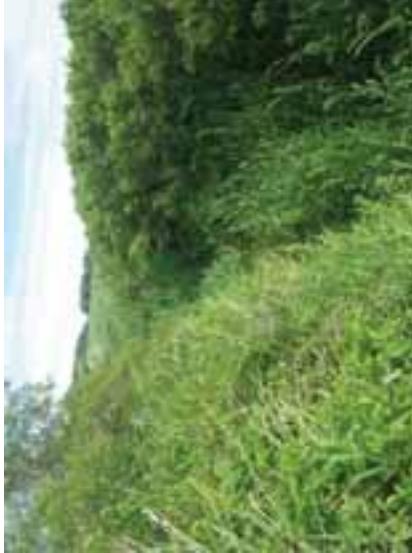
Feature ID	Project Component	Investigation Date	Description of Site	Feature Description	Feature Sensitivity
R9.29-C*	• Road Crossing	May 29, 2012	<ul style="list-style-type: none"> <li>The watercourse is located in corn and soybean fields.</li> <li>Tile drain inputs were observed at time of investigation.</li> <li>Surrounding topography is flat. Riparian buffer is 5 m of grasses and shrubs.</li> </ul>	<ul style="list-style-type: none"> <li>The watercourse is a defined channelized feature. The watercourse is a straight uniform channel with flats. The water was clear and had low flow at time of investigation. It is unclassified by SCRCA.</li> <li>Banks are stable and well vegetated. Substrate is dominated by silt followed by muck.</li> <li>Canopy cover is low and consists of grasses.</li> <li>Instream habitat cover is moderate and consists of grasses and aquatic vegetation.</li> <li>No groundwater indicators were observed.</li> <li>Approximately 6 km downstream, fish species consist of baitfish community, Green Sunfish and Black Bullhead (SCRCA, 2000).</li> </ul>	Moderate

Watercourse Name	McPherson Drain 2005	R9.29-C
DFO Drain Classification	Unclassified	
		MWW(m): 1.8
		MBW(m): 3.0
		MWD(m): 0.25
		MBD(m): 0.45

**Photograph 1. Site overview ↑**

**Photograph 2. Channel view↑**

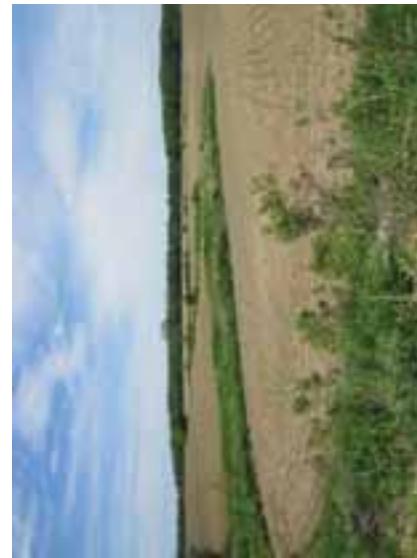
Feature ID	Project Component	Investigation Date	Description of Site	Feature Description	Feature Sensitivity												
R9.29-D*	<ul style="list-style-type: none"> <li>Collection Line Crossing and Buffer</li> <li>Road Crossing and Buffer</li> <li>Turbine 92</li> </ul>	May 29, 2012	<ul style="list-style-type: none"> <li>The watercourse is surrounded by soybean fields and crosses Hickory Creek. Flowing tile drain inputs were observed at time of investigation. Surrounding topography is very slightly rolling hills. Riparian buffer is 5 m of grasses.</li> <li>The watercourse is a defined channelized feature. The watercourse is all flats. The water was clear and had slow flow at time of investigation. It is classified as intermittent by SCRCA. Banks are stable and well vegetated. Substrate is dominated by clay followed by sand, silt, gravel and cobble. Canopy cover is low and is dominated by grasses. Instream cover is high and is dominated by aquatic vegetation, followed by cobble, undercut banks, woody debris and vegetation debris. No groundwater indicators were observed. Approximately 25 adult and 10 YOY Cyprinids were observed at time of investigation. Approximately 4 km downstream, fish species consist of baitfish community, Green Sunfish and Black Bullhead (SCRCA, 2000).</li> </ul>	<table border="1"> <tr> <td>R9.29-D</td> <td>R9.29-D</td> </tr> <tr> <td>MWW(m):</td> <td>0.8</td> </tr> <tr> <td>MBW(m):</td> <td>1.2</td> </tr> </table> <table border="1"> <tr> <td>R9.29-D</td> <td>R9.29-D</td> </tr> <tr> <td>MWD(m):</td> <td>0.2</td> </tr> <tr> <td>MBD(m):</td> <td>0.5</td> </tr> </table>	R9.29-D	R9.29-D	MWW(m):	0.8	MBW(m):	1.2	R9.29-D	R9.29-D	MWD(m):	0.2	MBD(m):	0.5	Moderate

**Photograph 1. Site overview ↑**

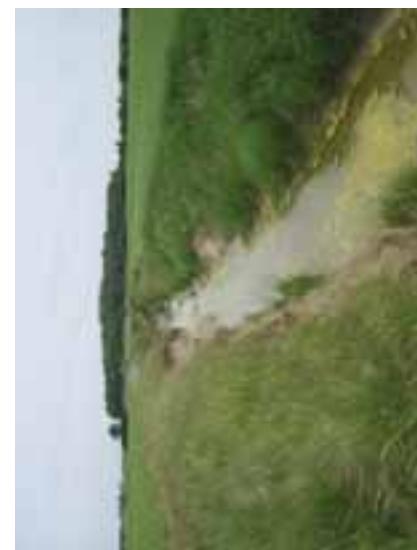
**Photograph 1. Site overview ↑**

Watercourse Name	McPherson Drain 2005
DFO Drain Classification	C
