Jericho Wind, Inc.

## **Final Water Assessment and Water Body Report – Jericho Wind Energy Centre**

60155032

February, 2013

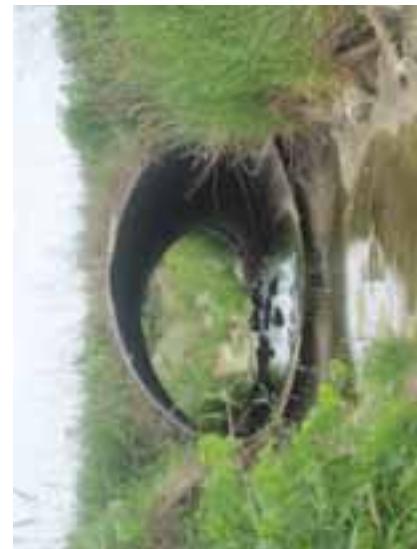
**Photograph 2. Perched culvert ↑**

Watercourse Name	McPherson Drain 2005
DFO Drain Classification	C

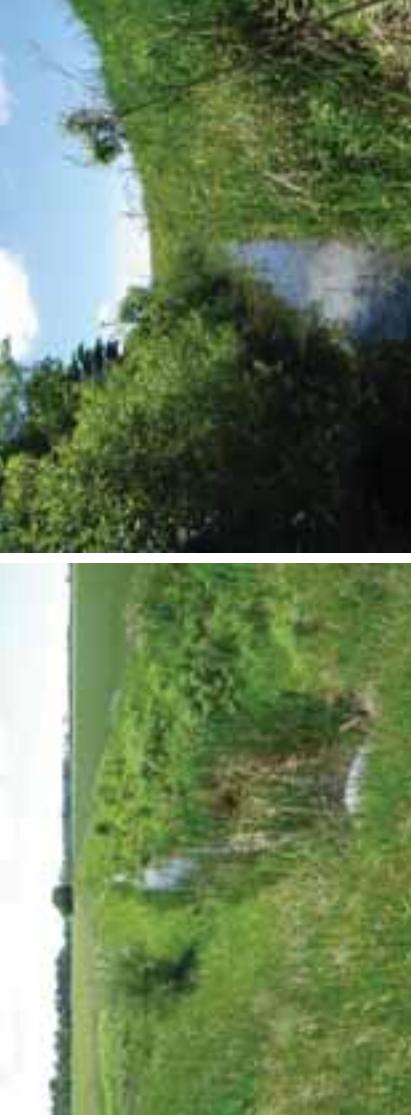
**Photograph 1. Site overview ↑**

Feature ID	Project Component	Investigation Date	Description of Site	Feature Description	Feature Sensitivity
R12.54-A*	• Collection Line Crossing and Buffer	June 4, 2012	<ul style="list-style-type: none"> <li>The watercourse is surrounded by soybean and corn fields and crosses Nauvo Road. Tile drain inputs that were not flowing were observed at time of investigation. Surrounding topography is flat. Riparian buffer is 5 m of grasses and trees.</li> </ul>	<ul style="list-style-type: none"> <li>The watercourse is a defined channelized feature. The watercourse is 100% flat. The water was clear and had no visible flow at time of investigation. It is classified as a permanent warmwater system by SCRCA. Banks are stable and well vegetated. Substrate consists of silt and muck. Canopy cover is moderate and is dominated by trees. Instream habitat cover is moderate and consists of aquatic vegetation followed by small woody debris. No groundwater indicators were observed. Cyprinids were observed at time of investigation. Approximately 2.5 km downstream, fish species consists of baitfish community, Rock Bass and Largemouth Bass (SCRCA, 2002).</li> </ul>	Moderate

Watercourse Name	Zavitz Drain	R12.54-A
DFO Drain Classification	C	MWD(m): MBW(m):
		2.4 3.4
		0.18 1.0

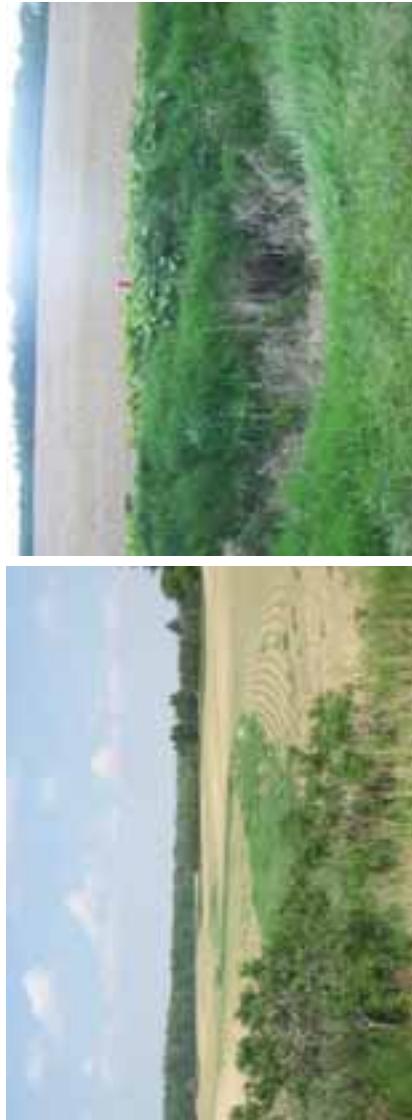
Photograph 1. Site overview north of Elginfield Road

Feature ID	Project Component	Investigation Date	Description of Site	Feature Description	Feature Sensitivity
R1.37*	• Transmission Line Crossing	May 24, 2012	<ul style="list-style-type: none"> <li>The watercourse is buried south of Elginfield Road and emerges from a tile drain. The watercourse crosses Elginfield Road into a corn field. No tile drain inputs were noted at time of investigation. Surrounding topography is flat. Riparian buffer is 3 m of grasses</li> </ul>	<ul style="list-style-type: none"> <li>The watercourse is a defined channelized feature. It is classified as tiled and intermittent by ABCA. Banks are stable and well vegetated. Canopy cover is low and dominated by grasses. No groundwater indicators were observed. Approximately 5 km downstream, fish species consist of baitfish community and Yellow Bullhead (MNR, 1974).</li> </ul>	Low

Watercourse Name	Dixon Drainage Works
DFO Drain Classification	T, F
MWW(m):	n/a
MBW(m):	n/a
MRD(m):	n/a

Photograph 2. Site overview south of Elginfield Road

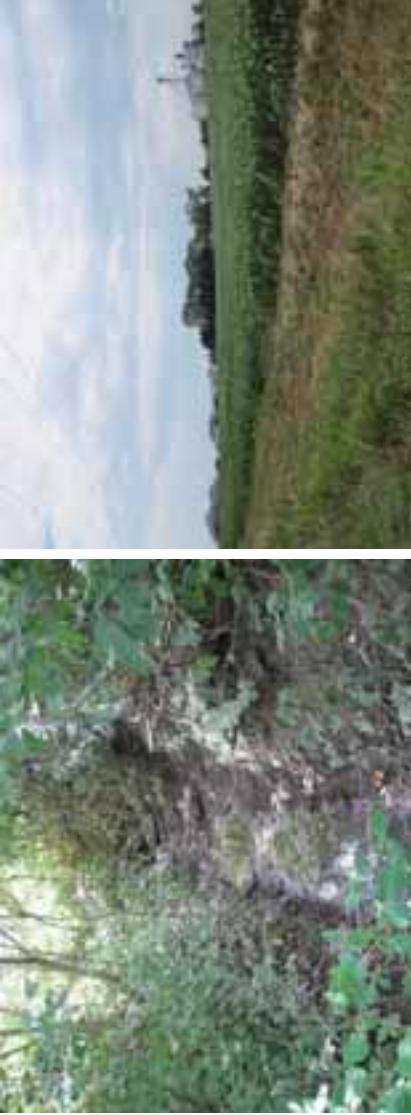
Photograph 1. Channel view in forest ↑

Feature ID	Project Component	Investigation Date	Description of Site	Feature Sensitivity
R2.28*	• Collection Line Crossing	July 25, 2012	<ul style="list-style-type: none"> <li>The watercourse is buried to the west of Arkona Road and opens up east of Arkona Road flowing through deciduous forest (classified as FOD7-4, ELC Feature ID 90) and livestock pasture. No tile drain inputs were noted at time of investigation. Surrounding topography is a small valley. Riparian buffer is 10 m.</li> <li>The watercourse is channelized in some portion and natural in others. There was no water, except for one pool area at time of investigation. It is classified as tiled and unknown by ABCA. Banks are slightly unstable with some erosion present. Substrate is dominated by clay followed by sand, silt, gravel and cobble. Canopy cover is high and is dominated by trees. Instream habitat cover is low and consists of cobble, debris, woody debris and undercut banks. No groundwater indicators were observed. Fish are present approximately 4.6 km downstream in the Ausable River.</li> </ul>	Low

Watercourse Name	Hayter Struyft Drain	R2.28
DFO Drain Classification	T, U	MWD(m): MBD(m):
		0.8 1.0
		n/a 0.4

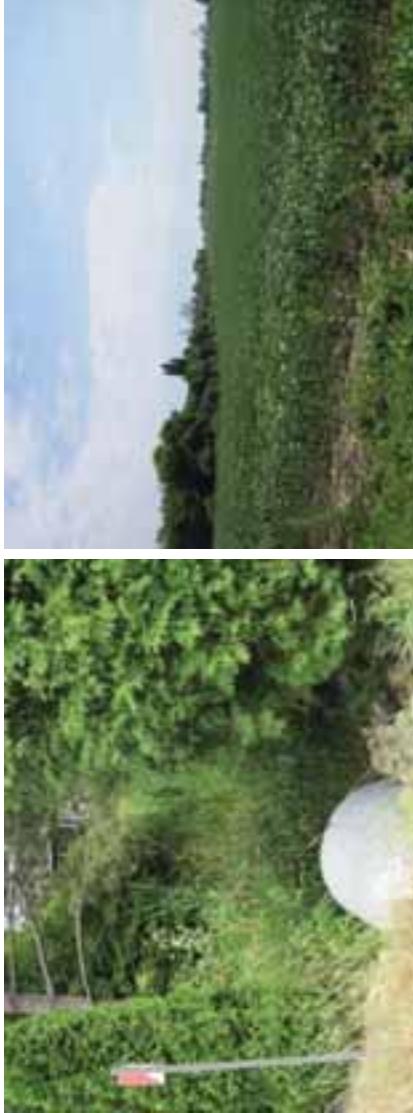
Photograph 1. Site overview ↑

Feature ID	Project Component	Investigation Date	Description of Site	Feature Description	Feature Sensitivity
R2.34*	• Collection Crossing	Line	July 25, 2012	<ul style="list-style-type: none"> <li>The watercourse is buried in a soybean field before flowing into cultural plantation and deciduous forest (classified as CUP3-2, FOD7-4, ELC Feature ID 90), crossing Arkona Road into a residential property. No tile drain inputs were noted at time of investigation. Surrounding topography a valley. Riparian buffer is greater than 5 m to the west of Arkona Road.</li> </ul>	Low

Watercourse Name	Borthwickie Drain Trib B	R2.34
DFO Drain Classification	T, U	MWW(m):
		n/a
		MBW(m):
		n/a

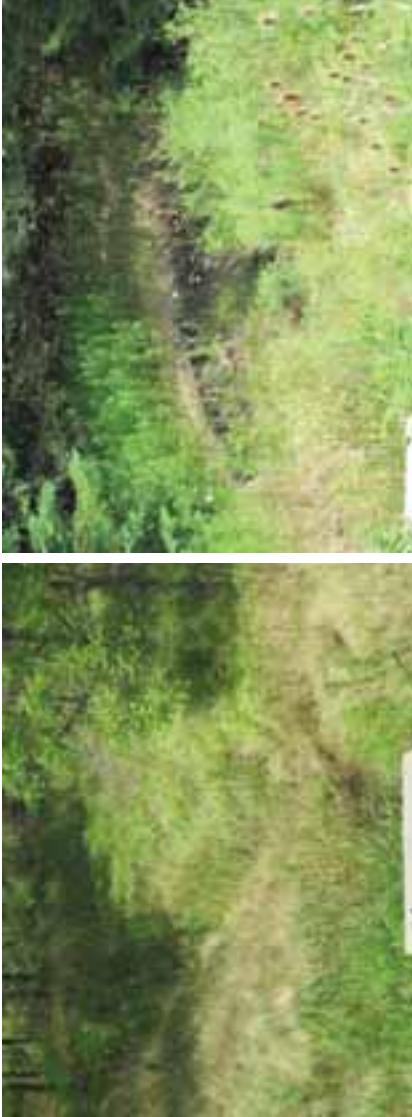
Photograph 1. Site overview ↗

Feature ID	Project Component	Investigation Date	Description of Site	Feature Description	Feature Sensitivity
R2.140-B*	• Collection Line Crossing	July 30, 2012	<ul style="list-style-type: none"> <li>The watercourse crosses Arkona Road and is surrounded by cultural plantation and woodland (classified as CUP3-2, CUW1a, ELC Feature ID 99). No tile drain inputs were noted at time of investigation. Surrounding topography is a small valley. Riparian buffer is 25 m.</li> </ul>	<ul style="list-style-type: none"> <li>The watercourse is channelized at the road but a natural feature beyond Arkona Road. The watercourse consists of 100% flat. The water was turbid and no flow was observed at time of investigation. It is classified as a permanent warmwater system by ABCA. Banks are slightly unstable with some erosion observed. Canopy cover is high and consists of trees and grasses. Instream habitat cover is low and consists of only aquatic vegetation. No groundwater indicators were observed. Fish are present approximately 3 km downstream in the Ausable River.</li> </ul>	Low

Watercourse Name	From Lameman Drain	R2.140-B
DFO Drain Classification	C	MWD(m): MBD(m):
		0.7 1.2
		n/a n/a

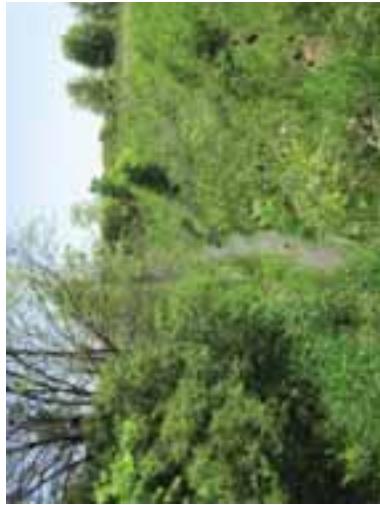
Photograph 1. Site overview ↑

Feature ID	Project Component	Investigation Date	Description of Site	Feature Description	Feature Sensitivity
R2.281*	• Collection Line Crossing and Buffer	May 9, 2012 May 23, 2012	<ul style="list-style-type: none"> <li>The watercourse runs parallel along Birnam Line through a crop agricultural field and crosses the road north into another agricultural field. Flowing tile drain inputs were noted through the site. The surrounding land topography is flat with hills on the north side. Riparian buffer is 4 m of grasses.</li> </ul>	<ul style="list-style-type: none"> <li>The watercourse is a channelized feature and is a straight uniform channel. The water was slightly turbid and had low flow at time of investigations. It is classified as intermittent by ABCA. Banks are stable and well vegetated. Canopy cover is low consisting of grasses, shrubs, herbaceous vegetation and trees. Instream habitat cover is high and consists only of aquatic vegetation. The channel is algae choked. No groundwater indicators were observed. Two rock structures and accumulation of large woody debris create potential for additional low flow barriers north of Birnam Line.</li> </ul>	Low

Watercourse Name	Hobbs-McKenzie Drain	R2.281
DFO Drain Classification	F	MWW(m): MBW(m):
		MWD(m): MBD(m):
		0.2 0.68

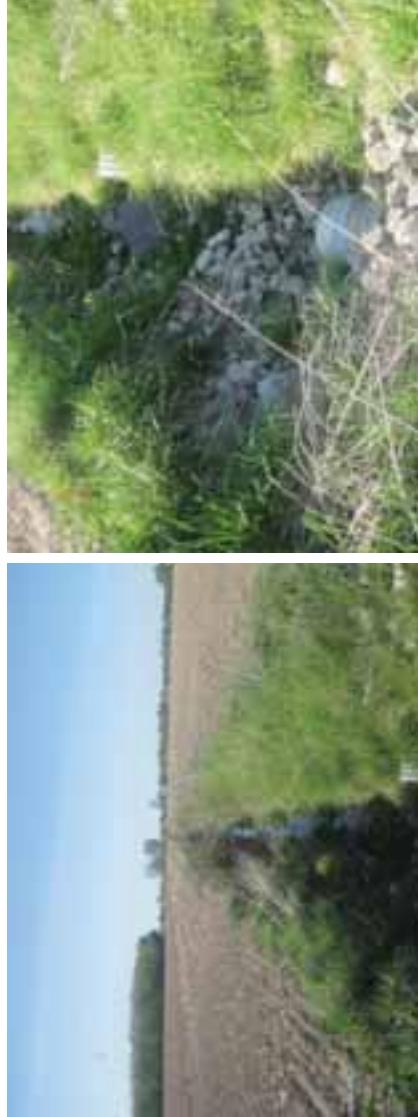
**Photograph 1. Site overview ↑**

Feature ID	Project Component	Investigation Date	Description of Site	Feature Description	Feature Sensitivity
R3.38	• Collection Line Crossing • Transmission Line Crossing	May 14, 2012 November 22, 2012	<ul style="list-style-type: none"> <li>The watercourse is located in a corn field and originates at Thompson Line. Flowing tile drain inputs were observed at time of investigation. The surrounding land topography is flat. Riparian buffer is 0.5 m of grasses.</li> </ul>	<ul style="list-style-type: none"> <li>The watercourse is a defined channelized feature. The watercourse has a straight run and uniform channel morphology. The water was slowly flowing at time of investigation, and is classified as intermittent by ABCA. Banks are stable and well vegetated. Substrate consists of cobble, clay and silt. Canopy cover is low with a mix of grasses and shrubs. Instream habitat cover is moderate with a mix of cobble and aquatic vegetation. No groundwater indicators were observed. Two perched culverts are creating a barrier to fish at the roadside; one is 0.5 m high and the other 0.2 m. Approximately 3.5 km downstream, fish species consist of baitfish community, Largemouth Bass and Green Sunfish (ABCA, 2001).</li> </ul>	Low

R3.38	
MWD(m):	0.15
MBD(m):	0.45

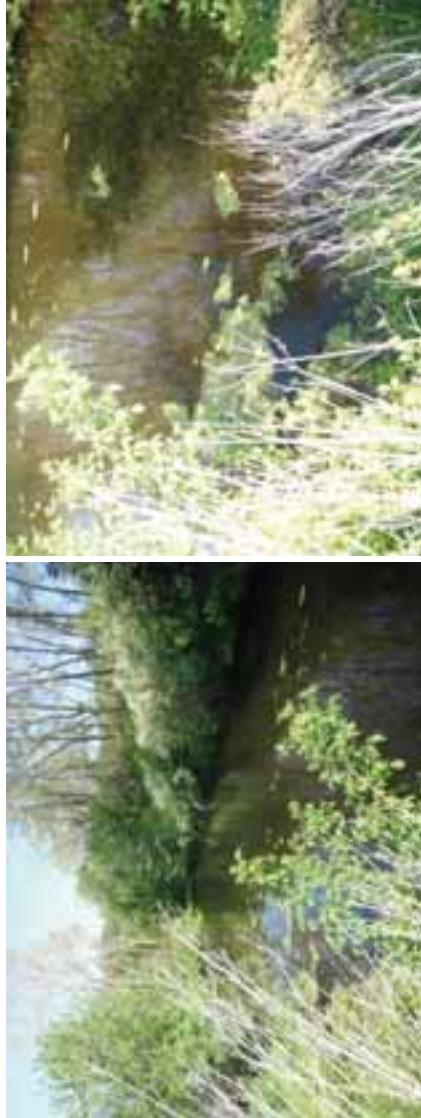
**Photograph 1. Pond overview ↑**

Feature ID	Project Component	Investigation Date	Description of Site	Feature Sensitivity
P3.44	<ul style="list-style-type: none"> <li>• Collection Line</li> <li>• Buffer</li> <li>• Road Buffer</li> <li>• Turbine 8</li> </ul>	May 16, 2012	<ul style="list-style-type: none"> <li>• The pond is dugout and located in an agricultural field adjacent to a forest area. The pond is 10 m by 40 m and greater than 2 m deep. A riparian buffer of shrubs and trees exists.</li> <li>• The pond is man made with an outflow culvert into R3.40. The water was clear at time of investigation. The substrate is silt and sand. <i>In-situ</i> cover is moderate and consists of aquatic vegetation and woody debris.</li> </ul>	Low

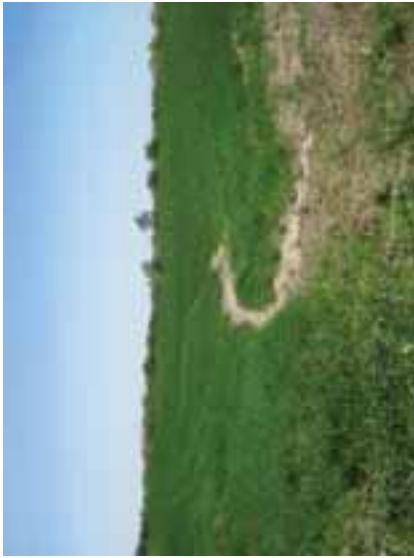
**Photograph 1. Site overview in hay field ↑**

Feature ID	Project Component	Investigation Date	Description of Site	Feature Description	Feature Sensitivity
R3.64	• Collection Buffer	May 14, 2012 June 7, 2012	<ul style="list-style-type: none"> <li>The watercourse begins as a tile drain emerging from a hay field into a defined channel. Surrounding topography is rolling hills. Riparian buffer is greater than 10 m.</li> </ul>	<ul style="list-style-type: none"> <li>The watercourse has been tiled and is a defined natural feature after the tile drain. There was no water at time of investigation. It is classified as tiled and unknown by ABCA. Banks are stable and well vegetated. Substrate consists of silt. Canopy cover is high and consists of trees and shrubs. There is no instream habitat cover. No groundwater indicators were observed. Approximately 500 m downstream, fish species consist of baitfish community and Pumpkinseeds (ABCA, 2003).</li> </ul>	Low

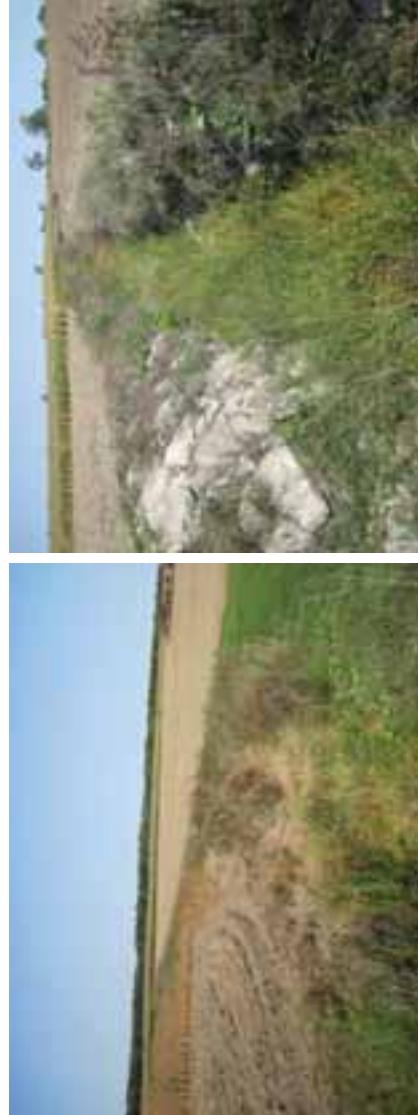
**Photograph 1. Site overview ↑**

Feature ID	Project Component	Investigation Date	Description of Site	Feature Description	Feature Sensitivity
R3.70	<ul style="list-style-type: none"> <li>• Collection Line Crossing and Buffer</li> <li>• Road Crossing</li> </ul>	September 17, 2012	<ul style="list-style-type: none"> <li>• The section of watercourse running parallel to Gordon Road does not exist. The watercourse begins a Gordon Road and flows through corn and soybean fields. Tile drain inputs that were not flowing were observed at time of investigation. Surrounding topography is slightly hilly. Riparian buffer is 4 m of meadow.</li> </ul>	<p>The watercourse is a defined natural feature. The watercourse is mostly flat with some pools present. The water was clear and had no flow with some dry areas during time of investigation. It is classified as a permanent warmwater system by ABCA. Banks are slightly unstable with evidence of erosion. Substrate is dominated by silt and muck followed by sand, clay and gravel. Canopy cover is low and consisted of grasses. Instream habitat cover is high and consists only of aquatic vegetation. The channel was mainly choked with grasses. No groundwater indicators were observed. Approximately 4.5 km downstream, fish species consists of baitfish community (ABCA, 2003).</p>	Low

R3.70	MWW(m):	R3.70
MBW(m):	2.0	MBD(m):

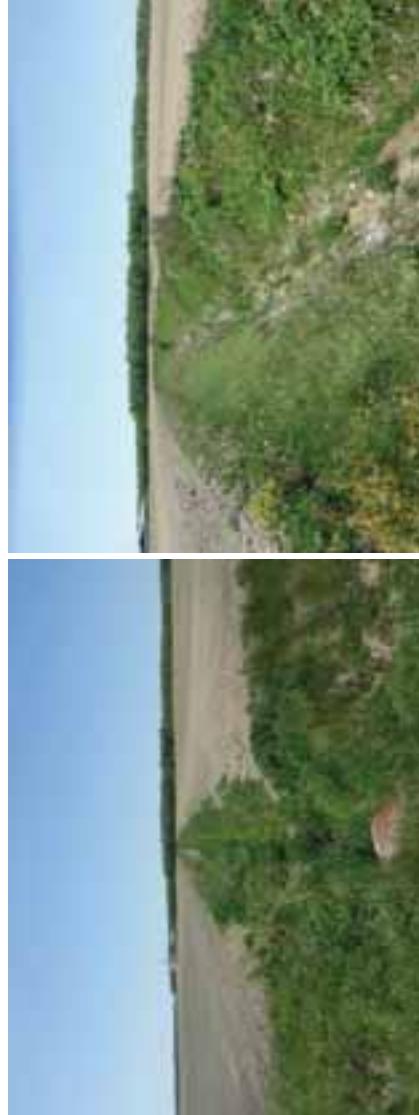
**Photograph 1. Site overview ↑**

Feature ID	Project Component	Investigation Date	Description of Site	Feature Description	Feature Sensitivity
R4-A	• Collection Line Crossing	May 17, 2012	<ul style="list-style-type: none"> <li>The watercourse flows through row agricultural fields.</li> <li>Flowing tile drain inputs were noted at time of investigation. Surrounding topography is flat. Riparian buffer is 5 m of grasses.</li> </ul>	<ul style="list-style-type: none"> <li>The watercourse is a defined channelized feature. The watercourse has a straight flat uniform channel. The water was clear and had low flow with some stagnant areas at time of investigation. It is classified as a permanent warmwater system by ABCA. The banks are stable and well vegetated. Substrate is dominated by sand and silt followed by clay. There is no canopy cover. Instream habitat cover is high and is dominated by aquatic vegetation followed by cobble. No groundwater indicators were observed. A perched culvert is present halfway through the site for farm vehicle access. The culvert is perched 0.2 m on the west and 0.02 on the east side creating a barrier to fish passage.</li> <li>Approximately 7 km downstream, fish species consist of baitfish community, Black Bullhead and Pumpkinseed (ABCA, 2001).</li> </ul>	Low

Watercourse Name	Upper Mud Creek Drain No 5	MWW(m):	R4-A
DFO Drain Classification	C	MBW(m):	1.0

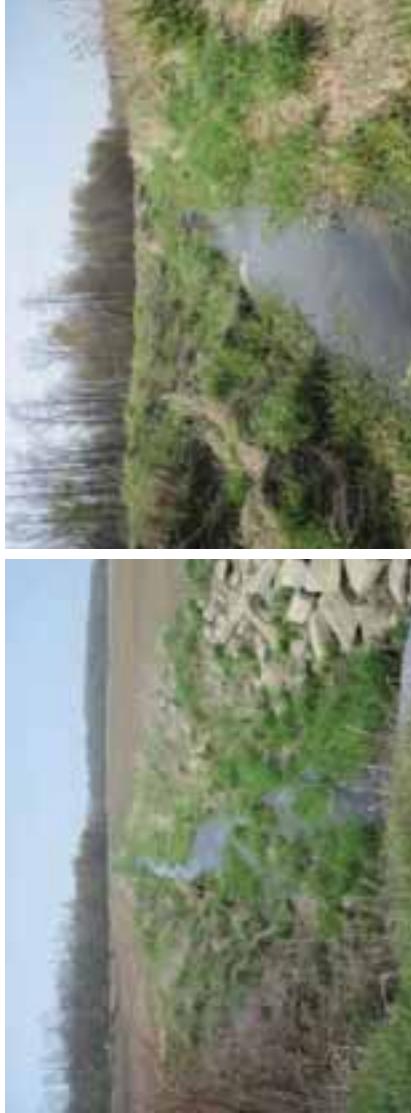
**Photograph 1. Site overview ↑**

Feature ID	Project Component	Investigation Date	Description of Site	Feature Description	Feature Sensitivity
R4-E	<ul style="list-style-type: none"> <li>• Collection Line Buffer</li> <li>• Road Buffer</li> <li>• Turbine 46</li> </ul>	May 2, 2012	<ul style="list-style-type: none"> <li>The site is located in an agricultural field that has flat topography. The west bank has been recently cleared. One flowing tile drain input was noted within the site. The riparian buffer is less than 0.5 m of grasses.</li> </ul>	<ul style="list-style-type: none"> <li>The watercourse is a defined channelized feature. The watercourse is a straight flat channel. The water was clear and had slow flow at time of investigation. It is classified as a permanent warmwater system by ABCA. Banks are slightly unstable and are becoming re-vegetated. Substrate consists of silt. Canopy cover is low and consists of grasses. Instream habitat cover is high and dominated by aquatic vegetation. No groundwater indicators were observed. Approximately 5 km downstream, fish species consist of batfish community, Black Bullhead and Pumpkinseed (ABCA, 2001).</li> </ul>	Low

MWW(m):	1.7	MWD(m)	0.22	MBW(m):	3.0	MBD(m):	0.7
MWW(m):	1.7									
MWD(m)	0.22									
MBW(m):	3.0									
MBD(m):	0.7

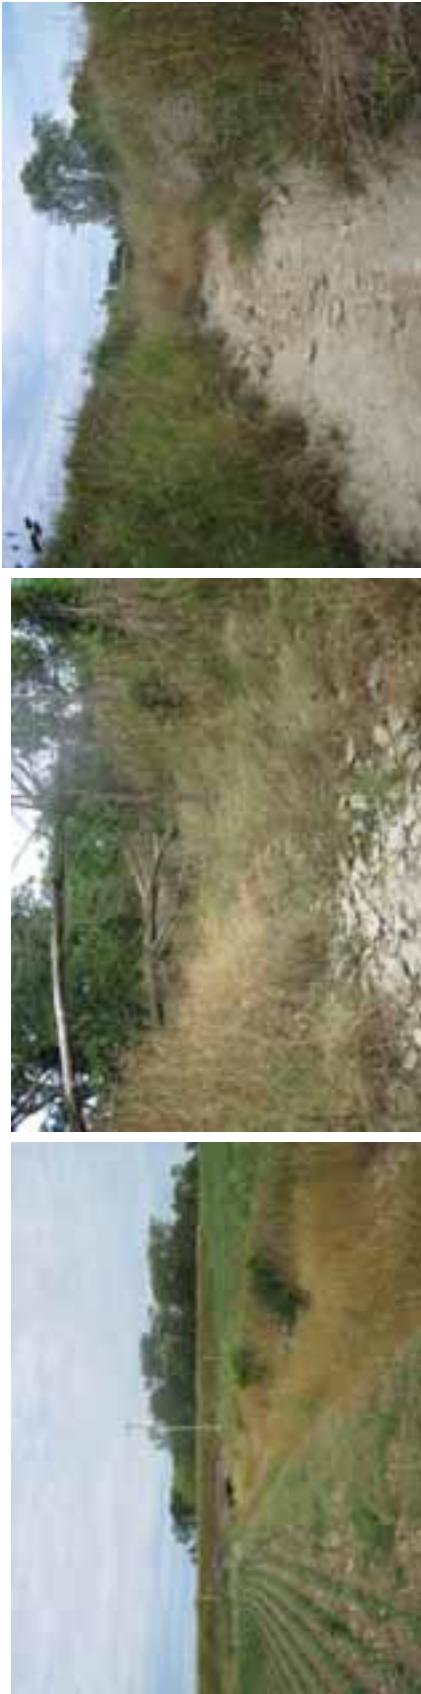
**Photograph 1. Site overview in soybean fields ↑****Photograph 2. Site overview in forest ↑****Photograph 3. Channel view ↑**

Feature ID	Project Component	Investigation Date	Description of Site	Feature Description	Feature Sensitivity
R4.8-C	• Collection Line Crossing	July 25, 2012	<ul style="list-style-type: none"> <li>The watercourse flows through soybean fields, crosses Northville Road into cultural woodland (10 m riparian buffer) then cultural meadow (1 to 2 m riparian buffer) (classified as CUM1, CUW1, ELC Feature ID 220) and more soybean fields. Tile drain inputs that were not flowing were observed at time of investigation. Surrounding topography is flat.</li> </ul>	<ul style="list-style-type: none"> <li>The watercourse is a defined channelized feature that is starting to naturalize. The watercourse was dry at time of investigation. It is classified as a permanent warmwater system by ABCA. Banks are stable and well vegetated. Substrate consists of bedrock and clay, followed by gravel, sand and silt. Canopy cover is moderate and is a mix of trees, shrubs, grasses and herbaceous vegetation. Instream habitat cover is moderate and consists of cobble and aquatic vegetation, followed by boulders and woody debris. No groundwater indicators were observed. Approximately 2.7 km upstream, fish species consist of baitfish community (ABCA, 2001).</li> </ul>	Low

Watercourse Name	Golden Creek Drain Branch East	R4.8-C
DFO Drain Classification	C	MWW(m): MBW(m):
		1.5 2.5
		n/a 0.4

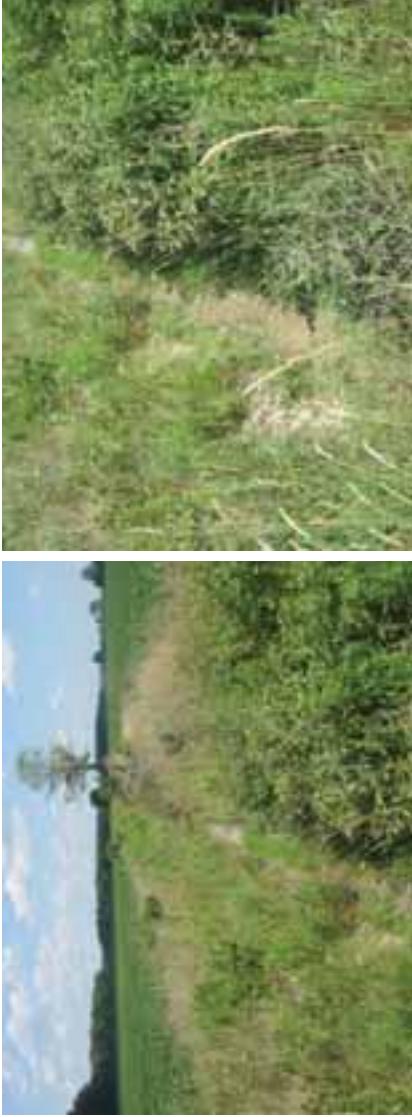
Photograph 1. Site overview ↑

Feature ID	Project Component	Investigation Date	Description of Site	Feature Description	Feature Sensitivity
R4.27*	• Collection Line Buffer	July 30, 2012	<ul style="list-style-type: none"> <li>The watercourse is located in a soybean field. No tile drain inputs were noted at time of investigation. Surrounding topography is flat. Riparian buffer is 5 m of meadow.</li> </ul>	<ul style="list-style-type: none"> <li>The watercourse is a defined channelized feature. The channel was dry except for one pool of water at time of investigation. It is classified as a permanent warmwater system by ABCA. Banks are stable and well vegetated. Substrate consists of sand, clay and silt. Canopy cover is low and is dominated by grasses. Instream habitat cover is low and consists of aquatic vegetation followed by cobble. No groundwater indicators were observed. Approximately 3.5 km downstream, fish species consists of baitfish community (MNR, 1976).</li> </ul>	Low

MWW(m):	R4.27
MBW(m):	2.5

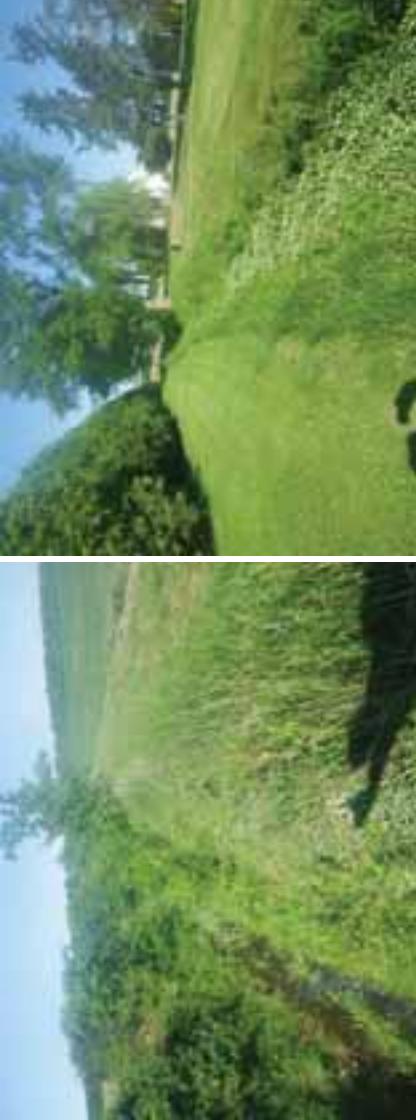
**Photograph 1. Site overview in agricultural fields**↑

Feature ID	Project Component	Investigation Date	Description of Site	Feature Description	Feature Sensitivity
R4.36*	<ul style="list-style-type: none"> <li>Collection Line Crossing and Buffer</li> <li>Road Crossing and Buffer</li> <li>Turbine 20</li> </ul>	May 30, 2012	<ul style="list-style-type: none"> <li>The watercourse is possibly tiled for 50 m emerging in crop agricultural fields and running behind a residential property. The watercourse crosses Northville Road and flows through more agricultural fields. Tile drain inputs were observed at time of investigation. The surrounding topography is flat and sloped towards the watercourse. Riparian buffer is 1 to 5 m of grasses and shrubs with some areas of manicured lawn.</li> </ul>	<ul style="list-style-type: none"> <li>The watercourse is a defined channelized feature. The watercourse has a straight run uniform channel. The water was clear and had low flow during the time of investigation. It is classified as unknown by ABCA. Banks are stable and vegetated. Substrate consists of silt. Canopy cover is very low with some shrubs present. Instream habitat cover is moderate and is dominated by aquatic vegetation. Channel is choked with vegetation creating a potential low flow barrier. No groundwater indicators were noted.</li> </ul>	Low

Watercourse Name	Bioe Drain	R4.36
DFO Drain Classification	U	MWW(m): 0.15
		MBD(m): 0.6

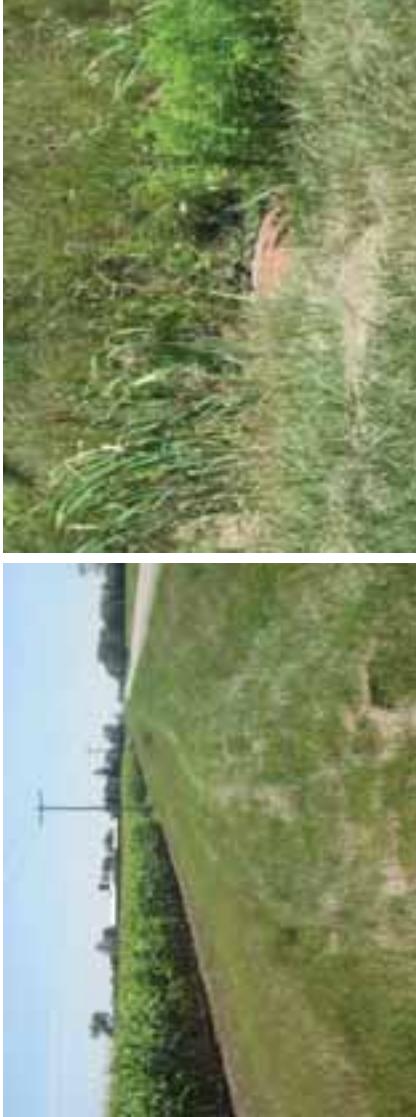
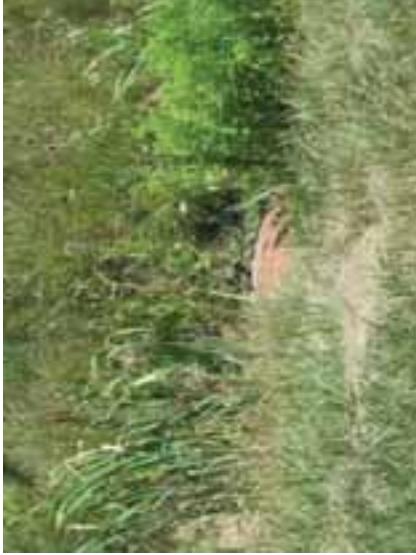
Feature ID	Project Component	Investigation Date	Description of Site	Feature Description	Feature Sensitivity						
R4.58	• Collection Line Crossing • Road Crossing	July 30, 2012	<ul style="list-style-type: none"> <li>The watercourse flows parallel to Arkona Road through corn fields and flows into R4. A culvert was observed to the east connecting to R4-A. Surrounding land topography is flat. Riparian buffer is 5 m of grasses. Instream habitat cover is low and consists of aquatic vegetation. No groundwater indicators were observed.</li> </ul> <p>Approximately 7 km downstream, fish species consists of a baitfish community, Pumpkinseed and Black Bullhead (ABCNA, 2001).</p>

<b>R4.58</b>	<b>R4.58</b>	<b>MWW(m):</b> <b>MBW(m):</b>	<b>MWD(m):</b> <b>MBD(m):</b>	0.5 0.75	n/a n/a	Low
<b>R4.58</b>	<b>R4.58</b>										
<b>MWW(m):</b> <b>MBW(m):</b>	<b>MWD(m):</b> <b>MBD(m):</b>										
0.5 0.75	n/a n/a

Photograph 1. Site overview ↑

Photograph 2. Channel view ↑

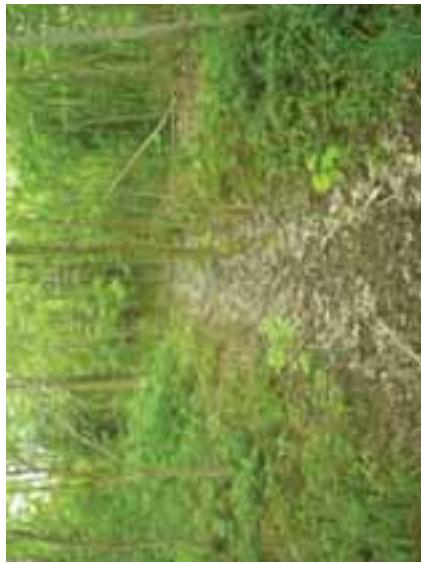
Feature ID	Project Component	Investigation Date	Description of Site	Feature Description	Feature Sensitivity
R4.60	• Collection Buffer	May 29, 2012	<ul style="list-style-type: none"> <li>The watercourse is located in a mix of deciduous forest, cultural thicket and swamp thicket (classified as FOD7-2, CUT11-1, SWT2-2, ELC Feature ID 172). No tile drain inputs were noted at time of investigation. Surrounding land topography is rolling hills. Riparian buffer is greater than 20 m.</li> </ul>	<ul style="list-style-type: none"> <li>The watercourse is an intermittent channelized feature. The watercourse has a straight flat uniform channel. There was no water at time of investigation. It is not mapped by ABCA. Banks are stable and vegetated. Substrate is dominated by silt followed by muck. Canopy cover is high and dominated by trees. Instream habitat cover is low and consists of woody debris. No groundwater indicators were observed.</li> </ul>	Low

MWW(m):	R4.60
MWD(m):	n/a

**Photograph 1. Site overview ↑**

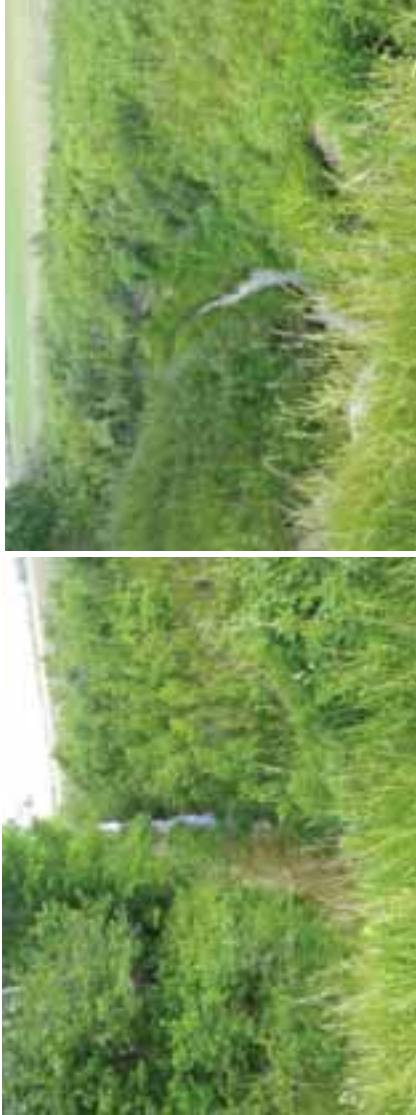
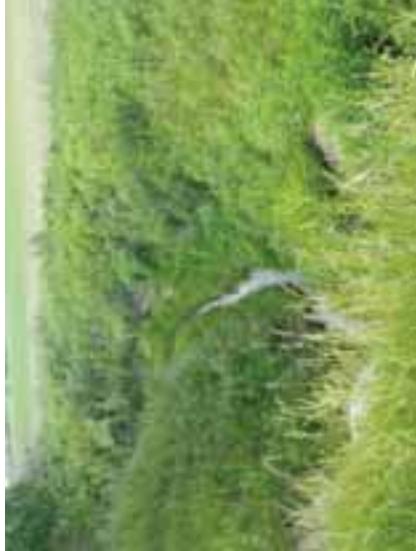
Feature ID	Project Component	Investigation Date	Description of Site	Feature Description	Feature Sensitivity
R5.10*	• Collection Line Crossing and Buffer	May 31, 2012	<ul style="list-style-type: none"> <li>The watercourse begins in a corn field and crosses Thomson Line into soy bean fields. No tile drain inputs were observed at time of investigation. Surrounding land topography is flat. Riparian buffer is 5 m consisting of grasses and shrubs.</li> </ul>	<ul style="list-style-type: none"> <li>The watercourse is a defined channelized feature. The watercourse has a straight flat run uniform channel. Water was clear and had moderate flow at time of investigation. It is classified as an intermittent system by SCRCA. Banks are stable and well vegetated. Substrate is dominated by silt followed by cobble. Canopy cover is low consisting of trees and shrubs. Instream habitat cover is low and consists of cobble. No groundwater indicators were observed. Many Cyprinids were observed during time of investigation. Approximately 2.5 km downstream, fish species consist of baitfish community (MNR, 1979).</li> </ul>	Low

Watercourse Name	Duffus Drain	R5.10
DFO Drain Classification	F	MWW(m): 1.25 MWD(m): 0.2 MBW(m): 2.5 MBD(m): 0.9

**Photograph 1. Site overview looking north↑**

**Photograph 1. Site overview looking south↑**

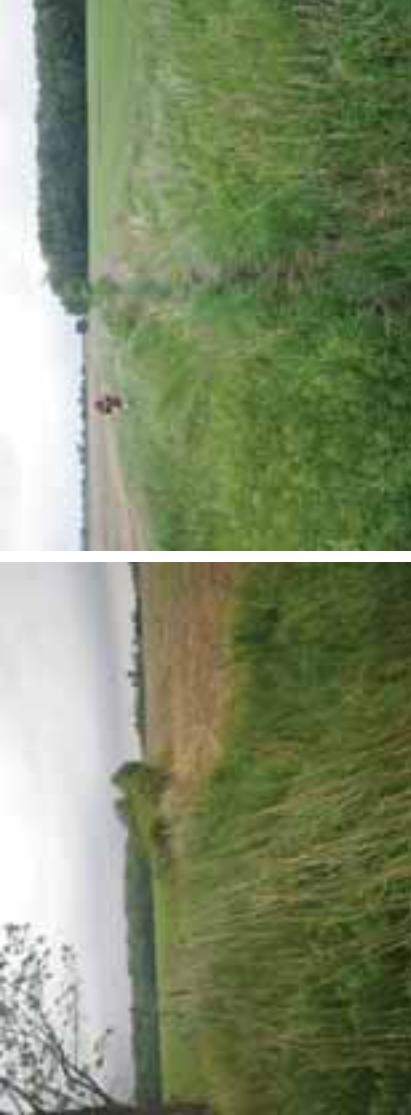
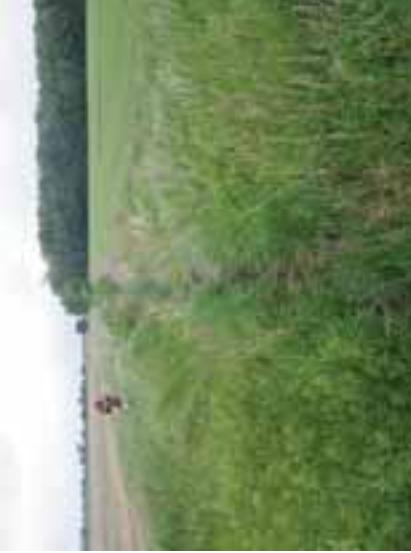
Feature ID	Project Component	Investigation Date	Description of Site	Feature Description	Feature Sensitivity
R8.10*	<ul style="list-style-type: none"> <li>Collection Line Crossing and Buffer</li> <li>Road Crossing and Buffer</li> <li>Turbine 37</li> </ul>	May 29, 2012	<ul style="list-style-type: none"> <li>The watercourse flows through soy bean and winter wheat fields, passing a deciduous forest (classified as FOD6-5, ELC Feature ID 131) and crosses over Kinard Road into more agricultural fields. No tile drain inputs were observed at time of investigation. Surrounding topography is flat. Riparian buffer is 5 m of grasses and shrubs.</li> </ul>	<ul style="list-style-type: none"> <li>The watercourse is a defined channelized feature. The watercourse is all run morphology. The water was clear and had very low flow at time of investigation. It is classified as an intermittent system by SCRCA. Banks are stable and well vegetated. Substrate consists of silt. Canopy cover is moderate and consists of trees, shrubs and grasses. Instream habitat cover is moderate and consists of grasses. No groundwater indicators were observed.</li> </ul>	Low

Watercourse Name	Malley Drain	R8.10
DFO Drain Classification	F	MWW(m): 1.15 MBW(m): 2.25

Photograph 1. Site overview ↗

Photograph 2. Site overview ↗

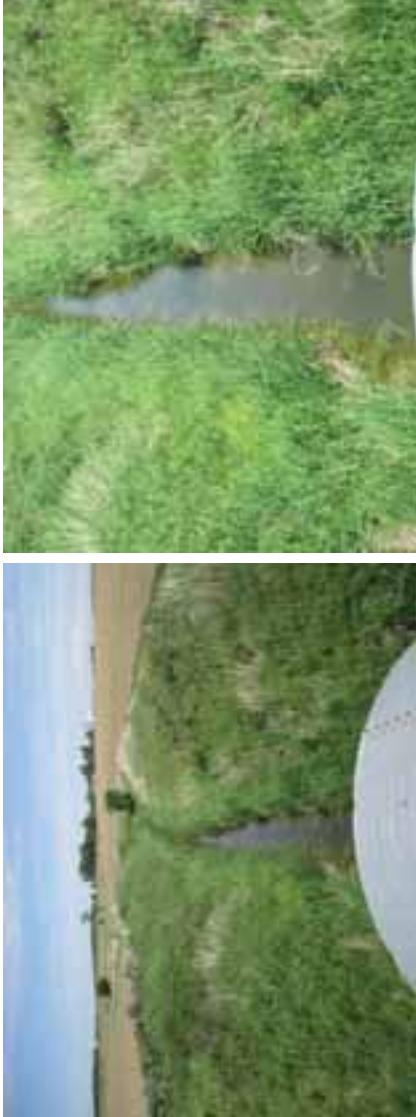
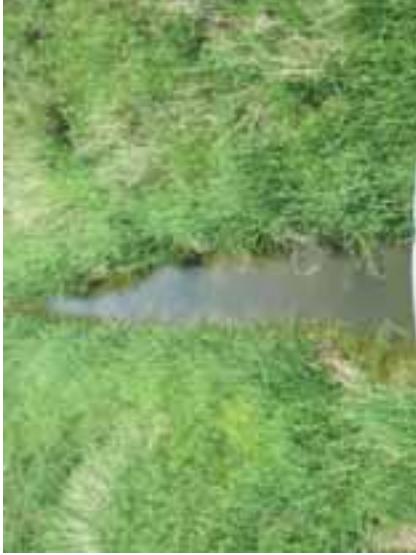
Feature ID	Project Component	Investigation Date	Description of Site	Feature Description	Feature Sensitivity
R9.29-E*	• Collection Line Buffer	May 29, 2012	<ul style="list-style-type: none"> <li>The watercourse is located in corn and soybean fields.</li> <li>No tile drain inputs were observed at time of investigation. Surrounding topography is slightly hilly. Riparian buffer is 5 m of meadow.</li> </ul>	<ul style="list-style-type: none"> <li>The watercourse is a defined channelized feature. The watercourse is all straight with flats. The water was clear and had very slow flow at time of investigation. It is classified as an intermittent system by SCRCA. Banks are stable and well vegetated. Substrate consists of clay, sand, silt and gravel. Canopy cover is low and consists of grasses. Instream habitat cover is high and consists only of aquatic vegetation. No groundwater indicators were observed. Approximately 4 km downstream, fish community consists of baitfish community, Black Bullhead and Green Sunfish (SCRCA, 2000).</li> </ul>	Low

Watercourse Name	McPherson Drain 2005	R9.29-E
DFO Drain Classification	F	MWW(m): 0.8 MWD(m): 0.2 MBW(m): 1.0 MBD(m): 0.5

**Photograph 1. Site overview ↑**

**Photograph 2. Channel overview ↑**

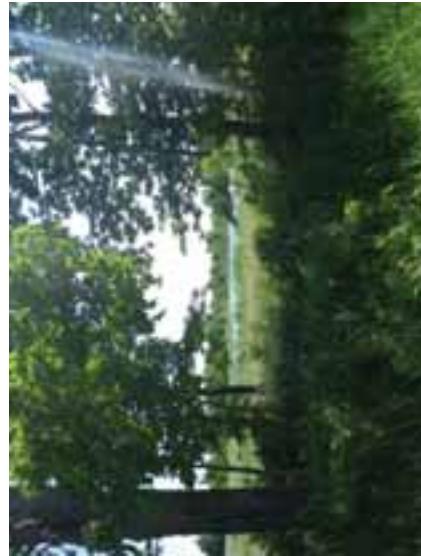
Feature ID	Project Component	Investigation Date	Description of Site	Feature Description	Feature Sensitivity
P12.22* • Collection Buffer	Line	June 7, 2012	• The pond is surrounded by deciduous forest and cultural meadow (classified as CUM1-1, FOD6-5, ELC Feature ID 42). The pond is 100 m by 200 m.	• The pond is dugout feature with emergent grasses around the edges. Appears to be an online feature.	Low

**Photograph 1. Site overview ↗**

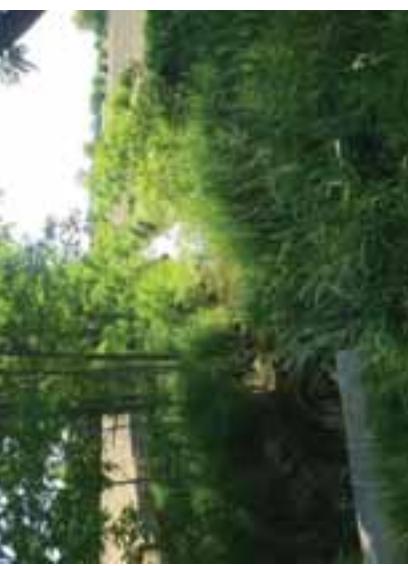
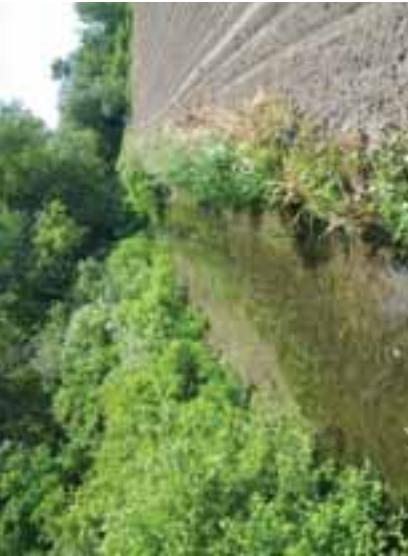
Feature ID	Project Component	Investigation Date	Description of Site	Feature Description	Feature Sensitivity
R12.54-B*	• Collection Line Crossing	June 7, 2012	<ul style="list-style-type: none"> <li>The watercourse runs adjacent to agricultural fields and deciduous forest (classified as FOD7-4, ELC Feature ID 42), crossing Binam Line. No tile drain inputs were noted at time of investigation. Surrounding topography is flat. Riparian buffer is less than 2 m of grasses along the agricultural field and greater than 15 m along the forest.</li> </ul>	<ul style="list-style-type: none"> <li>The watercourse is a defined channelized feature. The watercourse is all flat. The water was clear and did not have visible flow at time of investigation. It is classified as a permanent warmwater system by SCRCA. Banks are stable with no signs of erosion. Substrate is dominated by muck, silt and clay, followed by sand. Canopy cover is moderate and is dominated by shrubs. Instream habitat cover is low and consists only of aquatic vegetation. No groundwater indicators were observed. Cyprinids were observed during time of investigation. Approximately 3 km downstream, fish species consists of baitfish community, Rock Bass and Largemouth Bass (SCRCA, 2002).</li> </ul>	Low

Watercourse Name	Zaviz Drain	R12.54-B
DFO Drain Classification	C	MWD(m): 2.5
MBW(m):	3.5	MBD(m): 0.85

**Photograph 1. Site overview ↑**

**Photograph 2. Channel overview ↑**

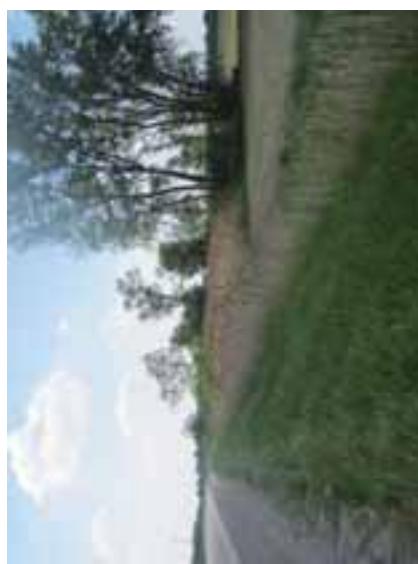
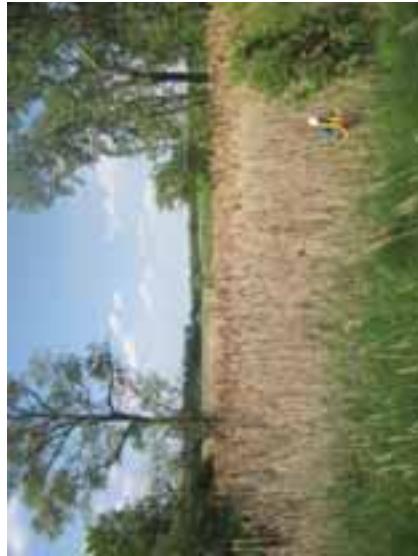
Feature ID	Project Component	Investigation Date	Description of Site	Feature Description	Feature Sensitivity
P1.23	• Transmission Line Buffer	May 24, 2012	<ul style="list-style-type: none"> <li>The pond is located along Elginfield Road, surrounded by a corn field. The pond is 20 by 15 m. Riparian buffer is greater than 1 m of grasses and shrubs.</li> </ul>	<ul style="list-style-type: none"> <li>The pond is offline pond that may be natural. The pond was dry at time of investigation. The pond was choked with common reed. No groundwater indicators were observed.</li> </ul>	non-REA

**Photograph 1. Site overview ↗**

**Photograph 2. Pond overview ↗**

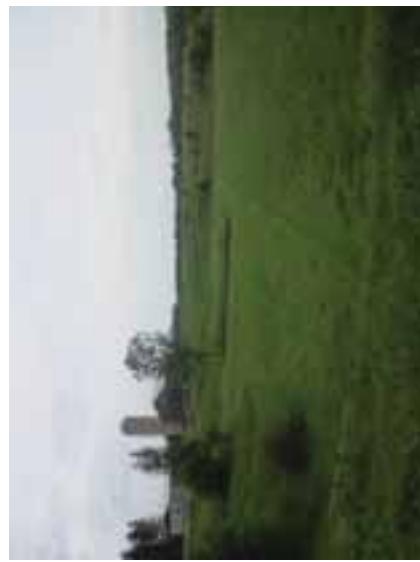
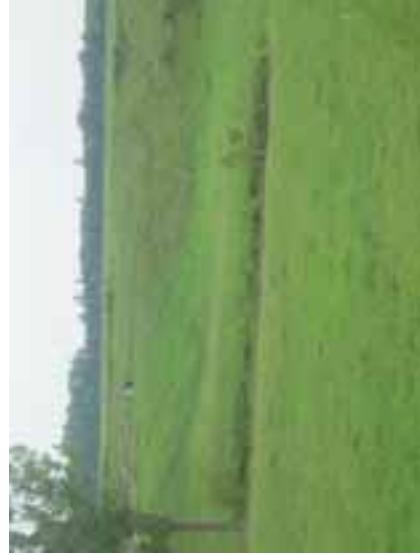
Feature ID	Project Component	Investigation Date	Description of Site	Feature Description	Feature Sensitivity
P1.27*	• Transmission Line Buffer	June 18, 2012	<ul style="list-style-type: none"> <li>The pond is located in cattle pasture. The pond is 15 by 7 m. Riparian buffer is less than 1 m of cultural meadow (classified as CUM1-1, ELC Feature ID 351).</li> </ul>	<ul style="list-style-type: none"> <li>The pond is a dugout offline feature. Cattle have access to the pond.</li> </ul>	non-REA

**Photograph 1. Site overview** ↗

**Photograph 2. Pond overview** ↗

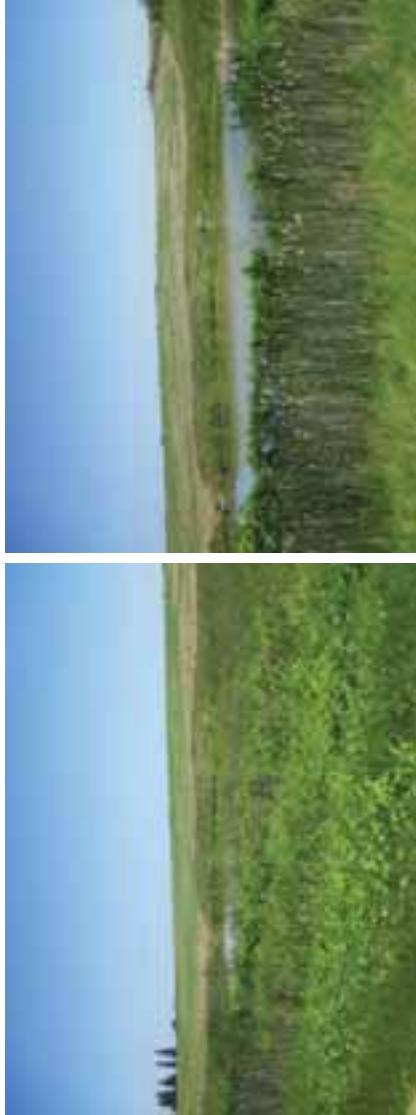
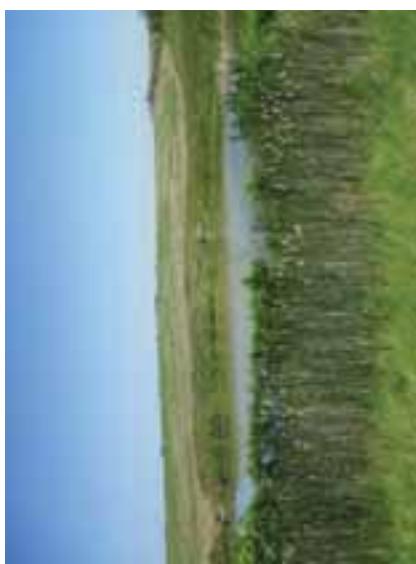
Feature ID	Project Component	Investigation Date	Description of Site	Feature Description	Feature Sensitivity
P1.32*	• Transmission Line Buffer	June 12, 2012	<ul style="list-style-type: none"> <li>The pond is located along Elginfield Road, surrounded by corn and wheat fields. The pond is 20 by 10 m. Riparian buffer is 3 m of grasses and some cattails.</li> </ul>	<ul style="list-style-type: none"> <li>The pond is a dugout offline feature. The water was turbid at time of investigation. <i>In-situ</i> cover consists of submergent vegetation, floating algae and cattails. No groundwater indicators were observed.</li> </ul>	non-REA

**Photograph 1. Site overview ↑**

**Photograph 2. Pond overview ↑**

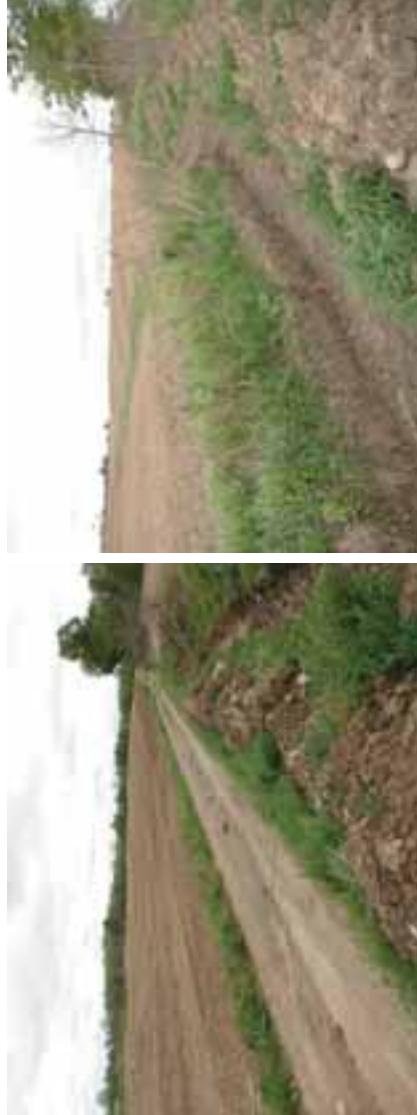
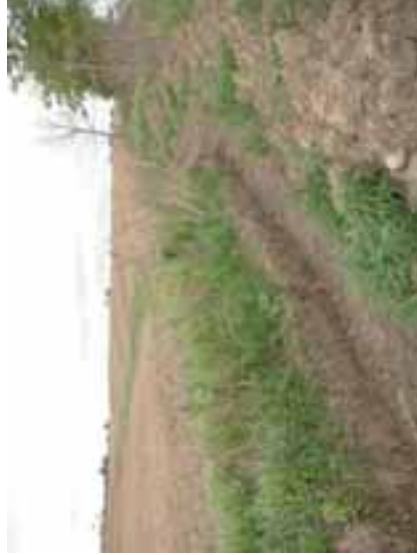
Feature ID	Project Component	Investigation Date	Description of Site	Feature Description	Feature Sensitivity
R2.10-A*	<ul style="list-style-type: none"> <li>• Collection Line Crossing</li> <li>• Road Crossing</li> <li>• Turbine 34</li> </ul>	May 16, 2012	<ul style="list-style-type: none"> <li>• The feature is located in crop agricultural fields and crosses a laneway.</li> </ul>	<ul style="list-style-type: none"> <li>• There is a grassy swale that goes into a trench that was dry and then goes underground. The feature appears to be tiled. There is no surface feature north of the laneway. It is classified as unknown by ABCA.</li> </ul>	non-REA

**Photograph 1. Site overview ↑**

**Photograph 2. Trenched area ↑**

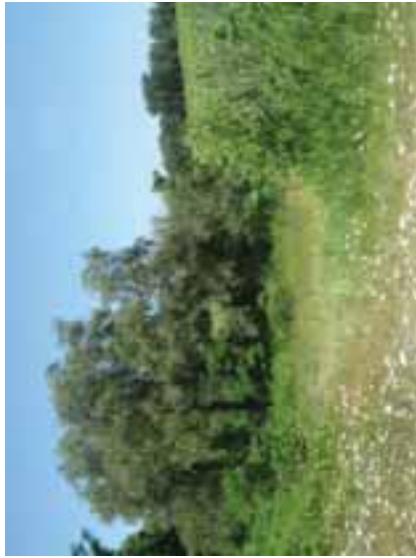
Feature ID	Project Component	Investigation Date	Description of Site	Feature Description	Feature Sensitivity
R2.32	• Transmission Line Buffer	July 31, 2012	<ul style="list-style-type: none"> <li>The feature is located in deciduous forest (classified as FOD7-4, ELC Feature ID 90) and corn fields.</li> </ul>	<ul style="list-style-type: none"> <li>No channel was observed, only a small area with common reed.</li> <li>It is classified as unknown by ABCA.</li> </ul>	non-REA

Watercourse Name	Boothill Creek Trib
DFO Drain Classification	U

**Photograph 1. Site overview ↑**

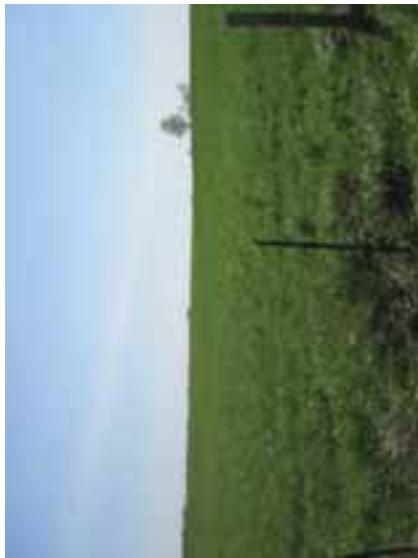
Feature ID	Project Component	Investigation Date	Description of Site	Feature Description	Feature Sensitivity				
R2.87*	<ul style="list-style-type: none"> <li>• Collection Line Crossing</li> <li>• Road Crossing</li> <li>• Turbine 80</li> </ul>	May 15, 2012	<ul style="list-style-type: none"> <li>• The feature is located in a wheat field and pasture.</li> </ul>	<ul style="list-style-type: none"> <li>• The feature has been ploughed through. It is classified as tiled by ABCA.</li> </ul>	non-REA				
		<table border="1"> <tr> <td>Watercourse Name</td> <td>Wight Drain Branch</td> </tr> <tr> <td>DFO Drain Classification</td> <td>T</td> </tr> </table>		Watercourse Name	Wight Drain Branch	DFO Drain Classification	T		
Watercourse Name	Wight Drain Branch								
DFO Drain Classification	T

**Photograph 1. Site overview ↗**

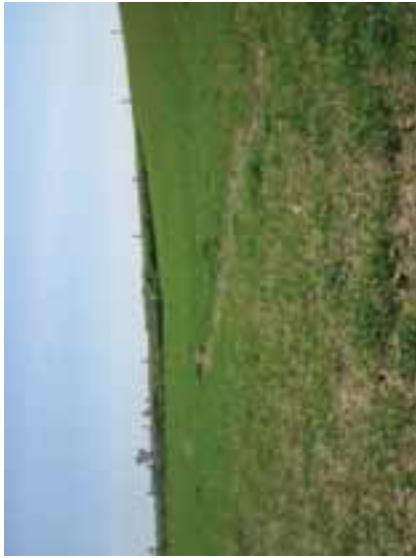
Feature ID	Project Component	Investigation Date	Description of Site	Feature Description	Feature Sensitivity				
R2.93*	<ul style="list-style-type: none"> <li>• Collection Line Buffer</li> <li>• Road Buffer</li> <li>• Turbine 80</li> </ul>	May 15, 2012	<ul style="list-style-type: none"> <li>• The feature is located in a wheat field and pasture.</li> </ul>	<ul style="list-style-type: none"> <li>• The feature has been ploughed through. It is classified as tiled by ABCA.</li> </ul>	non-REA				
		<table border="1"> <tr> <td>Watercourse Name</td> <td>Wight Drain Branch</td> </tr> <tr> <td>DFO Drain Classification</td> <td>T</td> </tr> </table>		Watercourse Name	Wight Drain Branch	DFO Drain Classification	T		
Watercourse Name	Wight Drain Branch								
DFO Drain Classification	T

**Photograph 1. Site overview ↗**
