Jericho Wind, Inc.

## **Final Water Assessment and Water Body Report – Jericho Wind Energy Centre**

60155032

February, 2013

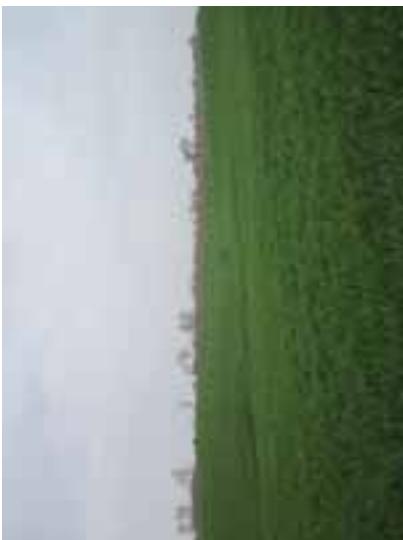
Feature ID	Project Component	Investigation Date	Description of Site	Feature Description	Feature Sensitivity
R2.111	<ul style="list-style-type: none"> <li>• Collection Line Crossing and Buffer</li> <li>• Road Crossing and Buffer</li> </ul>	May 2, 2012	<ul style="list-style-type: none"> <li>• Located in a crop agricultural field along Arkona Road, south of Cedar Point Line. The feature may be connected to the tiled portion of R2101.</li> </ul>	<ul style="list-style-type: none"> <li>• The feature is a temporary channel for surface drainage that has been tilled or driven through. It is classified as tiled by ABCA.</li> </ul>	non-REA

**Photograph 1. Site overview †**

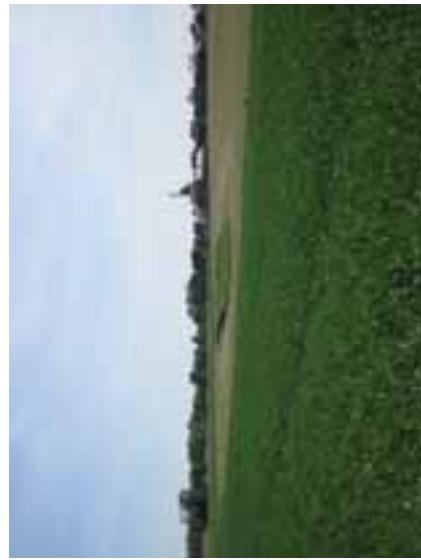
**Photograph 1. Site overview ↗**

Feature ID	Project Component	Investigation Date	Description of Site	Feature Description	Feature Sensitivity
P2.114*	<ul style="list-style-type: none"> <li>• Collection Line Buffer</li> <li>• Road Buffer</li> <li>• Turbine 56</li> </ul>	May 23, 2012	<ul style="list-style-type: none"> <li>• The pond is located in an agricultural field.</li> </ul>	<ul style="list-style-type: none"> <li>• There is a small depression in the field that may hold water. The pond was dry at time of investigation. No groundwater indicators were observed.</li> </ul>	non-REA

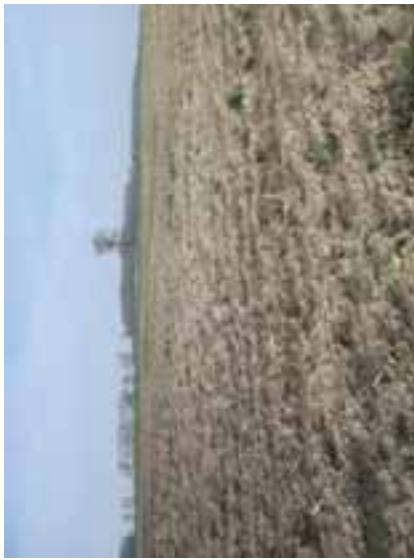
**Photograph 1. Site overview ↑**

Feature ID	Project Component	Investigation Date	Description of Site	Feature Description	Feature Sensitivity				
R2.140-A	• Collection Line Crossing • Road Crossing • Turbine 73 and 74	May 3, 2012	• The feature is located in an agricultural crop field. Surrounding topography is slightly rolling.	• There was no surface water feature present. The watercourse is buried. It is classified as tiled by ABCA.	The non -REA				
<table border="1"> <tr> <td>Watercourse Name</td> <td>Lamoman Drain</td> </tr> <tr> <td>DFO Drain Classification</td> <td>T</td> </tr> </table>					Watercourse Name	Lamoman Drain	DFO Drain Classification	T	
Watercourse Name	Lamoman Drain								
DFO Drain Classification	T

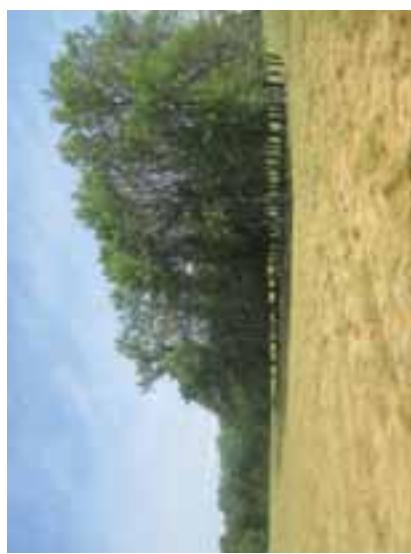
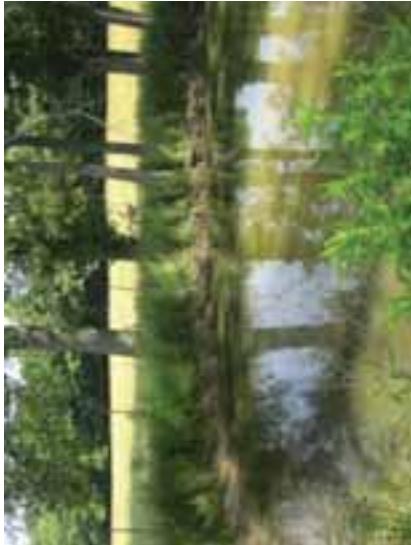
Feature ID	Project Component	Investigation Date	Description of Site	Feature Sensitivity
P2.140	<ul style="list-style-type: none"> <li>• Collection Line Buffer</li> <li>• Road Buffer</li> <li>• Turbine 73</li> </ul>	June 18, 2012	<ul style="list-style-type: none"> <li>• The pond is surrounded by a small forest and hay field in cattle pasture. The pond is 10 m by 15 m and is surrounded by a fence. Riparian buffer is 0.5 m of meadow and trees.</li> <li>• The pond is a dugout offline feature. The water was turbid at time of investigation. Substrate is clay and silt. <i>In-situ</i> cover is low and consists of aquatic vegetation and woody debris. No groundwater indicators were observed.</li> </ul>	non -REA

**Photograph 1. Site overview ↑**

**Photograph 2. Pond view ↑**

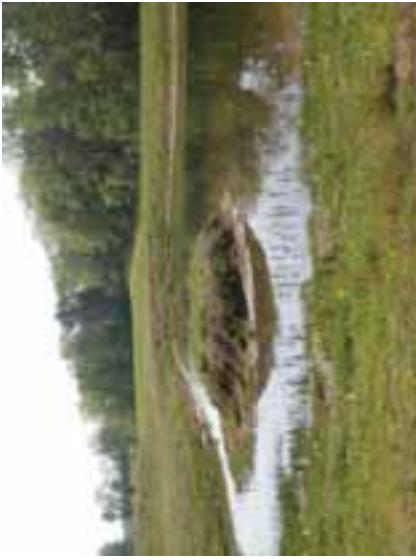
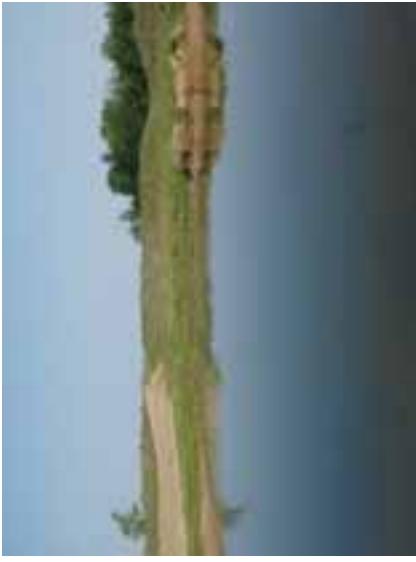
Feature ID	Project Component	Investigation Date	Description of Site	Feature Description	Feature Sensitivity
P2.143	• Collection Buffer	May 24, 2012	<ul style="list-style-type: none"> <li>The pond is surrounded by agricultural fields near a mixed forest (classified as FOM6-2, ELC Feature ID 90). The pond is approximately 25 by 40 m and 1 to 2 m in depth. Riparian buffer is newly planted and appears to be a restoration project.</li> </ul>	<ul style="list-style-type: none"> <li>The pond is a dugout offline feature. Emergent vegetation is very low.</li> </ul>	non -REA

**Photograph 1. Pond overview ↑**

**Photograph 2. Pond view ↑**

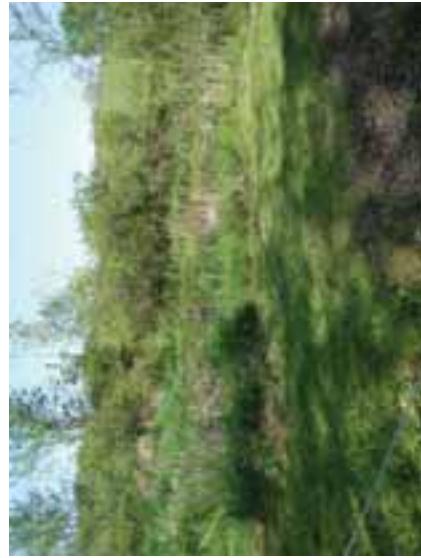
**Photograph 1. Pond overview** ↗

Feature ID	Project Component	Investigation Date	Description of Site	Feature Description	Feature Sensitivity
P2.144*	• Transmission Line Buffer	May 16, 2012	<ul style="list-style-type: none"> <li>The pond is located in a deciduous forest (classified as FOD, ELC Feature ID 90). The pond is 10 by 5 m. Riparian buffer consists of grasses and some shrubs.</li> </ul>	<ul style="list-style-type: none"> <li>The pond appears to be a natural feature that may be online. <i>In-situ</i> cover is moderate and consists of emergent vegetation.</li> </ul>	non -REA

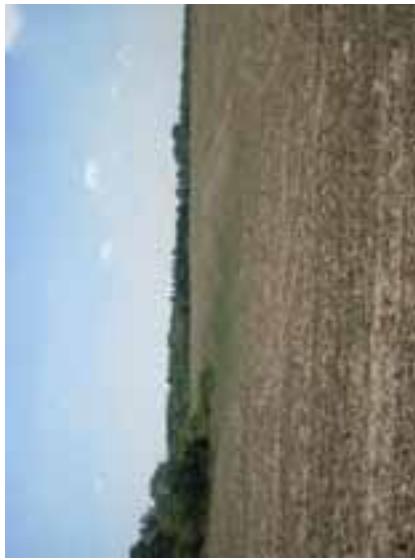
**Photograph 1. Channel overview ↑**

Feature ID	Project Component	Investigation Date	Description of Site	Feature Description	Feature Sensitivity
R2.193	• Collection Line Crossing • Road Crossing	May 24, 2012	• The feature is located in a corn field.	• The channel does not exist. The field has been tiled and only a small depression exists. It is classified as tiled by ABCA.	non -REA
			Watercourse Name	Hobbs-Mckenzie Trib	
			DFO Drain Classification	T

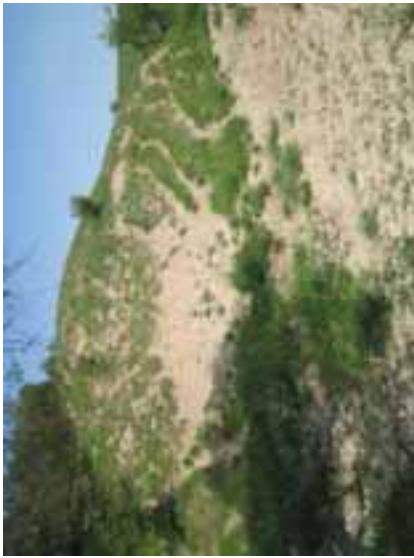
**Photograph 1. Site overview ↑**

Feature ID	Project Component	Investigation Date	Description of Site	Feature Description	Feature Sensitivity				
R2.311- A/B	<ul style="list-style-type: none"> <li>• Collection Line Crossing</li> <li>• Road Crossing</li> <li>• Turbine 82</li> </ul>	May 15, 2012	<ul style="list-style-type: none"> <li>• The feature is located in an agricultural field. There are two swale features present.</li> </ul>	<ul style="list-style-type: none"> <li>• No channel was found, however some low lying areas exist that may provide seasonal surface water conveyance. The swales outflow into an unmapped watercourse.</li> </ul>	non -REA				
			<table border="1"> <tr> <td>Watercourse Name</td> <td>Unmapped</td> </tr> <tr> <td>DFO Drain Classification</td> <td>Unclassified</td> </tr> </table>	Watercourse Name	Unmapped	DFO Drain Classification	Unclassified		
Watercourse Name	Unmapped								
DFO Drain Classification	Unclassified

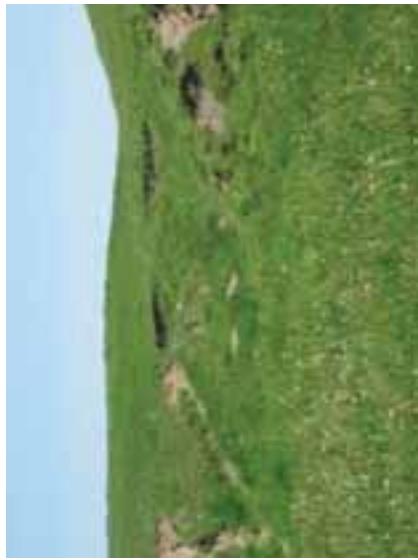
**Photograph 1. Site overview ↑**

Feature ID	Project Component	Investigation Date	Description of Site	Feature Description	Feature Sensitivity
R2.312	• Collection Line Buffer	May 15, 2012	• The feature is located in an agricultural field.	• The feature is a grassed waterway that can carry overland flow. It is unclassified by ABCA.	non -REA
	• Road Buffer	• Turbine 80			
Watercourse Name	Unmapped				
DFO Drain Classification	Unclassified

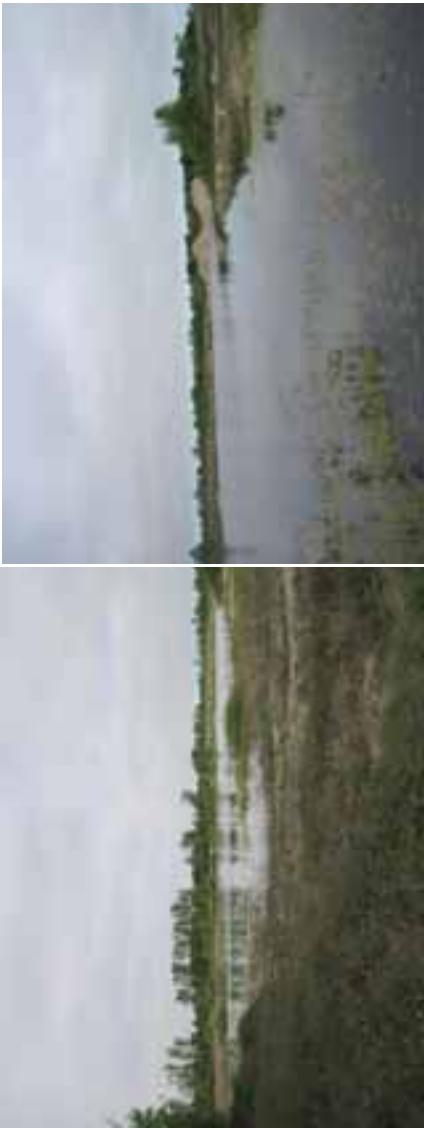
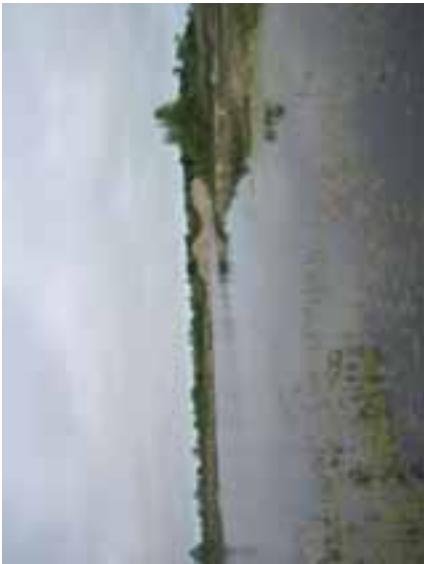
Feature ID	Project Component	Investigation Date	Description of Site	Feature Description	Feature Sensitivity
P3.29	<ul style="list-style-type: none"> <li>• Collection Line Buffer</li> <li>• Road Buffer</li> </ul>	May 23, 2012	<ul style="list-style-type: none"> <li>• Pond is located within an industrial area. The pond is approximately 300 m by 100 m. Riparian buffer is approximately 5 m to 15 m of meadow.</li> <li>• The pond is a dugout offline feature. However, there is an overflow channel that exists into R3. Substrate consists of silt, gravel, sand and clay. <i>In-situ</i> cover is high and consists of aquatic vegetation. No groundwater indicators were observed.</li> </ul>

**Photograph 1. Pond overview ↑**

**Photograph 2. Pond overview ↑**

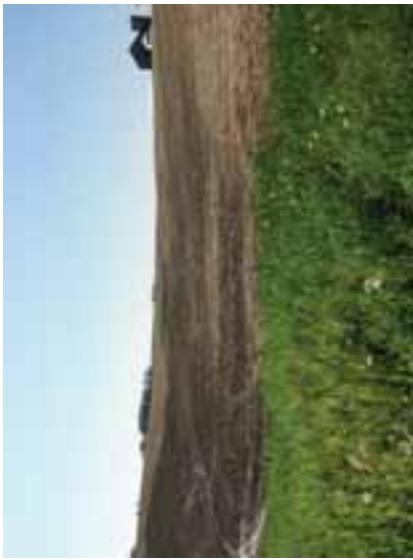
**Photograph 1. Site overview ↑**

Feature ID	Project Component	Investigation Date	Description of Site	Feature Description	Feature Sensitivity				
R3.62	<ul style="list-style-type: none"> <li>• Collection Line Crossing</li> <li>• Road Crossing</li> <li>• Turbine 77 and 78</li> </ul>	May 11, 2012	<ul style="list-style-type: none"> <li>• The feature is located in an agricultural field.</li> </ul>	<ul style="list-style-type: none"> <li>• There was no channel. The feature has been ploughed through. It is classified as tiled by ABCA.</li> </ul>	non -REIA				
			<table border="1"> <tr> <td>Watercourse Name</td> <td>Trick Drain Trib C</td> </tr> <tr> <td>DFO Drain Classification</td> <td>T</td> </tr> </table>	Watercourse Name	Trick Drain Trib C	DFO Drain Classification	T		
Watercourse Name	Trick Drain Trib C								
DFO Drain Classification	T

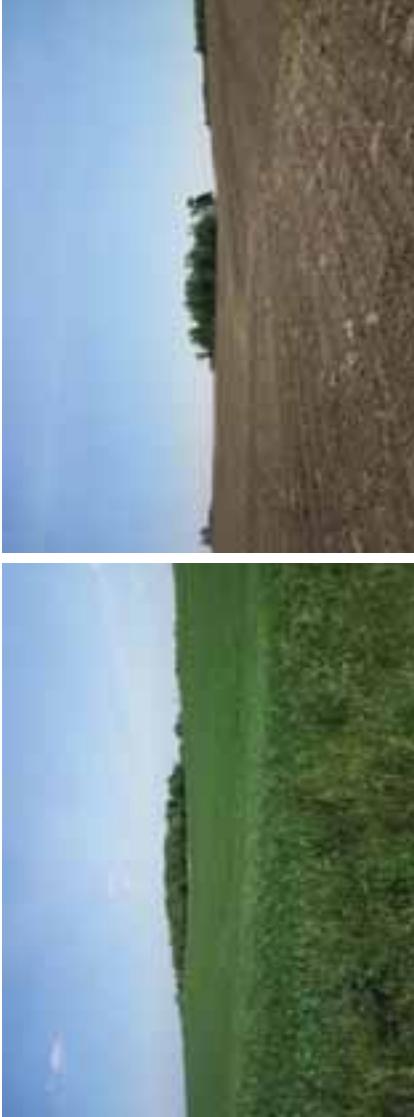
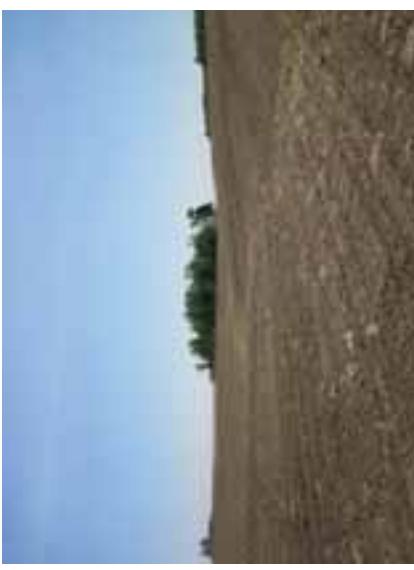
Feature ID	Project Component	Investigation Date	Description of Site	Feature Description	Feature Sensitivity
R3.68	<ul style="list-style-type: none"> <li>• Collection Line Crossing</li> <li>• Road Crossing and Buffer</li> <li>• Turbine 66 and 67</li> </ul>	May 23, 2012	<ul style="list-style-type: none"> <li>• The feature is located in a crop agricultural field.</li> </ul>	<ul style="list-style-type: none"> <li>• The feature has been ploughed through. It is classified as tiled by ABCA.</li> </ul>	non -REA

**Photograph 1. Site overview north of Farmers Line ↑**

**Photograph 2. Site overview south of Farmers Line ↑**

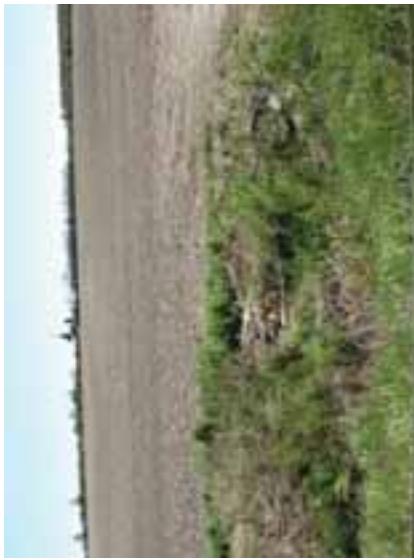
**Photograph 1. Site overview ↑**

Feature ID	Project Component	Investigation Date	Description of Site	Feature Description	Feature Sensitivity
R4.11-A	<ul style="list-style-type: none"> <li>• Collection Line Crossing</li> <li>• Road Crossing</li> <li>• Turbine 17</li> </ul>	May 10, 2012	<ul style="list-style-type: none"> <li>• The feature is located in crop agricultural fields.</li> </ul>	<ul style="list-style-type: none"> <li>• There was no surface feature present. It is classified as tiled by ABCA.</li> </ul>	non -REA
			Watercourse Name	Hamilton-Fischer-Anderson Drain	
			DFO Drain Classification	T

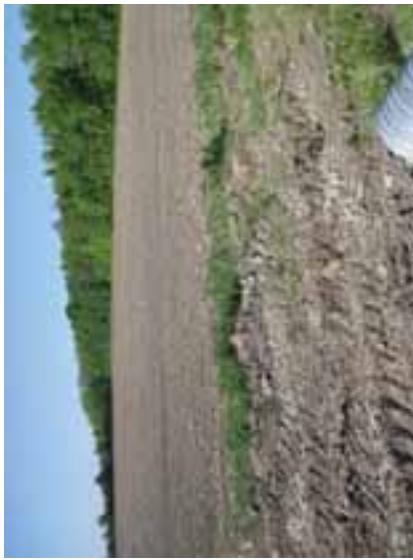
**Photograph 1. Site overview ↑**

Feature ID	Project Component	Investigation Date	Description of Site	Feature Description	Feature Sensitivity
R4.29	<ul style="list-style-type: none"> <li>Collection Line and Buffer</li> <li>Road Crossing and Buffer</li> <li>Turbine 14</li> </ul>	May 23, 2012	<ul style="list-style-type: none"> <li>The feature is located in crop agricultural fields.</li> </ul>	<ul style="list-style-type: none"> <li>The feature has been ploughed through. It is classified as tiled by ABCA.</li> </ul>	non -REA

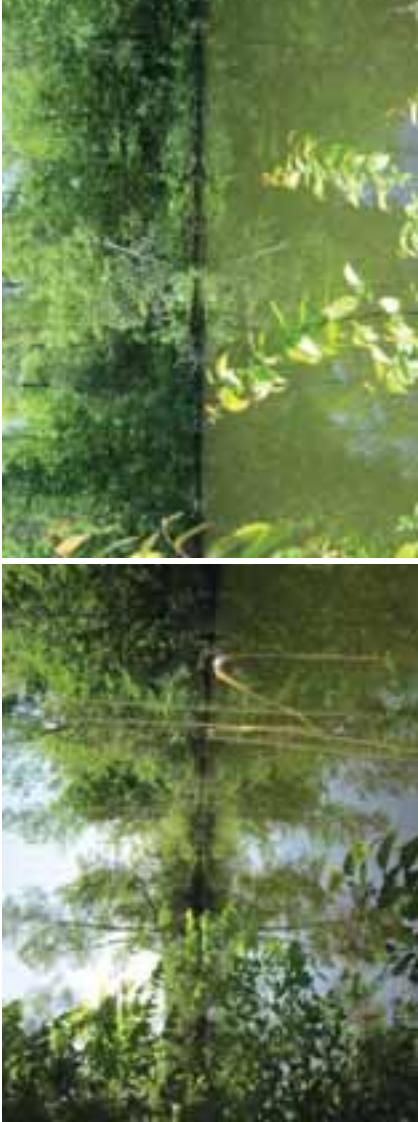
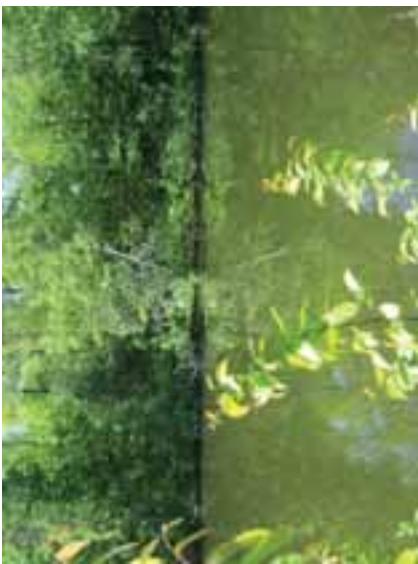
Feature ID	Project Component	Investigation Date	Description of Site	Feature Description	Feature Sensitivity
P4.29	<ul style="list-style-type: none"> <li>• Collection Line Buffer</li> <li>• Road Buffer</li> </ul>	May 23, 2012	<ul style="list-style-type: none"> <li>• Pond is located within a deciduous forest (classified as FOD6-5, ELC Feature ID 213) adjacent to agricultural field and Ravenswood Line. The pond is approximately 100 m by 20 m and greater than 2 m deep. Riparian buffer is greater than 30 m to the south and west, 6 m to the north and 3 m to the east.</li> <li>• The pond is an offline dugout feature. The water was turbid at time of investigation. Substrate consists of silt and sand. <i>In-situ</i> cover is low and consists of submergent aquatic vegetation. Several Cyprinids and catfish were observed at time of investigation.</li> </ul>		non -REA

**Photograph 1. Pond overview ↑**

**Photograph 2. Pond overview ↑**

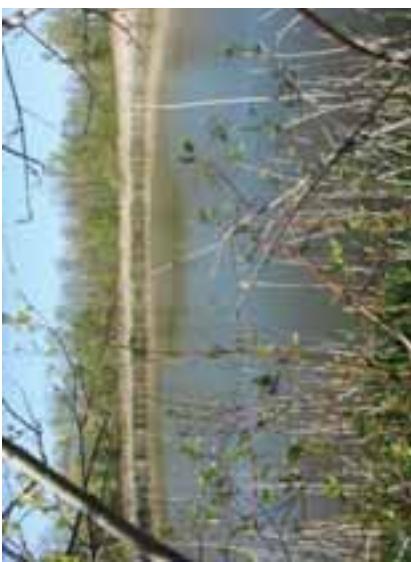
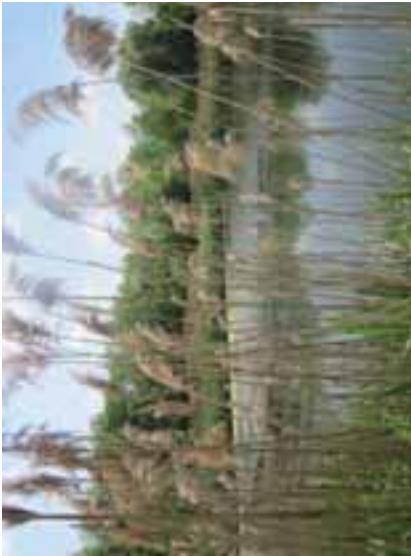
Feature ID	Project Component	Investigation Date	Description of Site	Feature Sensitivity
P4.30	<ul style="list-style-type: none"> <li>• Collection Line Buffer</li> <li>• Road Buffer</li> <li>• Turbine 15</li> </ul>	May 24, 2012	<ul style="list-style-type: none"> <li>• The pond is located in a deciduous swamp, surrounded by cultural meadow (classified as CUM1-1, SWD2-2, ELC Feature ID 213). The pond is 70 by 70 m and too deep to wade. Riparian buffer is greater than 3 m of common reed.</li> <li>• The pond is a dugout offline feature. The water was turbid at time of investigation. No groundwater indicators were observed.</li> </ul>	non -REA

**Photograph 1. Pond overview ↑**

**Photograph 2. Pond overview ↑**

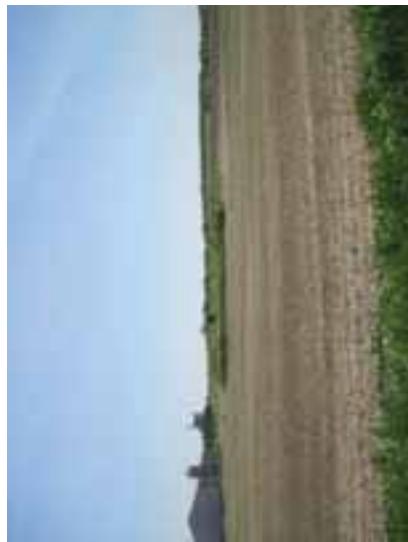
**Photograph 1. Pond overview ↑**

Feature ID	Project Component	Investigation Date	Description of Site	Feature Description	Feature Sensitivity
P4.36*	<ul style="list-style-type: none"> <li>• Collection Line Buffer</li> <li>• Road Buffer</li> </ul>	May 23, 2012	<ul style="list-style-type: none"> <li>• Pond is located in a corn field. Pond is approximately 30 m by 15 m. Riparian buffer is 1 m of cattails. Surrounding land topography is flat.</li> </ul>	<ul style="list-style-type: none"> <li>• The pond is defined as a dugout pond that appears to be used for agricultural purposes.</li> </ul>	non -REA

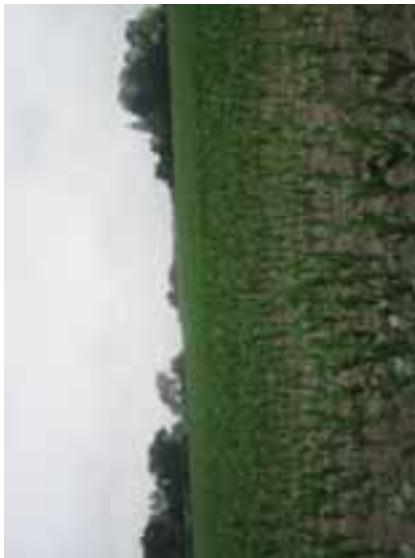
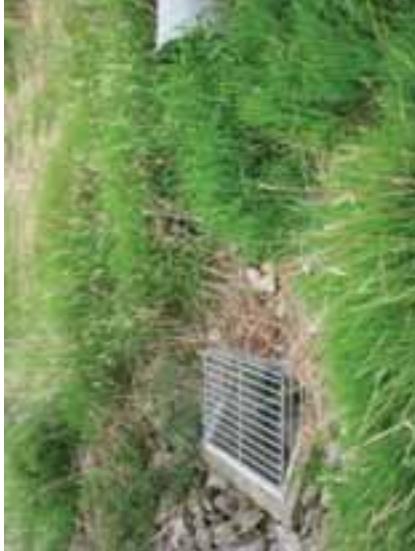
Feature ID	Project Component	Investigation Date	Description of Site	Feature Description	Feature Sensitivity
R4.37	<ul style="list-style-type: none"> <li>Collection Line Crossing and Buffer</li> <li>Road Buffer</li> </ul>	June 12, 2012	<ul style="list-style-type: none"> <li>The feature is located in a corn field.</li> </ul>	<ul style="list-style-type: none"> <li>The watercourse has been buried. An outlet/inlet pipe was observed at the road. It is classified as unknown by ABCA.</li> </ul>	non -REA

**Photograph 1. Site overview ↑**

**Photograph 2. Inlet/outlet pipe ↑**

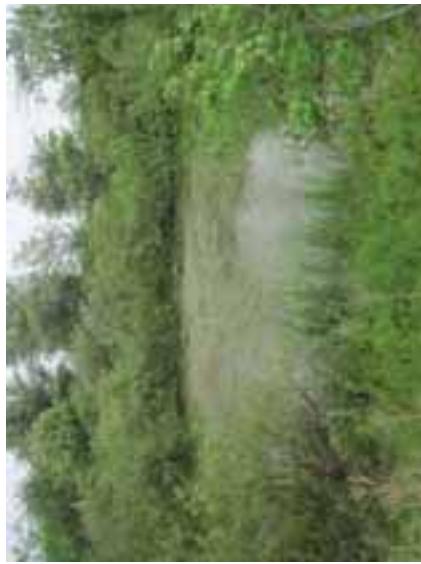
**Photograph 1. Pond overview ↑**

Feature ID	Project Component	Investigation Date	Description of Site	Feature Description	Feature Sensitivity
P4.37	• Road Buffer	May 22, 2012	<ul style="list-style-type: none"> <li>The pond is located in corn fields beside R4.8. The pond is an offline dugout feature. Substrate consists of silt, is 7 m by 7 m. Riparian buffer is 2 m of meadow and shrubs.</li> </ul>	<ul style="list-style-type: none"> <li>• Pond is an offline dugout feature. Substrate consists of silt, clay and sand. <i>In-situ</i> cover is moderate and consists of algae and emergent vegetation. No groundwater indicators were observed.</li> </ul>	non -REA

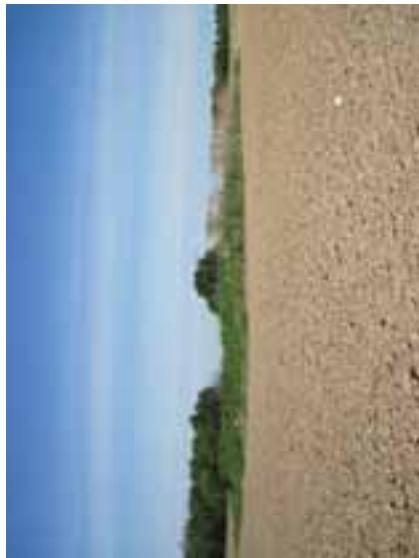
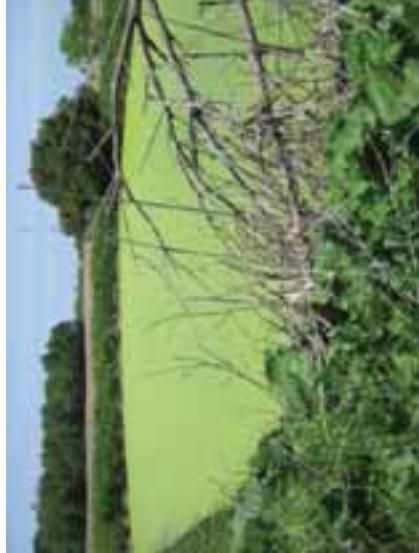
Feature ID	Project Component	Investigation Date	Description of Site	Feature Description	Feature Sensitivity
P4.39	<ul style="list-style-type: none"> <li>• Collection Line Buffer</li> <li>• Road Buffer</li> <li>• Turbine 71</li> </ul>	May 23, 2012	<ul style="list-style-type: none"> <li>• The pond is located in an agricultural field. The water column was 30 m by 30 m and too deep to wade. Riparian buffer is 3 m of grasses and shrubs.</li> <li>• The pond is clear at time of investigation. The pond was completely covered in duckweed. No groundwater indicators were observed.</li> </ul>		non -REA

**Photograph 1. Site overview ↑**

**Photograph 2. Pond overview ↑**

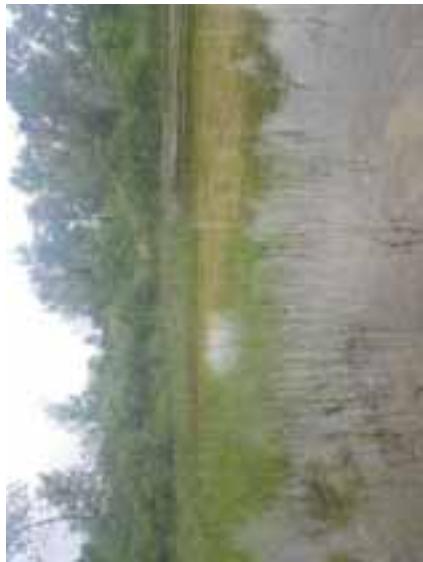
**Photograph 1. Pond overview ↑**

Feature ID	Project Component	Investigation Date	Description of Site	Feature Description	Feature Sensitivity
P4.40	• Collection Buffer	May 29, 2012	<ul style="list-style-type: none"> <li>The pond is located in a forest area. The pond is 20 m by 60 m and 0.5 m deep. Riparian buffer is 20 m of trees, shrubs and grasses.</li> </ul>	<ul style="list-style-type: none"> <li>The pond is a natural feature. The water was clear at time of investigation. Substrate consists of silt. <i>In-situ</i> cover is low and consists of aquatic vegetation. No groundwater indicators were observed.</li> </ul>	non -REA

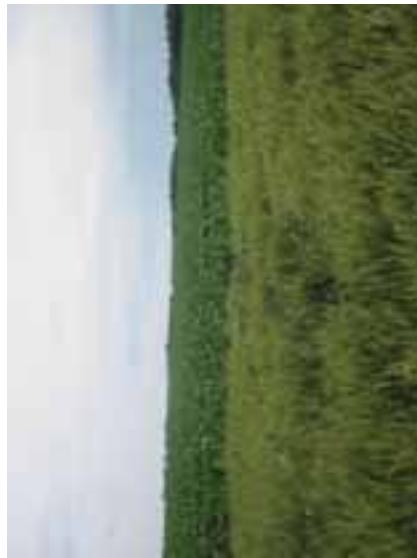
**Photograph 1. Site overview ↗**

Feature ID	Project Component	Investigation Date	Description of Site	Feature Description	Feature Sensitivity
R4.41	<ul style="list-style-type: none"> <li>Collection Line Crossing</li> <li>Road Crossing</li> <li>Turbine 24</li> </ul>	May 10, 2012 June 18, 2012 September 28, 2012	<ul style="list-style-type: none"> <li>The feature is located in corn and wheat fields.</li> </ul>	<ul style="list-style-type: none"> <li>The feature does not exist and has been ploughed through. It is classified as tilled by ABCA.</li> </ul>	non -REA
			Watercourse Name	Golden Creek Drain	
			DFO Drain Classification	T

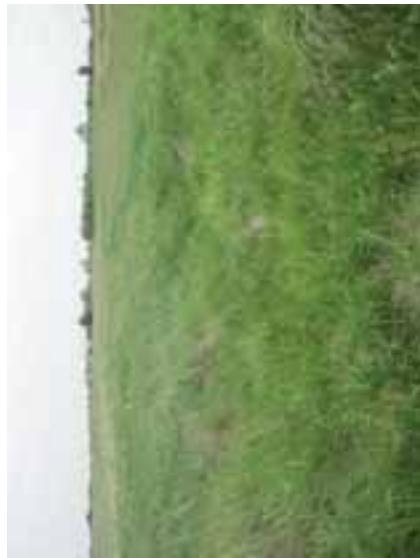
**Photograph 1. Site overview ↗**

Feature ID	Project Component	Investigation Date	Description of Site	Feature Description	Feature Sensitivity
R4.43	• Road Crossing	May 22, 2012	• The feature is located in fallow fields.	• The watercourse appears to be buried. It is classified as tiled by ABCA.	non -REA

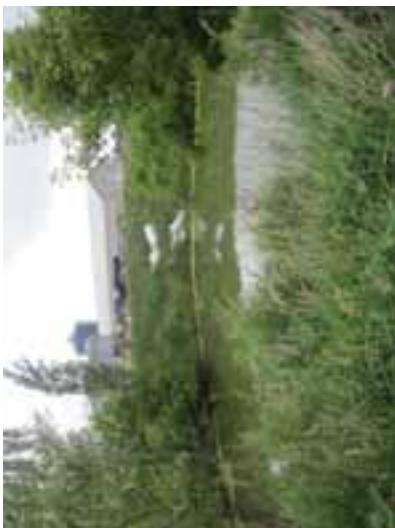
Feature ID	Project Component	Investigation Date	Description of Site	Feature Description	Feature Sensitivity
P4.43	<ul style="list-style-type: none"> <li>• Collection Line Buffer</li> <li>• Road Buffer</li> </ul>	June 12, 2012	<ul style="list-style-type: none"> <li>• The pond is surrounded by a residential property and corn fields. The pond is 20 m by 10 m and greater than 0.5 m deep. Riparian buffer is 1.5 m of grasses and shrubs.</li> </ul>	<ul style="list-style-type: none"> <li>• The pond is a dugout feature and appears to be offline, however there was a possible outlet pipe into R4 which could not be confirmed. The water was turbid at time of investigation. Algae were present around the edge of the pond. No groundwater indicators were observed.</li> </ul>	non -REA

**Photograph 1. Pond overview ↑**

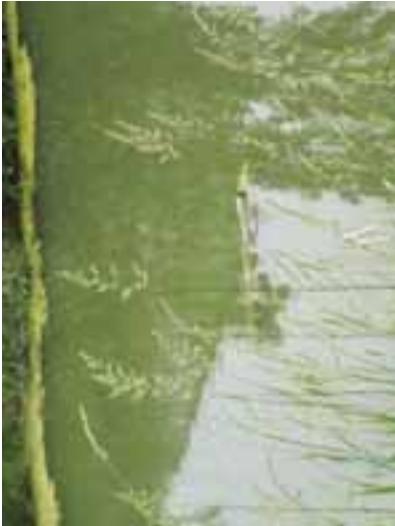
**Photograph 2. Possible outflow pipe ↑**

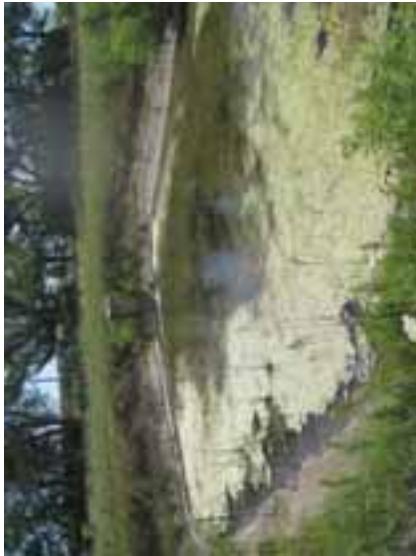
Feature ID	Project Component	Investigation Date	Description of Site	Feature Description	Feature Sensitivity
P4.44	• Collection Buffer	Line	July 25, 2012	<ul style="list-style-type: none"> <li>The pond is located in a soybean field. The pond is 15 by 10 m and approximately 1 m deep. Riparian buffer is 4 m of grasses</li> <li>The pond is 15 by 10 m and approximately 1 m deep. Riparian buffer is followed by silt and sand. <i>In-situ</i> cover is high and consists of pondweed, algae and cattails. No groundwater indicators were observed.</li> </ul>	non -REA

**Photograph 1. Pond overview ↑**

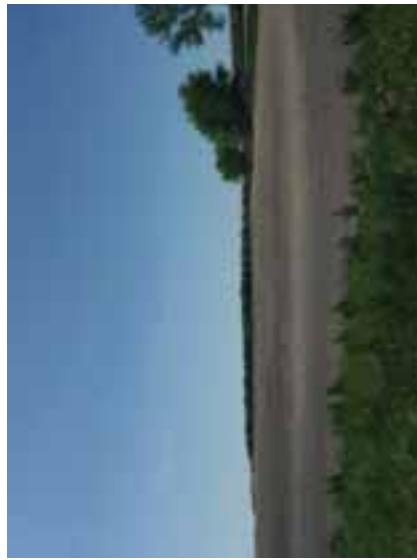
Feature ID	Project Component	Investigation Date	Description of Site	Feature Description	Feature Sensitivity
R4.45	• Collection Line Crossing • Road Crossing	May 17, 2012	• The feature is located in an agricultural field.	• There was no watercourse present. It is classified as tiled by ABCA.	non -REA

**Photograph 1. Site overview ↑**

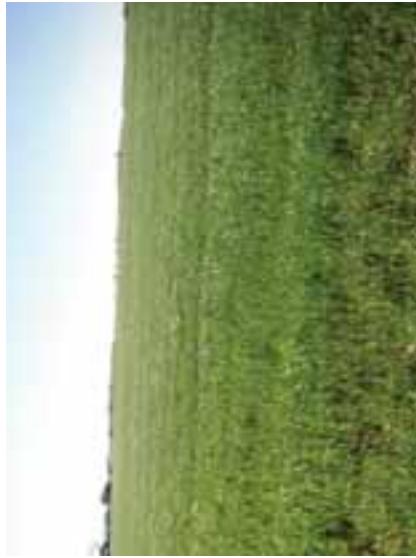
Feature ID	Project Component	Investigation Date	Description of Site	Feature Description	Feature Sensitivity
R4.48	• Collection Line Crossing • Road Crossing	May 10, 2012 September 28, 2012	• The feature is located in corn and hay fields.	• There was no channel or water present. It is classified as tiled by ABCA.	non -REA

**Photograph 1. Site overview ↑**

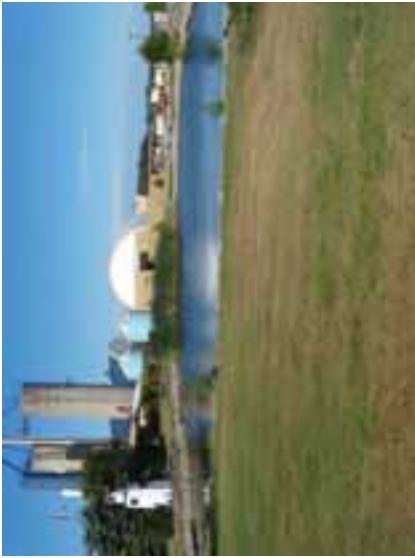
Feature ID	Project Component	Investigation Date	Description of Site	Feature Description	Feature Sensitivity
P4.48	• Collection Buffer	Line	July 25, 2012	<ul style="list-style-type: none"> <li>The pond is located in a residential property. The pond is approximately 25 m by 40 m and greater than 2 m in depth.</li> <li>The pond is a dugout offsite feature. The pond is for aesthetic purposes. The edges of the pond were covered in cobble. <i>In-situ</i> cover is low and consists of cattails. No groundwater indicators were observed. Fish were observed in the pond at time of investigation.</li> </ul>	non -REA

**Photograph 1. Pond overview ↑**

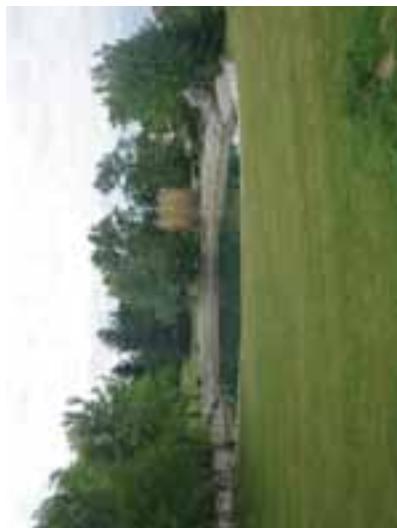
Feature ID	Project Component	Investigation Date	Description of Site	Feature Description	Feature Sensitivity
P4.50	• Collection Buffer	May 30, 2012	<ul style="list-style-type: none"> <li>The pond is located in a residential property. The pond is dugout and appears to be for aesthetic purposes only. Substrate and <i>in-situ</i> cover could not be assessed. Cobble surrounds the edges of the pond. No groundwater indicators were observed.</li> </ul>	<ul style="list-style-type: none"> <li>The pond is 25 m by 25 m. There is no riparian buffer, with the grasses mowed right up to the edges of the pond.</li> </ul>	non -REA

**Photograph 1. Pond overview** ↗

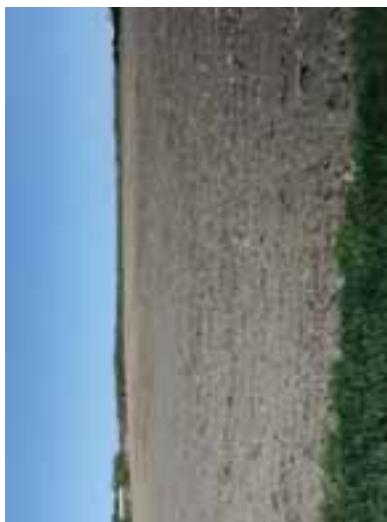
Feature ID	Project Component	Investigation Date	Description of Site	Feature Description	Feature Sensitivity
R4.54	• Collection Line Crossing • Road Crossing	May 10, 2012	• The feature is located in an agricultural field.	• There is no surface feature. It is classified as tiled by ABCA.	non -REA

**Photograph 1. Site overview ↑**

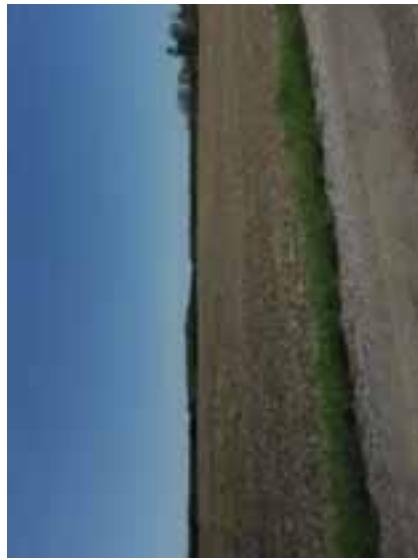
Feature ID	Project Component	Investigation Date	Description of Site	Feature Description	Feature Sensitivity				
R6-A	• Road Buffer • Turbine 44	May 17, 2012	• The feature is located in crop agricultural fields.	• The feature has been ploughed though. No surface feature is present. It is classified as an intermittent system by SCRCA.	non -REA				
<table border="1"> <tr> <td>Watercourse Name</td> <td>Russell Drain</td> </tr> <tr> <td>DFO Drain Classification</td> <td>F</td> </tr> </table>		Watercourse Name	Russell Drain	DFO Drain Classification	F				
Watercourse Name	Russell Drain								
DFO Drain Classification	F

**Photograph 1. Site overview ↑**

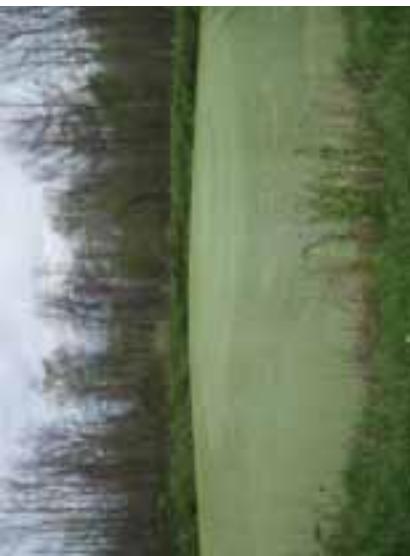
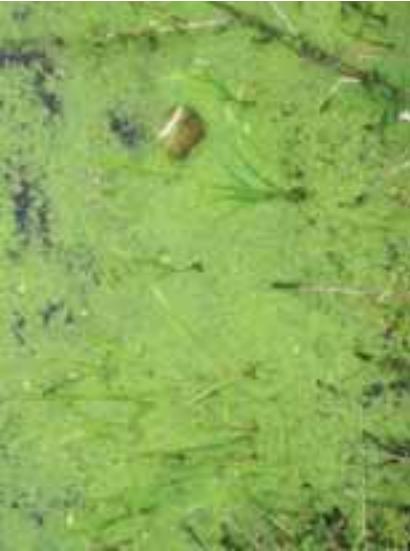
Feature ID	Project Component	Investigation Date	Description of Site	Feature Description	Feature Sensitivity
P6.6	• Road Buffer • Turbine 41	May 3, 2012	<ul style="list-style-type: none"> <li>The pond is located in a mix of deciduous forest and swamp (classified as FOD6-5, SWD3-3, ELC Feature ID 139) with an agricultural field along the east side. The pond is 30 m by 35 m and too deep to wade. Directly adjacent to the pond is a riparian buffer of 1 m consisting of grasses and greater than 40 m to the north, west and south.</li> </ul>	<ul style="list-style-type: none"> <li>The pond is a dugout offline feature. The water column was clear at time of investigation. The pond was completely covered in duckweed. No groundwater indicators were observed.</li> </ul>	non -REA

**Photograph 1. Pond overview ↑**

**Photograph 2. Duckweed ↑**

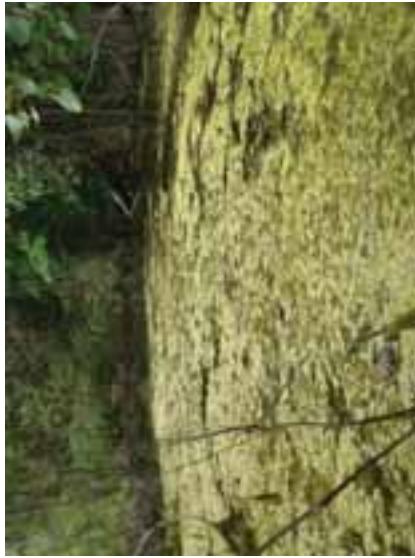
Feature ID	Project Component	Investigation Date	Description of Site	Feature Description	Feature Sensitivity
P8.7	• Turbine 88	May 22, 2012	<ul style="list-style-type: none"> <li>The pond is located in a deciduous forest (classified as FOD?-1, FOD5-2, ELC Feature ID 120). The pond is approximately 20 m by 5 m and 1.5 m deep. Riparian buffer is greater than 5 m.</li> </ul>	<ul style="list-style-type: none"> <li>The pond is a dugout offline feature. <i>In-situ</i> cover is high and consists of algae blooms and emergent grasses. No groundwater indicators were observed.</li> </ul>	non -REA

**Photograph 1. Pond overview ↑**

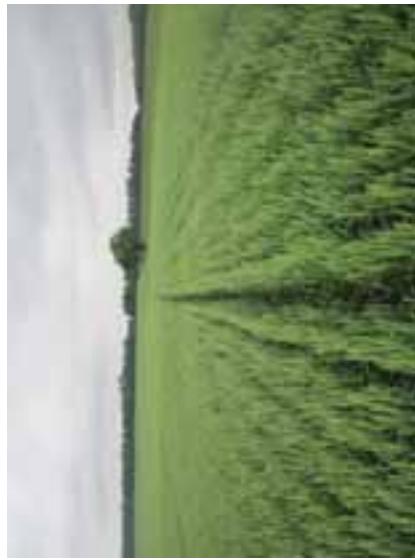
Feature ID	Project Component	Investigation Date	Description of Site	Feature Description	Feature Sensitivity
R9.33-B	• Collection Line Crossing • Road Crossing	May 29, 2012	• The feature is located in a wheat field.	• The feature does not exist, it has been ploughed through. It is classified as tied by SCRCA.	non -REA

**Photograph 1. Site overview ↗**

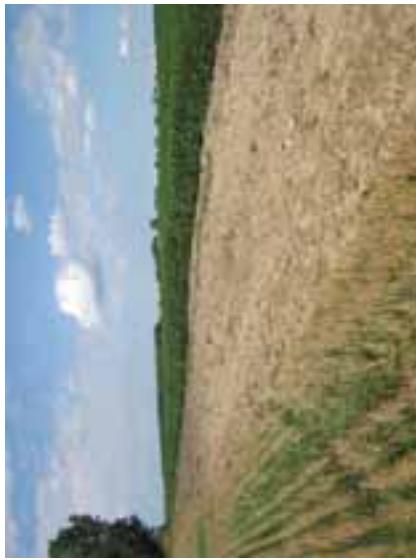
Feature ID	Project Component	Investigation Date	Description of Site	Feature Description	Feature Sensitivity
R12.2	<ul style="list-style-type: none"> <li>• Collection Line Buffer</li> <li>• Road Buffer</li> <li>• Turbine 105</li> </ul>	July 31, 2012	<ul style="list-style-type: none"> <li>• The feature is located in wheat fields.</li> </ul>	<ul style="list-style-type: none"> <li>• The feature has been filled in. It is classified as tiled by SCRCA.</li> </ul>	non -REA
			Watercourse Name DFO Drain Classification	Unknown Drain T

**Photograph 1. Site overview ↗**

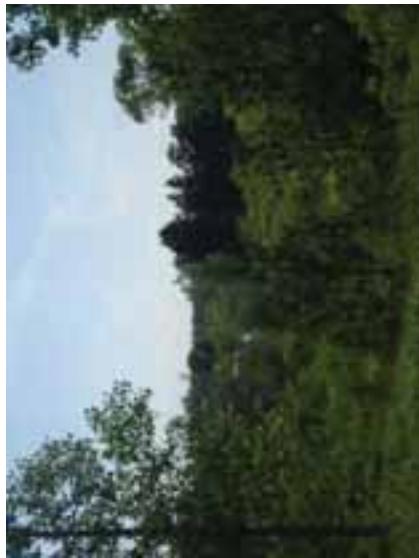
Feature ID	Project Component	Investigation Date	Description of Site	Feature Description	Feature Sensitivity
P12.14*	• Collection Line Buffer	June 7, 2012	• The pond is located in cultural meadow (classified as CUM1-1, ELC Feature 508) and surrounded by agricultural fields. The pond is 180 m by 60 m. Riparian buffer is greater than 30 m to the south.	• The pond is a natural offline feature. The pond could not be assessed because access was not granted.	non -REA

**Photograph 1. Site overview ↗**

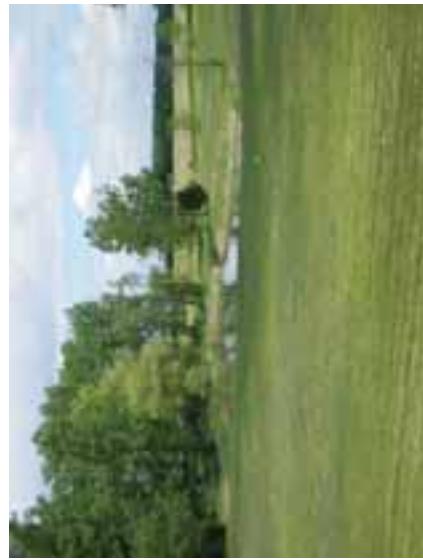
Feature ID	Project Component	Investigation Date	Description of Site	Feature Description	Feature Sensitivity
P12.30*	• Collection Buffer	June 4, 2012	<ul style="list-style-type: none"> <li>The pond is located on a residential property. The pond is 12 m by 12 m. There is no riparian buffer as the grass is mowed to the edges of the pond.</li> </ul>	<ul style="list-style-type: none"> <li>The pond is a dugout offline feature. Substrate consists of silt. <i>In-situ</i> cover is low and consists of cattails. No groundwater indicators were observed.</li> </ul>	non -REA

**Photograph 1. Pond overview** ↑

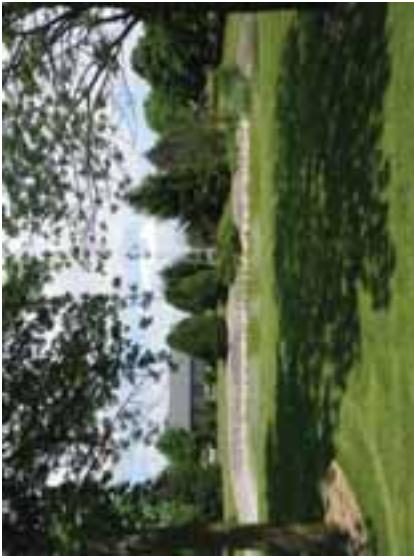
Feature ID	Project Component	Investigation Date	Description of Site	Feature Description	Feature Sensitivity
P12.31	• Collection Line Buffer	June 4, 2012	<ul style="list-style-type: none"> <li>The pond is located in a residential property. The pond is 10 m by 20 m and too deep to wade. There is no riparian buffer, the grass is mowed up to the edges of the pond. <i>In-situ</i> cover is low and consists of cattails. No groundwater indicators were observed.</li> </ul>	<ul style="list-style-type: none"> <li>The pond is a dugout offline feature that is for aesthetic purposes. The water was turbid and green in colour at time of investigation. Cobble lines the edges of the pond. <i>In-situ</i> cover is low and consists of cattails. No groundwater indicators were observed.</li> </ul>	non -REA

**Photograph 1. Pond overview ↑**

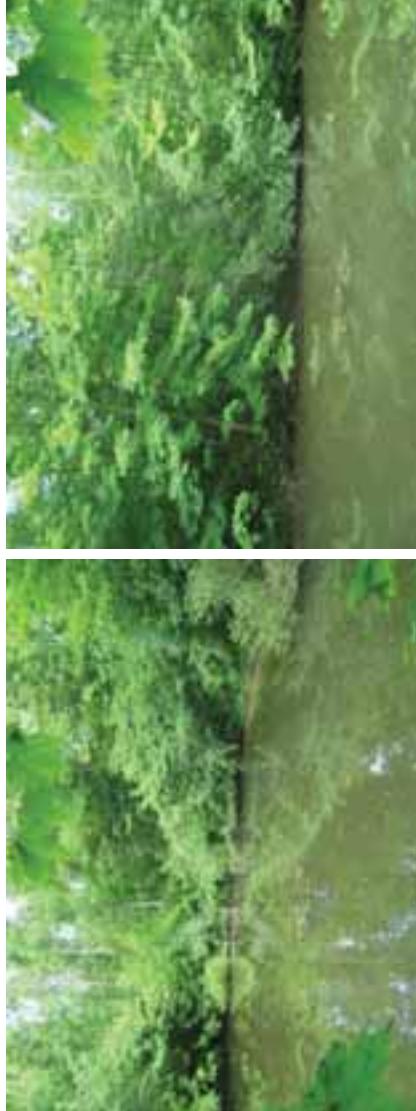
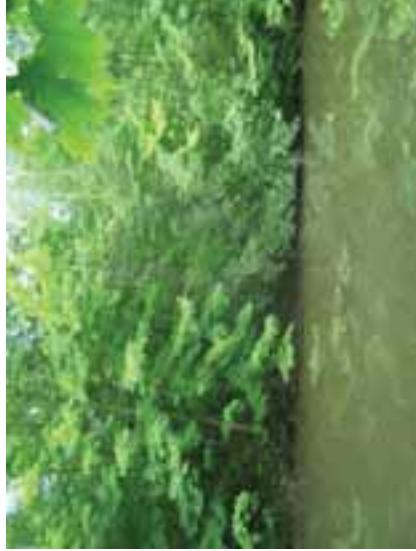
Feature ID	Project Component	Investigation Date	Description of Site	Feature Description	Feature Sensitivity
P12.32	<ul style="list-style-type: none"> <li>• Collection Line Buffer</li> <li>• Road Buffer</li> </ul>	September 18, 2012	<ul style="list-style-type: none"> <li>• The pond is located in a deciduous forest (classified as FOD9-4, FOD7-2, ELC Feature ID 7). The pond is approximately 25 m by 30 m and greater than 1 m deep. Riparian buffer is greater than 25 m.</li> </ul>	<ul style="list-style-type: none"> <li>• The pond is a dugout offline feature. There was no emergent vegetation present. No groundwater indicators were observed.</li> </ul>	non REA

**Photograph 1. Pond overview ↑**

**Photograph 2. Pond view ↑**
