**Water Bodies Assessment Field Collection Form**

Study Area: Jericho Goshen Bluewater Land Parcel# June 12/17 Site ID R2.70

<b>AECOM</b>		Page 1 of 4	
<b>General Information</b>			
Study Area: <u>Jericho</u> Goshen Bluewater		Land Parcel# <u>BOR1103</u>	Site ID: <u>R2.40 SBOR1103</u> <i>CSoc</i>
Date: <u>May 16/12</u>		Start time: <u>15:10</u>	End Time: <u>15:30</u>
Weather Conditions: <u>14°C Sunny</u>		Field Crew: <u>5 Lonnes JEpp</u> Field Notes By: <u>J.Epp</u>	
<b>Site Location</b>			
<u>South of Eighmfield, west of Sylvan</u>			
<b>UTM Co-ordinates (continue on page 3 if necessary)</b>			
Easting: <u>436088</u>	Northing: <u>4777819</u>	Description:	
Easting:	Northing:	Description:	
Easting:	Northing:	Description:	
Easting:	Northing:	Description:	
<b>Surrounding Landuse</b>		<b>Type of Watercourse</b>	
Residential <input type="checkbox"/>	Meadow <input type="checkbox"/>	Intermittent <input type="checkbox"/>	Channelized <input type="checkbox"/>
Agriculture <input type="checkbox"/>	Wetland <input type="checkbox"/>	Permanent <input checked="" type="checkbox"/>	Natural Channel <input checked="" type="checkbox"/>

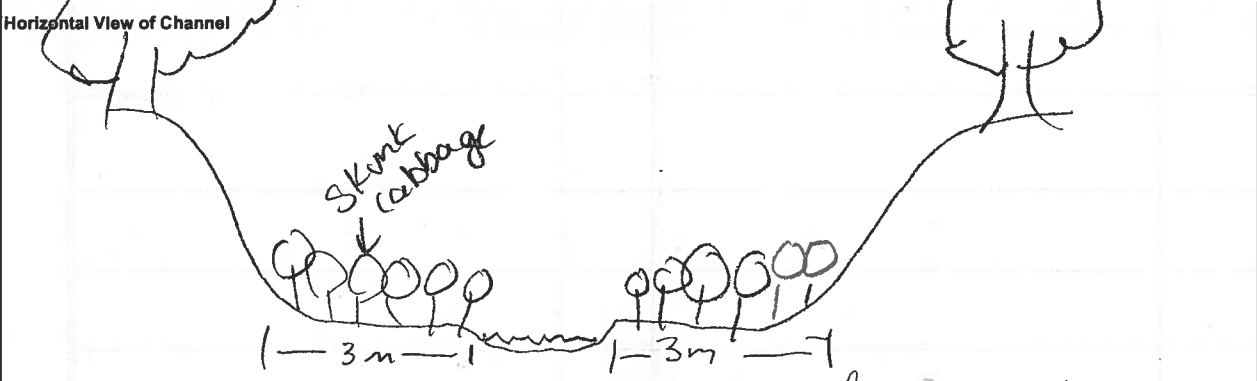
Watercourse Sketch

Watercourse begins at seep and flow down to converge with R2.54. The watercourse was shallow and had an extremely sandy bottom. The channel runs through a larger wetland channel, that is very moist and covered in skunk cabbage, and then up the slope is deciduous forest.

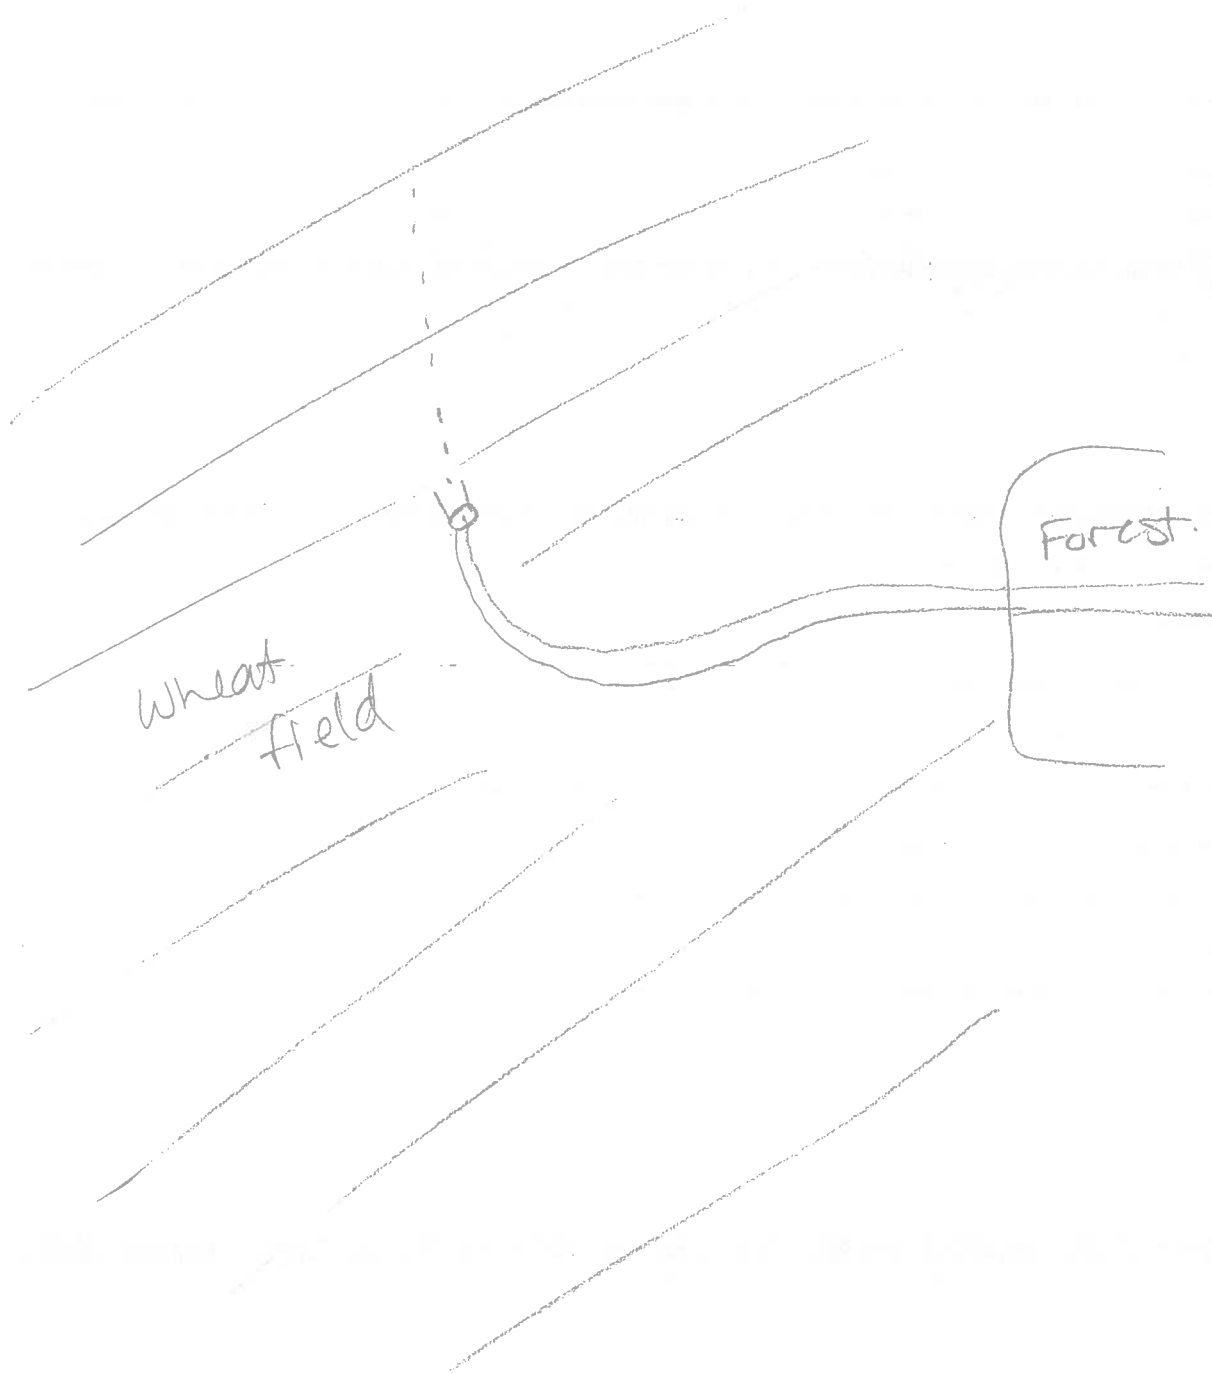
Site Sketch

Land Parcel/Site ID: JER 1059/3277 R2.78 Page 2 of 2
