Assessment of Non-Water Body
(update to mapping required)

AECOM				Page 1 of 2			
General Information							
Study Area: Jericho		Goshen		Bluewater		Land Parcel# 3499/3090	
Date: May 31/12		Start time: 16:30		End Time: 16:40		Site ID: R3.28 R3.51	
Weather Conditions: Cloudy 10°C				Field Crew: C. Boros, A. Arsenault			
				Field Notes By: C. Boros			
Site Location							
Gordon Rd, (S) of Kennedy Ln.							
UTM Co-ordinates							
Easting:		Northing:		Description:			
Easting:		Northing:		Description:			
Easting:		Northing:		Description:			
Easting:		Northing:		Description:			
Surrounding Landuse				Ground Water and Seepage Indicators			
Residential	<input type="checkbox"/>	Meadow	<input type="checkbox"/>	Watercross	<input type="checkbox"/>	Bank Seepage	<input type="checkbox"/>
Agriculture	<input checked="" type="checkbox"/>	Wetland	<input type="checkbox"/>	Iron Staining	<input type="checkbox"/>	None	<input checked="" type="checkbox"/>
Forest	<input type="checkbox"/>	Livestock	<input type="checkbox"/>	Bubbling	<input type="checkbox"/>

Water Bodies Assessment Field Collection Form

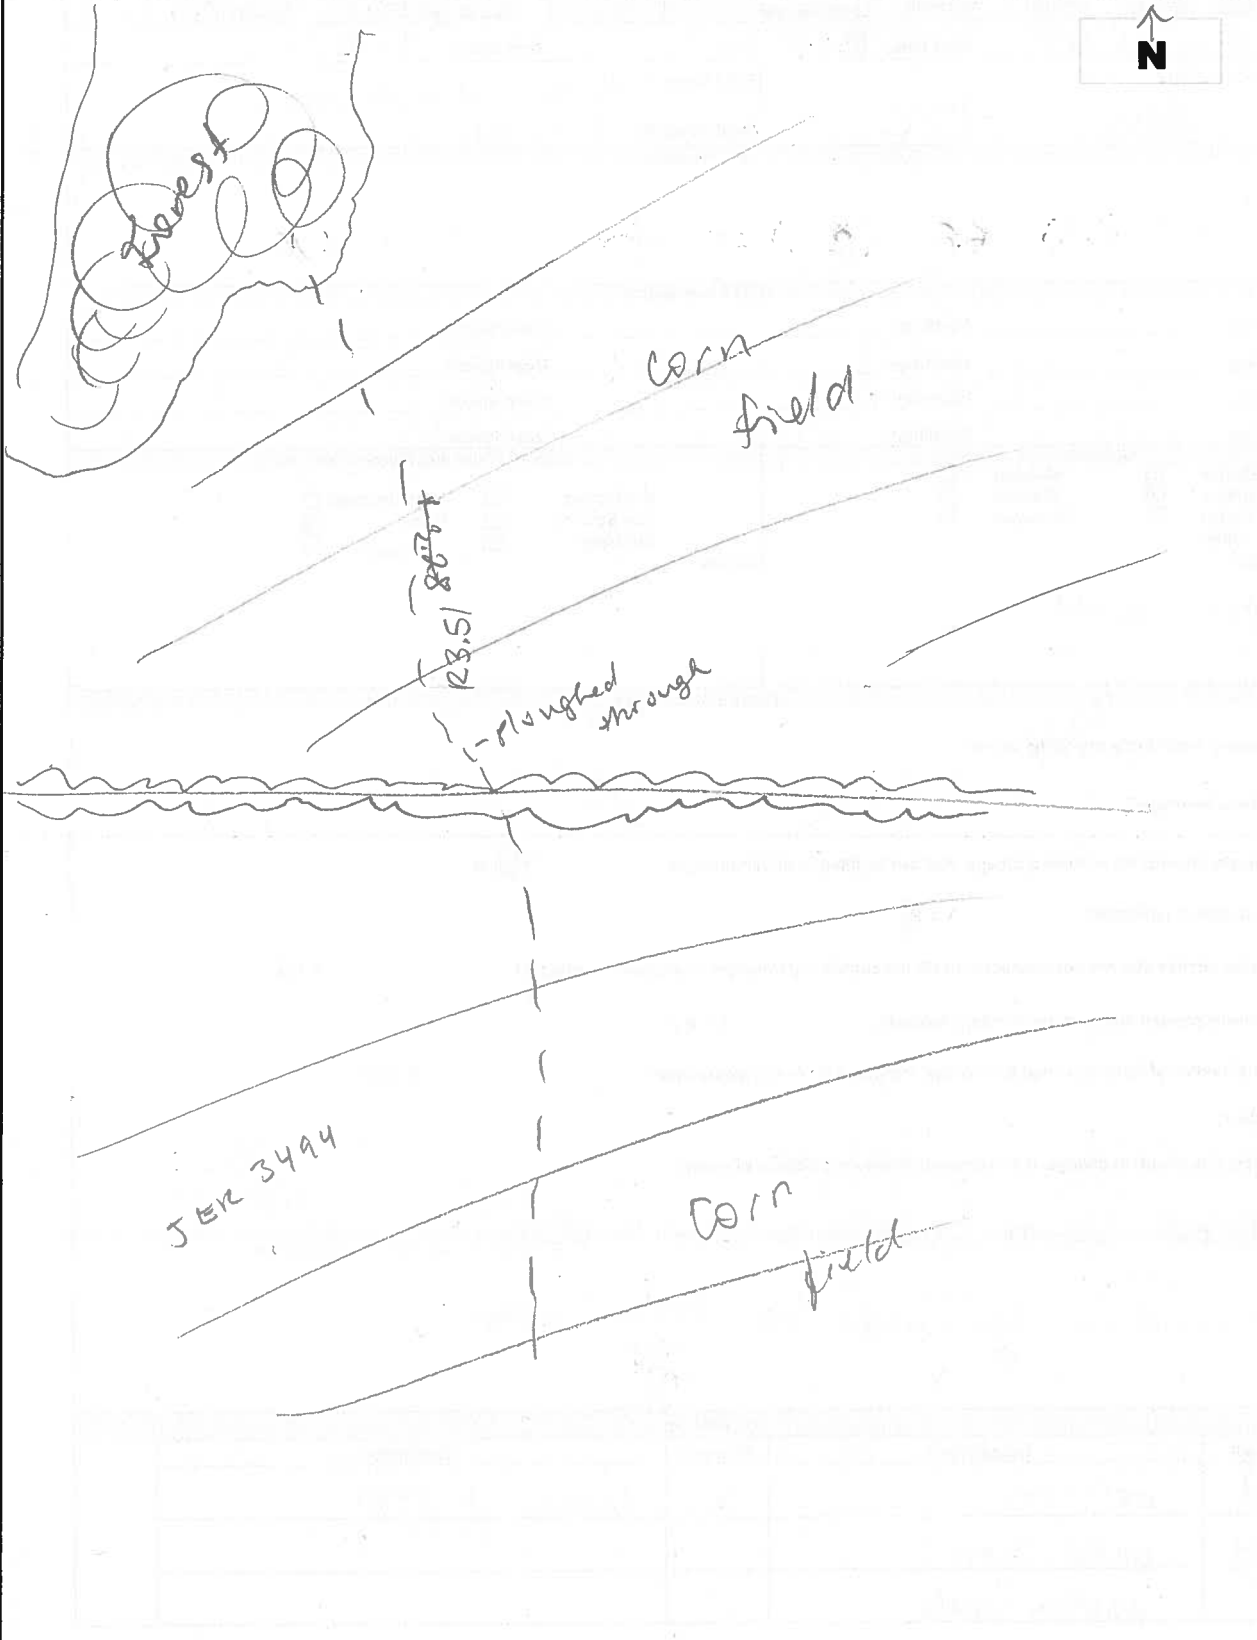
Site Sketch

6) Artificial bodies of water intended for storage, treatment for farming purposes?				Y / (N)			
8) Any other:							
Description: (i.e. length of change, if it reappears, if there is evidence of water)							
Potential swale feature as area is hilly - No defined channel in the woods were found either							
Photo log							
Picture #	Description	Picture #	Description				
1-2	overviews	6	looking at 3494				
3-4	forest area						
5	looking north

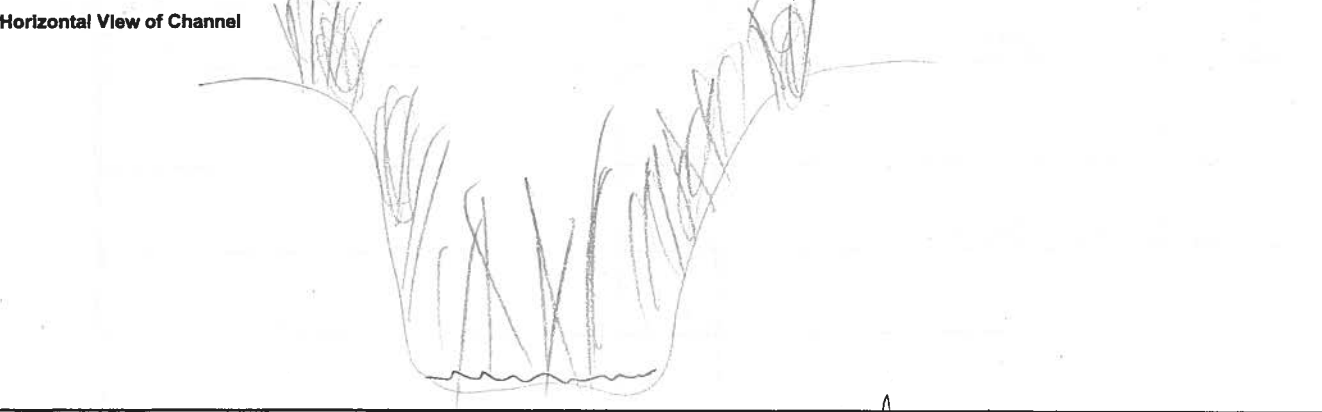
Watercourse Sketch

- tile drain inputs observed - not flowing

- no flow → watercourse broken up by stretches of dry channel																		
Substrate (<=>)		Habitat																
Bo - Boulder Co - Cobble Gr - Gravel Sa - Sand Si - Silt Cl - Clay MK - Muck DT - Detritus	Description: si, mk > sa, cl > gr	<table border="1" style="width:100%; text-align: center;"> <tr> <th colspan="4">Morphological Structure (%)</th> </tr> <tr> <th>Pool</th> <th>Riffle</th> <th>Run</th> <th>Flat</th> </tr> <tr> <td>10</td> <td></td> <td></td> <td>90</td> </tr> </table> Notes: pooled areas at 2 culverts + large tile drain input		Morphological Structure (%)				Pool	Riffle	Run	Flat	10			90			
Morphological Structure (%)																		
Pool	Riffle	Run	Flat															
10			90															
Instream Cover (%)																		
Other	Woody Debris	Boulders	Cobble	Aquatic Vegetation*	None	Undercut Banks												
/	/	/	/	90		Average Depth: / (% Cover)												
Note: Low = 0 - 30%; Moderate = 30 - 75%; High = 75 - 100%

Study Area: Jericho Goshen Bluewater Land Parcel# JER1125 Site ID J56 R3.70

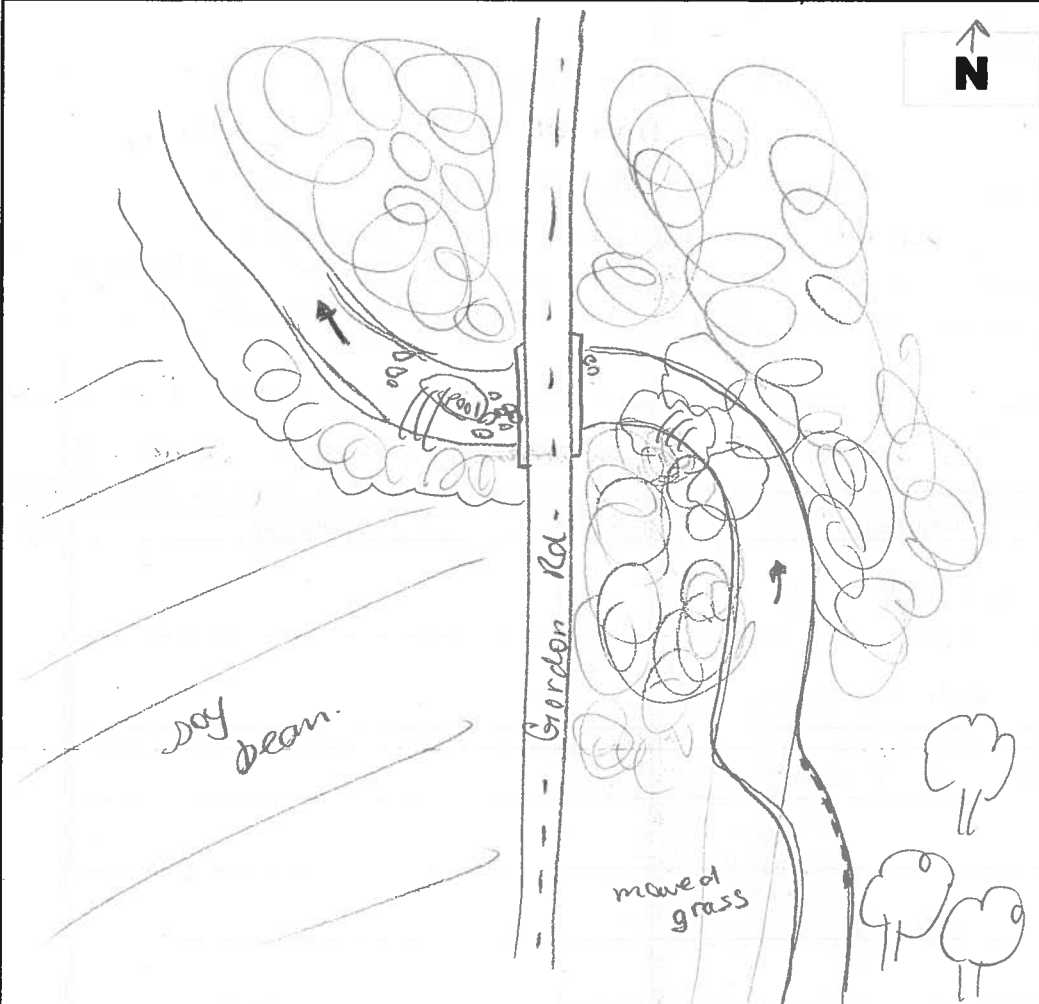
R3C

Riparian Vegetation																				
Width and Description of riparian vegetation: LB - 70m - deciduous forest			RB - 5m - south west - forest 70m - east side																	
Overhanging Vegetation Present <input checked="" type="checkbox"/> N			% Overhanging Vegetation: 10																	
Description of Overhanging Vegetation: Not hanging close to stream - willow + dog wood - 2 locations																				
Obstructions to Fish Passage																				
None Observed	<input checked="" type="checkbox"/>	Man-Made	<input type="checkbox"/>	Natural	<input type="checkbox"/>	Low Flow Barrier	<input type="checkbox"/>													
Description of Barrier:																				
Height of Barrier (m): /																				
GPS Coordinates: /

≡≡≡ overhanging veg
 --- highly eroded.
