Water Bodies Assessment Field Collection Form

AECOM		R4.11B Page 1 of 4	
General Information			
Study Area: Jericho	Goshen	Bluewater	Land Parcel# JER1098/4378 Site ID: R4.11-JER 1098
Date: MAY 9, 2012	Start time: 11:48 AM	End Time: 12:42 PM.	
Weather Conditions: p/cloudy, 15°C		Field Crew: S. LOHNES CHARDING	
		Field Notes By: S. LOHNES	
Site Location			
Jericho R north of Kennedy, west of Elliott			
UTM Co-ordinates (continue on page 3 if necessary)			
Easting: 17T0426217	Northing: 4782477	Description: START	
Easting: 17T0426242	Northing: 4782715	Description: watercress/ripple	
Easting: 17T0426301	Northing: 4782976	Description: END	
Easting:	Northing:	Description:	
Surrounding Landuse		Type of Watercourse	
Residential <input type="checkbox"/>	Meadow <input type="checkbox"/>	Intermittent <input type="checkbox"/>	Channelized <input checked="" type="checkbox"/>
Agriculture <input checked="" type="checkbox"/>	Wetland <input type="checkbox"/>	Permanent <input checked="" type="checkbox"/>	Natural Channel <input type="checkbox"/>

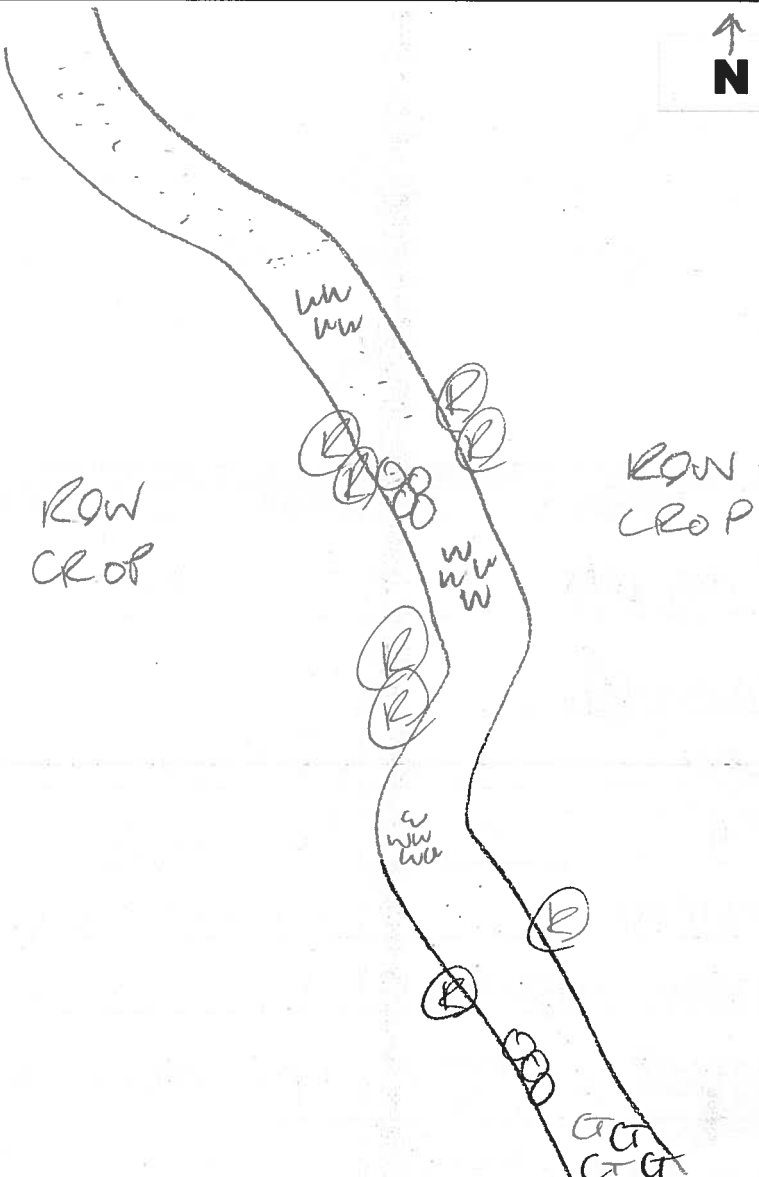
Watercourse Sketch

Study Area: Jericho Goshen Bluewater Land Parcel# 1023/1007 Site ID R4.16-JER1023

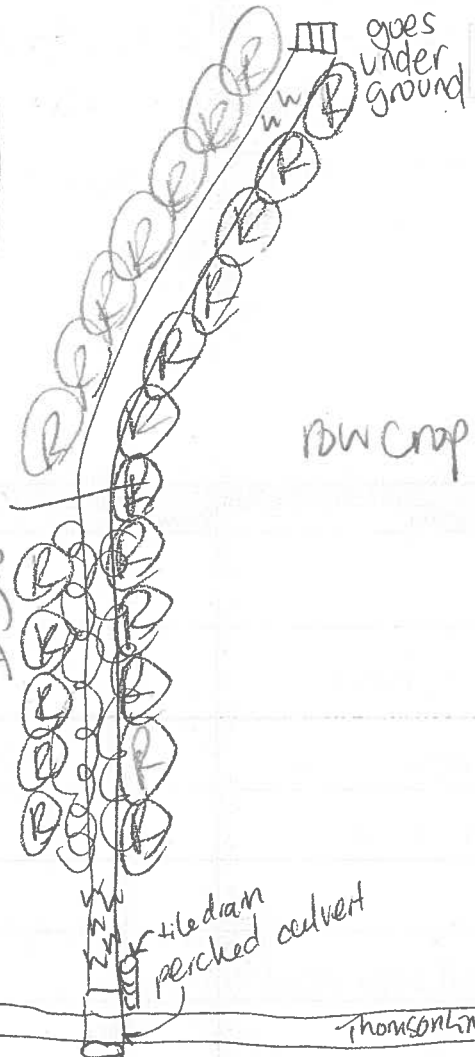
R4.33A

pond
(not able
to assess)

goes
under
ground

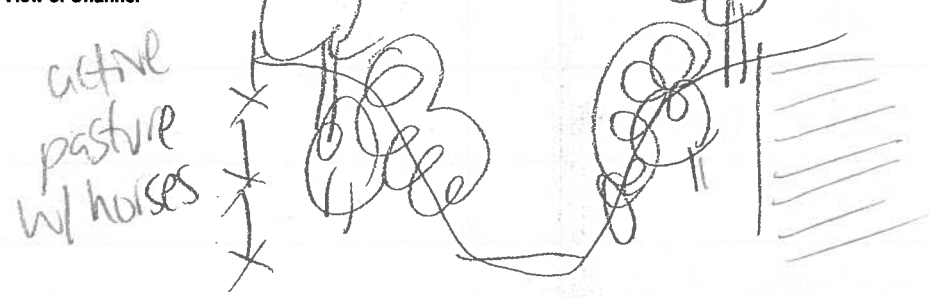
Horizontal View of Channel

dry ditches

active
pasture
w/ horses

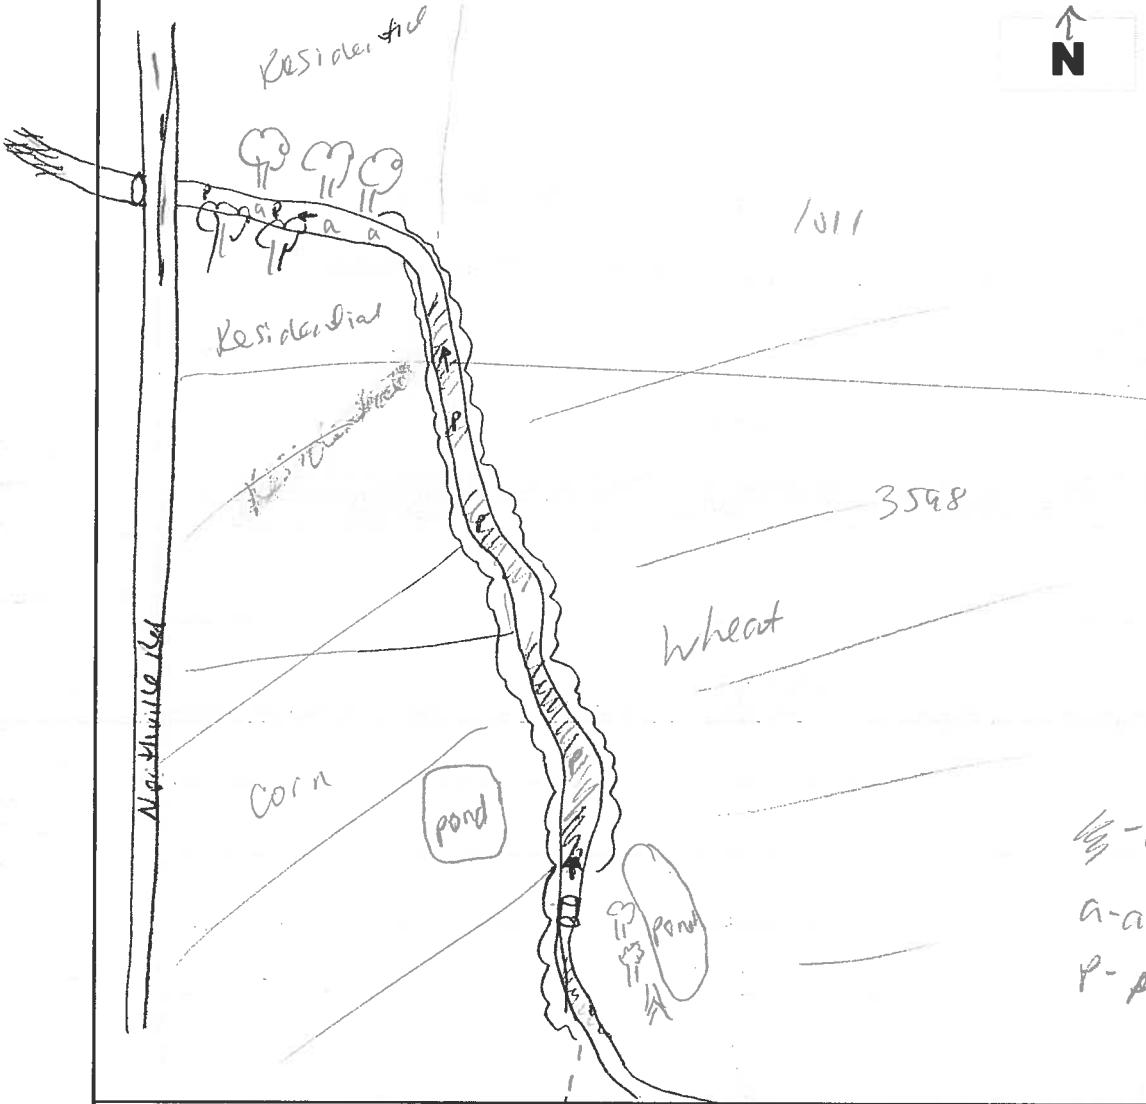
R4D

1/3 - algae - mats (attached) → blooms
 a - algae attached
 P - pondweed
