## Other General Comments Regarding the Study Area:

# Water Bodies Assessment Field Collection Form

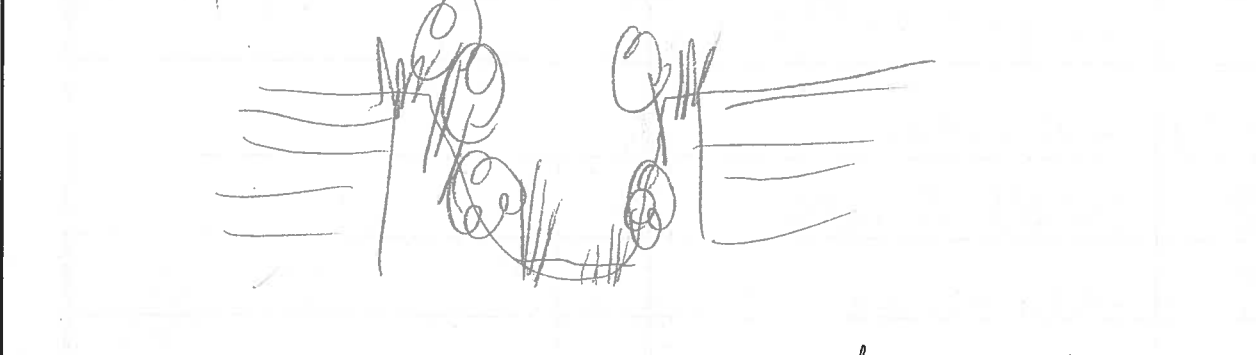
## Horizontal View of Channel

| Stream Morphology | | | | | | | | | | | | | | | | | | | | |
|---|---|---|---|---|---|---|---|---|---|---|---|---|---|---|---|---|---|---|---|---|
| Mean Wetted Width (m): 1.0 | Mean Wetted Depth (m): 0.15 | Description: erosion + undercutting observed | | | | | | | | | | | | | | | | | | |
