Jericho Wind Energy Centre
 NHA Amendment

Significant Wildlife Habitat

August 2013
 Project 60155032

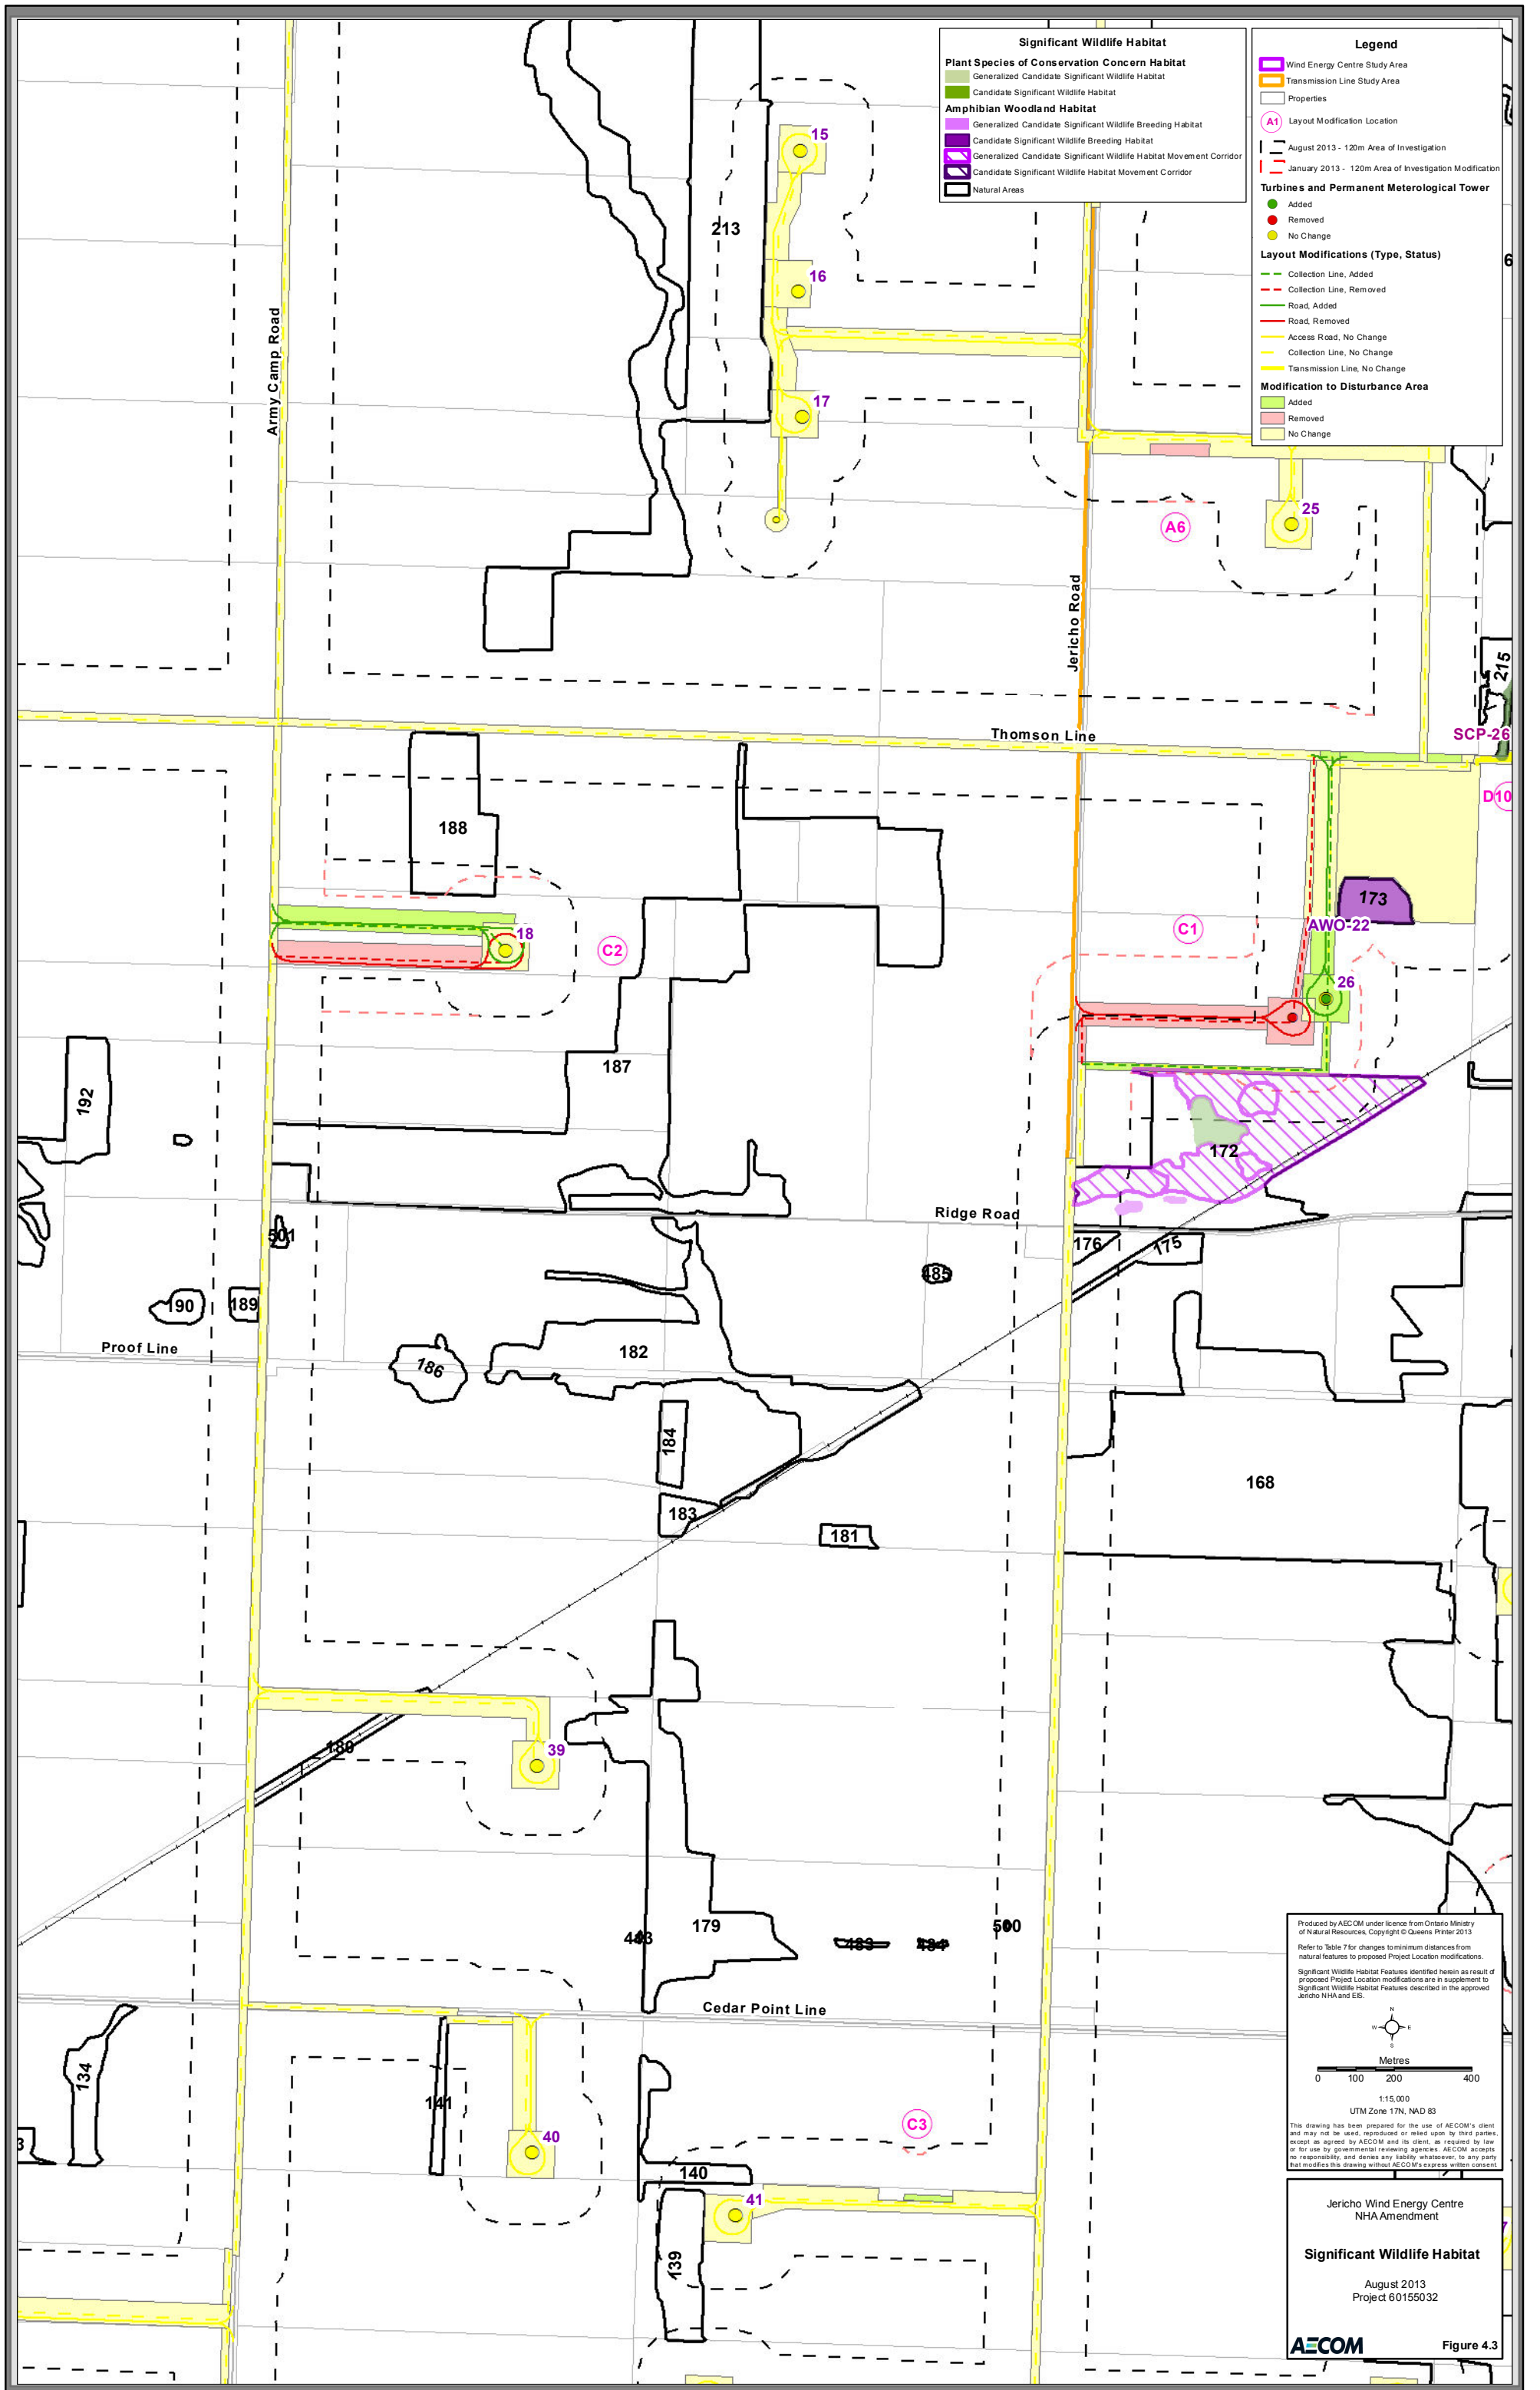
AECOM Figure 4.3

Significant Wildlife Habitat

Plant Species of Conservation Concern Habitat

- Generalized Candidate Significant Wildlife Habitat
- Candidate Significant Wildlife Habitat

Amphibian Woodland Habitat

- Generalized Candidate Significant Wildlife Breeding Habitat
- Candidate Significant Wildlife Breeding Habitat
- Generalized Candidate Significant Wildlife Habitat Movement Corridor
- Candidate Significant Wildlife Habitat Movement Corridor
- Natural Areas

- Generalized Candidate Significant Wildlife Habitat for Amphibian Woodland Breeding in Natural Area 173 was changed to candidate Significant Wildlife Habitat Feature AWO-22 because it is within 120 m of a proposed access road as a result of Modification C1 (refer to **Figure 4.3**);

- Candidate Significant Amphibian Woodland Breeding Habitat Feature AWO-20 in Natural Area 172 was changed to Generalized Candidate Significant Wildlife Habitat because it is more than 120 m away from a proposed access road as a result of Modification C1 (refer to **Figure 4.3**);

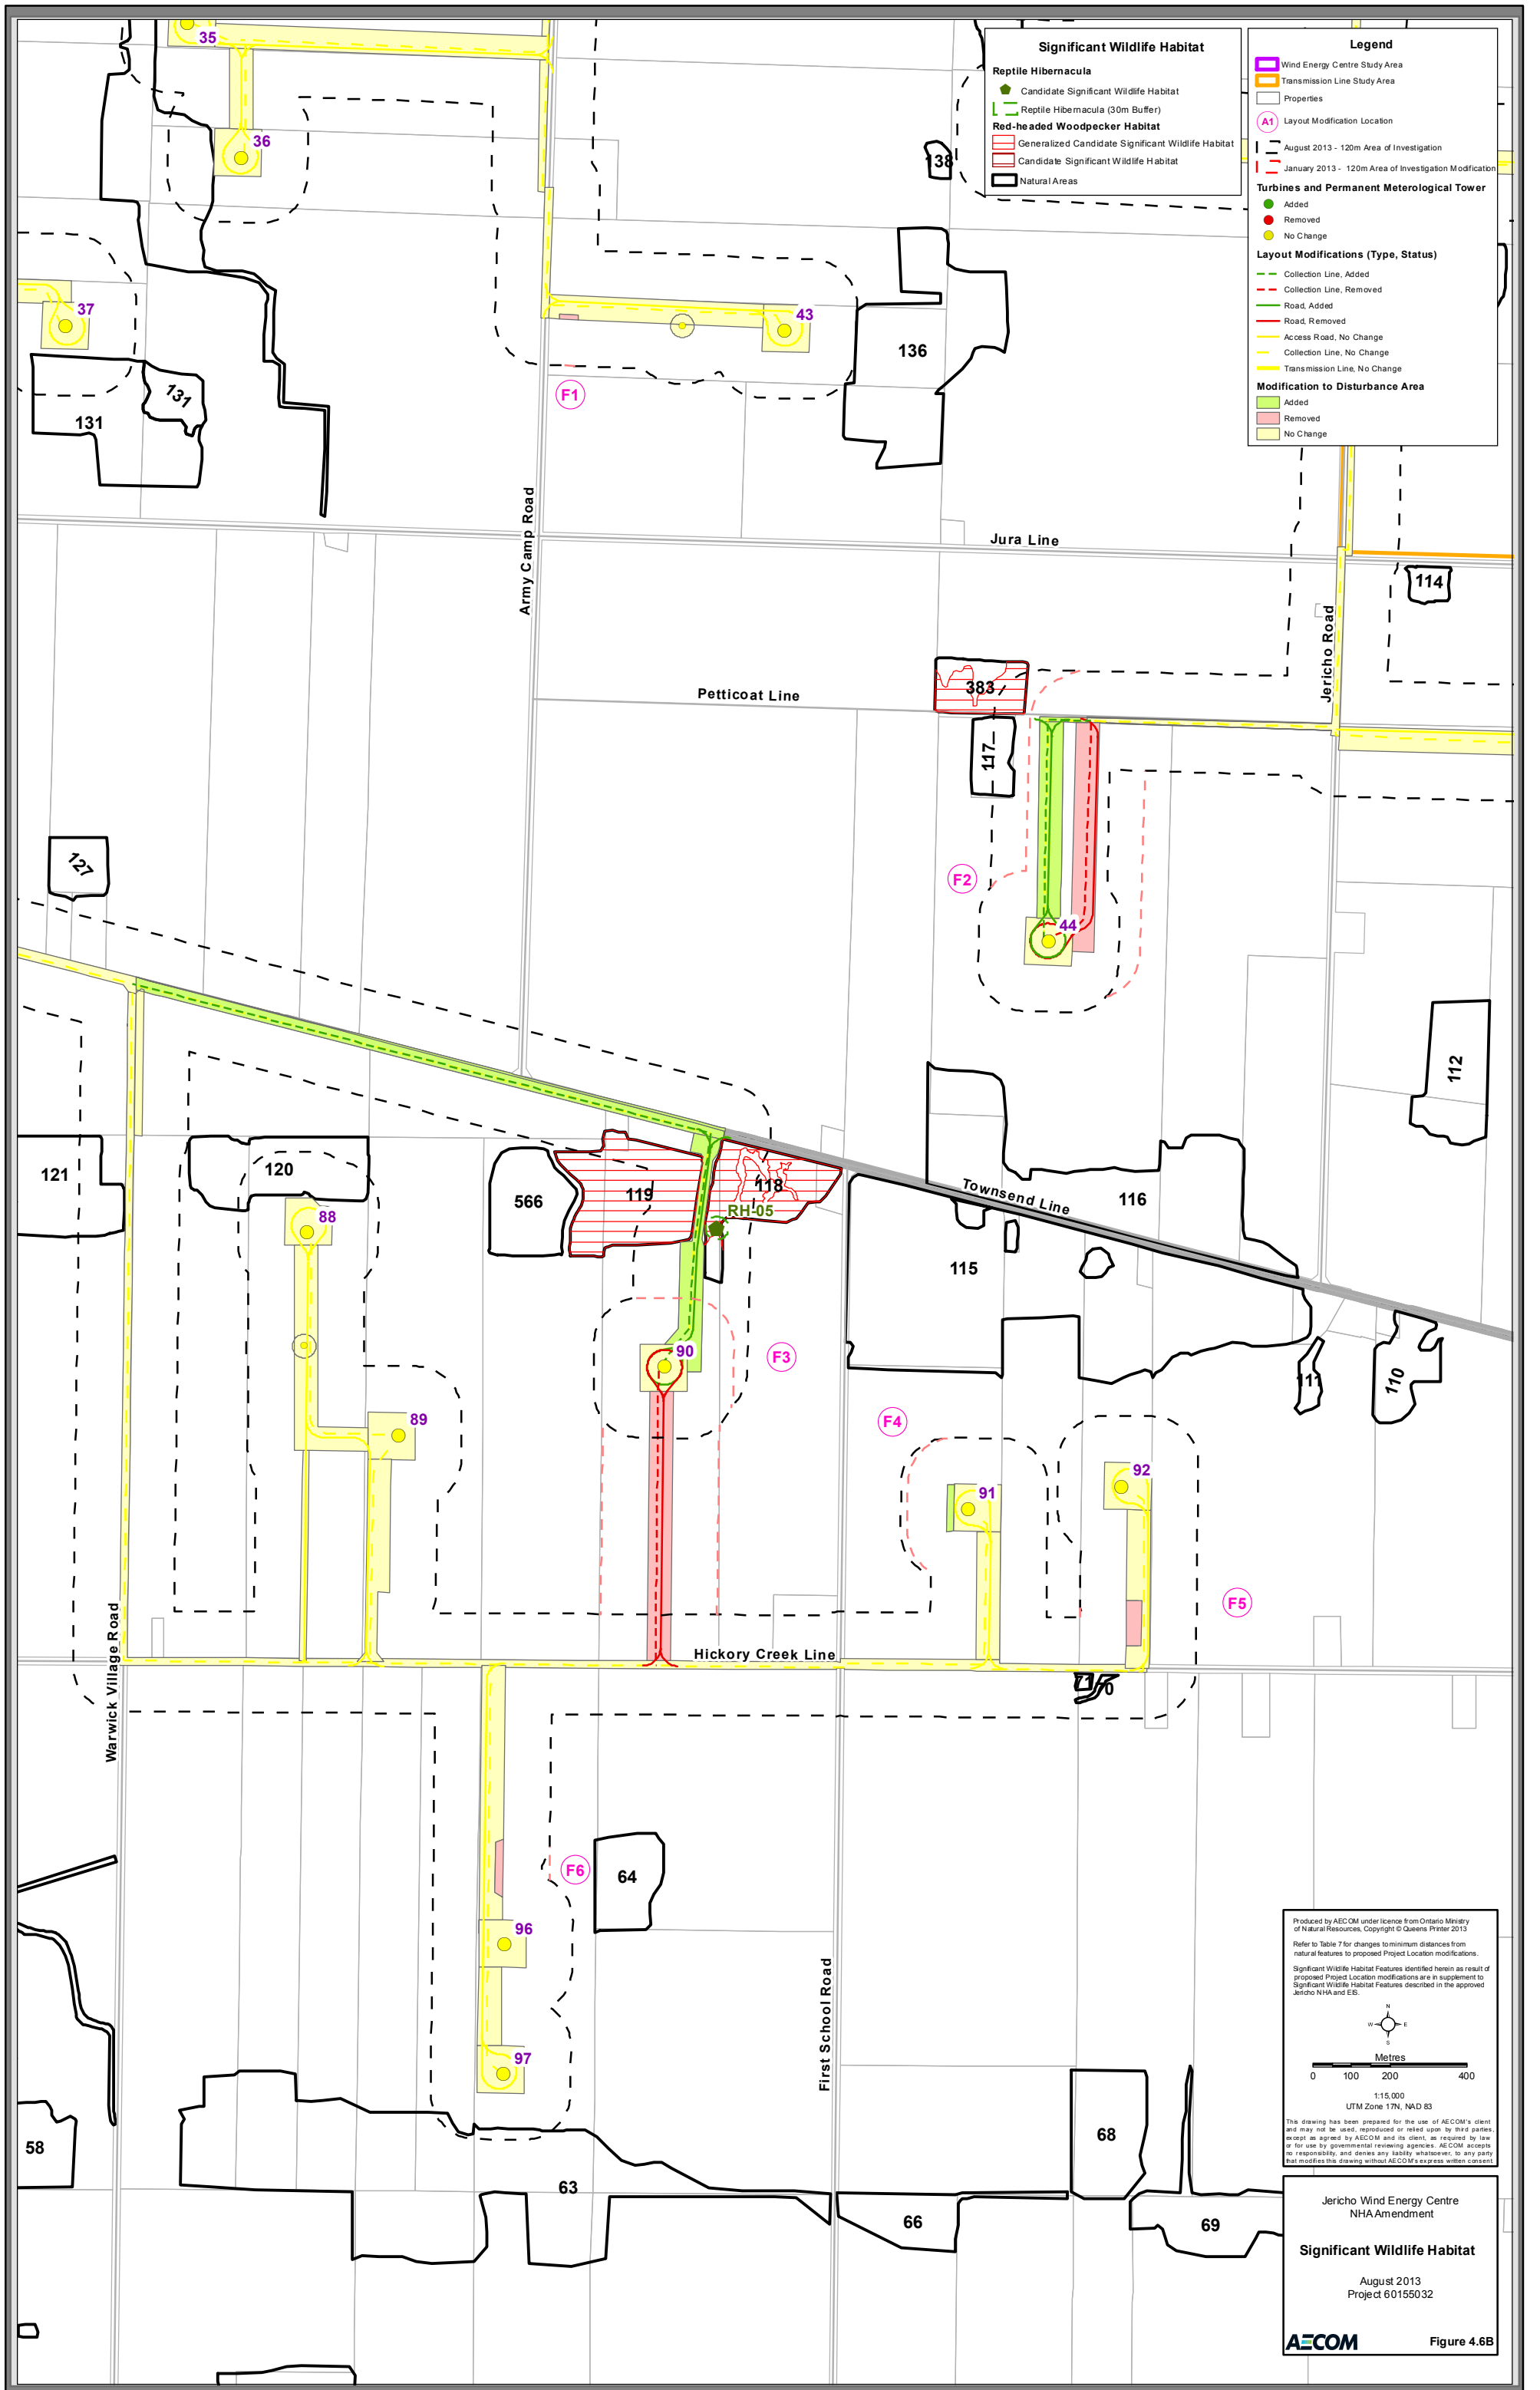
Jericho Wind Energy Centre
 NHA Amendment
Significant Wildlife Habitat
 August 2013
 Project 60155032
AECOM Figure 4.6B

Significant Wildlife Habitat

- Reptile Hibernacula
 - Candidate Significant Wildlife Habitat
 - Reptile Hibernacula (30m Buffer)
- Red-headed Woodpecker Habitat
 - Generalized Candidate Significant Wildlife Habitat
 - Candidate Significant Wildlife Habitat
- Natural Areas
