**HERITAGE ASSESSMENT REPORT, VERSION 3  
NEXTERA SUMMERHAVEN WIND ENERGY CENTRE**

## **Inventory of Cultural Features at the Project Location**

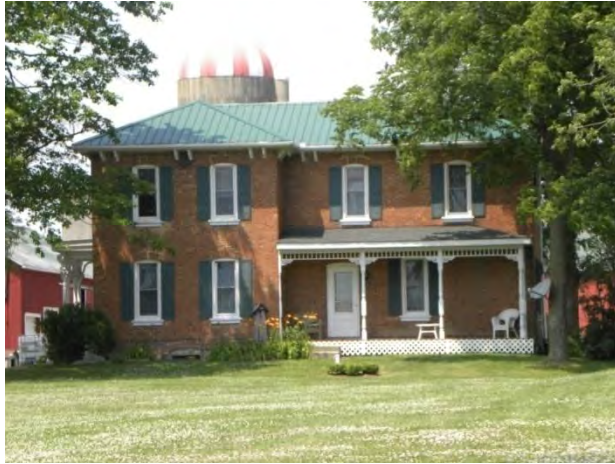
### Site #3

**Description:** Two storey red brick house, low pitch hip gable roof with heavy brackets, porch on main façade as well as on the side.

**Determination of Cultural Heritage Value or Interest (CHVI) According to O. Reg. 9/06:** Not identified to have CHVI.

**Description:** Timber frame, gambrel roof. Modern outbuildings and concrete silos.

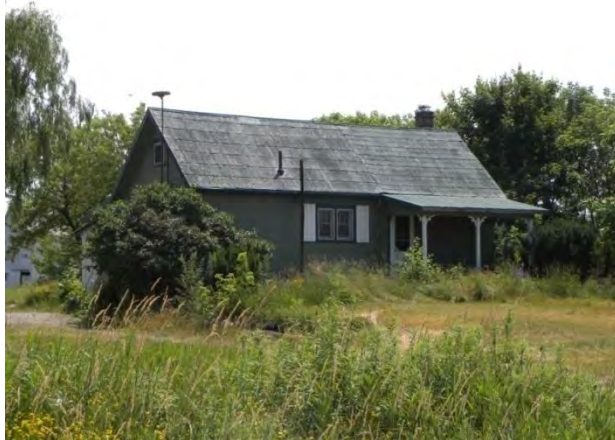
### Site #4

**Description:** One and a half storey frame house, high pitch gable roof, porch on main façade.

**Determination of Cultural Heritage Value or Interest (CHVI) According to O. Reg. 9/06:** Not identified to have CHVI.

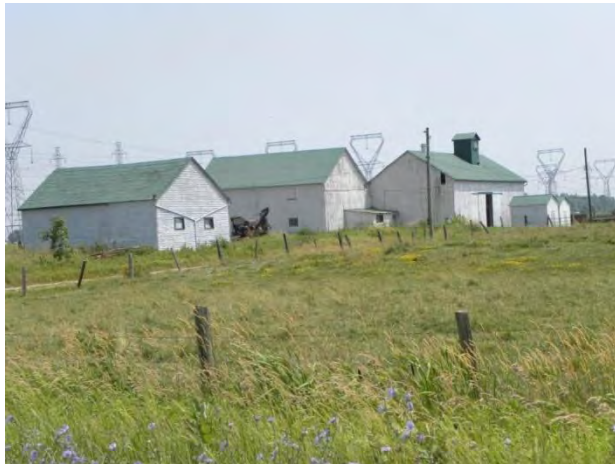
**Description:** Timber frame, rectangular, medium pitch roof.

**According to O. Reg. 9/06:** Not identified to have CHVI.

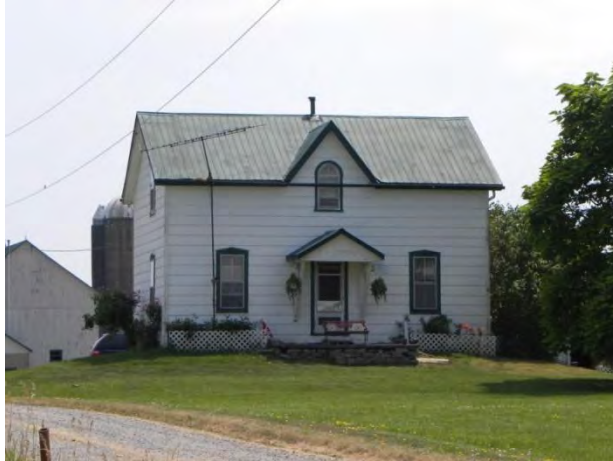
### Site #5

**Description:** One and a half storey frame house, high pitch gable end tin roof with centre dormer

**Determination of Cultural Heritage Value or Interest (CHVI) According to O. Reg. 9/06:** Not identified to have CHVI.

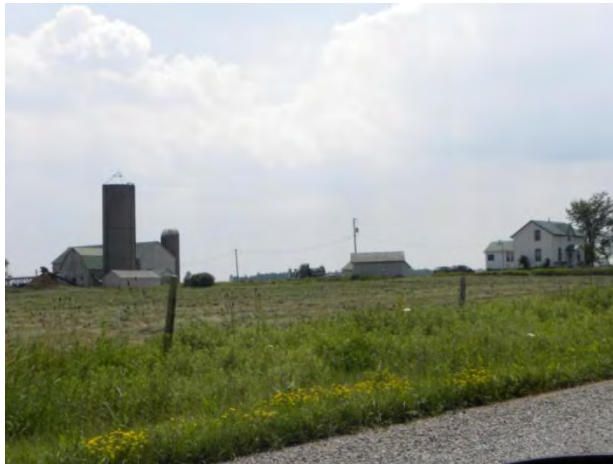
**Description:** One timber frame, gambrel roof. One rectangular, high pitch gable roof. Modern outbuildings, concrete silos.

**Determination of Cultural Heritage Value or Interest (CHVI) According to O. Reg. 9/06:** Not identified to have CHVI.

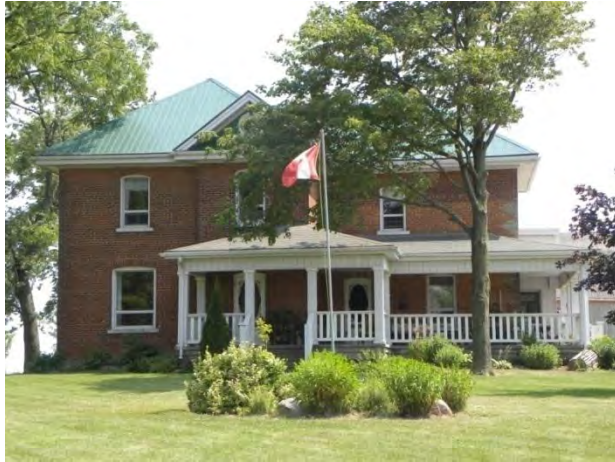
### Site #6

**Description:** Two storey red brick house, Queen Anne style dormer on main façade. Wrap around porch and modern addition on back.

**Determination of Cultural Heritage Value or Interest (CHVI) According to O. Reg. 9/06:** Not identified to have CHVI.

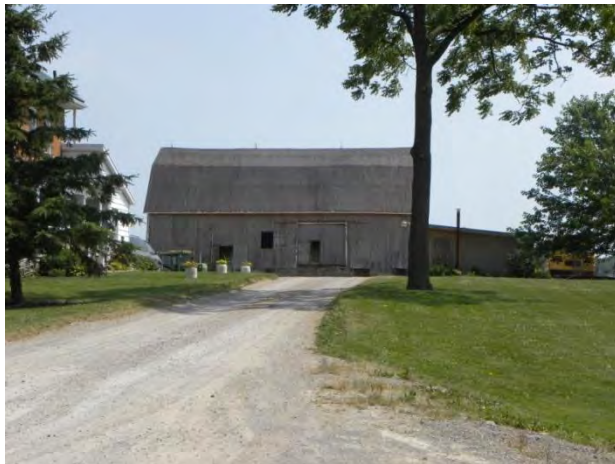
**Description:** Stone foundation, gambrel roof.

**Determination of Cultural Heritage Value or Interest (CHVI) According to O. Reg. 9/06:** Not identified to have CHVI.

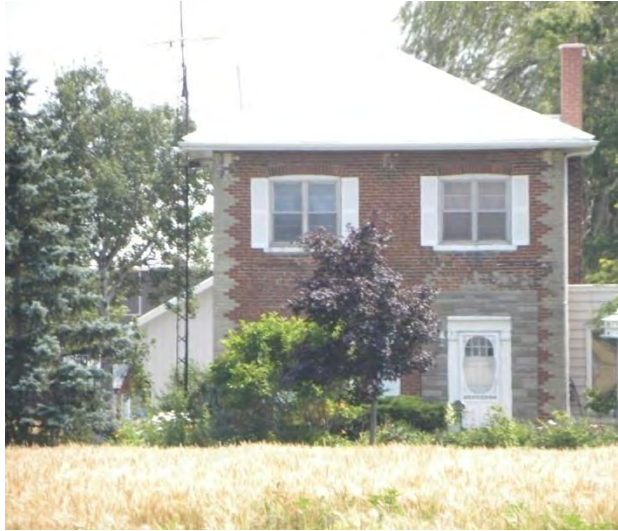
### Site #7

**Description:** Two storey red brick with white brick quoins; new windows and door; low pitch hip gable roof, modern addition on side and back. Heavily modified.

**Determination of Cultural Heritage Value or Interest (CHVI) According to O. Reg. 9/06:** Not identified to have CHVI.

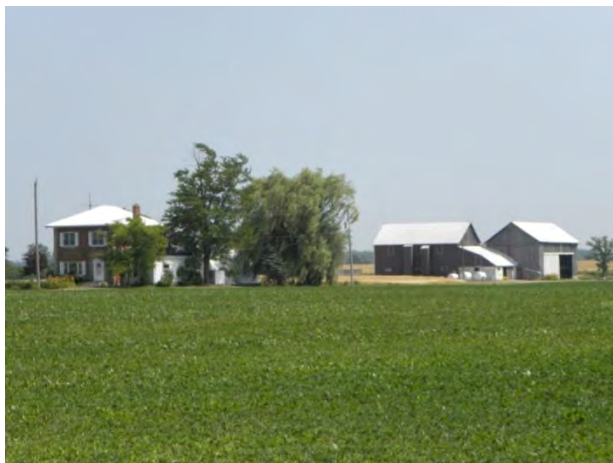
**Description:** Both barns are rectangular timber frame with high pitch gambrel roof, one has a lean-to on the side.

**Determination of Cultural Heritage Value or Interest (CHVI) According to O. Reg. 9/06:** Not identified to have CHVI.

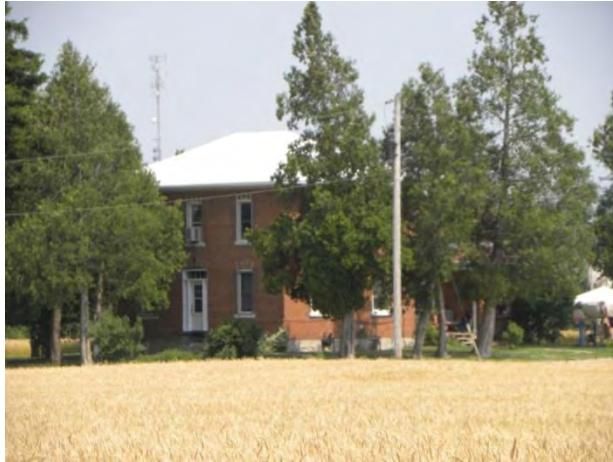
### Site #8

**Description:** Two storey red brick house, low pitch hip gable roof.

**Determination of Cultural Heritage Value or Interest (CHVI) According to O. Reg. 9/06:** Not identified to have CHVI.

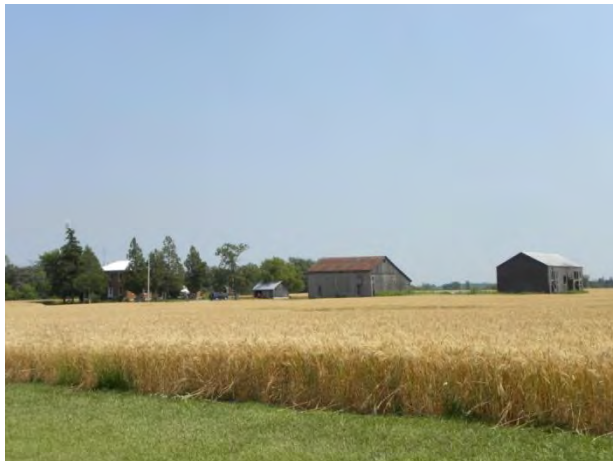
**Description:** Rectangular timber frame, medium pitch gable end roof. One with lean-to addition.

**Determination of Cultural Heritage Value or Interest (CHVI) According to O. Reg. 9/06:** Not identified to have CHVI.

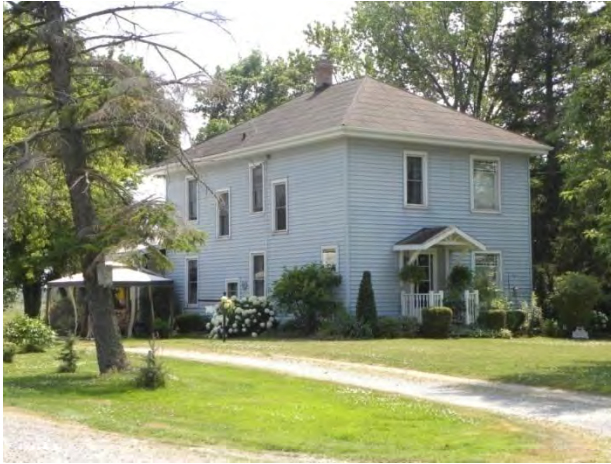
### Site #9

**Description:** Two storey frame house, low pitch hip gable roof, modern one storey addition on back

**Determination of Cultural Heritage Value or Interest (CHVI) According to O. Reg. 9/06:** Not identified to have CHVI.

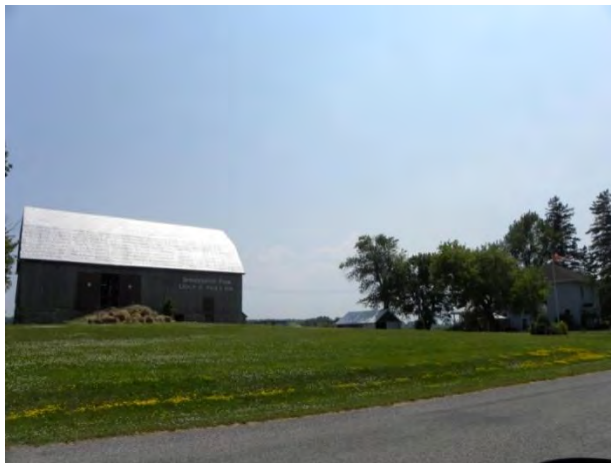
**Description:** Timber frame, gambrel tin roof

**Determination of Cultural Heritage Value or Interest (CHVI) According to O. Reg. 9/06:** Not identified to have CHVI.

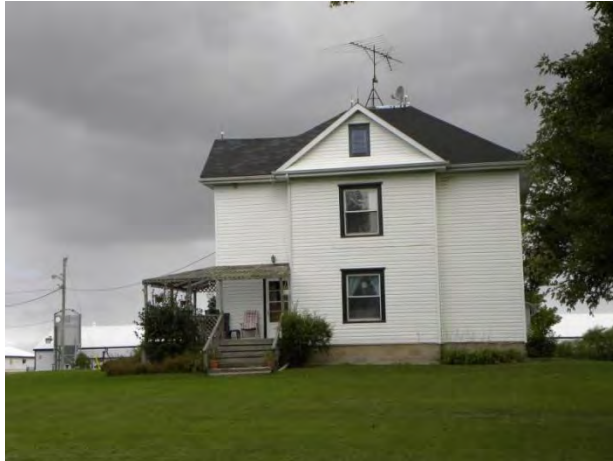
### Site #10

**Description:** Two storey frame house, gambrel dormer on main façade, modern wrap around porch, modern one storey addition on back. Modern outbuildings and concrete silo at this location.

**Determination of Cultural Heritage Value or Interest (CHVI) According to O. Reg. 9/06:** Not identified to have CHVI.

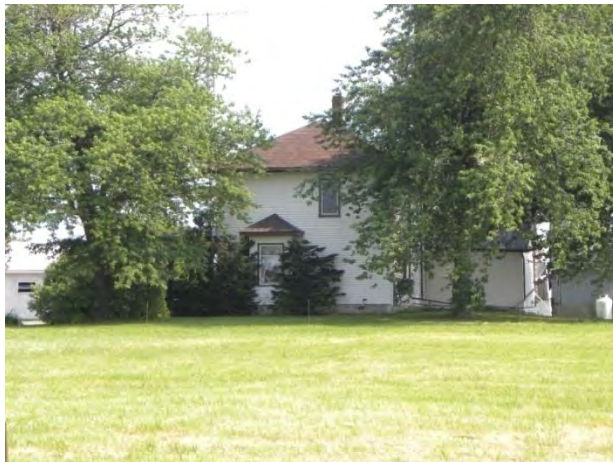
### Site #11

**Description:** Two storey frame house, low pitch hip gable roof, addition on back and side. Modern outbuildings and concrete silos at this location.

**Determination of Cultural Heritage Value or Interest (CHVI) According to O. Reg. 9/06:** Not identified to have CHVI.

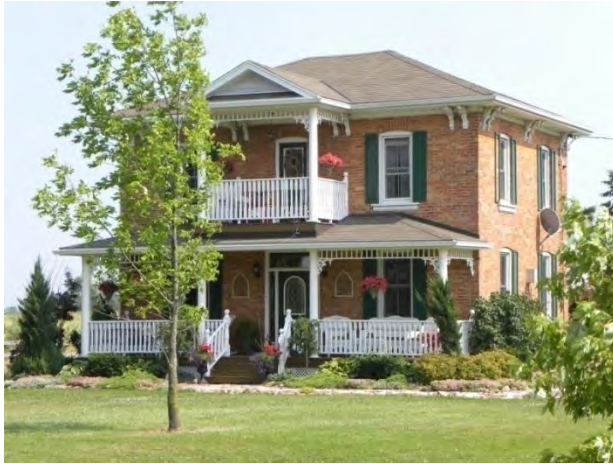
### Site #12

**Description:** Two storey red brick house, low pitch hip gable roof, heavy brackets in eaves; two storey modern porch. Modern outbuildings and concrete silos at this location.

**Determination of Cultural Heritage Value or Interest (CHVI) According to O. Reg. 9/06:** Not identified to have CHVI.

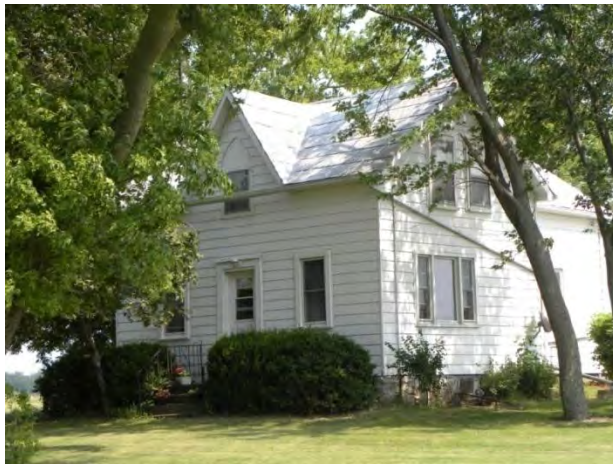
### Site #13

**Description:** One and a half storey frame house, medium pitch gable roof with centre gable; modern outbuildings and concrete silos at this location.

**Determination of Cultural Heritage Value or Interest (CHVI) According to O. Reg. 9/06:** Not identified to have CHVI.

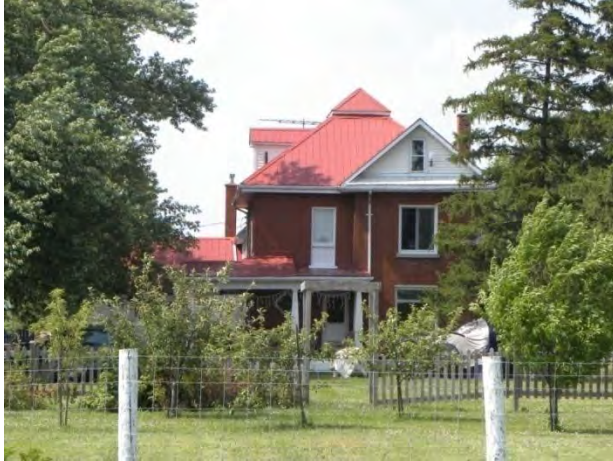
### Site #14

**Description:** Two storey red brick house, steep pitch, hip roof; gable dormer on main façade

Not Identified to have CHVI.

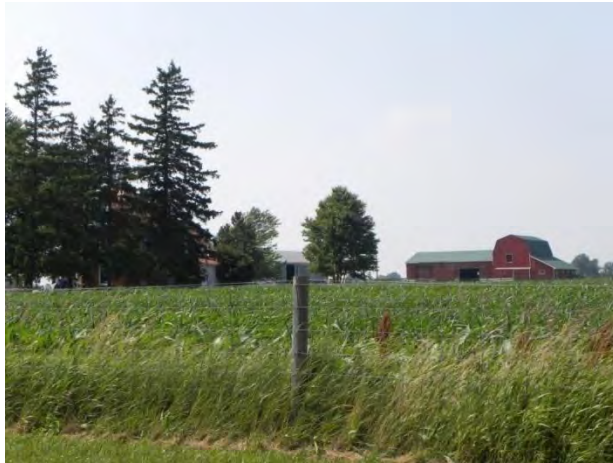
**Description:** One is a rectangular timber frame, gable roof and the other has a gambrel roof

**Determination of Cultural Heritage Value or Interest (CHVI) According to O. Reg. 9/06:** Not identified to have CHVI.

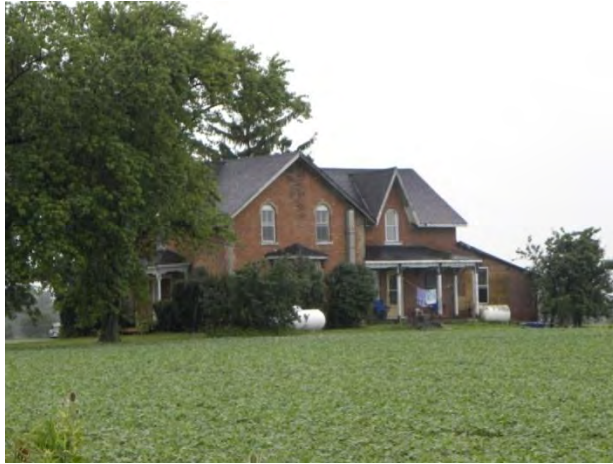
### Site #15

**Description:** One and a half storey red brick house, gable roof, modern lean-to addition on back. Original porches.

**Determination of Cultural Heritage Value or Interest (CHVI) According to O. Reg. 9/06:** Not identified to have CHVI.

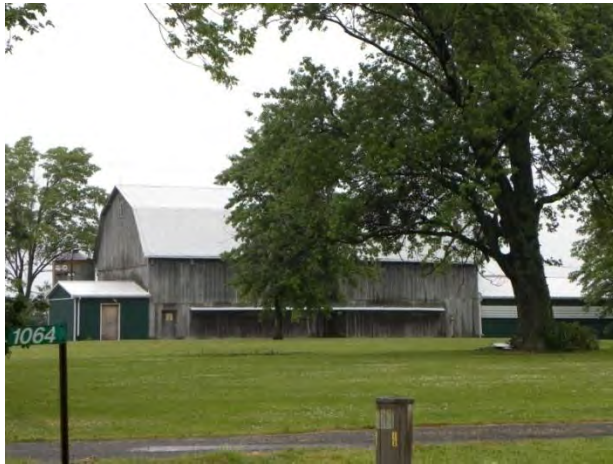
**Description:** Timber frame, gambrel roof with modern addition on front.

**Determination of Cultural Heritage Value or Interest (CHVI) According to O. Reg. 9/06:** Not identified to have CHVI.

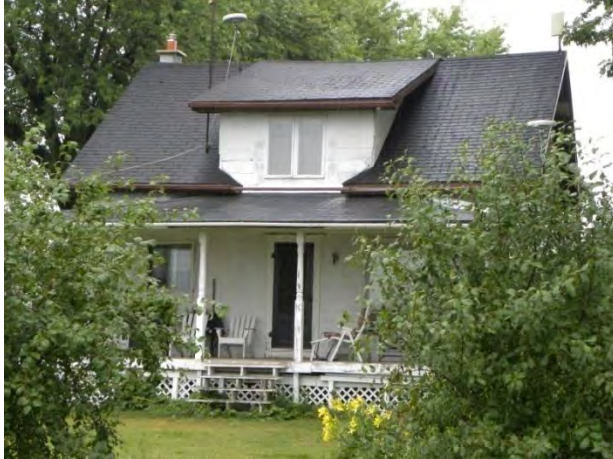
### Site #16

**Description:** One and a half storey frame house, medium pitch gable shingled roof, shed dormer

**Determination of Cultural Heritage Value or Interest (CHVI) According to O. Reg. 9/06:** Not identified to have CHVI.

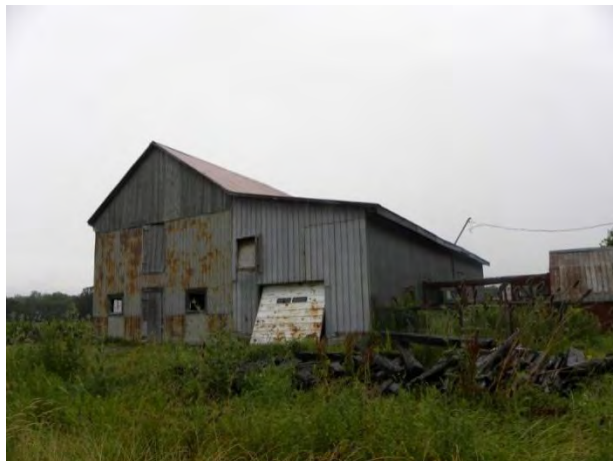
**Description:** Timber frame with lean-to steel sided addition

**Determination of Cultural Heritage Value or Interest (CHVI) According to O. Reg. 9/06:** Not identified to have CHVI.

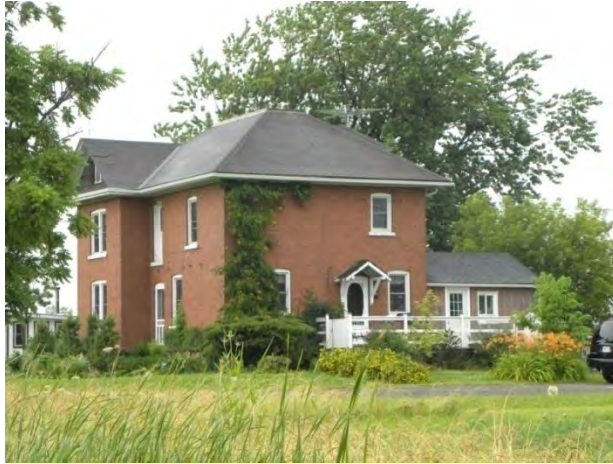
### Site #17

**Description:** Two storey red brick house, low pitch hip gable roof. Modern addition on back.

**Determination of Cultural Heritage Value or Interest (CHVI) According to O. Reg. 9/06:** Not identified to have CHVI.

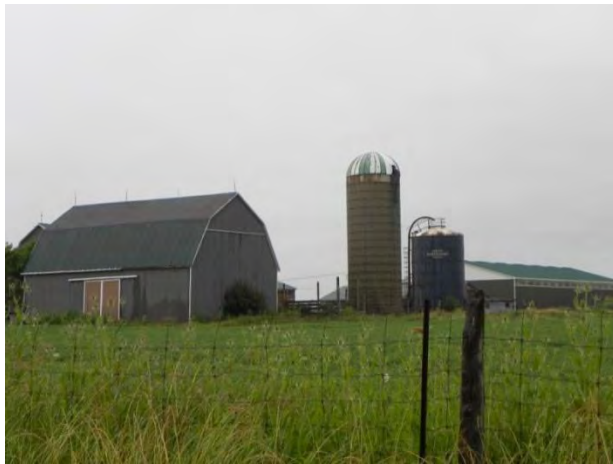
**Description:** Timber frame, gambrel roof. Concrete silos and modern outbuildings

**Determination of Cultural Heritage Value or Interest (CHVI) According to O. Reg. 9/06:** Not identified to have CHVI.

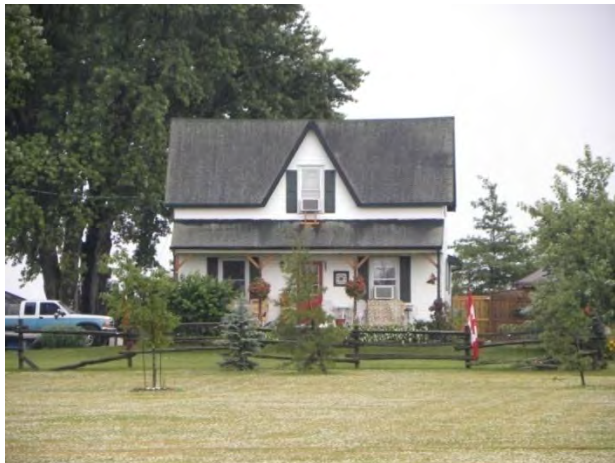
### Site #19

**Description:** One and a half storey, steep pitch gable roof with centre dormer

**Determination of Cultural Heritage Value or Interest (CHVI) According to O. Reg. 9/06:** Not identified to have CHVI.

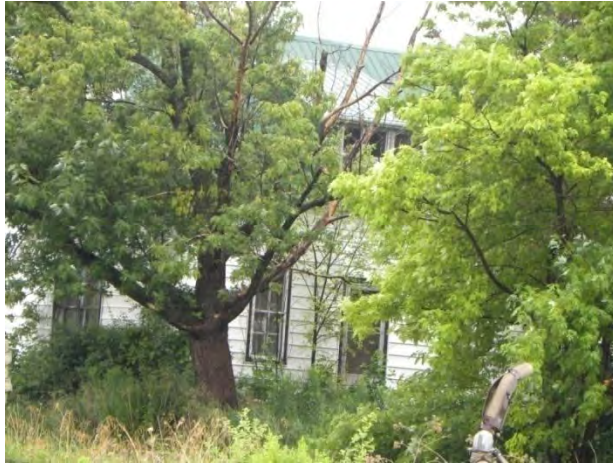
### Site #20

**Description:** One and a half storey frame house. Modern outbuildings and concrete silos. Tin roof.

**Determination of Cultural Heritage Value or Interest (CHVI) According to O. Reg. 9/06:** Not identified to have CHVI.

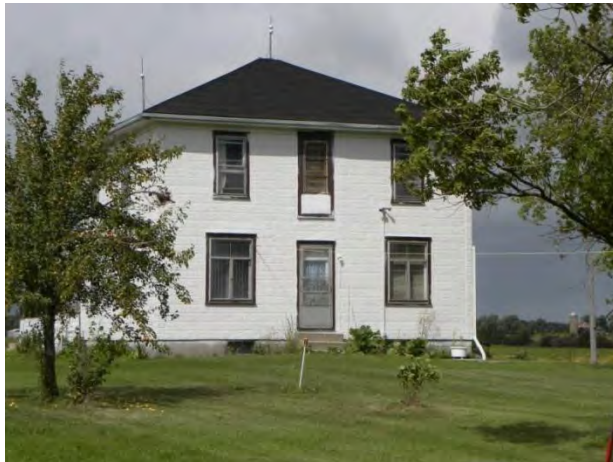
### Site #21

**Description:** Two storey concrete block house, low pitch hip gable roof.

**Determination of Cultural Heritage Value or Interest (CHVI) According to O. Reg. 9/06:** Not identified to have CHVI.

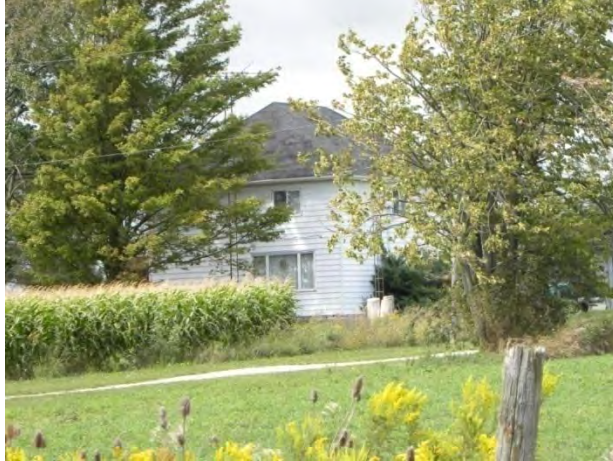
**Site #22**

**Description:** Two storey frame house, low pitch hip gable roof

**Determination of Cultural Heritage Value or Interest (CHVI) According to O. Reg. 9/06:** Not identified to have CHVI.

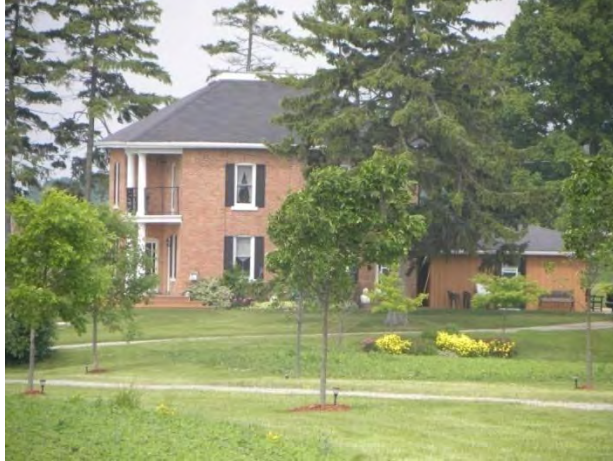
### Site #23

**Description:** Two storey red brick house, modern addition on back and modern two storey porch on front façade.

**Determination of Cultural Heritage Value or Interest (CHVI) According to O. Reg. 9/06:** This house was included on a Heritage Haldimand Inventory of Properties of Potential Heritage Significance (pre. 1991). Not identified at this time to have CHVI.

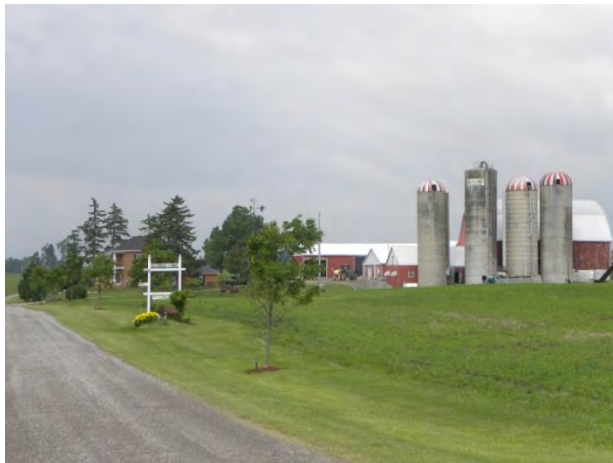
**Description:** Timber frame, gambrel roof. Modern outbuildings and concrete silos

**Determination of Cultural Heritage Value or Interest (CHVI) According to O. Reg. 9/06:** Not identified to have CHVI.

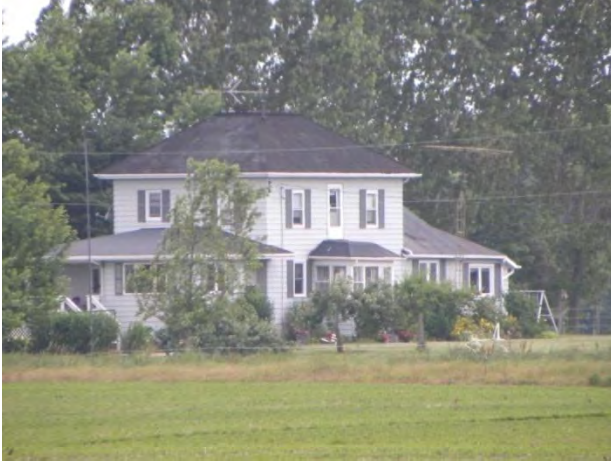
### Site #24

**Description:** Two storey frame house, low pitch hip gable roof with modern addition on back, front and side

**Determination of Cultural Heritage Value or Interest (CHVI) According to O. Reg. 9/06:** Not identified to have CHVI.

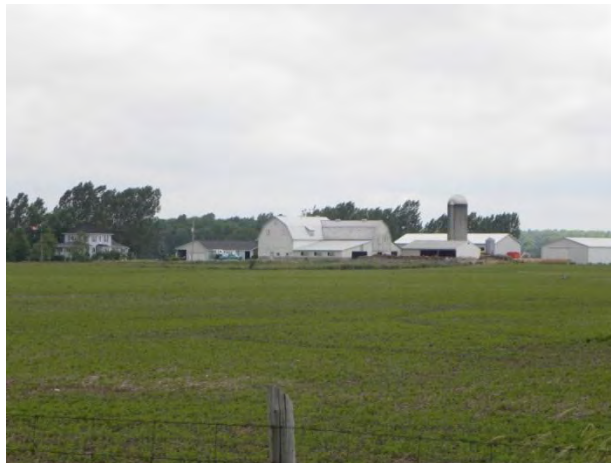
**Description:** Gambrel roof with modern lean-to addition. Modern outbuildings and a concrete silo.

**Determination of Cultural Heritage Value or Interest (CHVI) According to O. Reg. 9/06:** Not identified to have CHVI.

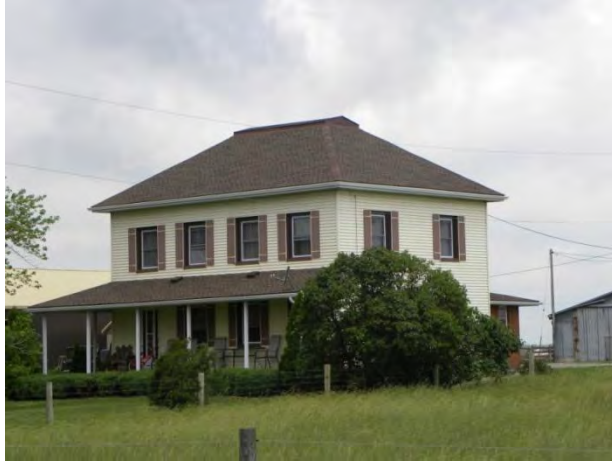
### Site #25

**Description:** Two storey frame house, low pitch hip gable roof, modern addition on back

**Determination of Cultural Heritage Value or Interest (CHVI) According to O. Reg. 9/06:** Not identified to have CHVI.

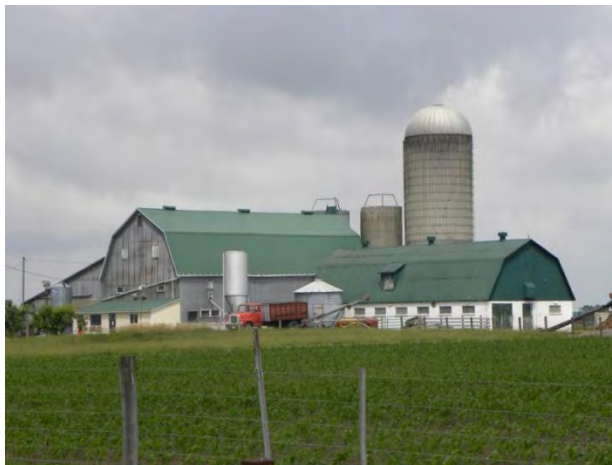
**Description:** Timber frame, gambrel roof, one with a lean-to addition, concrete silos

**Determination of Cultural Heritage Value or Interest (CHVI) According to O. Reg. 9/06:** Not identified to have CHVI.

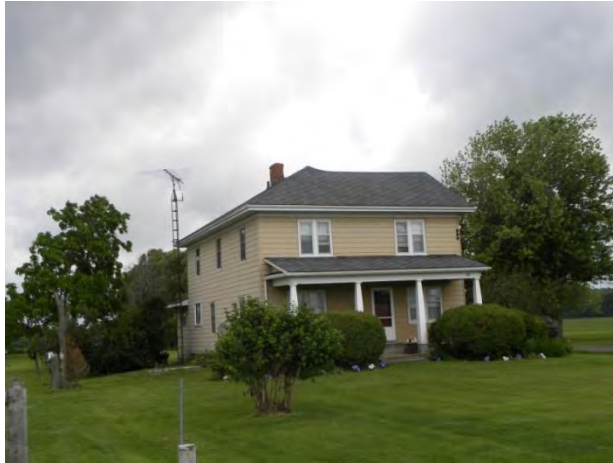
### Site #26

**Description:** Two storey frame house, low pitch hip gable roof, porch on main façade, modern addition on back

**Determination of Cultural Heritage Value or Interest (CHVI) According to O. Reg. 9/06:** Not identified to have CHVI.

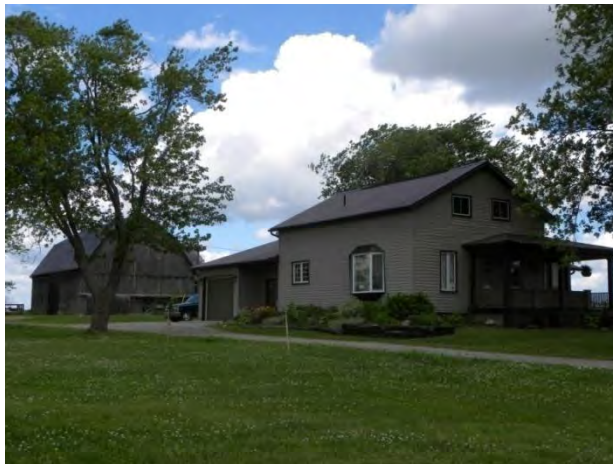
### Site #27

**Description:** One and a half storey frame house, medium pitch gable roof, modern garage addition on back.

**Determination of Cultural Heritage Value or Interest (CHVI) According to O. Reg. 9/06:** Not identified to have CHVI.

**Description:** Timber frame, gambrel roof

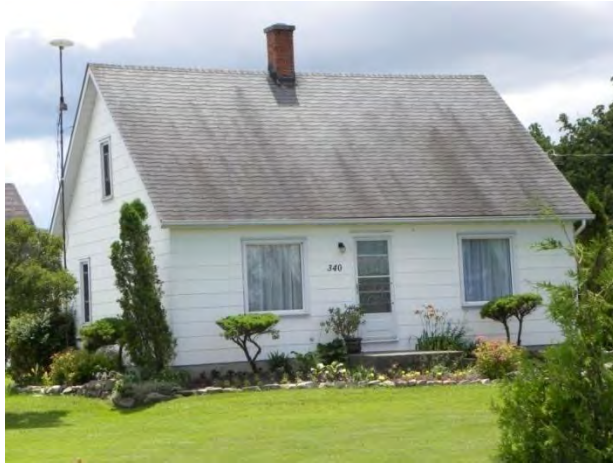
### Site #28

**Description:** One and a half storey frame house, high pitch gable end roof

**Determination of Cultural Heritage Value or Interest (CHVI) According to O. Reg. 9/06:** Not identified to have CHVI.

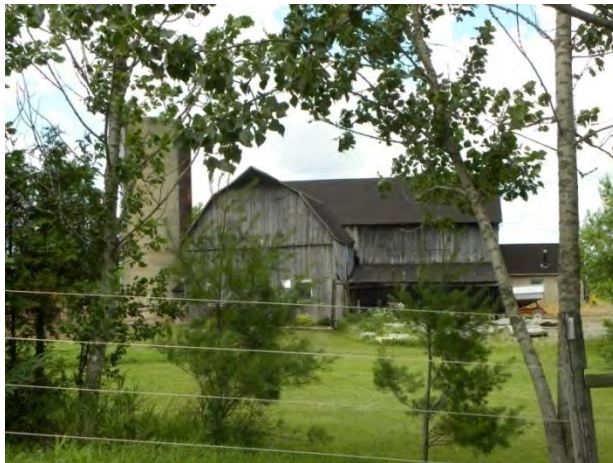
### Site #29

**Description:** Timber frame, gambrel roof. Modern outbuildings and concrete silo.

**Determination of Cultural Heritage Value or Interest (CHVI) According to O. Reg. 9/06:** Not identified to have CHVI.

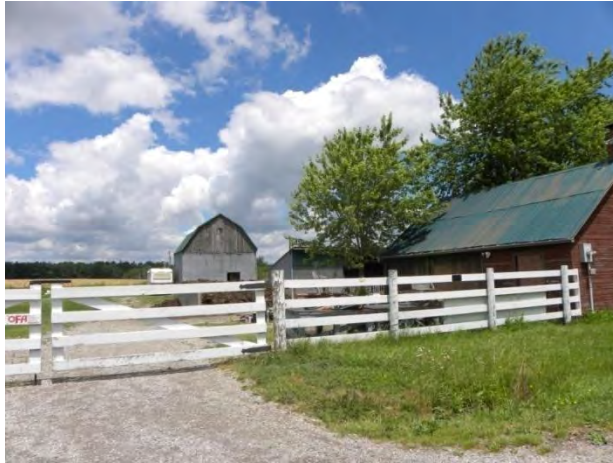
### Site #30

**Description:** Timber frame, gambrel roof, partially steel sided

**Determination of Cultural Heritage Value or Interest (CHVI) According to O. Reg. 9/06:** Not identified to have CHVI.

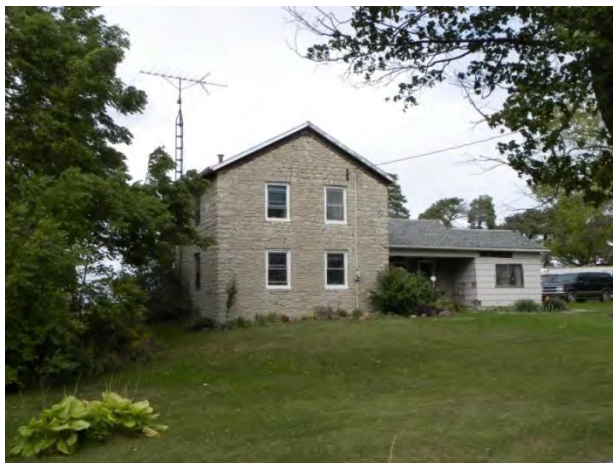
### Site #31

**Description:** Two storey, stone house with medium pitch gambrel shingled roof, modern one storey addition on back.

**Determination of Cultural Heritage Value or Interest (CHVI) According to O. Reg. 9/06:** Not identified to have CHVI.
