NextEra Energy Canada, ULC
Bluewater Wind Energy Centre

Final Water Assessment and Water Body Report

60155032

June, 2012

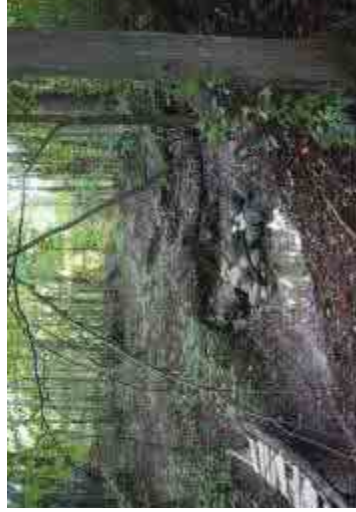
Photograph 1. Site overview ↑

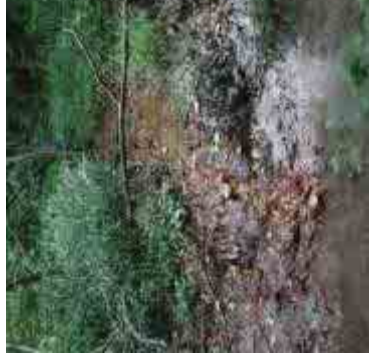
Photograph 2. Iron staining ↑

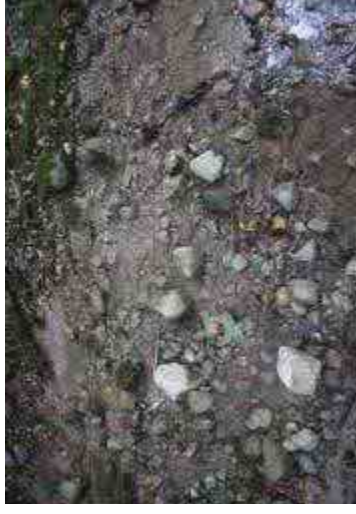
Photograph 3. Watercourse substrate ↑

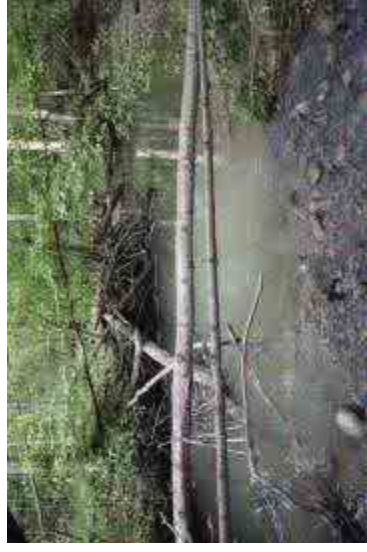
Photograph 3. Woody debris ↑

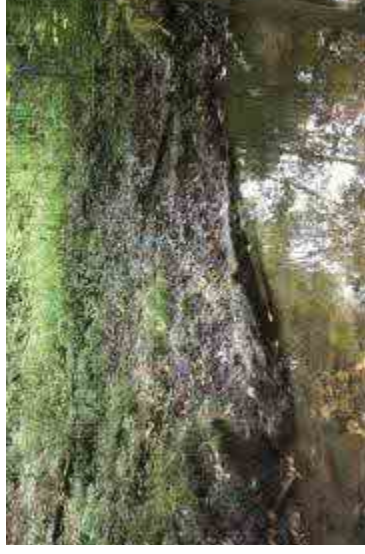
Photograph 3. Bank seepage ↑

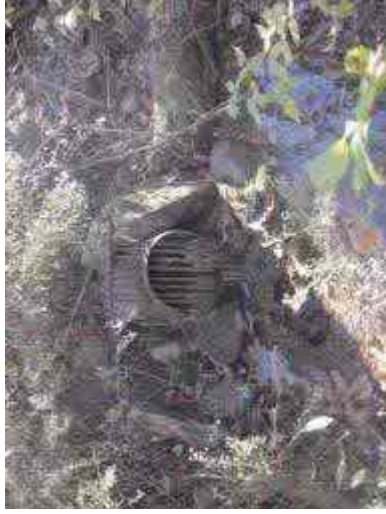
Photograph 2. Tile drain input ↕

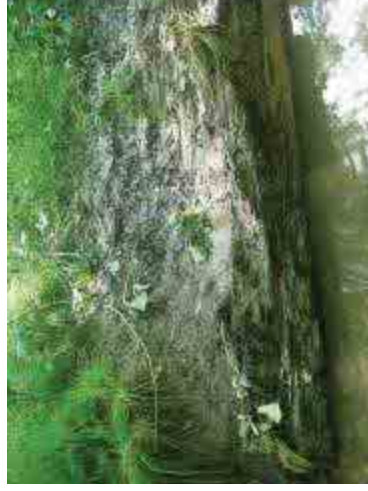
Photograph 3. Bank seepage ↗

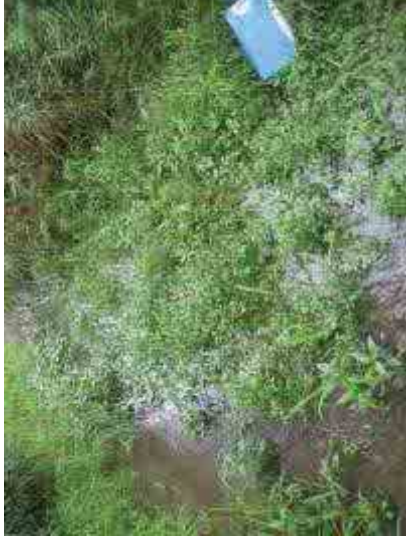
Photograph 3. Watercress on North side ↑

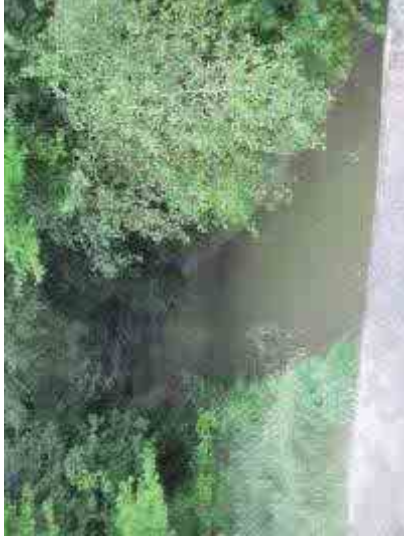
Photograph 1. Site overview looking North ↑

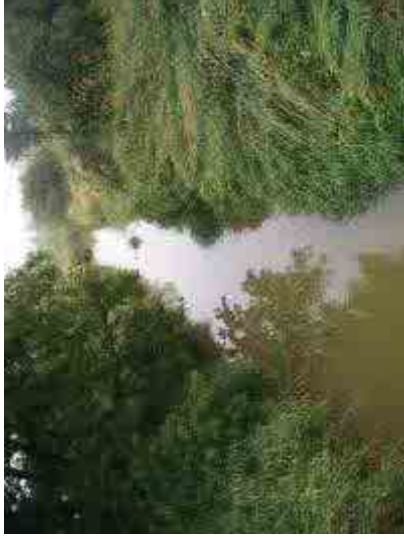
Photograph 2. Site overview looking South ↑

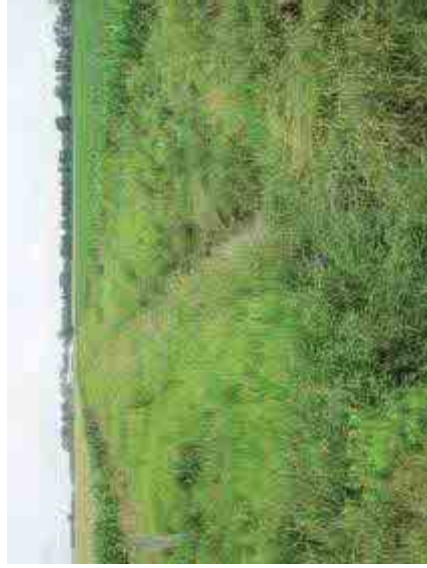
Photograph 1. Site overview looking North ↑

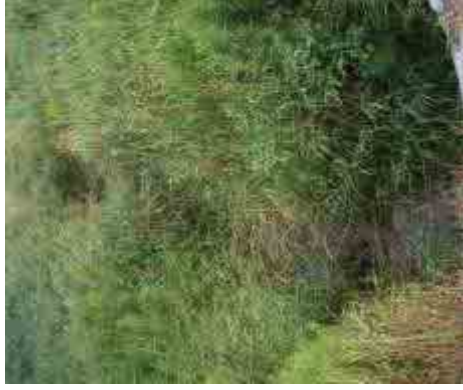
Photograph 2. Site overview looking South ↑

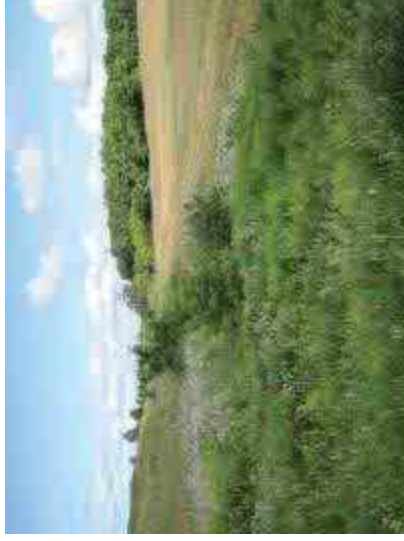
Photograph 2. North side overview ↗

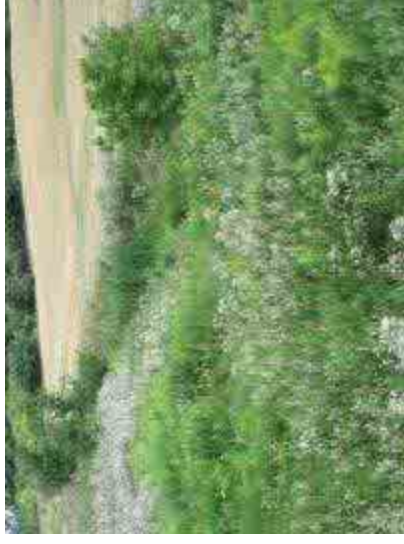
Photograph 3. North side vegetation ↗

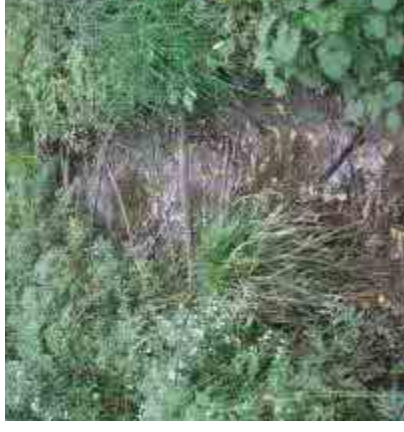
Photograph 3. Pooling ↑

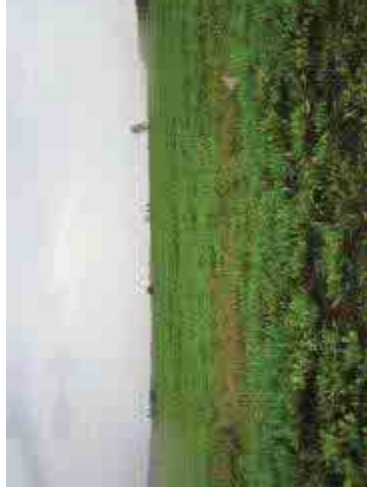
Photograph 1. East site overview, buried channel ↗

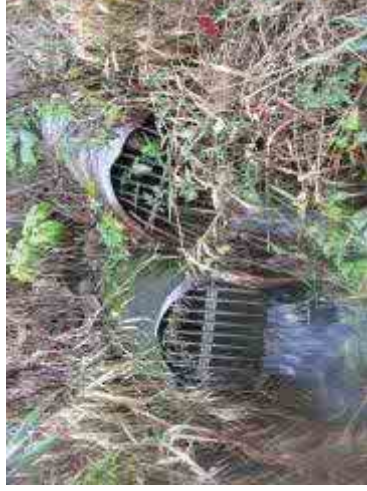
Photograph 2. Tile drain inputs at point where channel flows openly ↗

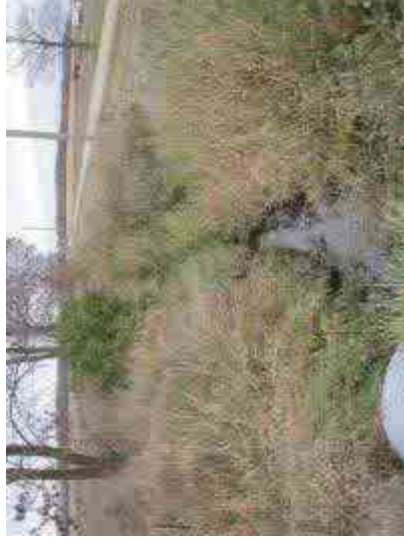
Feature ID	Project Component	Investigation Date	Description of Site	Feature Description	Feature Sensitivity
C88	Collection Line Buffer	November 3, 2011	<ul style="list-style-type: none"> The watercourse runs parallel with the adjacent road with agriculture fields as the surrounding land use. The channel starts from the output of a tile drain from the adjacent west field. Tile drain inputs were observed throughout the site investigation area. 	<p>The watercourse is a defined channelized feature. This feature is classified as cool/cold water by ABCA. It runs along the roadside and is a straightened watercourse consisting of run only. The banks are slightly unstable to observed scouring. The water is clear and the substrate is sandy silt clay. Canopy cover is low and is a mix of grasses, trees and shrubs. No instream habitat cover was noted. Groundwater indicator watercress was observed. The downstream fish species is baitfish community (MNR, 1992).</p>	Low

Photograph 1. Site overview looking east ↗

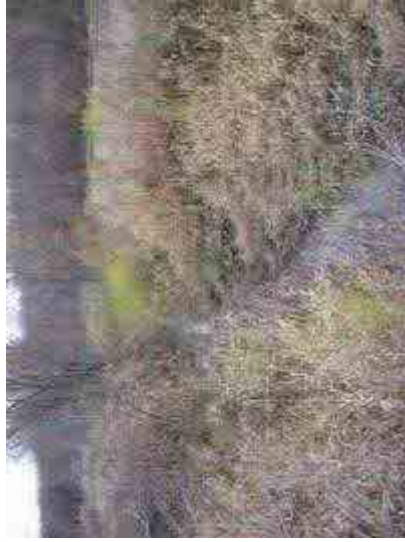
Feature ID	Project Component	Investigation Date	Description of Site	Feature Description	Feature Sensitivity
C99	<ul style="list-style-type: none"> Turbine 41 Road Buffer 	November 3, 2011	<ul style="list-style-type: none"> The watercourse flows through an agricultural field with crops and into a meadow marsh and deciduous swamp (classified as MAM2-2 and SWD3, ELC Feature ID 514). No tile inputs were noted and topography is flat. Of note, a beaver dam was observed downstream just outside of the site investigation area (within C71 study area). 	<p>The watercourse is a defined channelized feature. This site is classified as cool/cold water by ABCA. No observable flow due to beaver dam. It is a straight channel that is uniform run. The banks are slightly unstable. The water is turbid and has a green colour. Substrate consists of sandy silt clay. Canopy cover is low and consists of grasses, trees, and shrubs. Instream cover is moderate and consists of aquatic vegetation and woody debris. No groundwater indicators were observed. Downstream fish species consist of a baitfish community (MNR 1992, 1995).</p>	Low

Photograph 1. Site overview ↑

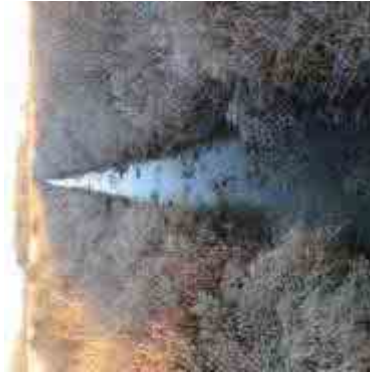
Photograph 1. Channel overview, upstream ↑

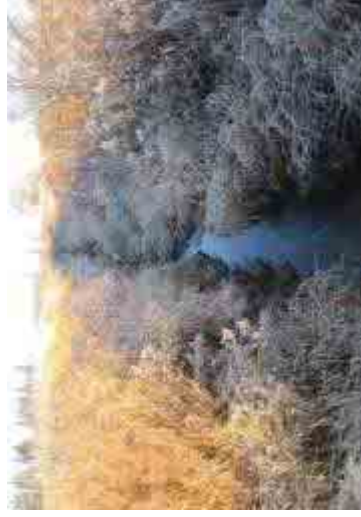
Photograph 2. Channel overview, midway ↑
